**California Department of Fish and Wildlife
San Mateo County
San Mateo Coastal Watersheds
Stream Habitat Assessment Reports**

Pilarcitos Creek

Surveyed 2010

STREAM INVENTORY REPORT

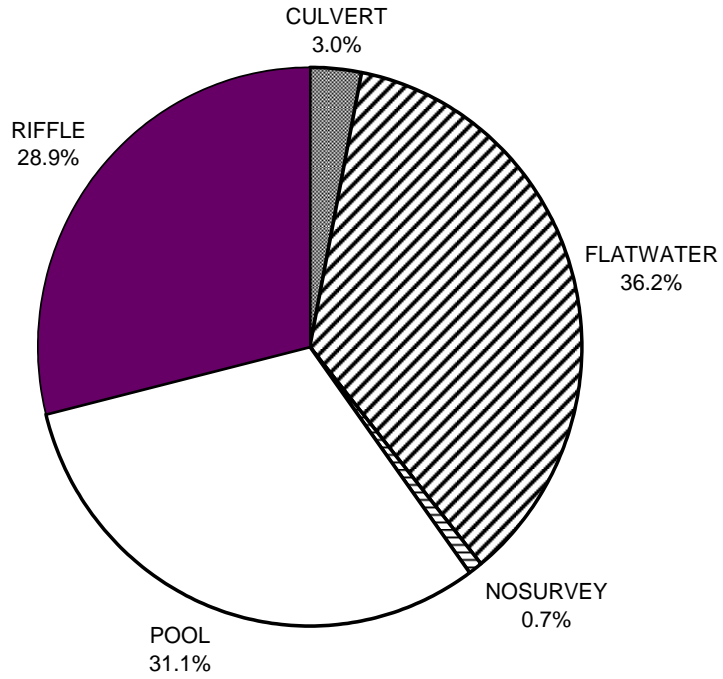
GRAPH 1

Table 1 summarizes the Level II riffle, flatwater, and pool habitat types. Based on frequency of occurrence there were 1% nosurvey units, 3% culvert units, 36% flatwater units, 29% riffle units and 31% pool units (Graph 1). Based on total length of Level II habitat types there were 14% nosurvey units, 1% culvert units, 42% flatwater units, 27% riffle units and 16% pool units (Graph 2).

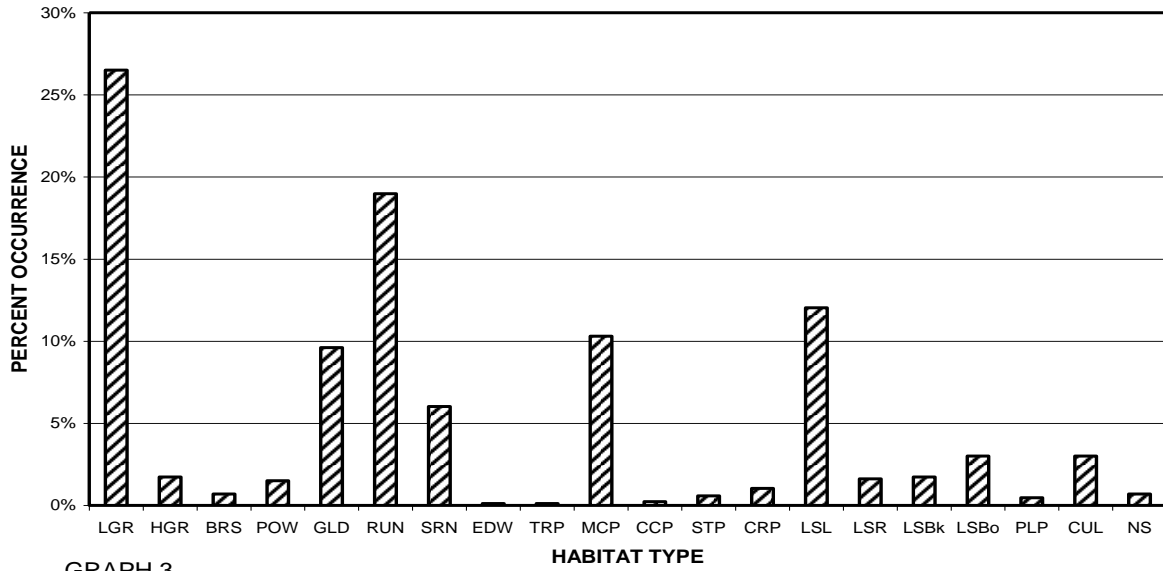
GRAPH 3

Eighteen Level IV habitat types were identified (Table 2). The most frequent habitat types by percent occurrence were 27% Low Gradient Riffle units, 19% Run units and 12% Lateral Scour Pool - Log Enhanced units (Graph 3). The most frequent habitat types based on percent total length by percent occurrence were 24% Low Gradient Riffle units, 22% Run units and 14% Not Surveyed units.

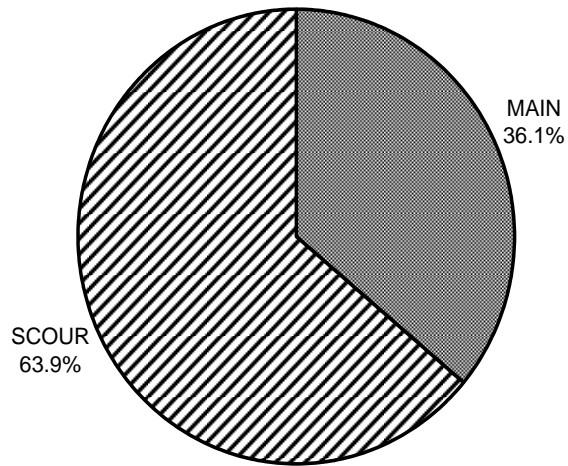
GRAPH 4

A total of 269 pools were identified (Table 3). Scour pools were the most frequently encountered, at 64%, and comprised 62% of the total length of all pools (Graph 4).

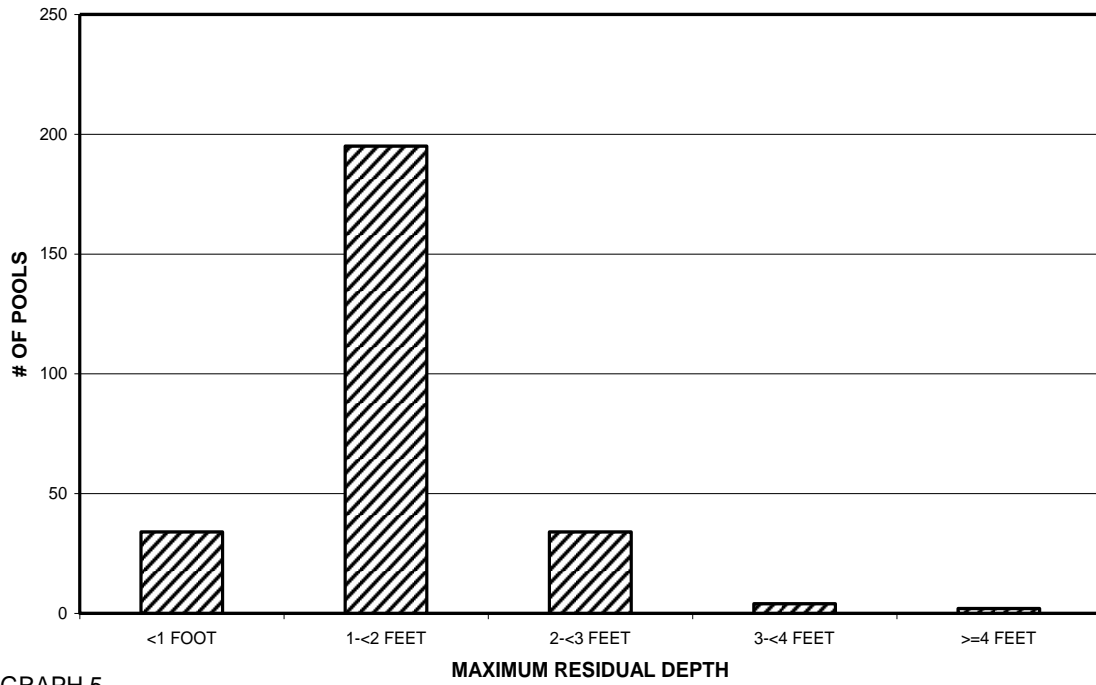
GRAPH 5

Table 4 is a summary of maximum residual pool depths by pool habitat types. Pool quality for salmonids increases with depth. Six of the 269 pools (2%) had a residual depth of three feet or greater (Graph 5).

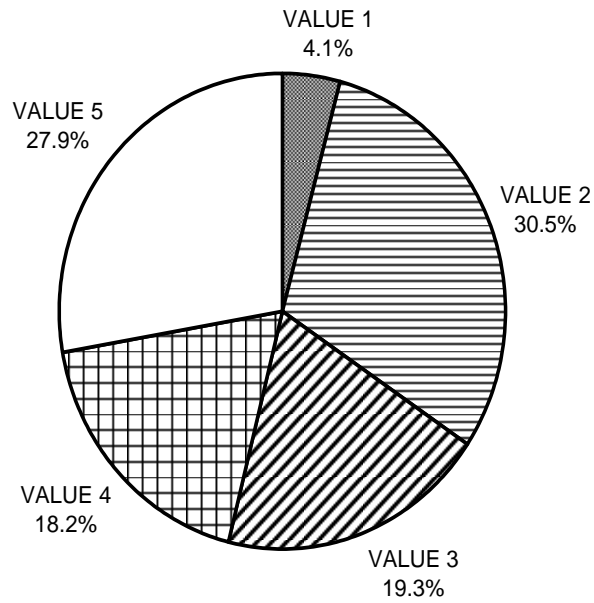
GRAPH 6

The depth of cobble embeddedness was estimated at pool tail-outs. Of the 269 pool tail-outs measured, 11 had a value of 1 (4.1%); 82 had a value of 2 (30.5%); 52 had a value of 3 (19.3%); 49 had a value of 4 (18.2%); and 75 had a value of 5 (27.9%) (Graph 6). On this scale, a value of 1 indicates the best spawning conditions and a value of 4 the worst. Additionally, a value of 5 was assigned to tail-outs deemed unsuited for spawning due to inappropriate substrate such as bedrock, log sills, boulders, or other considerations.

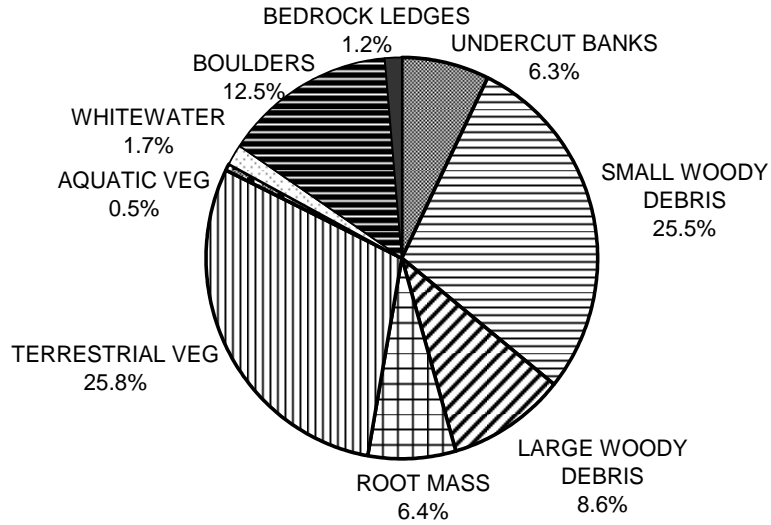
GRAPH 7

Table 5 summarizes mean percent cover by habitat type. Terrestrial Vegetation is the dominant cover types in Pilarcitos Creek. Graph 7 describes the pool cover in Pilarcitos Creek. Terrestrial Vegetation is the dominant pool cover type followed by small woody debris.

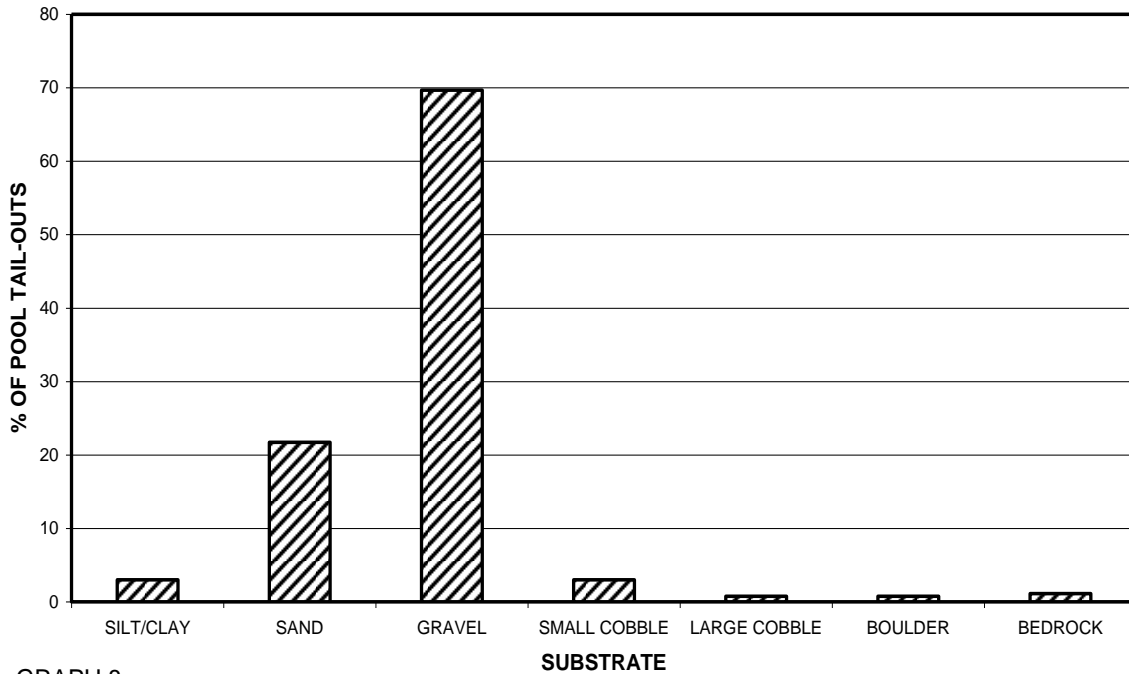
GRAPH 8

Table 6 summarizes the dominant substrate by habitat type. Graph 8 depicts the dominant substrate observed in pool tail-outs. The most frequent substrate types by percent of pool tail-outs were gravel observed in 70% of pool tail-outs and sand observed in 22% of pool tail-outs.

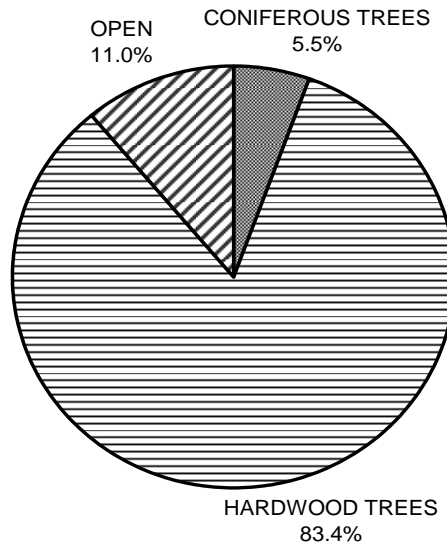
GRAPH 9

The mean percent canopy density for the surveyed length of Pilarcitos Creek was 89%. The mean percentages of hardwood and coniferous trees were 94% and 6%, respectively. Eleven percent of the canopy was open. Graph 9 describes the mean percent canopy in Pilarcitos Creek.

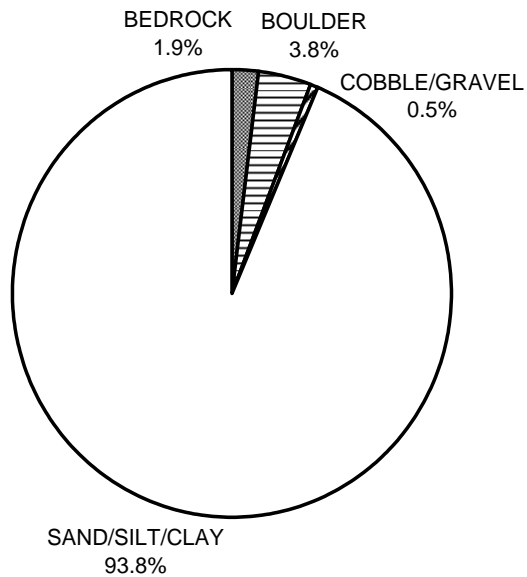
GRAPH 10

For the stream reach surveyed, the mean percent right bank vegetated was 85%. The mean percent left bank vegetated was 84%. The dominant elements composing the structure of the

stream banks consisted of 2% bedrock, 4% boulder, 1% cobble/gravel and 94% sand/silt/clay (Graph 10). Hardwood trees were the dominant vegetation type observed in 91.5% of the units surveyed. Additionally, 7.9% of the units surveyed had brush as the dominant vegetation type, 0.3% of the units surveyed had grass as the dominant vegetation type and 0.1% had coniferous trees as the dominant vegetation (Graph 11).

The percentage of right and left bank covered with vegetation was 85% and 84%, respectively. In areas of stream bank erosion or where bank vegetation is sparse, planting endemic species of coniferous and hardwood trees, in conjunction with bank stabilization, is recommended.
