POLE CREEK

STREAM INVENTORY REPORT

Prepared by:
Dave Kajtaniak
Fisheries Biologist
Pacific States Marine Fisheries Commission and
California Department of Fish and Game
4665 Lampson Ave, Suite C
Los Alamitos, CA 91711

February 15, 2008

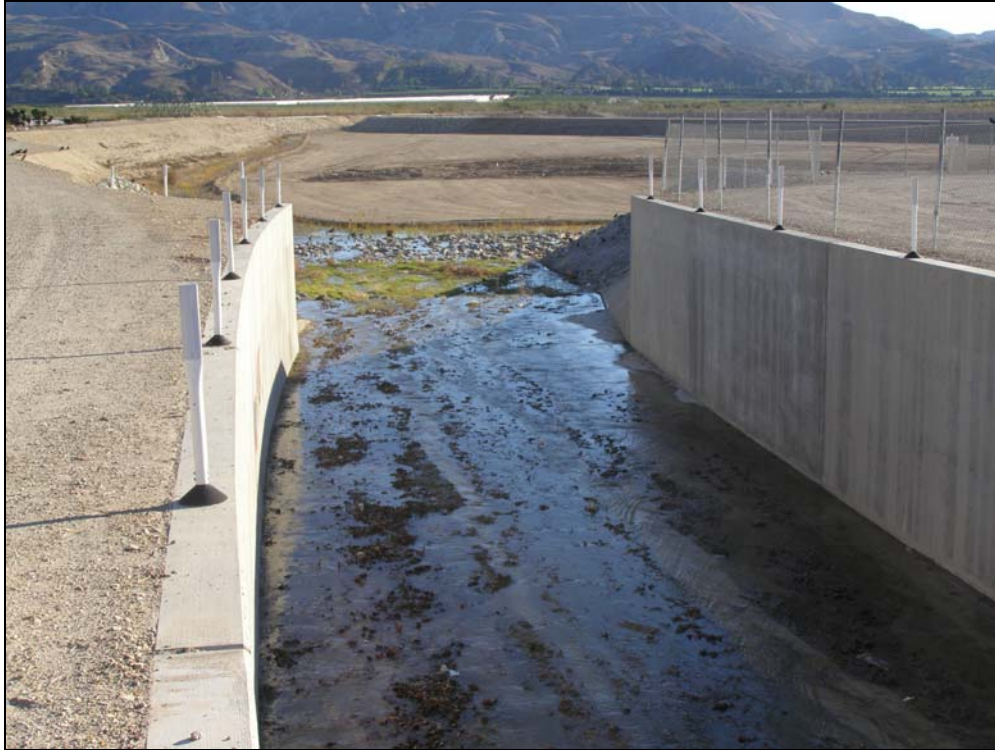
Photo 1. View of Pole Creek flowing into retention basin.

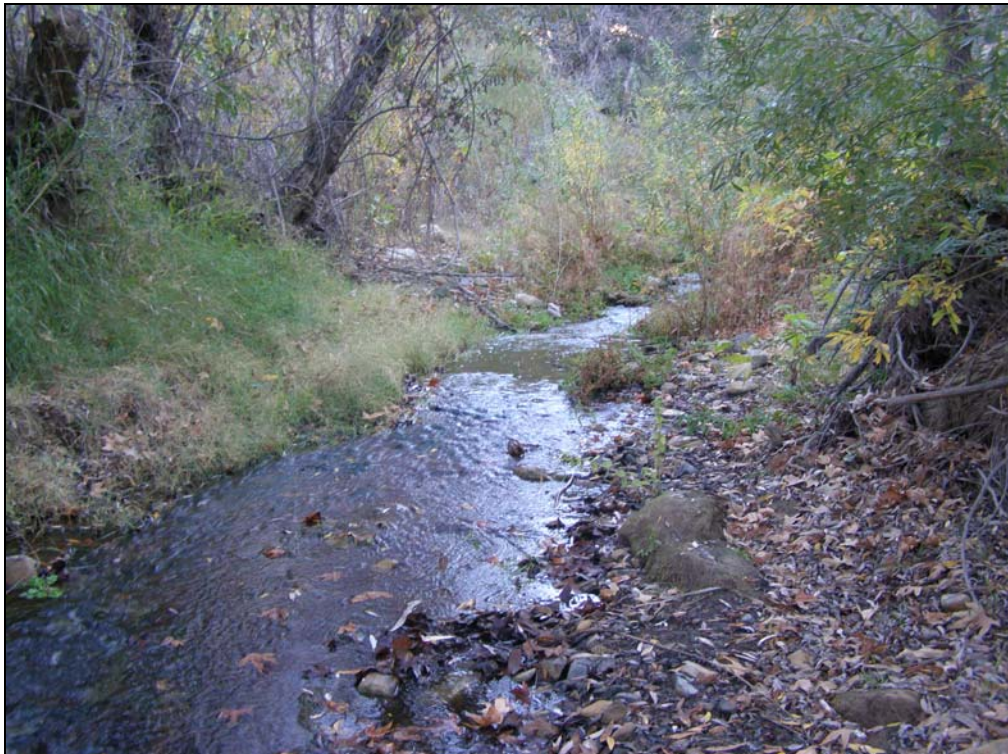
Photo 1. View of lower Pole Creek

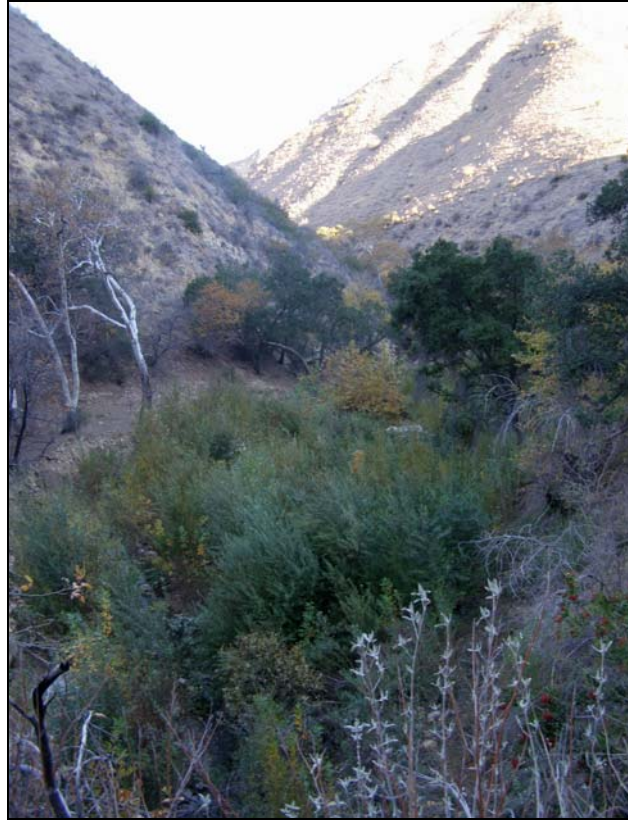
Photo 2. View of Pole Creek downstream of confluence with N.F. Pole Creek

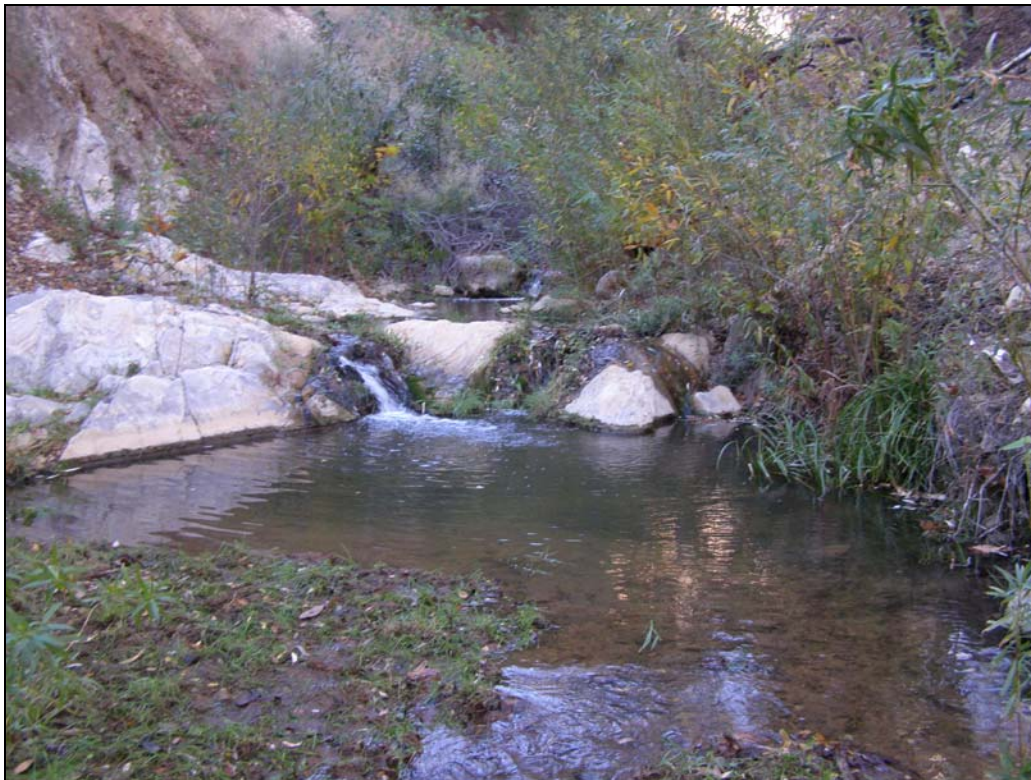
Photo 3. View of Pole Creek (mid to upper portion of the survey).

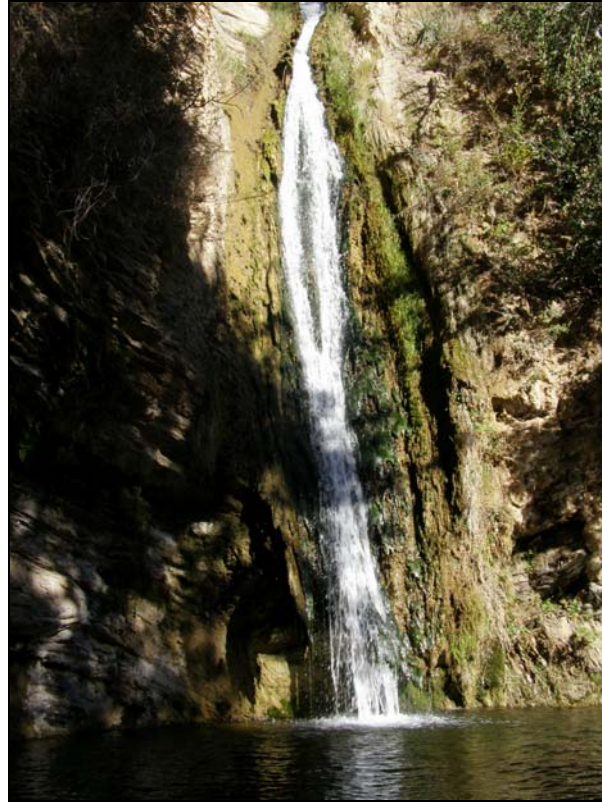
Pole Creek is a C4 channel type for 7,226.00 feet of the stream surveyed (Reach 1), a B4 channel type for 6,444.60 feet of the stream surveyed (Reach 2), and a B1 channel type for 2,399.00 feet of the stream surveyed (Reach 3). The survey concluded at a 40-foot waterfall, a natural barrier to all upstream migration.

Photo 4: Pole Creek, end of survey at 40 foot waterfall.

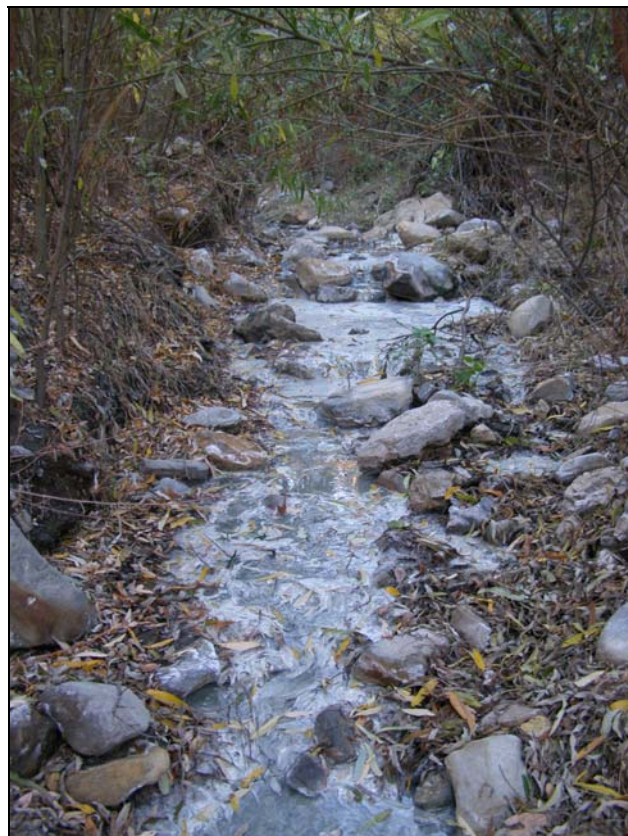
Photo 5. North Fork Pole Creek near the confluence with Pole Creek
