**California Department of Fish and Game  
East Marin County  
San Francisco Bay Watersheds  
Stream Habitat Assessment Reports**

**Arroyo Avichi Creek**

*Surveyed 2009*

**STREAM INVENTORY REPORT  
Arroyo Avichi**

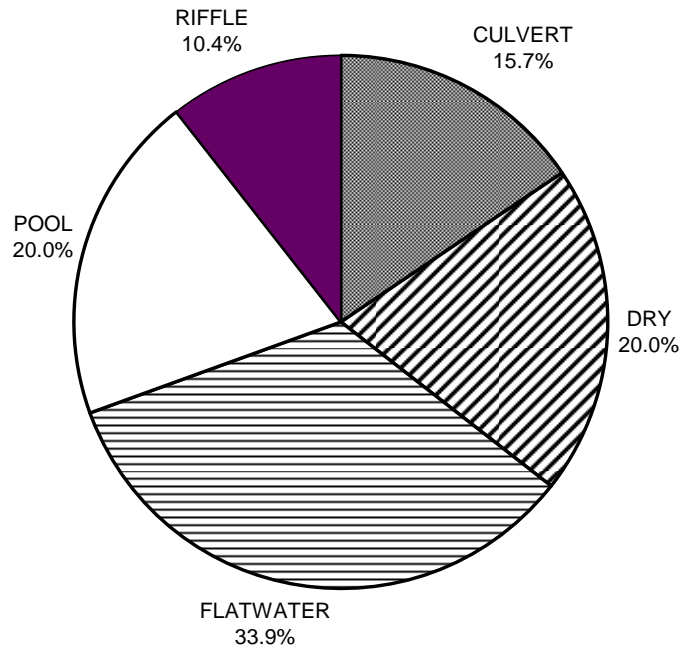
GRAPH 1

Table 1 summarizes the Level II riffle, flatwater, and pool habitat types. Based on frequency of occurrence there were 34% flatwater units, 20% dry units and 20% pool units (Graph 1). Based on total length of Level II habitat types there were 66% dry units, 19% flatwater units and 9% culvert units (Graph 2).

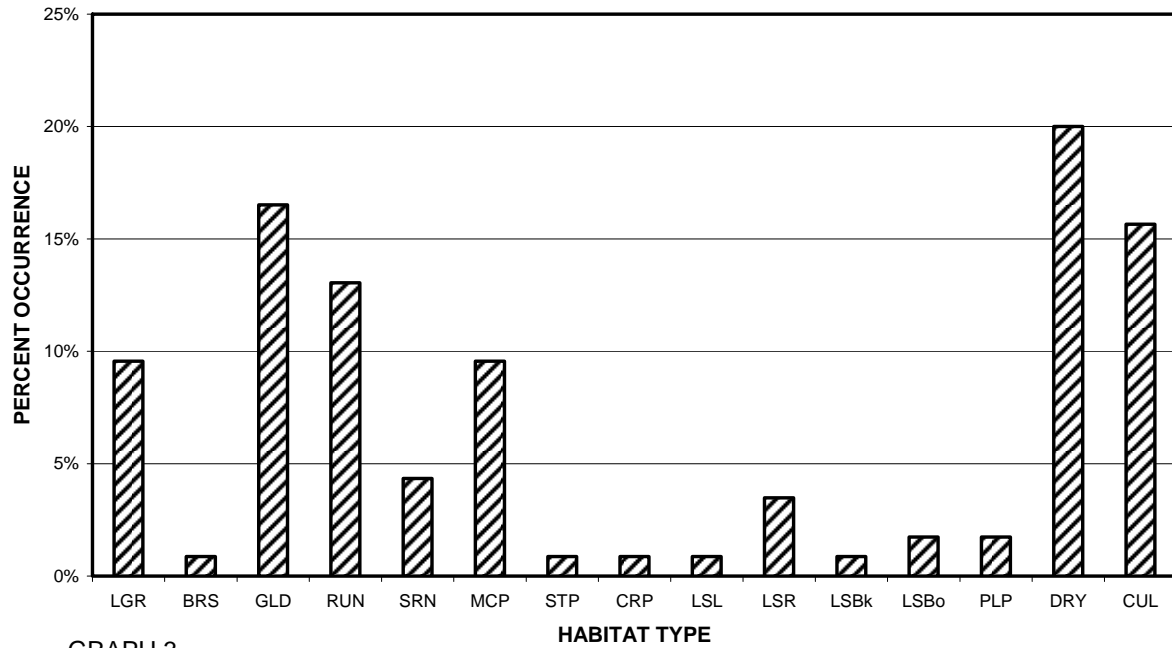
GRAPH 3

Fifteen Level IV habitat types were identified (Table 2). The most frequent habitat types by percent occurrence were 20% Dry units, 17% Glide units and 16% Culvert units (Graph 3). Based on percent total length there were 66% Dry units, 9% Culvert units and 9% Glide units.

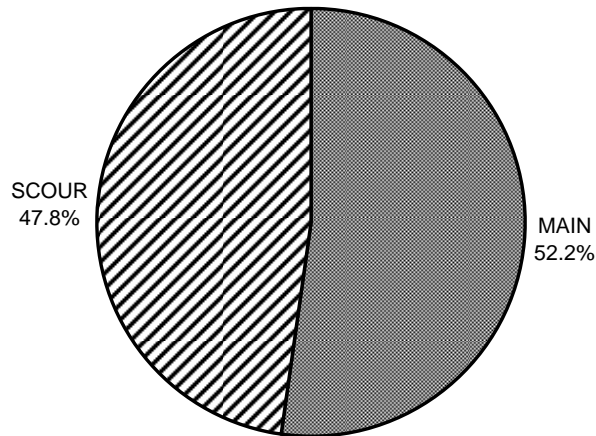
GRAPH 4

A total of 23 pools were identified (Table 3). Main Channel pools were the most frequently encountered, at 52%, and comprised 57% of the total length of all pools (Graph 4).

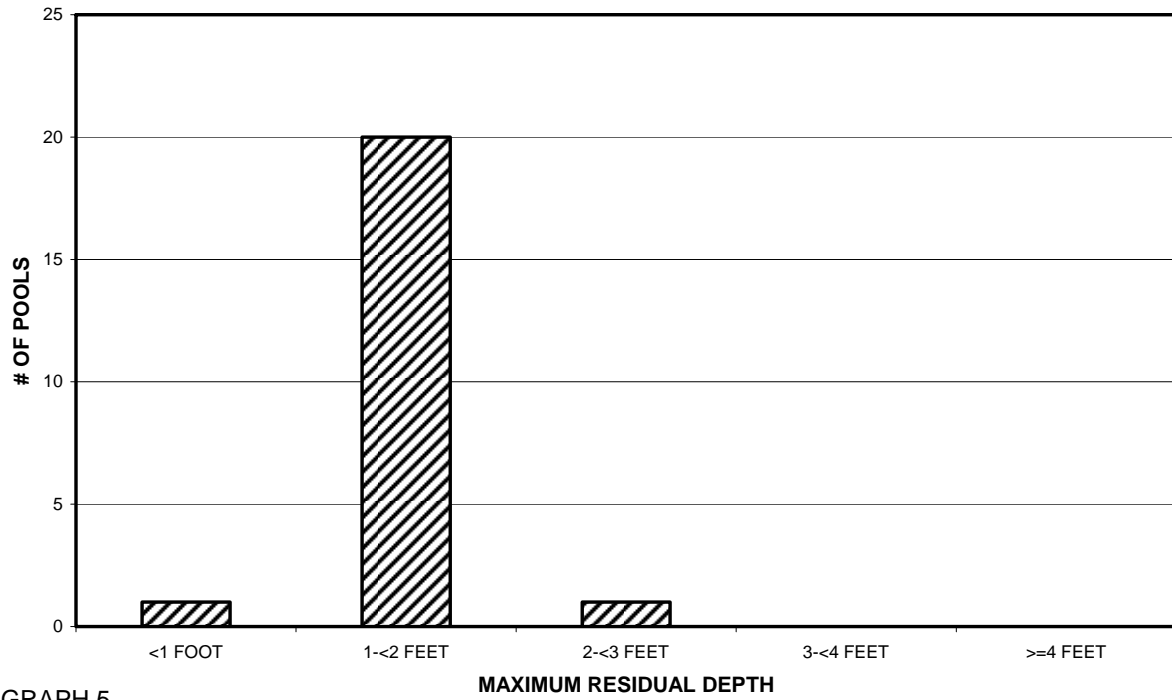
GRAPH 5

Table 4 is a summary of maximum residual pool depths by pool habitat types. Pool quality for salmonids increases with depth. 1 of the 22 pools (5%) had a residual depth of two feet or greater (Graph 5).

Flatwater habitat types comprised 19% of the total length of this survey, riffles 2% and pools 4%. The pools are relatively shallow, with only 1 of the 22 (5%) pools having a maximum residual depth greater than 2 feet. In general, pool enhancement projects are considered when primary pools comprise less than 40% of the length of total stream habitat. In first and second order streams, a primary pool is defined to have a maximum residual depth of at least two feet, occupy at least half the width of the low flow channel, and be as long as the low flow channel width. Installing structures that will increase or deepen pool habitat is recommended for locations where their installation will not be threatened by high stream energy, or where their installation will not conflict with the modification of any log debris accumulations (LDA's) in the stream.

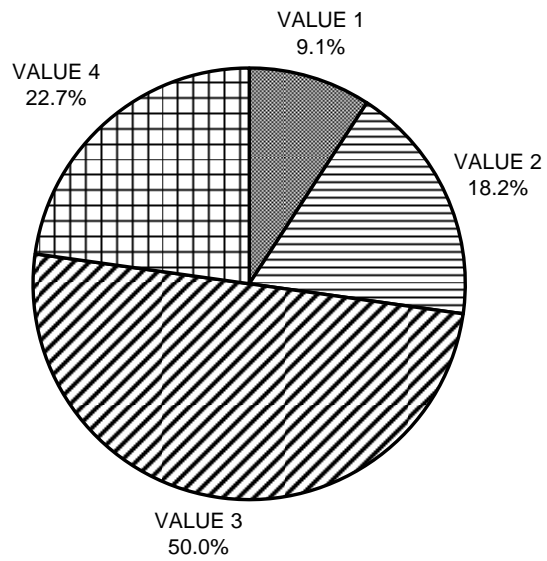
GRAPH 6

The depth of cobble embeddedness was estimated at pool tail-outs. Of the 22 pool tail-outs measured, 2 had a value of 1 (9.1%); 4 had a value of 2 (18.2%); 11 had a value of 3 (50%); 5 had a value of 4 (22.7%) (Graph 6). On this scale, a value of 1 indicates the best spawning conditions and a value of 4 the worst.

Six of the 22 pool tail-outs measured had embeddedness ratings of 1 or 2. Sixteen of the pool tail-outs had embeddedness ratings of 3 or 4. None of the pool tail-outs had a rating of 5, which is considered unsuitable for spawning. Cobble embeddedness measured to be 25% or less, a rating of 1, is considered to indicate good quality spawning substrate for salmon and steelhead. Sediment sources in Arroyo Avichi should be mapped and rated according to their potential sediment yields, and control measures should be taken.

- 3) Inventory and map sources of stream bank erosion and prioritize them according to present and potential sediment yield. Identified sites should then be treated to reduce the amount of fine sediments entering the stream. Active and potential sediment sources related to the road system need to be identified, mapped, and treated according to their potential for sediment yield to the stream and its tributaries.

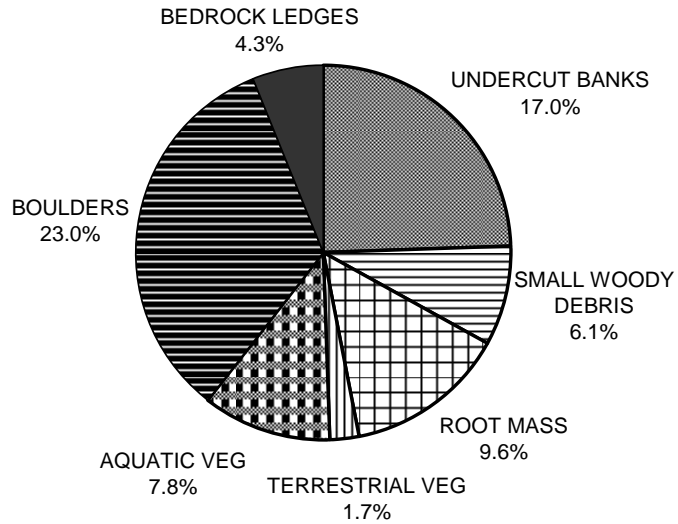
GRAPH 7

Table 5 summarizes mean percent cover by habitat type. Boulders are the dominant cover type in Arroyo Avichi. Graph 7 describes the pool cover in Arroyo Avichi. Boulders are the dominant pool cover type followed by undercut banks.

The mean shelter rating for pools was 15. The shelter rating in the flatwater habitats was 11. A pool shelter rating of approximately 100 is desirable. The amount of cover that now exists is being provided primarily by boulders in Arroyo Avichi. Boulders are the dominant cover type in pools followed by undercut banks. Log and root wad cover structures in the pool and flatwater habitats would enhance both summer and winter salmonid habitat. Log cover structure provides rearing fry with protection from predation, rest from water velocity, and also divides territorial units to reduce density related competition.

- 2) Increase woody cover in the pools and flatwater habitat units. Most of the existing cover in the pools is from boulders. Adding high quality complexity with woody cover in the pools is desirable.

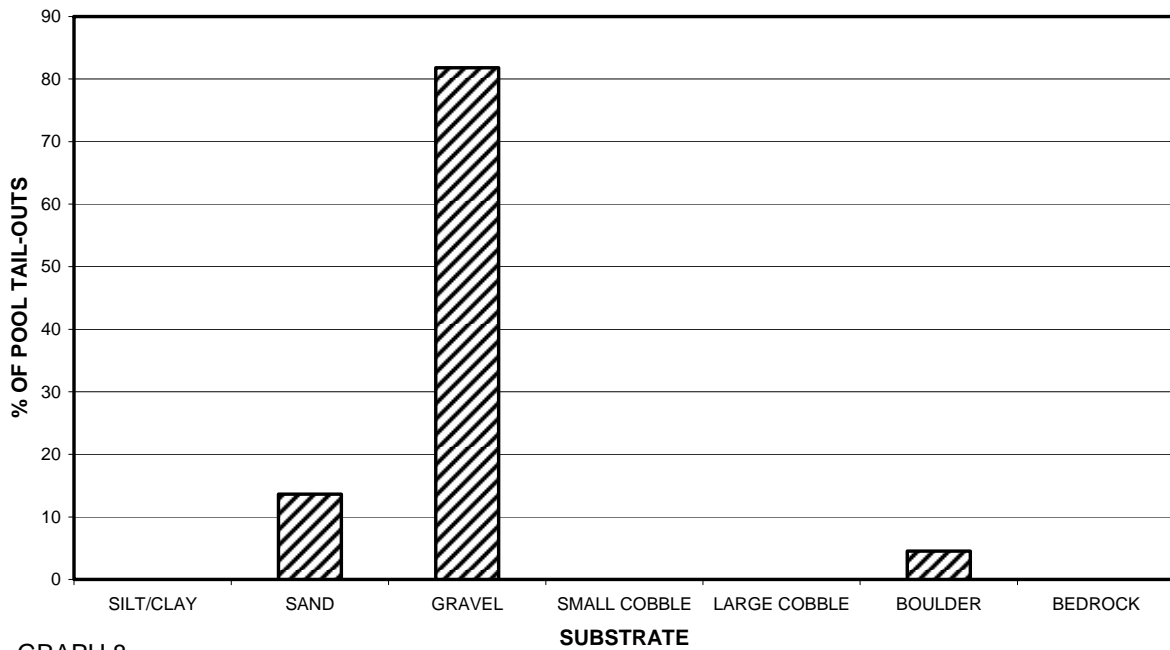
GRAPH 8

Table 6 summarizes the dominant substrate by habitat type. Graph 8 depicts the dominant substrate observed in pool tail-outs. Sand dominance was observed in 14% of pool tail-outs and gravel dominance was observed in 82% of pool tail-outs.

Eighteen of the 22 pool tail-outs measured had gravel or small cobble as the dominant substrate. This is generally considered good for spawning salmonids.

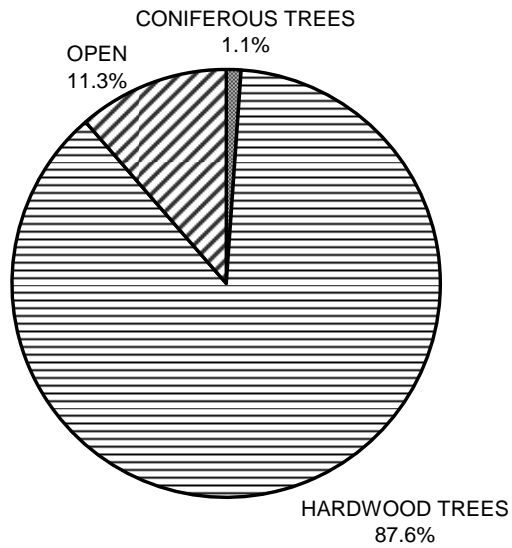
GRAPH 9

The mean percent canopy density for the surveyed length of Arroyo Avichi was 89%. The mean percentages of hardwood and coniferous trees were 99% and 1%, respectively. 11 percent of the canopy was open. Graph 9 describes the mean percent canopy in Arroyo Avichi.

The mean percent canopy density for the stream was 89%. In general, revegetation projects are considered when canopy density is less than 80%.

- 4) Increase the canopy on Arroyo Avichi Creek by planting appropriate native vegetation like willow, alder, and redwood along the stream where shade canopy is not at acceptable levels. In many cases, planting will need to be coordinated to follow bank stabilization or upslope erosion control projects.
- 5) Where feasible, design and engineer pool enhancement structures to increase the number of pools. This must be done where the banks are stable or in conjunction with stream bank armor to prevent erosion.

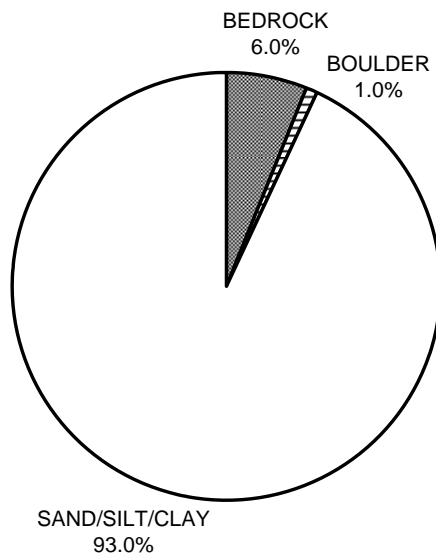
GRAPH 10

For the stream reach surveyed, the mean percent right bank vegetated was 36%. The mean percent left bank vegetated was 42%. The dominant elements composing the structure of the stream banks consisted of 93% sand/silt/clay, 6% bedrock and 1% boulder (Graph 10). Hardwood trees were the dominant vegetation type observed in 79% of the units surveyed. Additionally, 18% of the units surveyed had brush as the dominant vegetation type and 3% had grass as the dominant vegetation (Graph 11).

The percentage of right and left bank covered with vegetation was 36% and 42%, respectively. In areas of stream bank erosion or where bank vegetation is sparse, planting endemic species of coniferous and hardwood trees, in conjunction with bank stabilization, is recommended.
