**California Department of Fish and Wildlife
East Marin County
San Pablo Bay Watershed
Stream Habitat Assessment Reports**

Arroyo San Jose Creek

Surveyed 2009

STREAM INVENTORY REPORT

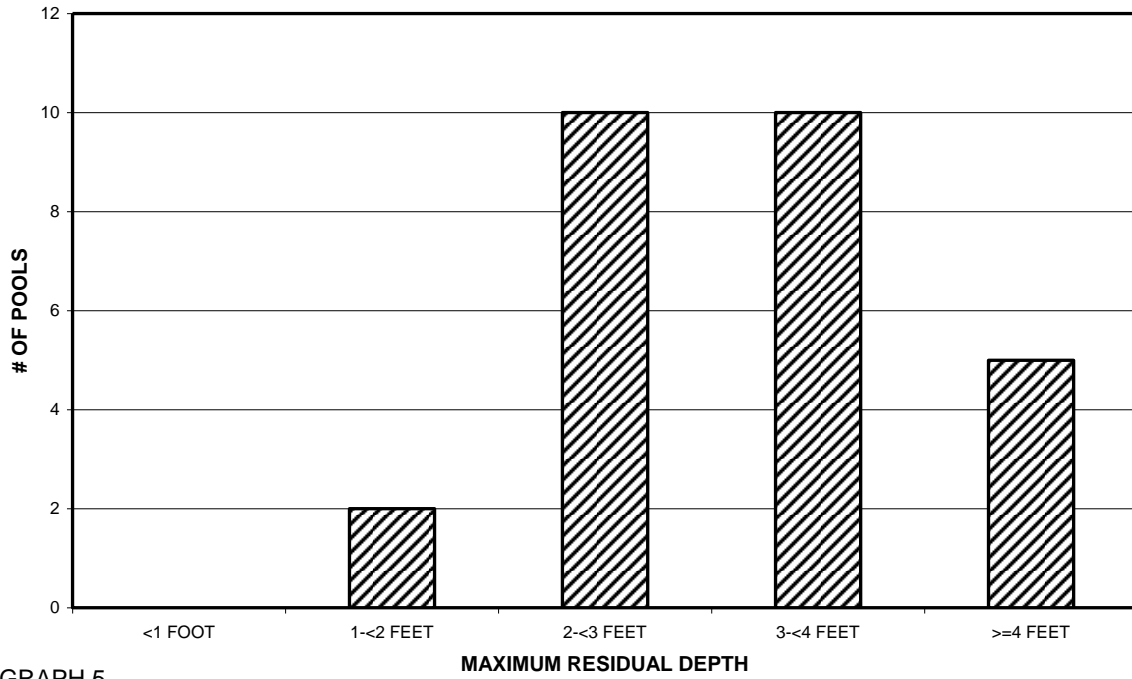
GRAPH 5

Table 4 is a summary of maximum residual pool depths by pool habitat types. Pool quality for salmonids increases with depth. Twenty of the 34 pools (89%) had a residual depth of two feet or greater (Graph 5).

Flatwater habitat types comprised 32% of the total length of this survey, riffles 9%, and pools 23%. The pools are relatively deep, with 24 of the 34 (89%) pools having a maximum residual depth greater than two feet. In general, pool enhancement projects are considered when primary pools comprise less than 40% of the length of total stream habitat. In first and second order streams, a primary pool is defined to have a maximum residual depth of at least two feet, occupy at least half the width of the low flow channel, and be as long as the low flow channel width. Installing structures that will increase or deepen pool habitat is recommended for locations where their installation will not be threatened by high stream energy, or where their installation will not conflict with the modification of the numerous log debris accumulations (LDA's) in the stream.

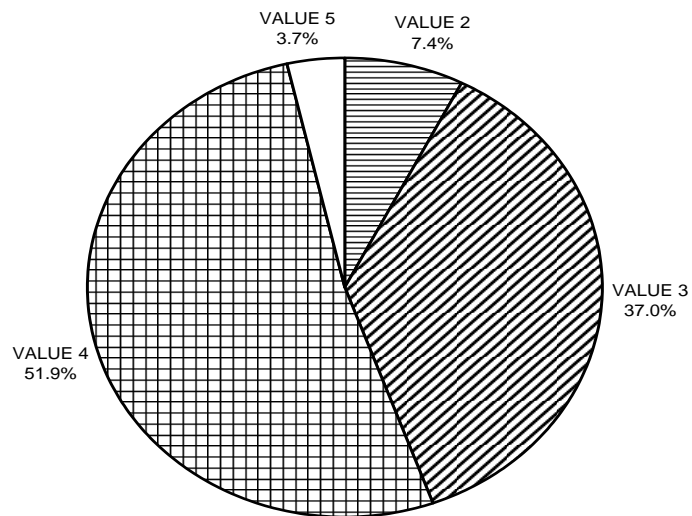
GRAPH 6

The depth of cobble embeddedness was estimated at pool tail-outs. Of the 34 pool tail-outs measured, 2 had a value of 2 (6%), 10 had a value of 3 (29%), 14 had a value of 4 (41%), 1 had a value of 5 (3%) (Graph 6). On this scale, a value of 1 indicates the best spawning conditions and a value of 4 the worst. Additionally, a value of 5 was assigned to tail-outs deemed unsuited for spawning due to inappropriate substrate such as bedrock, log sills, boulders, or other considerations.

Two of the 34 pool tail-outs measured had embeddedness ratings of 1 or 2. Twenty-four of the pool tail-outs had embeddedness ratings of 3 or 4. One of the pool tail-outs had a rating of 5, which is considered unsuitable for spawning. Cobble embeddedness measured to be 25% or less, a rating of 1, is considered to indicate good quality spawning substrate for salmon and steelhead. Sediment sources in Arroyo San Jose should be mapped and rated according to their potential sediment yields, and control measures should be taken.

- 4) Inventory and map sources of stream bank erosion and prioritize them according to present and potential sediment yield. Identified sites should then be treated to reduce the amount of fine sediments entering the stream. Active and potential sediment sources related to the road system need to be identified, mapped, and treated according to their potential for sediment yield to the stream and its tributaries.

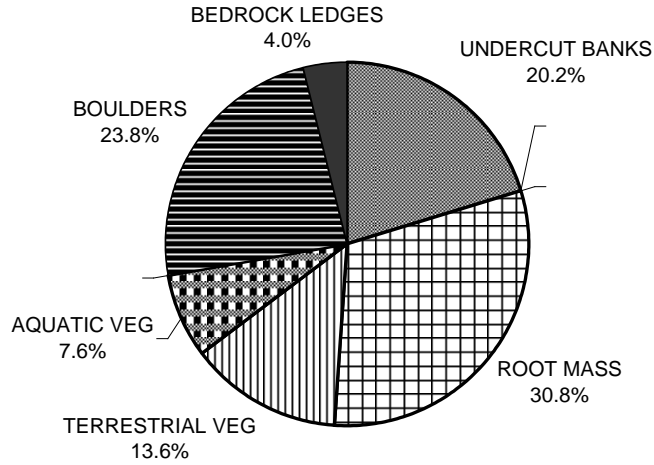
GRAPH 7

Table 5 summarizes mean percent cover by habitat type. Root masses are the dominant cover type in Arroyo San Jose. Graph 7 describes the pool cover in Arroyo San Jose. Root masses are the dominant pool cover type, followed by boulders.

The mean shelter rating for pools is 31. The shelter rating in the flatwater habitats is 28. A pool shelter rating of approximately 100 is desirable. The amount of cover that now exists is being provided primarily by root masses in Arroyo San Jose. Root masses are the dominant cover type in pools, followed by boulders. Log and root wad cover structures in the pool and flatwater habitats would enhance both summer and winter salmonid habitat. Log cover structure provides rearing fry with protection from predation, rest from water velocity, and also divides territorial units to reduce density related competition.

- 1) Increase woody cover in the pools and flatwater habitat units. Most of the existing cover in the pools is from Root Masses. Adding high quality complexity with woody cover in the pools is desirable.

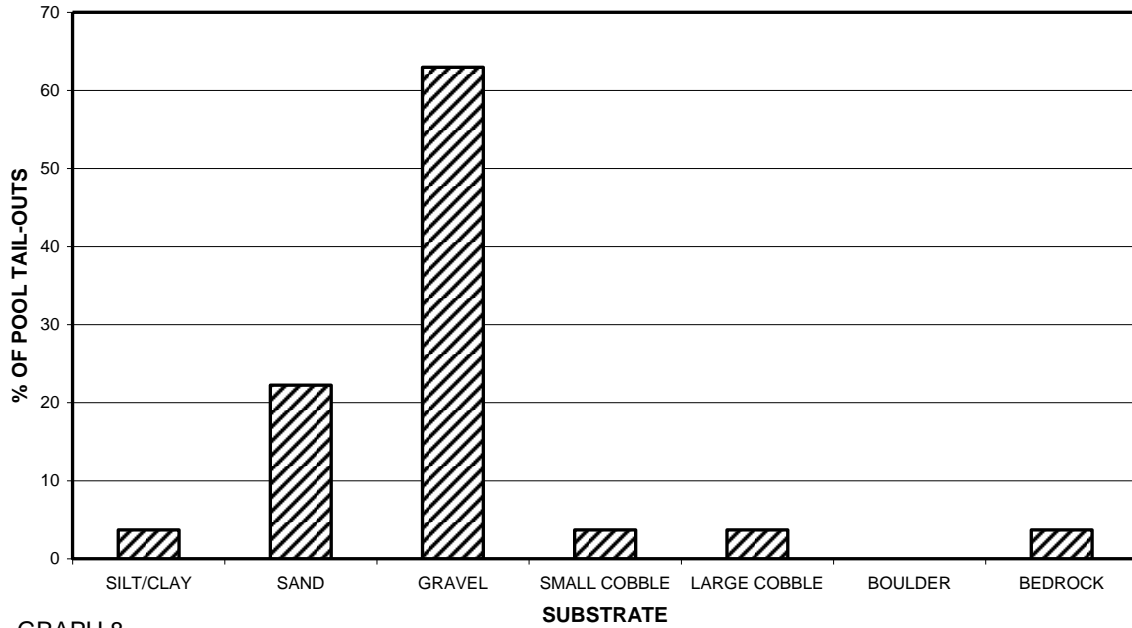
GRAPH 8

Table 6 summarizes the dominant substrate by habitat type. Graph 8 depicts the dominant substrate observed in pool tail-outs. Gravel substrate was observed in 63% of pool tail-outs; and sand substrate was observed in 22% of pool tail-outs.

Eighteen of the 34 pool tail-outs measured had gravel and small cobble as the dominant substrate. This is generally considered good for spawning salmonids.

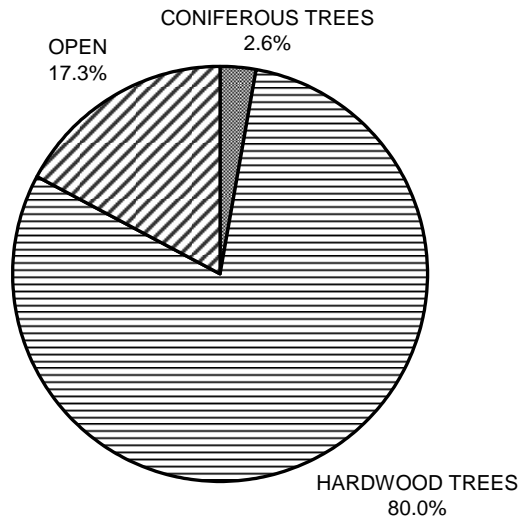
GRAPH 9

The mean percent canopy density for the surveyed length of Arroyo San Jose was 83%. Of the canopy present, the mean percentages of hardwood and coniferous trees were 97% and 3%, respectively. Seventeen percent of the canopy was open. Graph 9 describes the mean percent canopy in Arroyo San Jose.

The mean percent canopy density for the stream was 83%. Reach 1 had a canopy density of 83.1%, and Reach 2 had a canopy density of 47%. In general, revegetation projects are considered when canopy density is less than 80%.

- 6) Increase the canopy on Arroyo San Jose Creek, particularly from the Marin Country Club Golf Course upstream to Reach 2, by planting appropriate native vegetation like willow, alder, redwood, and Douglas fir along the stream where shade canopy is not at acceptable levels. The reaches above this survey section should be inventoried and treated as well, since the water flowing here is affected from upstream. In many cases, planting will need to be coordinated to follow bank stabilization or upslope erosion control projects.
- 7) The limited water temperature data available suggest that maximum temperatures are above the acceptable range for juvenile salmonids. To establish more complete and meaningful temperature regime information, 24-hour monitoring during the July and August temperature extreme period should be performed for 3 to 5 years.

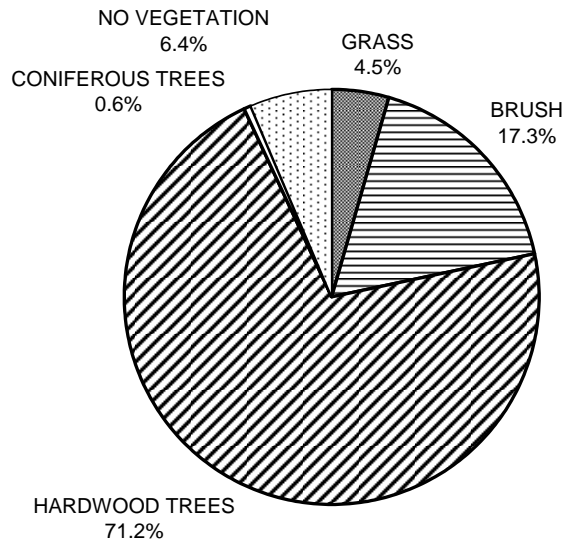
GRAPH 11

For the stream reach surveyed, the mean percent right bank vegetated was 56%. The mean percent left bank vegetated was 58% (Table 7). The dominant elements composing the structure of the stream banks consisted of 84% sand/silt/clay, 10% boulder, 6% bedrock, 0% cobble/gravel (Graph 10). Deciduous trees were the dominant vegetation type observed in 71% of the units surveyed. Additionally, 17% of the units surveyed had brush as the dominant vegetation type, and 6% had no vegetation as the dominant vegetation type (Graph 11).

The percentage of right and left bank covered with vegetation was 56% and 58%, respectively. In areas of stream bank erosion or where bank vegetation is sparse, planting endemic species of coniferous and hardwood trees, in conjunction with bank stabilization, is recommended.
