**California Department of Fish and Game
East Marin County
San Francisco Bay Watersheds
Stream Habitat Assessment Reports**

STREAM INVENTORY REPORT

Cascade Creek

Surveyed 2009

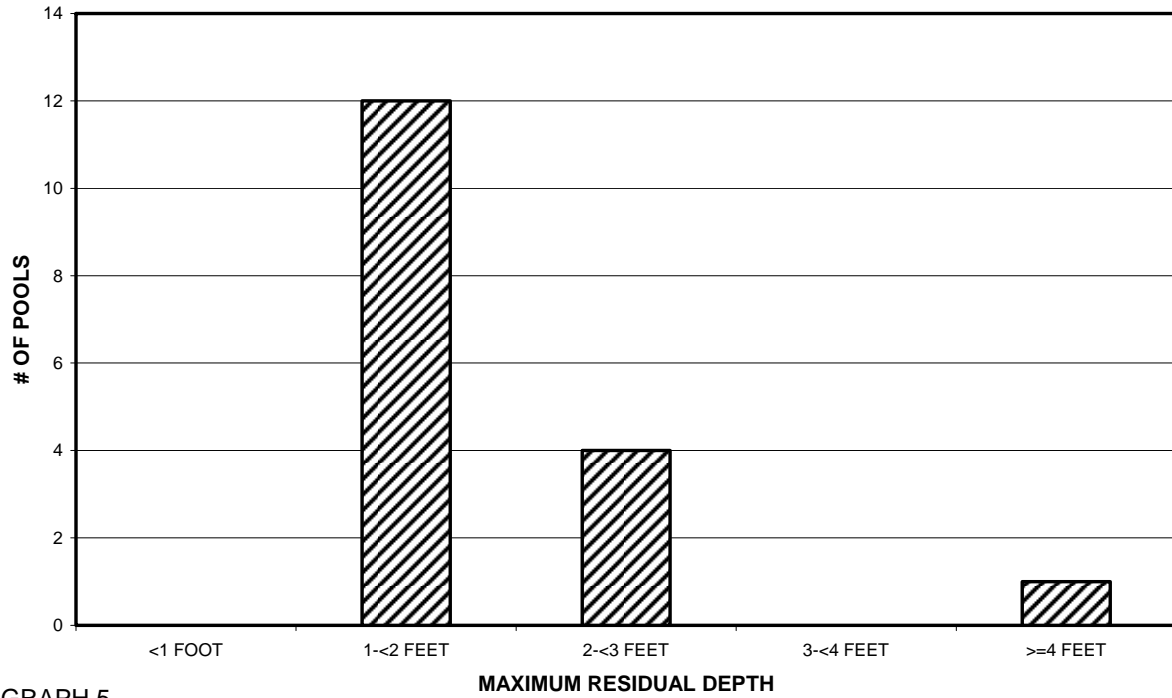
GRAPH 5

Table 4 is a summary of maximum residual pool depths by pool habitat types. Pool quality for salmonids increases with depth. Five of the 17 pools (29%) had a residual depth of two feet or greater (Graph 5).

Flatwater habitat types comprised 16% of the total length of this survey, riffles 14%, and pools 7%. The pools are relatively shallow, with only 5 of the 17 (29%) pools having a maximum residual depth greater than 2 feet. In general, pool enhancement projects are considered when primary pools comprise less than 40% of the length of total stream habitat. In first and second order streams, a primary pool is defined to have a maximum residual depth of at least two feet, occupy at least half the width of the low flow channel, and be as long as the low flow channel width. Installing structures that will increase or deepen pool habitat is recommended for locations where their installation will not be threatened by high stream energy, or where their installation will not conflict with the modification of any log debris accumulations (LDA's) in the stream.

CASCADE CREEK 2009 MAXIMUM DEPTH IN POOLS

- 1) Increase woody cover in the pools and flatwater habitat units. Most of the existing cover in the pools is from boulders. Adding high quality complexity with woody cover in the pools is desirable.
- 2) Increase the canopy on Cascade Creek by planting appropriate native vegetation like willow, alder, redwood, and Douglas fir along the stream where shade canopy is not at acceptable levels. The reaches above this survey section should be inventoried and treated as well, since the water flowing here is affected from upstream. In many cases, planting will need to be coordinated to follow bank stabilization or upslope erosion control projects.

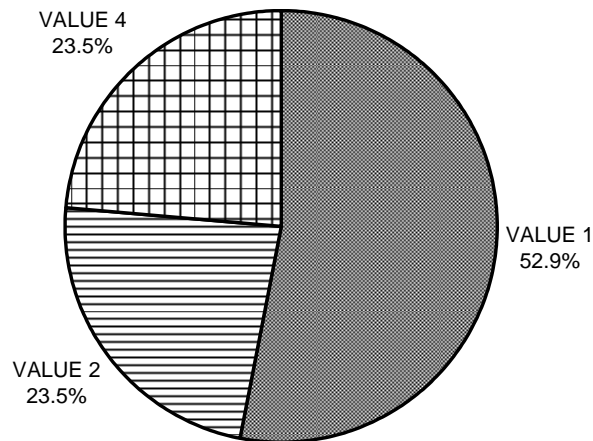
GRAPH 6

The depth of cobble embeddedness was estimated at pool tail-outs. Of the 17 pool tail-outs measured, 9 had a value of 1 (52.9%); 4 had a value of 2 (23.5%); 4 had a value of 4 (23.5%); (Graph 6). On this scale, a value of 1 indicates the best spawning conditions and a value of 4 the worst. Additionally, a value of 5 was assigned to tail-outs deemed unsuited for spawning due to inappropriate substrate such as bedrock, log sills, boulders, or other considerations.

Thirteen of the 17 pool tail-outs measured had embeddedness ratings of 1 or 2. Four of the pool tail-outs had embeddedness ratings of 3 or 4. None of the pool tail-outs had a rating of 5, which is considered unsuitable for spawning. Cobble embeddedness measured to be 25% or less, a rating of 1, is considered to indicate good quality spawning substrate for salmon and steelhead.

CASCADE CREEK 2009 PERCENT EMBEDDEDNESS

Sediment sources in Cascade Creek should be mapped and rated according to their potential sediment yields, and control measures should be taken.

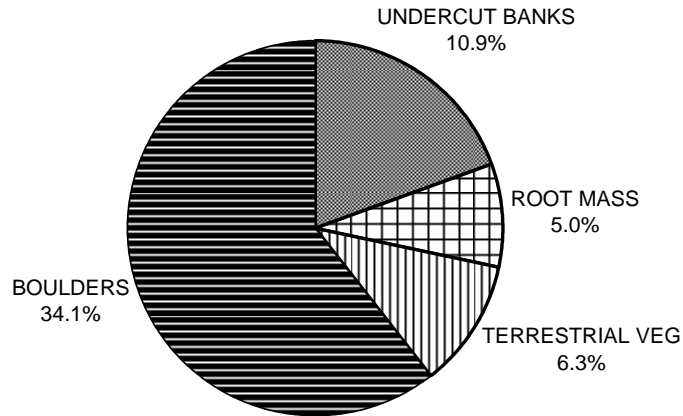
GRAPH 7

Table 5 summarizes mean percent cover by habitat type. Boulders are the dominant cover types in Cascade Creek. Graph 7 describes the pool cover in Cascade Creek. Boulders are the dominant pool cover type followed by undercut banks.

The mean shelter rating for pools was 8. The shelter rating in the flatwater habitats was 21. A pool shelter rating of approximately 100 is desirable. The amount of cover that now exists is being provided primarily by boulders in Cascade Creek. Boulders are the dominant cover type in pools followed by undercut banks. Log and root wad cover structures in the pool and flatwater habitats would enhance both summer and winter salmonid habitat. Log cover structure provides rearing fry with protection from predation, rest from water velocity, and also divides territorial units to reduce density related competition.

CASCADE CREEK 2009 MEAN PERCENT COVER TYPES IN POOLS

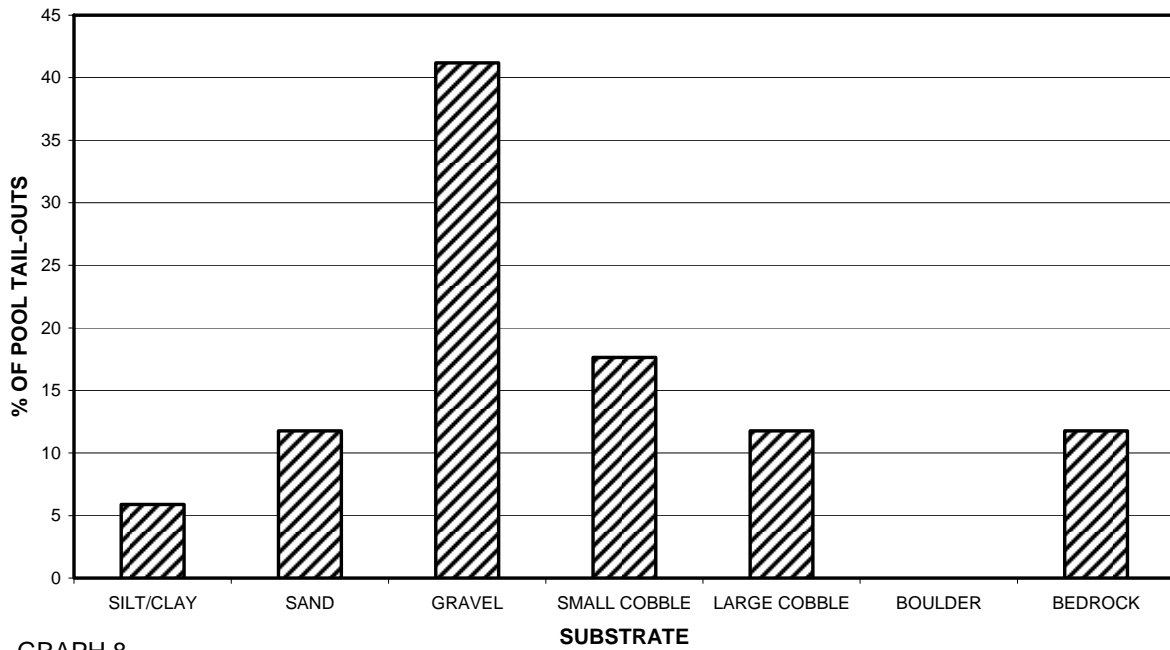
GRAPH 8

Table 6 summarizes the dominant substrate by habitat type. Graph 8 depicts the dominant substrate observed in pool tail-outs. Gravel dominance was observed in 41% of pool tail-outs, small cobble dominance was observed in 18% of pool tail-outs.

Ten of the 17 pool tail-outs measured had gravel or small cobble as the dominant substrate. This is generally considered good for spawning salmonids.

CASCADE CREEK 2009 SUBSTRATE COMPOSITION IN POOL TAIL-OUTS

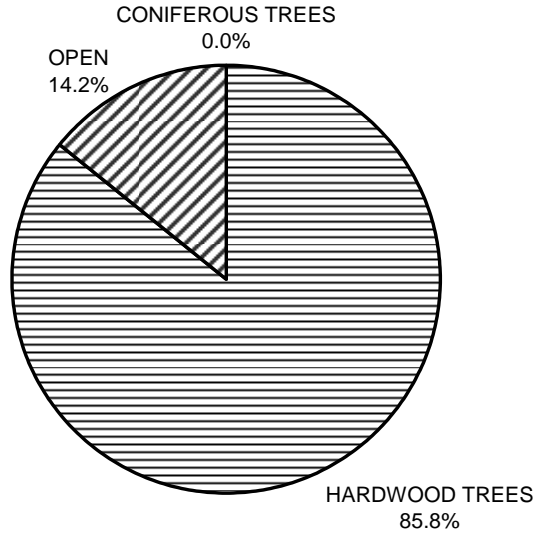
GRAPH 9

The mean percent canopy density for the surveyed length of Cascade Creek was 86%. The mean percentages of hardwood and coniferous trees were 100% and 0%, respectively. Fourteen percent of the canopy was open. Graph 9 describes the mean percent canopy in Cascade Creek.

The mean percent canopy density for the stream was 86%. Reach 1 had a canopy density of 83%, Reach 2 had a canopy density of 95%. In general, revegetation projects are considered when canopy density is less than 80%

**CASCADE CREEK 2009
MEAN PERCENT CANOPY**

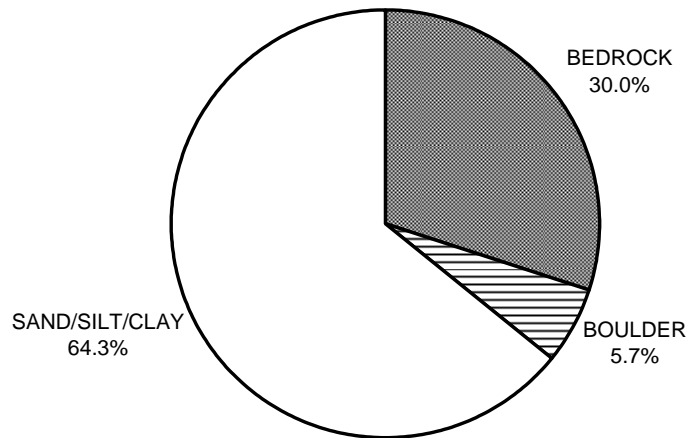
GRAPH 10

For the stream reach surveyed, the mean percent right bank vegetated was 50%. The mean percent left bank vegetated was 45%. The dominant elements composing the structure of the stream banks consisted of 30% bedrock, 6% boulder, 64% sand/silt/clay (Graph 10). Hardwood trees were the dominant vegetation type observed in 73% of the units surveyed. Additionally, 26% of the units surveyed had brush as the dominant vegetation type, and 1.4% had grass as the dominant vegetation (Graph 11).

The percentage of right and left bank covered with vegetation was 50% and 45%, respectively. In areas of stream bank erosion or where bank vegetation is sparse, planting endemic species of coniferous and hardwood trees, in conjunction with bank stabilization, is recommended.

**CASCADE CREEK 2009
DOMINANT BANK COMPOSITION IN SURVEY REACH**
