**California Department of Fish and Game
East Marin County
San Francisco Bay Watersheds
Stream Habitat Assessment Reports**

Corte Madera Creek

Surveyed 2009

STREAM INVENTORY REPORT

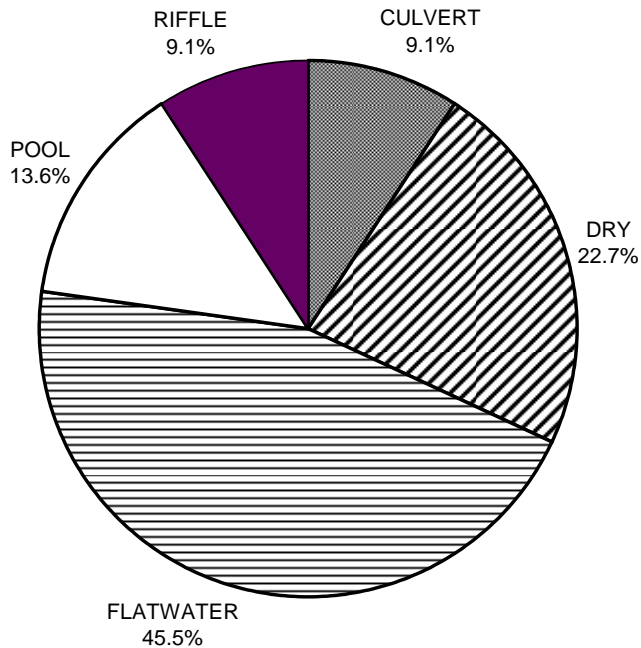
GRAPH 1

Table 1 summarizes the Level II riffle, flatwater, and pool habitat types. Based on frequency of occurrence there were 45% flatwater units, 23% dry units, 14% pool units, 9% culvert units and 9% riffle units (Graph 1). Based on total length of Level II habitat types there were 68% flatwater units, 19% dry units, 7% pool units, 1% culvert units and 4% riffle units (Graph 2).

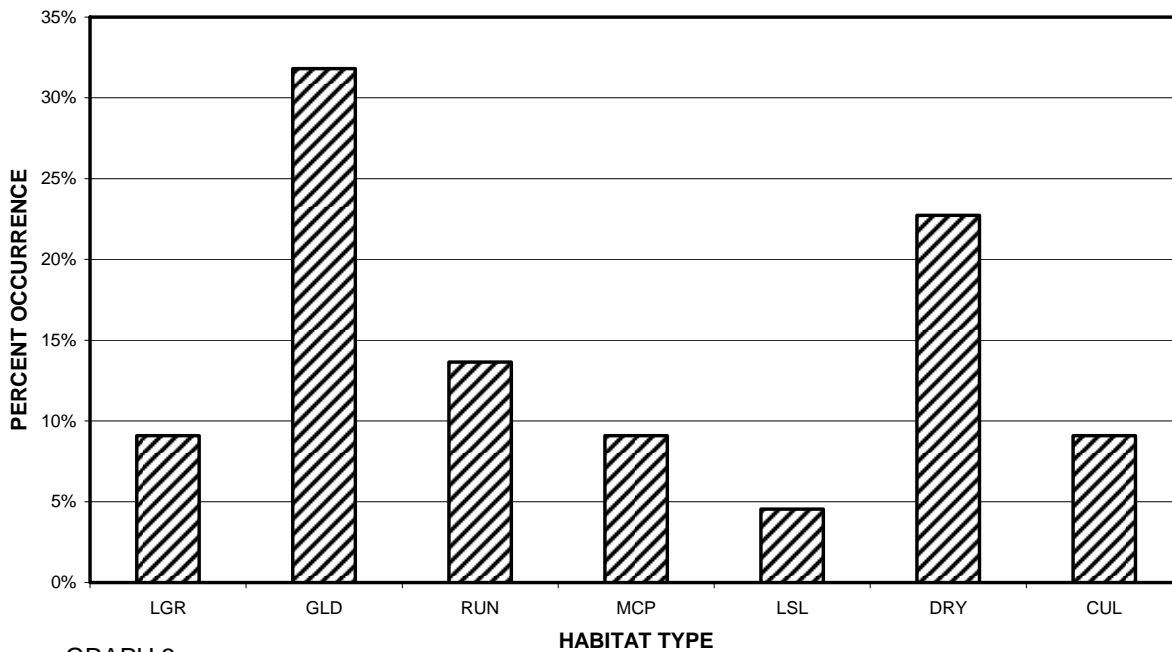
GRAPH 3

Seven Level IV habitat types were identified (Table 2). The most frequent habitat types by percent occurrence were 32% Glide units, 23% Dry units and 14% Run units (Graph 3). Based on percent total length the most frequent were 37% Glide units, 31% Run units and 19% Dry

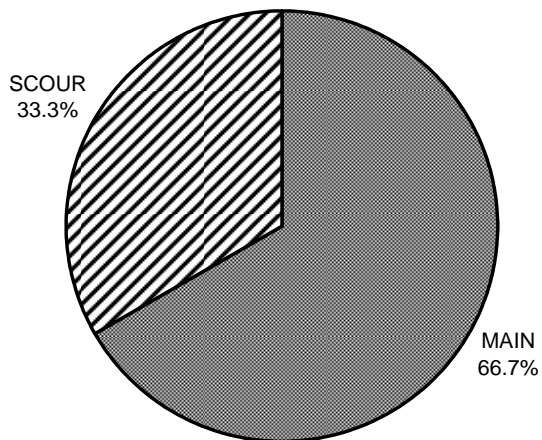
GRAPH 4

A total of 3 pools were identified (Table 3). Main Channel pools were the most frequently encountered, at 67%, and comprised 58% of the total length of all pools (Graph 4).

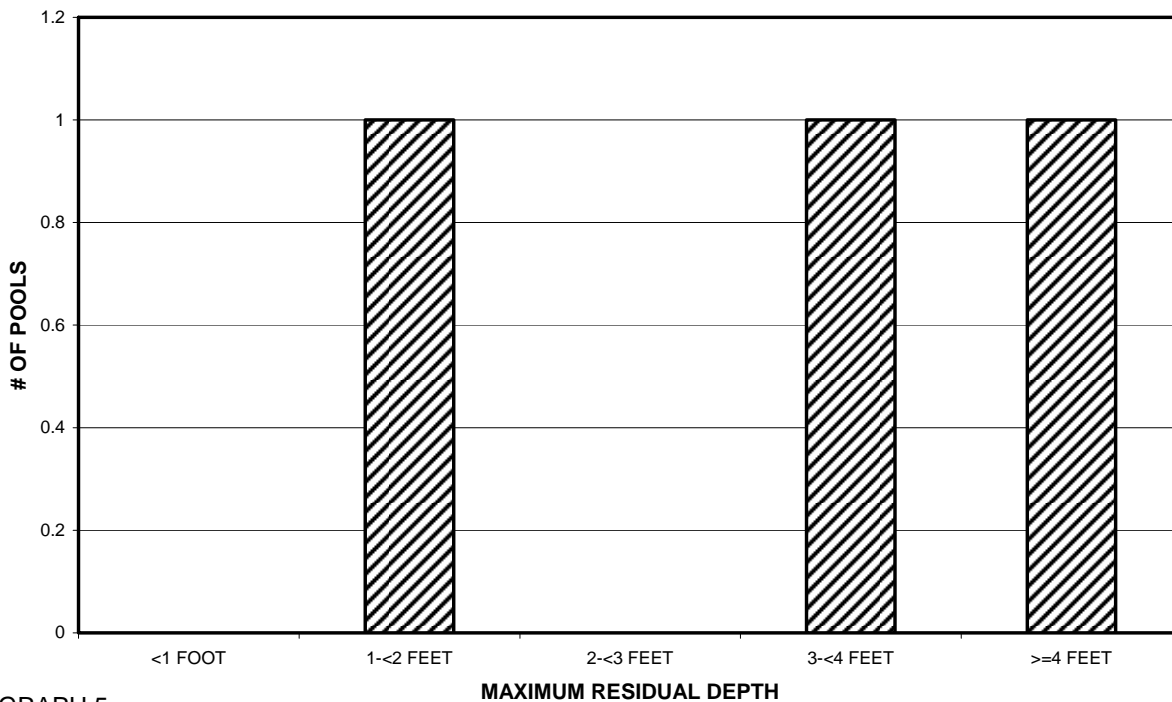
GRAPH 5

Table 4 is a summary of maximum residual pool depths by pool habitat types. Pool quality for salmonids increases with depth. Two of the 3 pools (67%) had a residual depth of three feet or greater (Graph 5).

Installing structures that will increase or deepen pool habitat is recommended for locations where their installation will not be threatened by high stream energy, or where their installation will not conflict with the modification of any log debris accumulations (LDA's) in the stream.

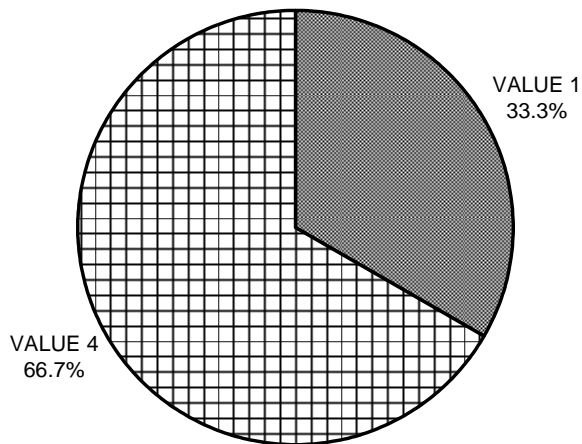
GRAPH 6

The depth of cobble embeddedness was estimated at pool tail-outs. Of the 3 pool tail-outs measured, 1 had a value of 1 (33.3%) and 2 had a value of 4 (66.7%) (Graph 6). On this scale, a value of 1 indicates the best spawning conditions and a value of 4 the worst.

One of the 3 pool tail-outs measured had embeddedness ratings of 1 or 2. Two of the pool tail-outs had embeddedness ratings of 3 or 4. None of the pool tail-outs had a rating of 5, which is considered unsuitable for spawning. Cobble embeddedness measured to be 25% or less, a rating of 1, is considered to indicate good quality spawning substrate for salmon and steelhead.

Sediment sources in Corte Madera Creek should be mapped and rated according to their potential sediment yields, and control measures should be taken.

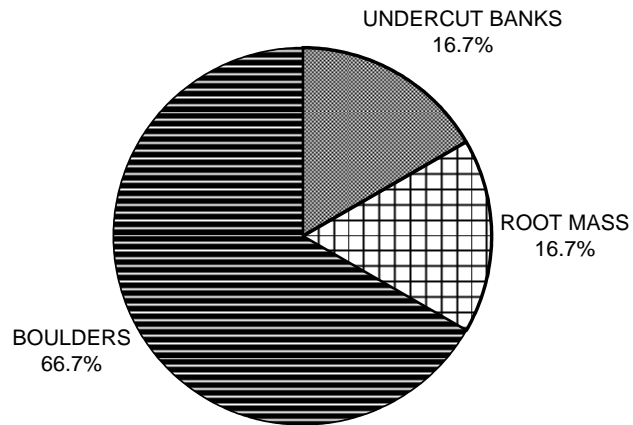
GRAPH 7

Table 5 summarizes mean percent cover by habitat type. Boulders are the dominant cover type in Corte Madera Creek. Graph 7 describes the pool cover in Corte Madera Creek. Boulders are the dominant pool cover type followed by root mass and undercut banks.

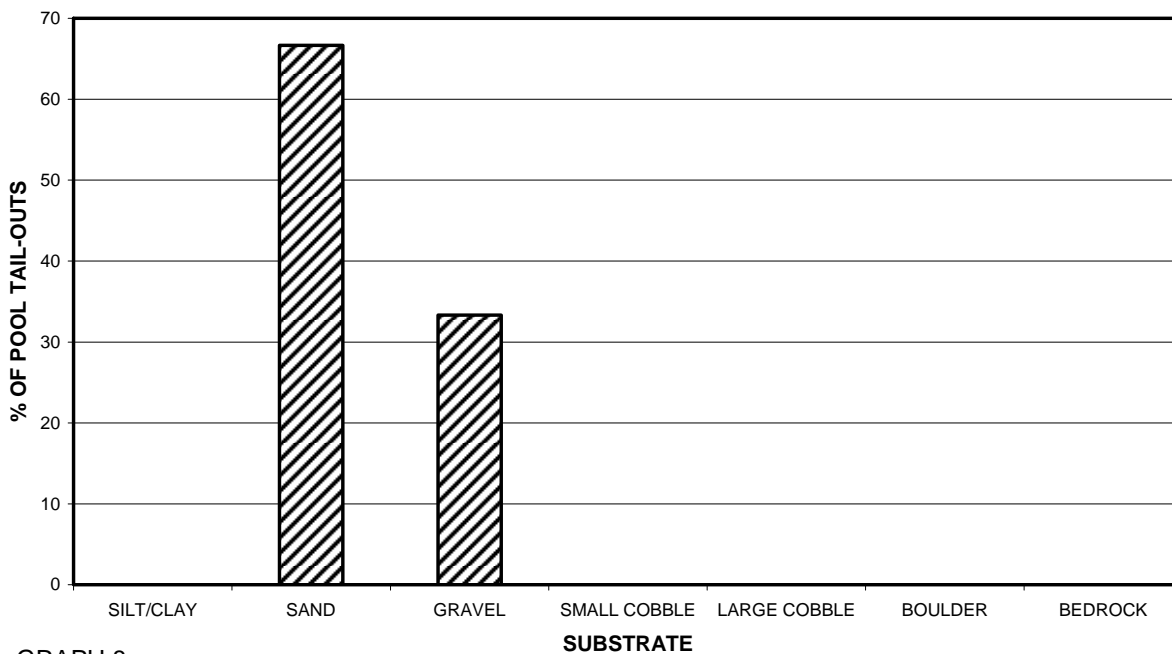
GRAPH 8

Table 6 summarizes the dominant substrate by habitat type. Graph 8 depicts the dominant substrate observed in pool tail-outs. Sand dominance was observed in 67% of pool tail-outs, gravel dominance was observed in 33% of pool tail-outs.

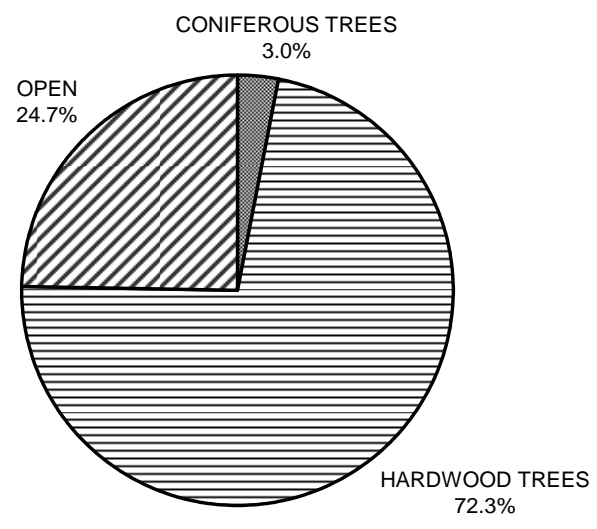
GRAPH 9

The mean percent canopy density for the surveyed length of Corte Madera Creek was 75%. The mean percentages of hardwood and coniferous trees were 96% and 4%, respectively. 25 percent of the canopy was open. Graph 9 describes the mean percent canopy in Corte Madera Creek.

The mean percent canopy density for the stream was 75%. Reach 1 had a canopy density of 55%, Reach 2 had a canopy density of 76.8%. In general, revegetation projects are considered when canopy density is less than 80%.

- 4) Increase the canopy on Corte Madera Creek by planting appropriate native vegetation like willow, alder, redwood, and Douglas fir along the stream where shade canopy is not at acceptable levels. The reaches above this survey section should be inventoried and treated as well, since the water flowing here is affected from upstream. In many cases, planting will need to be coordinated to follow bank stabilization or upslope erosion control projects.

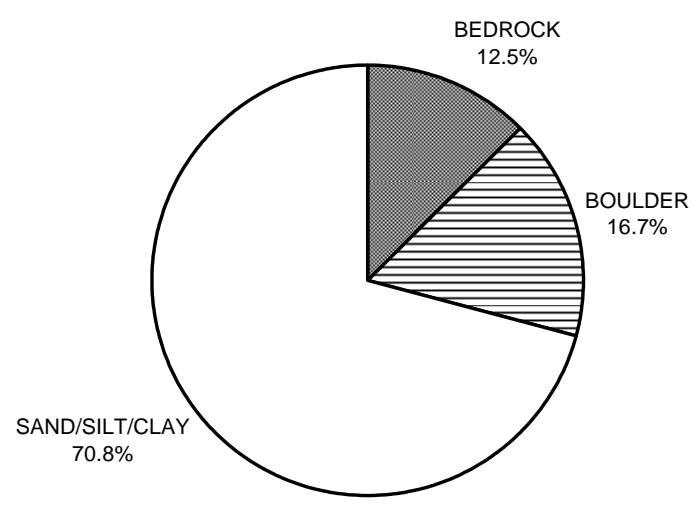
GRAPH 10

For the stream reach surveyed, the mean percent right bank vegetated was 45%. The mean percent left bank vegetated was 55%. The dominant elements composing the structure of the stream banks consisted of 12% bedrock, 17% boulder and 71% sand/silt/clay (Graph 10). Hardwood trees were the dominant vegetation type observed in 62.5% of the units surveyed. Additionally, 29.2% of the units surveyed had brush as the dominant vegetation type and 8.3% was dominated by no vegetation (Graph 11).

The percentage of right and left bank covered with vegetation 45% and 55%, respectively. In areas of stream bank erosion or where bank vegetation is sparse, planting endemic species of coniferous and hardwood trees, in conjunction with bank stabilization, is recommended.
