**California Department of Fish and
Wildlife
East Marin County
San Francisco Bay Watersheds
Stream Habitat Assessment Reports**

Coyote Creek

Surveyed 2009

STREAM INVENTORY REPORT

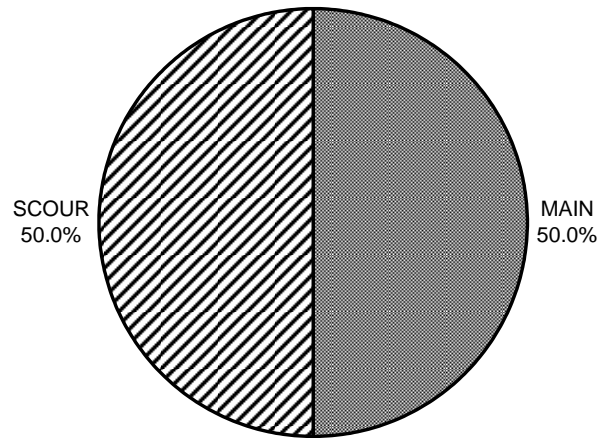
GRAPH 4

A total of 2 pools were identified (Table 3). Main Channel and Scour Pools were both encountered at 50% (Graph 4). The Main Channel pool comprised 38% while the Scour pool comprised 62% of the total length of all pools.

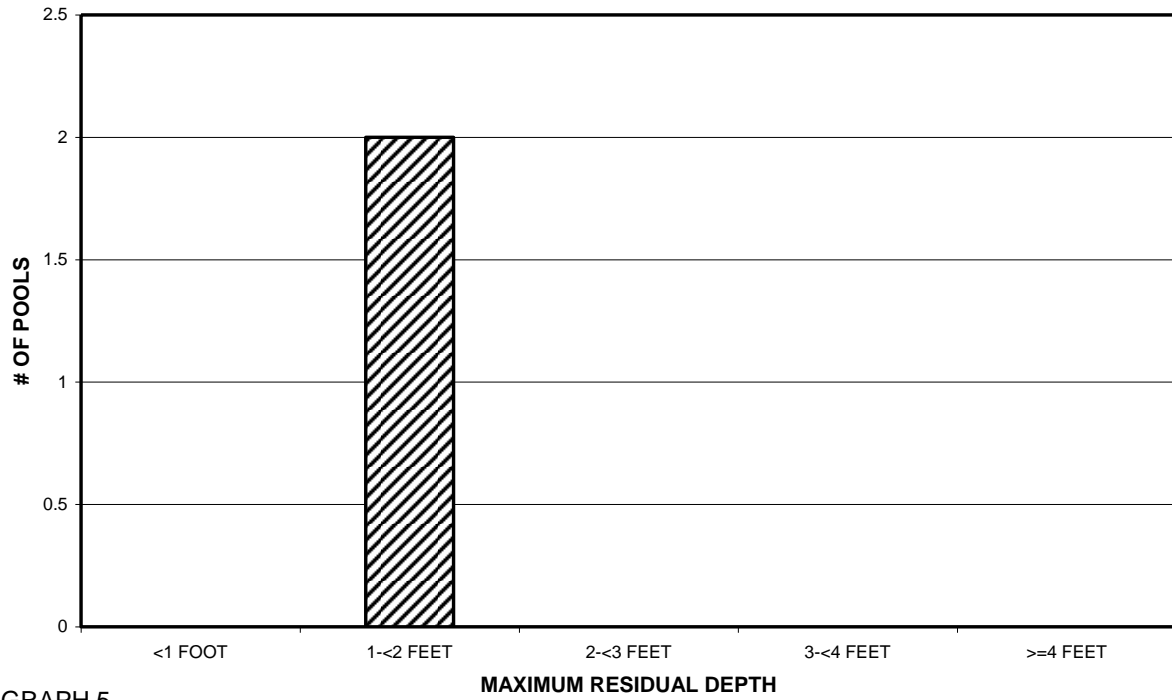
GRAPH 5

Table 4 is a summary of maximum residual pool depths by pool habitat types. Pool quality for salmonids increases with depth. None of the 2 pools had a residual depth of three feet or greater (Graph 5).

Installing structures that will increase or deepen pool habitat is recommended for locations where their installation will not be threatened by high stream energy, or where their installation will not conflict with the modification of any log debris accumulations (LDA's) in the stream.

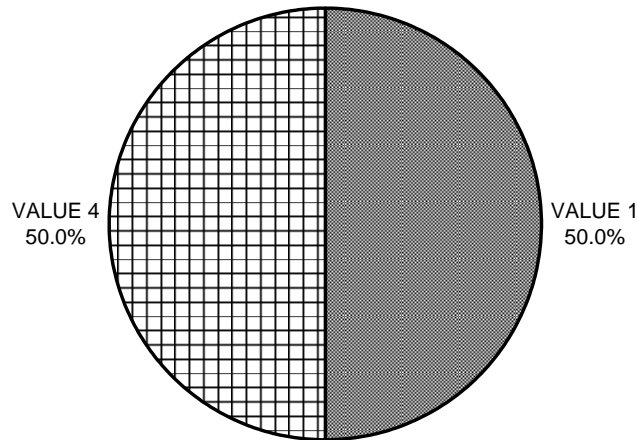
GRAPH 6

The depth of cobble embeddedness was estimated at pool tail-outs. Of the 2 pool tail-outs measured, 1 had a value of 1 (50%) and 1 had a value of 4 (50%) (Graph 6). On this scale, a value of 1 indicates the best spawning conditions and a value of 4 the worst.

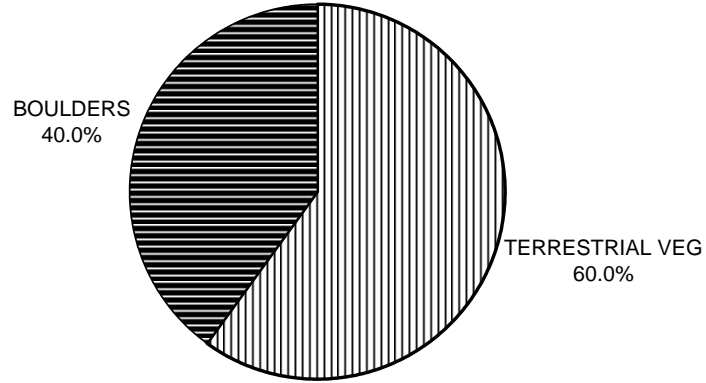
GRAPH 7

Table 5 summarizes mean percent cover by habitat type. Terrestrial vegetation is the dominant cover types in Coyote Creek. Graph 7 describes the pool cover in Coyote Creek. Terrestrial vegetation is the dominant pool cover type followed by boulders.

- 2) Increase woody cover in the pools and flatwater habitat units. Most of the existing cover in the pools is from Terrestrial Vegetation. Adding high quality complexity with woody cover in the pools is desirable.

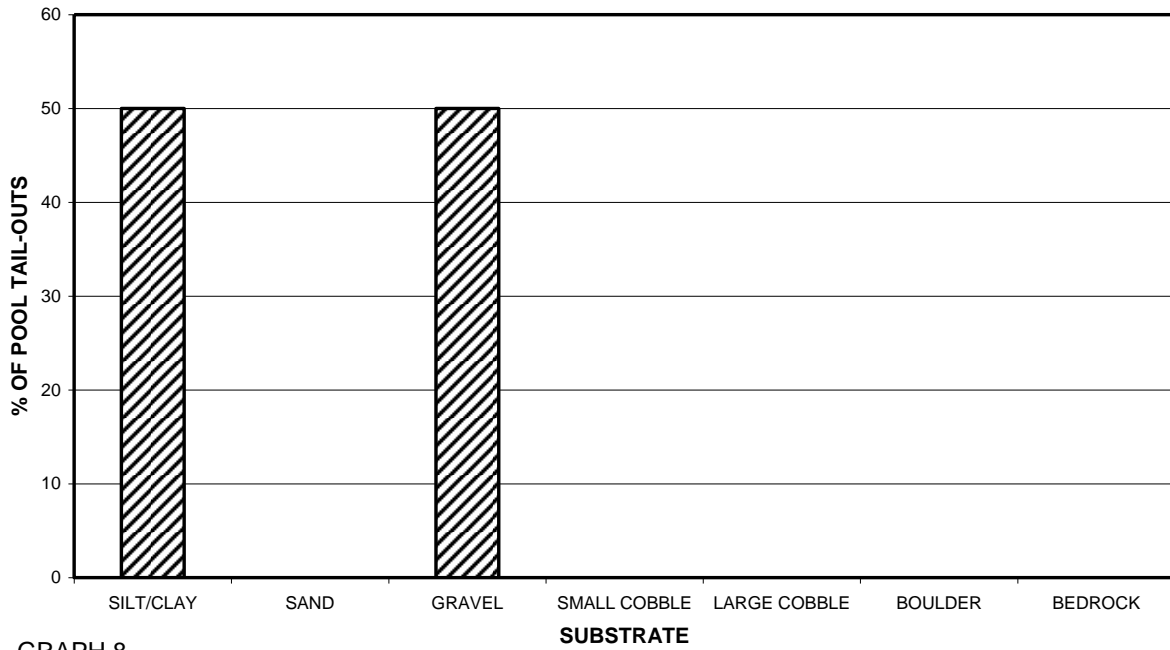
GRAPH 8

Table 6 summarizes the dominant substrate by habitat type. Graph 8 depicts the dominant substrate observed in pool tail-outs. A silt/clay substrate type was observed in 50% of pool tail-outs, and gravel substrate was observed in 50% of pool tail-outs.

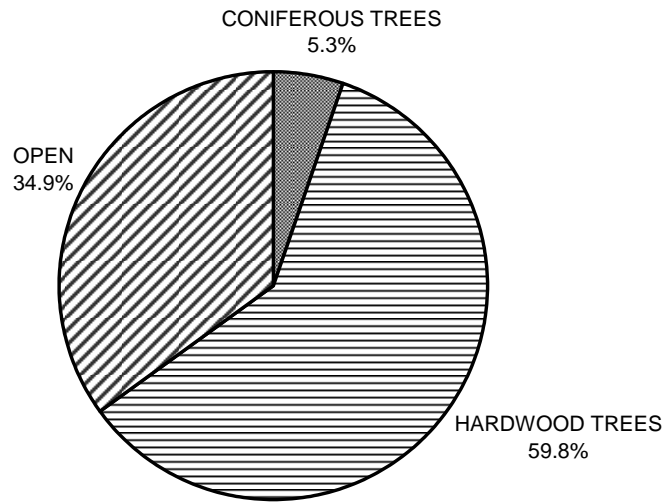
GRAPH 9

The mean percent canopy density for the surveyed length of Coyote Creek was 65%. The mean percentages of hardwood and coniferous trees were 92% and 8%, respectively. Thirty-five percent of the canopy was open. Graph 9 describes the mean percent canopy in Coyote Creek.

- 4) Increase the canopy on Coyote Creek by planting appropriate native vegetation like willow, alder, redwood, and Douglas fir along the stream where shade canopy is not at acceptable levels. The reaches above this survey section should be inventoried and treated as well, since the water flowing here is affected from upstream. In many cases, planting will need to be coordinated to follow bank stabilization or upslope erosion control projects.

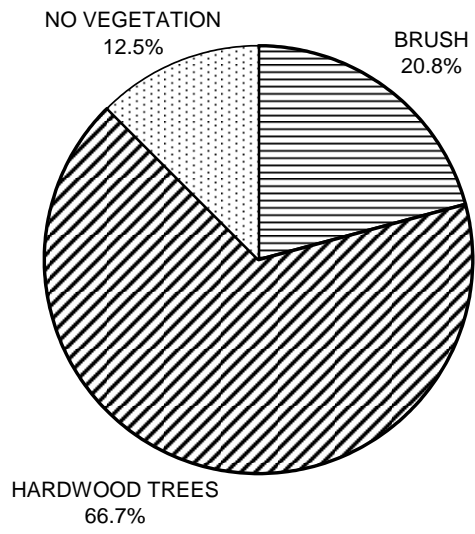
GRAPH 11

For the stream reach surveyed, the mean percent right bank vegetated was 33%. The mean percent left bank vegetated was 47%. The dominant elements composing the structure of the stream banks consisted of 8.3% bedrock, 8.3% boulder, 33.3% cobble/gravel and 50% sand/silt/clay (Graph 10). Hardwood trees were the dominant vegetation type observed in 66.7% of the units surveyed. Additionally, 20.8% of the units surveyed had brush as the dominant vegetation type, and 12.5% was dominated by no vegetation (Graph 11).
