California Department of Fish and Wildlife
East Marin County
San Francisco Bay Watersheds
Stream Habitat Assessment Reports

Fairfax Creek

STREAM INVENTORY REPORT

Survey Completed Summer 2009

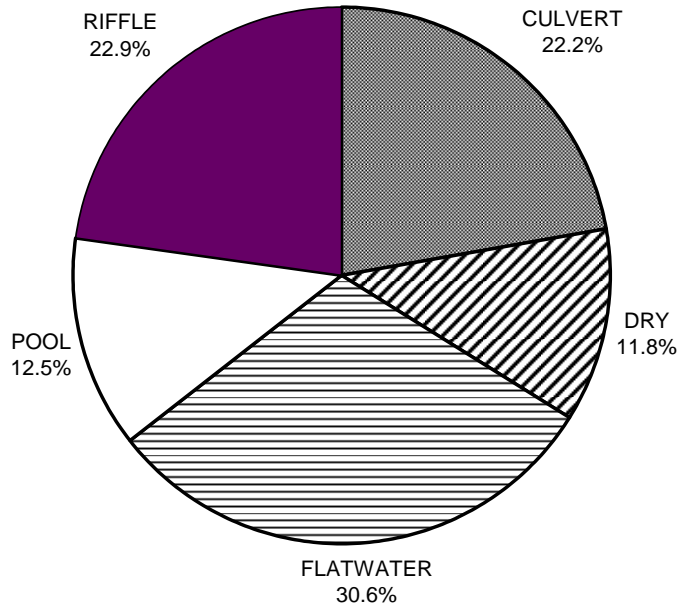
GRAPH 1

Table 1 summarizes the Level II riffle, flatwater, and pool habitat types. Based on frequency of occurrence there were 22% culvert units, 23% riffle units, 31% flatwater units, 12% pool units and 12% dry units (Graph 1). Based on total length of Level II habitat types there were 9% culvert units, 16% riffle units, 28% flatwater units, 5% pool units and 42% dry units (Graph 2).

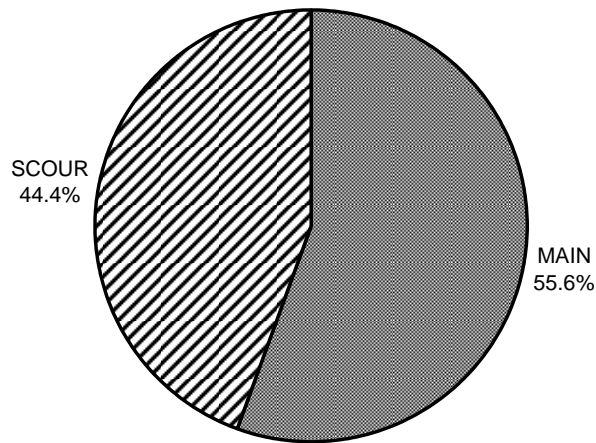
GRAPH 4

A total of 18 pools were identified (Table 3). Main channel pools were the most frequently encountered, at 56%, and comprised 55% of the total length of all pools (Graph 4).

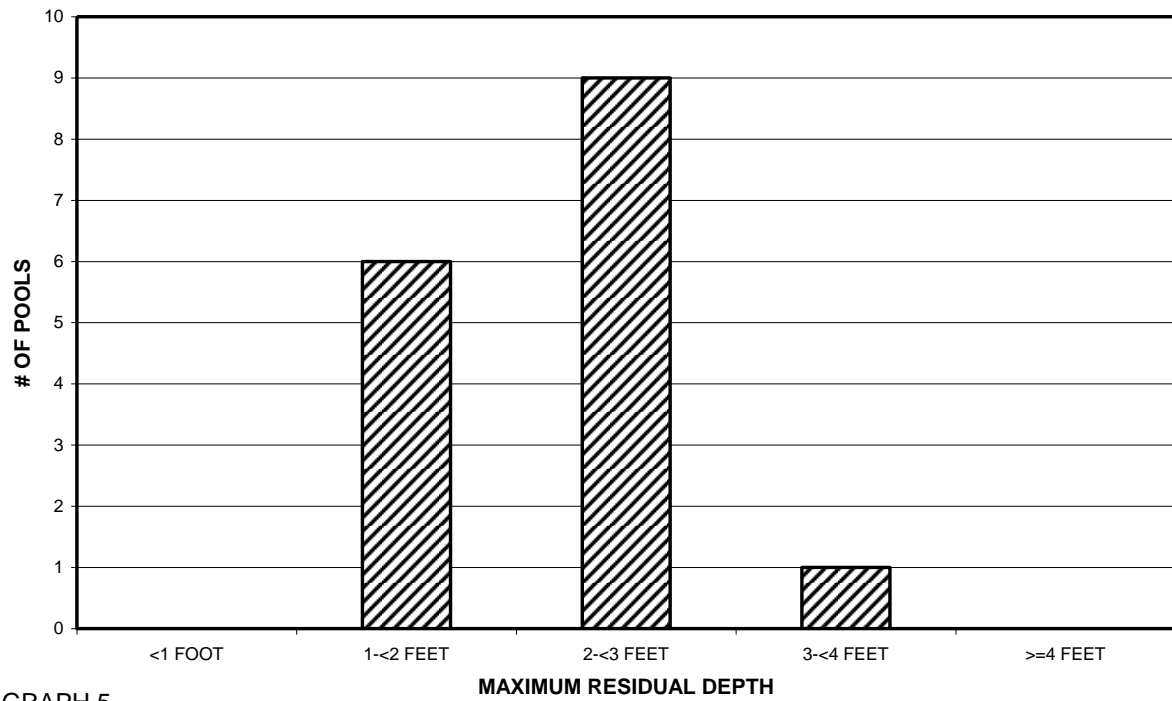
GRAPH 5

Table 4 is a summary of maximum residual pool depths by pool habitat types. Pool quality for salmonids increases with depth. Ten of the 16 pools (62%) had a residual depth of two feet or greater (Graph 5).

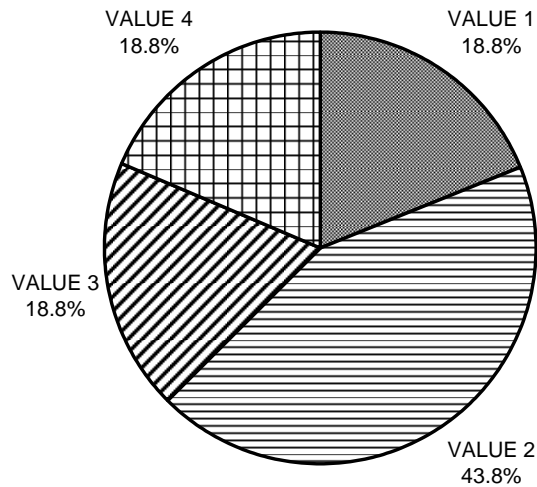
GRAPH 6

The depth of cobble embeddedness was estimated at pool tail-outs. Of the 16 pool tail-outs measured, 3 had a value of 1 (18.8%); 7 had a value of 2 (43.8%); 3 had a value of 3 (18.8%); and 3 had a value of 4 (18.8%) (Graph 6). On this scale, a value of 1 indicates the best spawning conditions and a value of 4 the worst. Additionally, a value of 5 was assigned to tail-outs deemed unsuited for spawning due to inappropriate substrate such as bedrock, log sills, boulders, or other considerations.

Ten of the 16 pool tail-outs measured had embeddedness ratings of 1 or 2. Six of the pool tail-outs had embeddedness ratings of 3 or 4. None of the pool tail-outs had a rating of 5, which is considered unsuitable for spawning. Cobble embeddedness measured to be 25% or less, a rating of 1, is considered to indicate good quality spawning substrate for salmon and steelhead. Sediment sources in Fairfax Creek should be mapped and rated according to their potential sediment yields, and control measures should be taken.

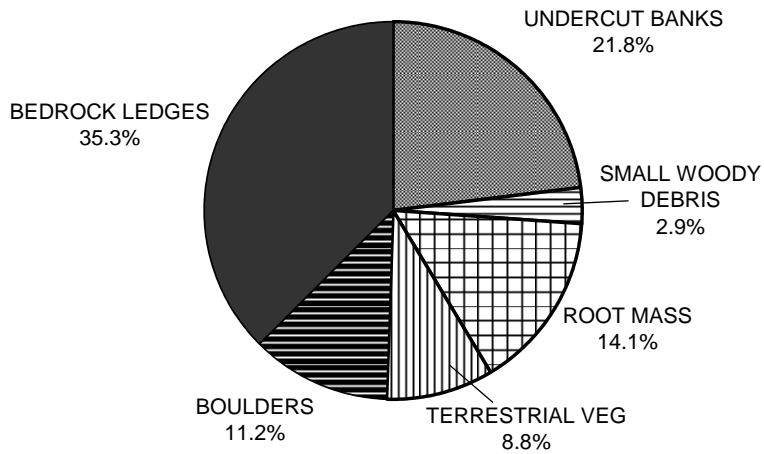
GRAPH 7

Table 5 summarizes mean percent cover by habitat type. Undercut Banks are the dominant cover types in Fairfax Creek. Graph 7 describes the pool cover in Fairfax Creek. Bedrock Ledges are the dominant pool cover type followed by undercut banks.

The mean shelter rating for pools was 17. The shelter rating in the flatwater habitats was 6. A pool shelter rating of approximately 100 is desirable. The amount of cover that now exists is being provided primarily by Undercut Banks in Fairfax Creek. Bedrock Ledges are the dominant cover type in pools followed by undercut banks. Log and root wad cover structures in the pool and flatwater habitats would enhance both summer and winter salmonid habitat. Log cover structure provides rearing fry with protection from predation, rest from water velocity, and also divides territorial units to reduce density related competition.

- 1) Increase woody cover in the pools and flatwater habitat units. Most of the existing cover in the pools is from Undercut Banks. Adding high quality complexity with woody cover in the pools is desirable.

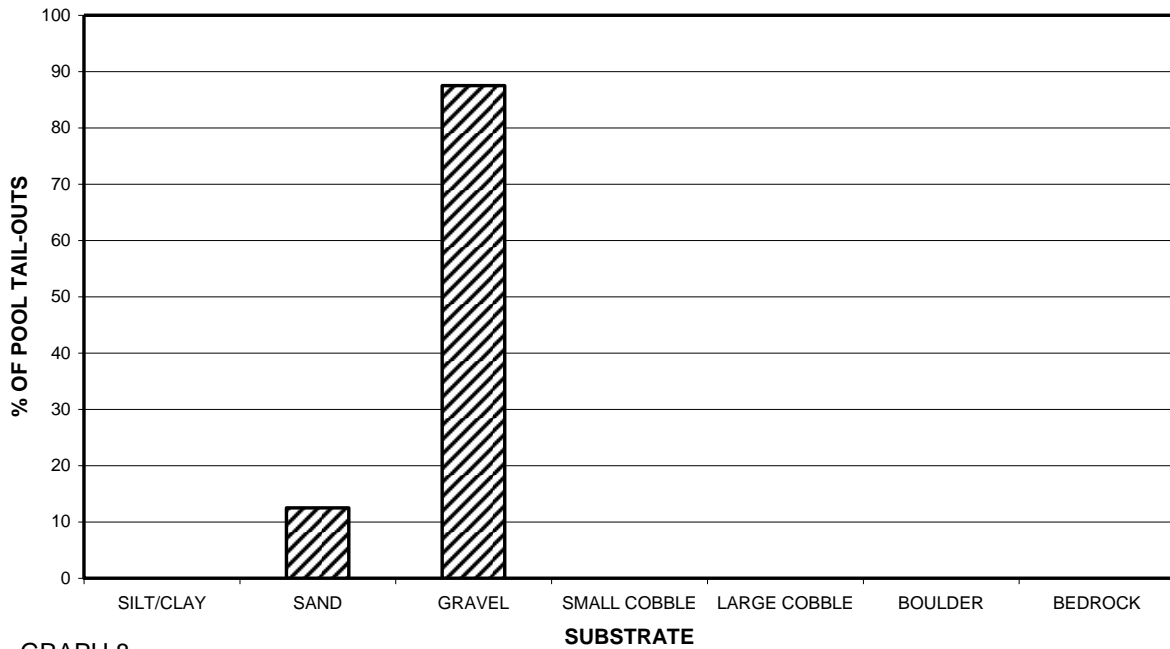
GRAPH 8

Table 6 summarizes the dominant substrate by habitat type. Graph 8 depicts the dominant substrate observed in pool tail-outs. Sand dominance was observed in 12% of pool tail-outs, and gravel dominance was observed in 88% of pool tail-outs.

Fourteen of the 16 pool tail-outs measured had gravel or small cobble as the dominant substrate. This is generally considered good for spawning salmonids.

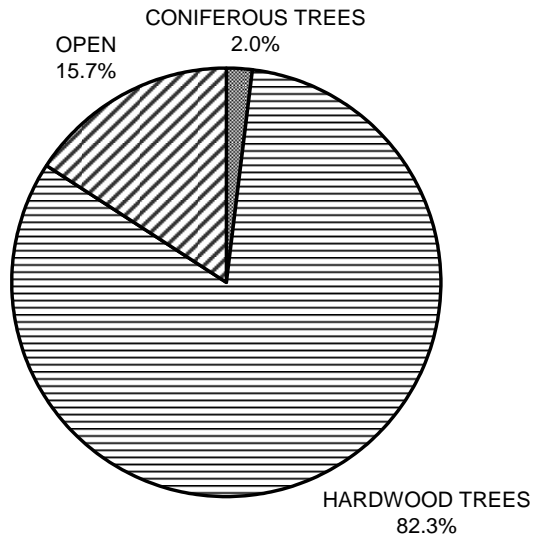
GRAPH 9

The mean percent canopy density for the surveyed length of Fairfax Creek was 84%. The mean percentages of hardwood and coniferous trees were 98% and 2%, respectively. Sixteen percent of the canopy was open. Graph 9 describes the mean percent canopy in Fairfax Creek.

The mean percent canopy density for the stream was 84%. Reach 1 had a canopy density of 84.1%, Reach 2 had a canopy density of 93%. In general, revegetation projects are considered when canopy density is less than 80%.

- 3) Increase the canopy on Fairfax Creek, particularly in Reach 1, by planting appropriate native vegetation like willow, alder, redwood, and Douglas fir along the stream where shade canopy is not at acceptable levels. The reaches above this survey section should be inventoried and treated as well, since the water flowing here is affected from upstream. In many cases, planting will need to be coordinated to follow bank stabilization or upslope erosion control projects.

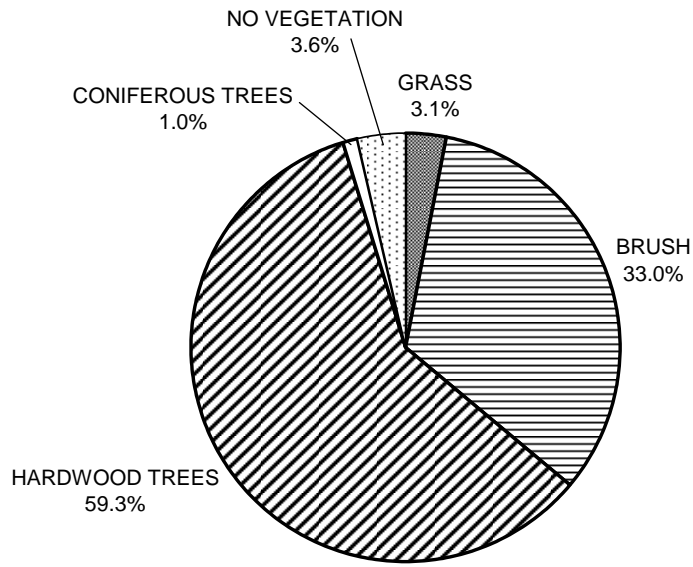
GRAPH 11

For the stream reach surveyed, the mean percent right bank vegetated was 43%. The mean percent left bank vegetated was 50%. The dominant elements composing the structure of the stream banks consisted of 18% bedrock, 8% boulder, 75% sand/silt/clay (Graph 10). Deciduous trees were the dominant vegetation type observed in 59% of the units surveyed. Additionally, 33% of the units surveyed had brush as the dominant vegetation type, and 3% had grass as the dominant vegetation (Graph 11).

The percentage of right and left bank covered with vegetation was 43% and 50%, respectively. In areas of stream bank erosion or where bank vegetation is sparse, planting endemic species of coniferous and hardwood trees, in conjunction with bank stabilization, is recommended.
