**California Department of Fish and  
Wildlife  
East Marin County  
San Francisco Bay Watershed  
Stream Habitat Assessment Reports**

# **Larkspur Creek**

*Surveyed 2009*

## STREAM INVENTORY REPORT

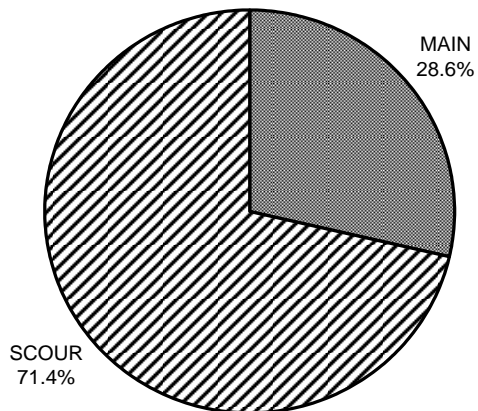
GRAPH 4

A total of 7 pools were identified (Table 3). Scour pools were the most frequently encountered, at 71%, and comprised 29% of the total length of all pools (Graph 4).

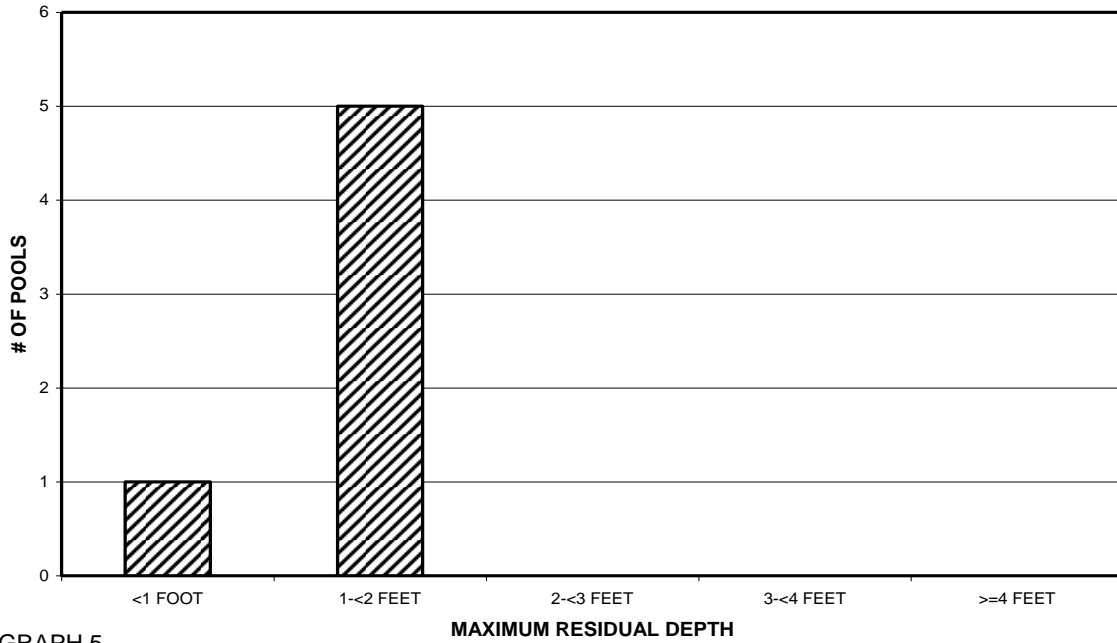
GRAPH 5

Table 4 is a summary of maximum residual pool depths by pool habitat types. Pool quality for salmonids increases with depth. None of the 6 pools (0%) had a residual depth of two feet or greater (Graph 5).

Flatwater habitat types comprised 10% of the total length of this survey, riffles comprised 20%, and pools comprised 3%. The pools are relatively shallow, with none of the 6 (0%) pools having a maximum residual depth greater than 2 feet. In general, pool enhancement projects are considered when primary pools comprise less than 40% of the length of total stream habitat. In first and second order streams, a primary pool is defined to have a maximum residual depth of at least two feet, occupy at least half the width of the low flow channel, and be as long as the low flow channel width. Installing structures that will increase or deepen pool habitat is recommended for locations where their installation will not be threatened by high stream energy, or where their installation will not conflict with the modification of any log debris accumulations (LDA's) in the stream.

- 3) Where feasible, design and engineer pool enhancement structures to increase the number of pools. This must be done where the banks are stable or in conjunction with stream bank armor to prevent erosion.

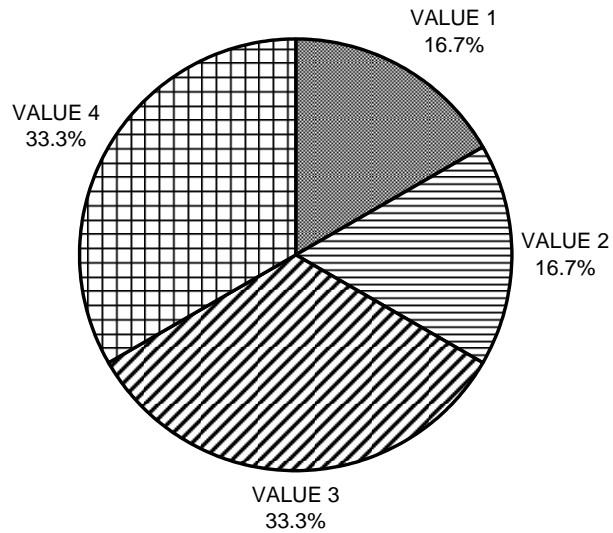
GRAPH 6

The depth of cobble embeddedness was estimated at pool tail-outs. Of the 6 pool tail-outs measured, 1 had a value of 1 (16.7%); 1 had a value of 2 (16.7%); 2 had a value of 3 (33.3%); and 2 had a value of 4 (33.3%) (Graph 6). On this scale, a value of 1 indicates the best spawning conditions and a value of 4 the worst. Additionally, a value of 5 was assigned to tail-outs deemed unsuited for spawning due to inappropriate substrate such as bedrock, log sills, boulders, or other considerations.

Two of the 6 pool tail-outs measured had embeddedness ratings of 1 or 2. Four of the pool tail-outs had embeddedness ratings of 3 or 4. None of the pool tail-outs had a rating of 5, which is considered unsuitable for spawning. Cobble embeddedness measured to be 25% or less, a rating of 1, is considered to indicate good quality spawning substrate for salmon and steelhead. Sediment sources in Larkspur Creek should be mapped and rated according to their potential sediment yields, and control measures should be taken.

- 2) Inventory and map sources of stream bank erosion and associated sites (particularly in lower urbanized reach of Larkspur Creek) and prioritize them according to present and potential sediment yield. Identified sites should then be treated to reduce the amount of fine sediments entering the stream. Active and potential sediment sources related to the road system need to be identified, mapped, and treated according to their potential for sediment yield to the stream and its tributaries.

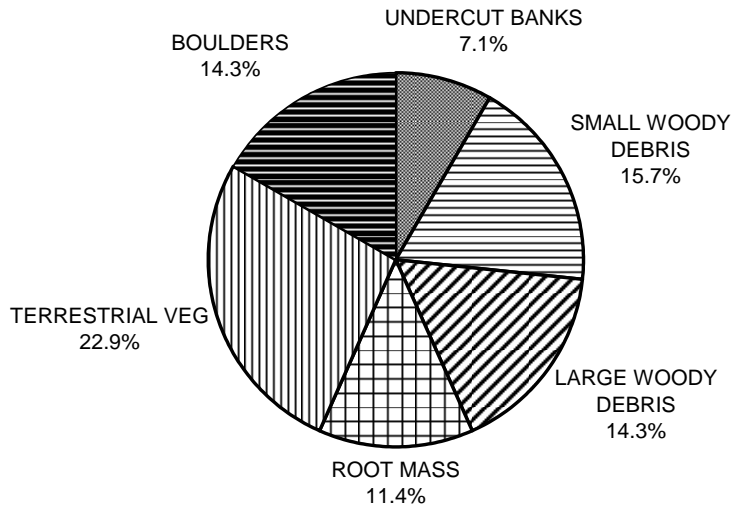
GRAPH 7

Table 5 summarizes mean percent cover by habitat type. Boulders are the dominant cover types in Larkspur Creek. Graph 7 describes the pool cover in Larkspur Creek. Terrestrial vegetation is the dominant pool cover type followed by small woody debris.

The mean shelter rating for pools was 16. The shelter rating in the flatwater habitats was 4. A pool shelter rating of approximately 100 is desirable. The amount of cover that now exists is being provided primarily by Boulders in Larkspur Creek. Terrestrial Vegetation is the dominant cover type in pools followed by small woody debris. Log and root wad cover structures in the pool and flatwater habitats would enhance both summer and winter salmonid habitat. Log cover structure provides rearing fry with protection from predation, rest from water velocity, and also divides territorial units to reduce density related competition.

- 4) Increase woody cover in the pools and flatwater habitat units. Most of the existing cover in the pools is from Boulders. Adding high quality complexity with woody cover in the pools is desirable.

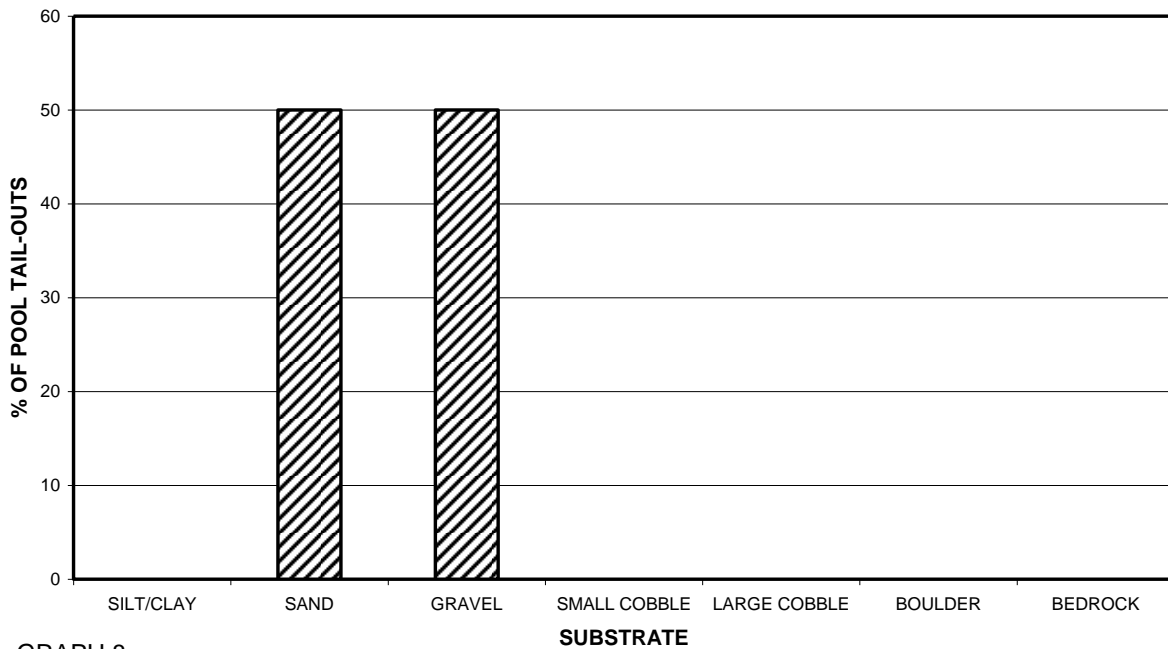
GRAPH 8

Table 6 summarizes the dominant substrate by habitat type. Graph 8 depicts the dominant substrate observed in pool tail-outs. Sand dominance was observed in 50% of pool tail-outs, and gravel dominance was observed in 50% of pool tail-outs.

Three of the 6 pool tail-outs measured had gravel or small cobble as the dominant substrate. This is generally considered good for spawning salmonids.

- 5) Suitable size spawning substrate on Larkspur Creek is limited to relatively few reaches. Projects should be designed at suitable sites to trap and sort spawning gravel.

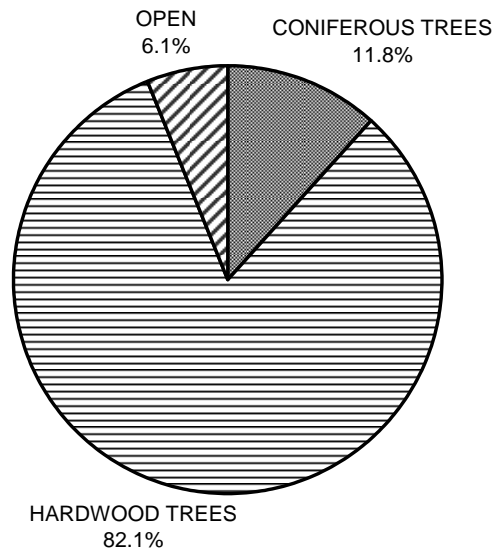
GRAPH 9

The mean percent canopy density for the surveyed length of Larkspur Creek was 94%. The mean percentages of hardwood and coniferous trees were 87% and 13%, respectively. Six percent of the canopy was open. Graph 9 describes the mean percent canopy in Larkspur Creek.

The mean percent canopy density for the stream was 94%. In general, revegetation projects are considered when canopy density is less than 80%.

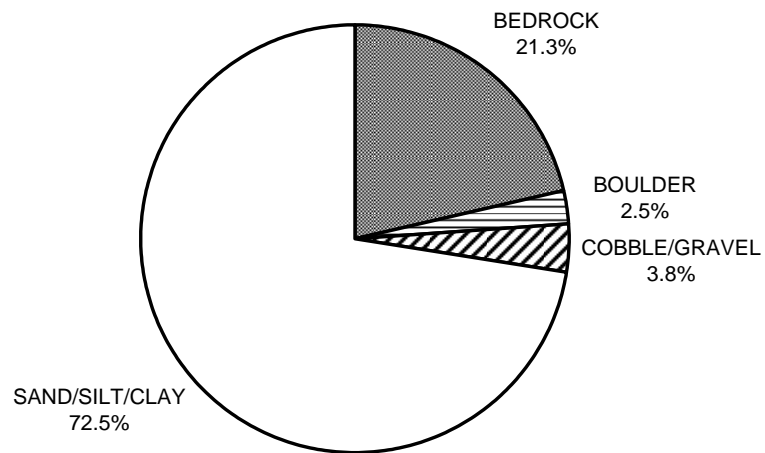
GRAPH 10

For the stream reach surveyed, the mean percent right bank vegetated was 38%. The mean percent left bank vegetated was 37%. The dominant elements composing the structure of the stream banks consisted of 21% bedrock, 2% boulder, 4% cobble/gravel, 72% sand/silt/clay, (Graph 10). Hardwood trees were the dominant vegetation type observed in 75% of the units surveyed. Additionally, 18% of the units surveyed had brush as the dominant vegetation type, and 2% had grass as the dominant vegetation (Graph 11).

The percentage of right and left bank covered with vegetation was 38% and 37%, respectively. In areas of stream bank erosion or where bank vegetation is sparse, planting endemic species of coniferous and hardwood trees, in conjunction with bank stabilization, is recommended.

- 7) Larkspur Creek would benefit from utilizing bio-technical vegetative techniques to re-establish floodplain benches and a defined low flow channel. This would discourage lateral migration of the base flow channel and decrease bank erosion.
