California Department of Fish and Game
East Marin County
San Francisco Bay Watersheds
Stream Habitat Assessment Reports

Miller Creek

Surveyed 2009

STREAM INVENTORY REPORT

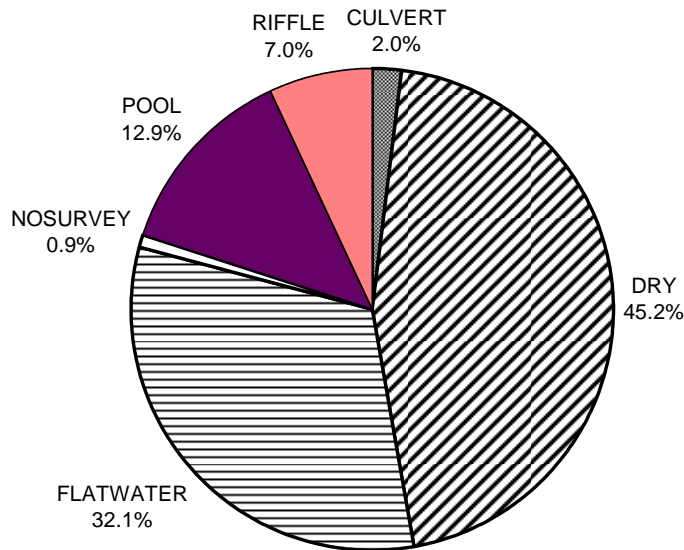
GRAPH 2

Table 1 summarizes the Level II riffle, flatwater, and pool habitat types. Based on frequency of occurrence there were 38% flatwater units, 27% pool units, 16% riffle units, 12% dry units, 6% culvert units and 1% no survey units (Graph 1). Based on total length of Level II habitat types there were 45% dry units, 32% flatwater units, 13% pool units, 7% riffle units, 2% culvert units and 1% no survey units (Graph 2).

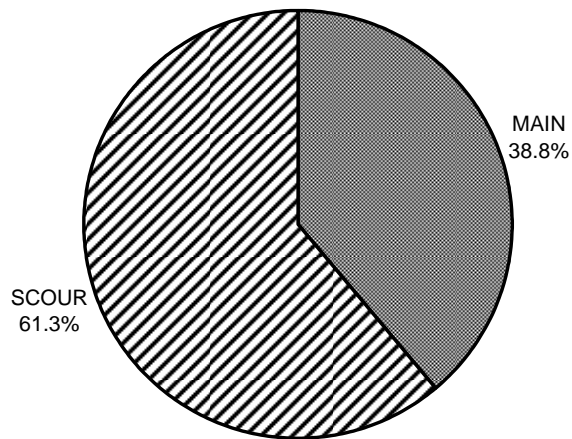
GRAPH 4

A total of 80 pools were identified (Table 3). Scour pools were the most frequently encountered, at 61%, and comprised 61% of the total length of all pools (Graph 4).

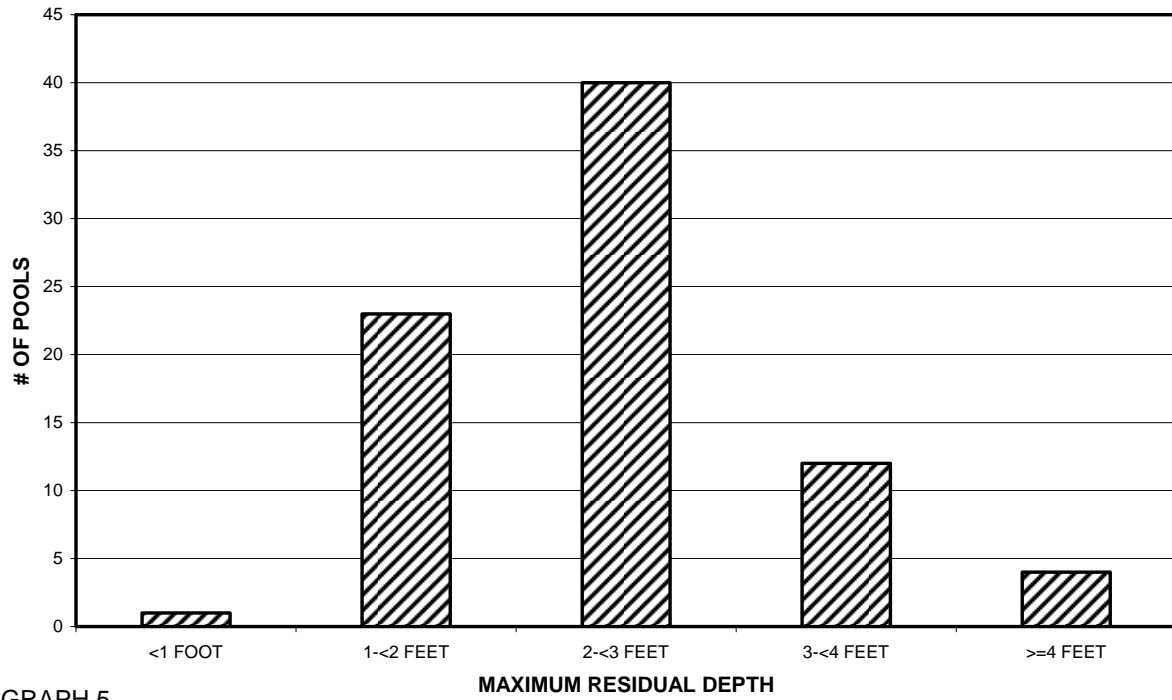
GRAPH 5

Table 4 is a summary of maximum residual pool depths by pool habitat types. Pool quality for salmonids increases with depth. Fifty-six of the 80 pools (70%) had a residual depth of two feet or greater (Graph 5).

Flatwater habitat types comprised 32% of the total length of this survey, riffles 7%, and pools 13%. The pools are relatively deep, with 56 of the 80 (70%) pools having a maximum residual depth greater than 2 feet. In general, pool enhancement projects are considered when primary pools comprise less than 40% of the length of total stream habitat. In first and second order streams, a primary pool is defined to have a maximum residual depth of at least two feet, occupy

at least half the width of the low flow channel, and be as long as the low flow channel width. Installing structures that will increase or deepen pool habitat is recommended for locations where their installation will not be threatened by high stream energy, or where their installation will not conflict with the modification of any log debris accumulations (LDA's) in the stream.

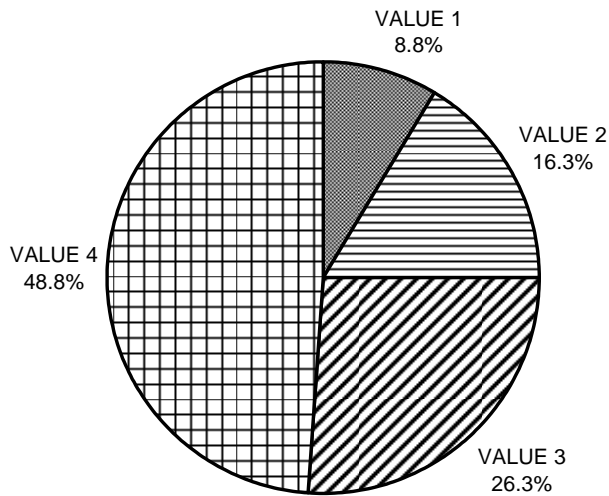
GRAPH 6

The depth of cobble embeddedness was estimated at pool tail-outs. Of the 80 pool tail-outs measured, 7 had a value of 1 (8.8%); 13 had a value of 2 (16.2%); 21 had a value of 3 (26.2%); 39 had a value of 4 (48.8%) (Graph 6). On this scale, a value of 1 indicates the best spawning conditions and a value of 4 the worst. Additionally, a value of 5 was assigned to tail-outs deemed unsuited for spawning due to inappropriate substrate such as bedrock, log sills, boulders, or other considerations.

Twenty of the 80 pool tail-outs measured had embeddedness ratings of 1 or 2. Sixty of the pool tail-outs had embeddedness ratings of 3 or 4. None of the pool tail-outs had a rating of 5, which is considered unsuitable for spawning. Cobble embeddedness measured to be 25% or less, a rating of 1, is considered to indicate good quality spawning substrate for salmon and steelhead. Sediment sources in Miller Creek should be mapped and rated according to their potential sediment yields, and control measures should be taken.

- 3) Inventory and map sources of stream bank erosion and active or potential sediment sources related to the road system. These sites should be identified, mapped, prioritized and treated according to their potential to reduce the amount of fine sediments entering the stream and its tributaries.

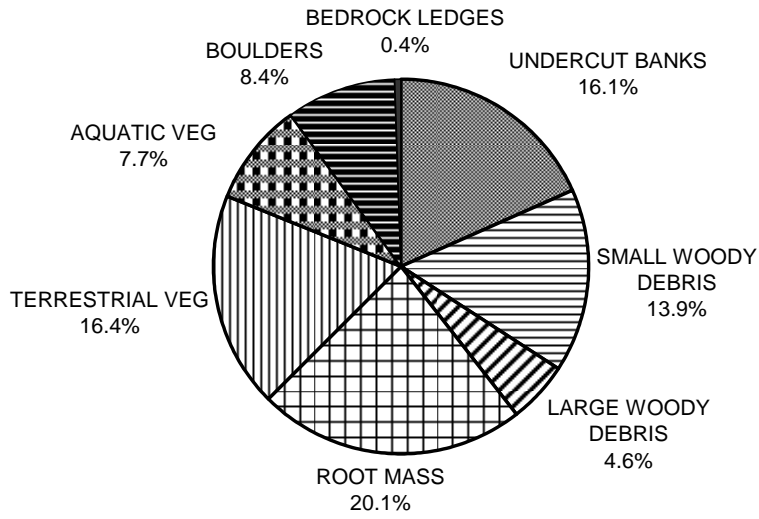
GRAPH 7

Table 5 summarizes mean percent cover by habitat type. Terrestrial vegetation is the dominant cover types in Miller Creek. Graph 7 describes the pool cover in Miller Creek. Root mass is the dominant pool cover type followed by terrestrial vegetation.

The mean shelter rating for pools was 37. The shelter rating in the flatwater habitats was 15. A pool shelter rating of approximately 100 is desirable. The amount of cover that now exists is being provided primarily by Terrestrial vegetation in Miller Creek. Root mass is the dominant cover type in pools followed by terrestrial vegetation. Log and root wad cover structures in the pool and flatwater habitats would enhance both summer and winter salmonid habitat. Log cover structure provides rearing fry with protection from predation, rest from water velocity, and also divides territorial units to reduce density related competition.

- 4) Increase woody cover in the pools and flatwater habitat units. Most of the existing cover in the pools is from Boulders. Adding high quality complexity with woody cover in the pools is desirable.

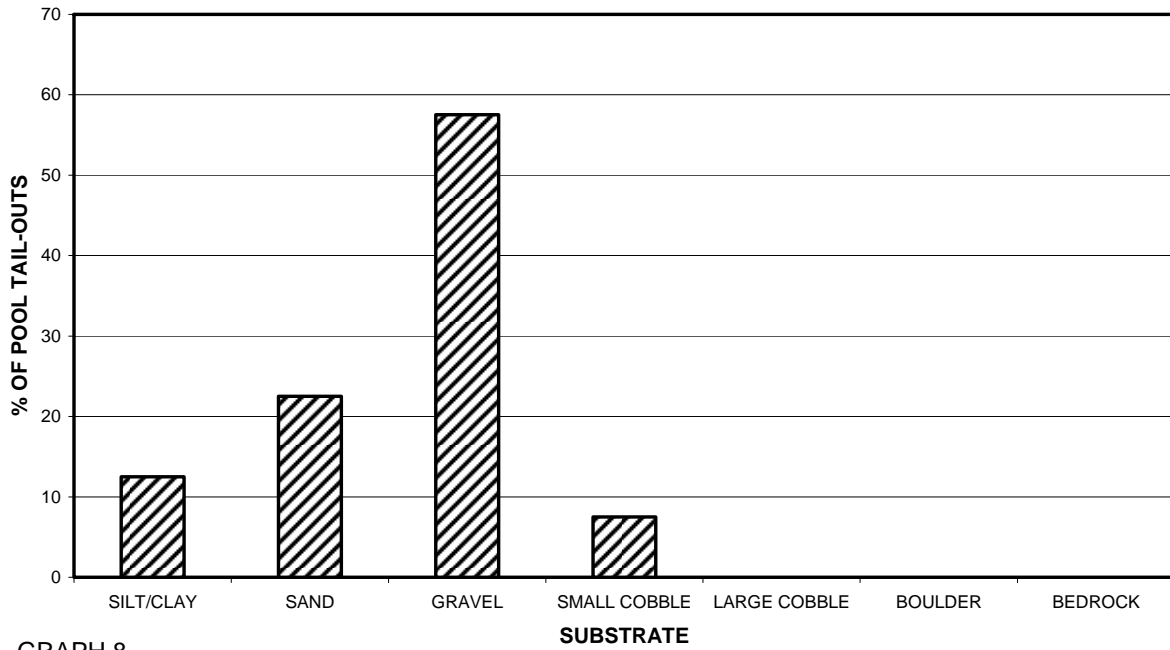
GRAPH 8

Table 6 summarizes the dominant substrate by habitat type. Graph 8 depicts the dominant substrate observed in pool tail-outs. Gravel dominance was observed in 58% of pool tail-outs and sand dominance was observed in 22% of pool tail-outs (Graph 8).

Fifty two of the 80 pool tail-outs measured had gravel or small cobble as the dominant substrate. This is generally considered good for spawning salmonids.

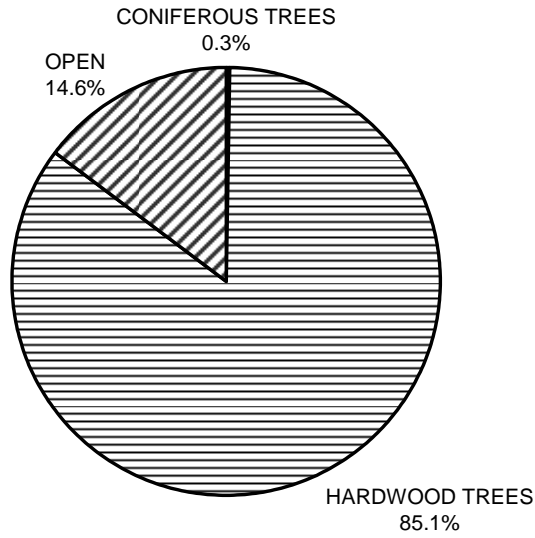
GRAPH 9

The mean percent canopy density for the surveyed length of Miller Creek was 85%. The mean percentages of hardwood and coniferous trees were 100% and 0%, respectively. Fifteen percent of the canopy was open. Graph 9 describes the mean percent canopy in Miller Creek.

The mean percent canopy density for the stream was 85%. In general, revegetation projects are considered when canopy density is less than 80%.

- 5) Increase the canopy on Miller Creek by planting appropriate native vegetation like willow, alder, redwood, and Douglas fir along the stream where shade canopy is not at acceptable levels. The reaches above this survey section should be inventoried and treated as well, since the water flowing here is affected from upstream. In many cases, planting will need to be coordinated to follow bank stabilization or upslope erosion control projects.

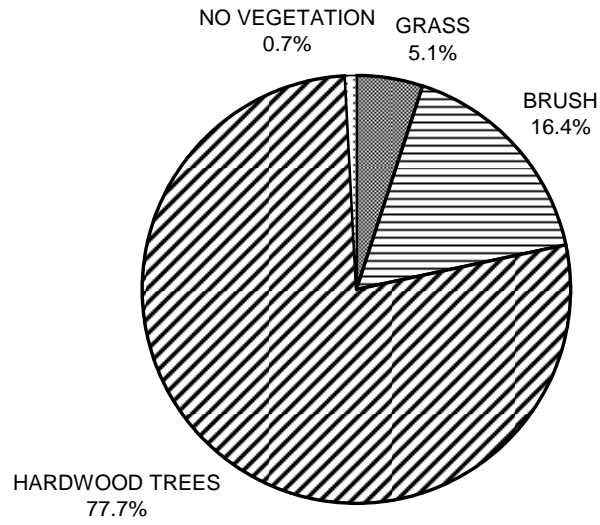
GRAPH 11

For the stream reach surveyed, the mean percent right bank vegetated was 63%. The mean percent left bank vegetated was 59%. The dominant elements composing the structure of the stream banks consisted of 4% bedrock, 7% boulder, 1% cobble/gravel and 88% sand/silt/clay (Graph 10). Hardwood trees were the dominant vegetation type observed in 78% of the units surveyed. Additionally, 16% of the units surveyed had brush as the dominant vegetation type and 5% had grass as the dominant vegetation (Graph 11).

The percentage of right and left bank covered with vegetation was 63% and 59%, respectively. In areas of stream bank erosion or where bank vegetation is sparse, planting endemic species of coniferous and hardwood trees, in conjunction with bank stabilization, is recommended.
