**California Department of Fish and Wildlife  
East Marin County  
San Francisco Bay Watersheds  
Stream Habitat Assessment Reports**

# **Old Mill Creek**

*Surveyed 2009  
Report Completed in 2013*

**STREAM INVENTORY REPORT**

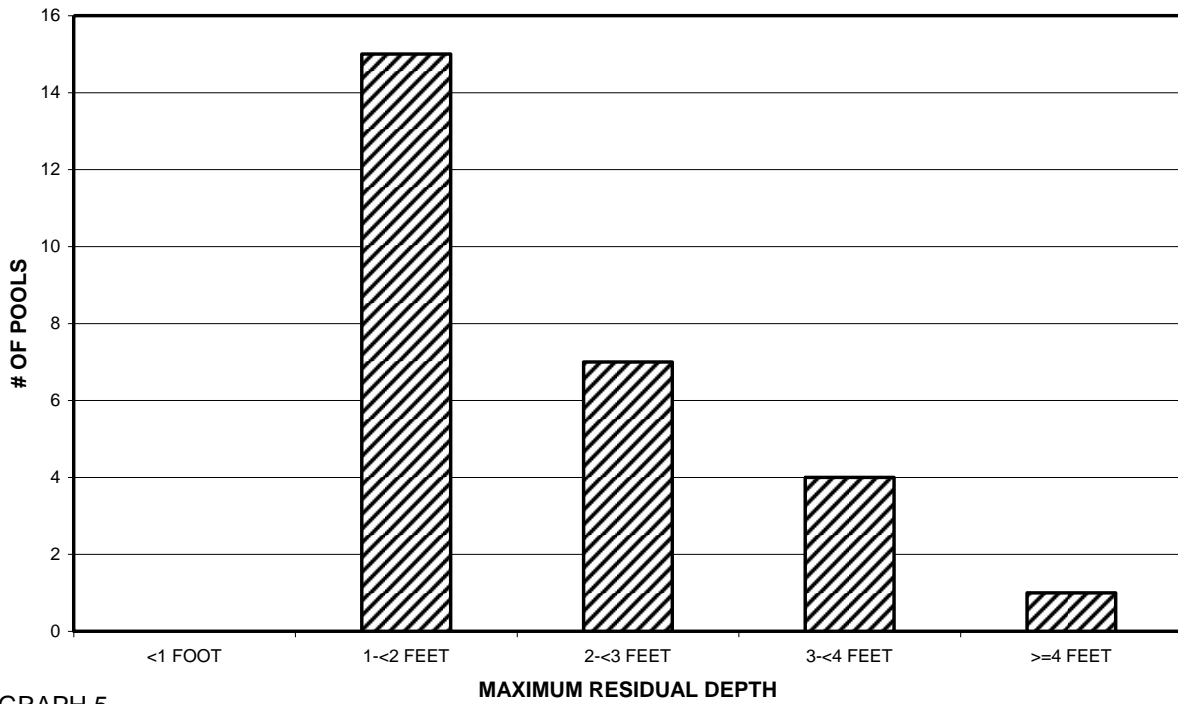
GRAPH 5

Table 4 is a summary of maximum residual pool depths by pool habitat types. Pool quality for salmonids increases with depth. Twelve of the 27 pools (44%) had a residual depth of two feet or greater (Graph 5).

Flatwater habitat types comprised 39% of the total length of this survey, riffles 40%, and pools 10%. The pools are relatively shallow, with only 12 of the 27 (44%) pools having a maximum residual depth greater than 2 feet. In general, pool enhancement projects are considered when primary pools comprise less than 40% of the length of total stream habitat. In first and second order streams, a primary pool is defined to have a maximum residual depth of at least two feet, occupy at least half the width of the low flow channel, and be as long as the low flow channel width. Installing structures that will increase or deepen pool habitat is recommended for locations where their installation will not be threatened by high stream energy, or where their installation will not conflict with the modification of any log debris accumulations (LDA's) in the stream.

- 1) Where feasible, design and engineer pool enhancement structures to increase the number of pools. This must be done where the banks are stable or in conjunction with stream bank armor to prevent erosion.

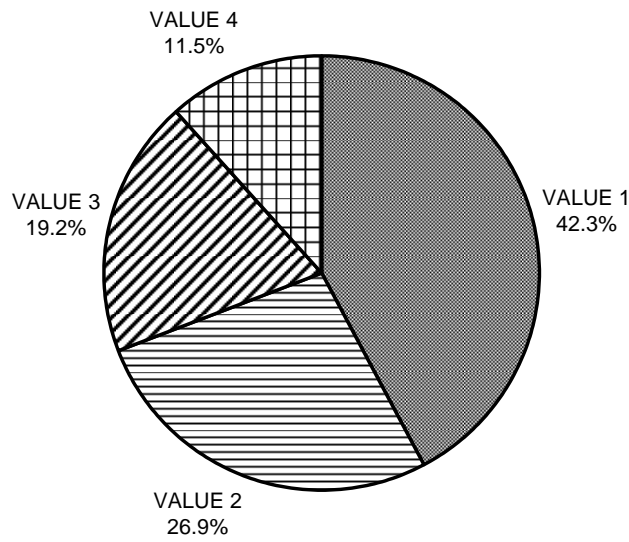
GRAPH 6

The depth of cobble embeddedness was estimated at pool tail-outs. Of the 26 pool tail-outs measured, 11 had a value of 1 (42.3%); 7 had a value of 2 (26.9%); 5 had a value of 3 (19.2%) and 3 had a value of 4 (11.5%) (Graph 6). On this scale, a value of 1 indicates the best spawning conditions and a value of 4 the worst. Additionally, a value of 5 was assigned to tail-outs deemed unsuited for spawning due to inappropriate substrate such as bedrock, log sills, boulders, or other considerations.

Eighteen of the 26 pool tail-outs measured had embeddedness ratings of 1 or 2. Eight of the pool tail-outs had embeddedness ratings of 3 or 4. None of the pool tail-outs had a rating of 5, which is considered unsuitable for spawning. Cobble embeddedness measured to be 25% or less, a rating of 1, is considered to indicate good quality spawning substrate for salmon and steelhead. Sediment sources in Old Mill Creek should be mapped and rated according to their potential sediment yields, and control measures should be taken.

- 4) Inventory and map sources of stream bank erosion and prioritize them according to present and potential sediment yield. Identified sites should then be treated to reduce the amount of fine sediments entering the stream. Active and potential sediment sources related to the road system need to be identified, mapped, and treated according to their potential for sediment yield to the stream and its tributaries.

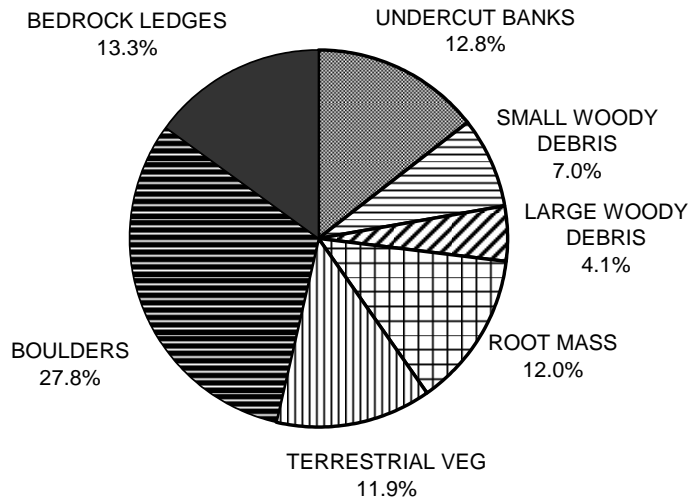
GRAPH 7

Table 5 summarizes mean percent cover by habitat type. Boulders are the dominant cover types in Old Mill Creek. Graph 7 describes the pool cover in Old Mill Creek. Boulders are the dominant pool cover type followed by bedrock ledges.

The mean shelter rating for pools was 23. The shelter rating in the flatwater habitats was 7. A pool shelter rating of approximately 100 is desirable. The amount of cover that now exists is being provided primarily by boulders in Old Mill Creek. Boulders are the dominant cover type in pools followed by bedrock ledges. Log and root wad cover structures in the pool and flatwater habitats would enhance both summer and winter salmonid habitat. Log cover structure provides rearing fry with protection from predation, rest from water velocity, and also divides territorial units to reduce density related competition.

- 2) Increase woody cover in the pools and flatwater habitat units. Most of the existing cover in the pools is from Terrestrial Vegetation. Adding high quality complexity with woody cover in the pools is desirable.
