**California Department of Fish and Wildlife**  
**East Marin County**  
**San Francisco Bay Watersheds**  
**Stream Habitat Assessment Reports**

# **San Anselmo Creek**

*Surveyed 2009*

**STREAM INVENTORY REPORT**

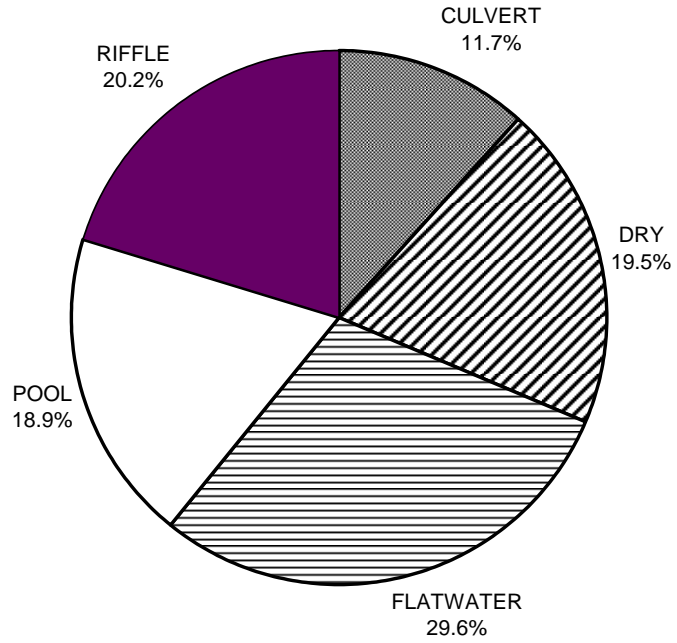
GRAPH 1

Table 1 summarizes the Level II riffle, flatwater, and pool habitat types. Based on frequency of occurrence there were 20% dry units, 30% flatwater units, 20% riffle units, 19% pool units, and 12% culvert units (Graph 1). Based on total length of Level II habitat types there were 48% dry units, 27% flatwater units, 10% riffle units, 11% pool units, and 4% culvert units (Graph 2).

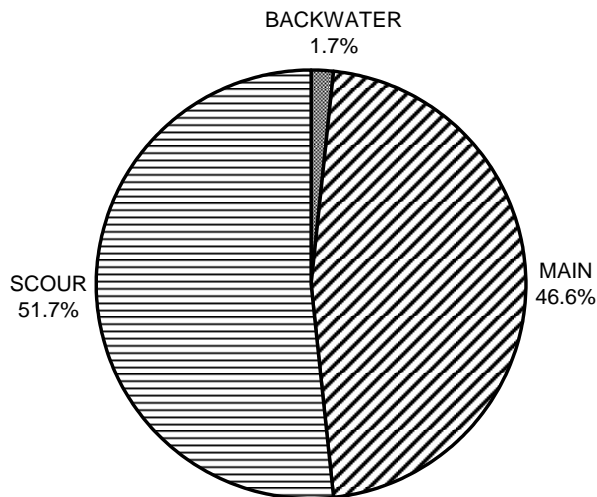
GRAPH 4

A total of 58 pools were identified (Table 3). Scour pools were the most frequently encountered at 52% and comprised 59% of the total length of all pools (Graph 4).

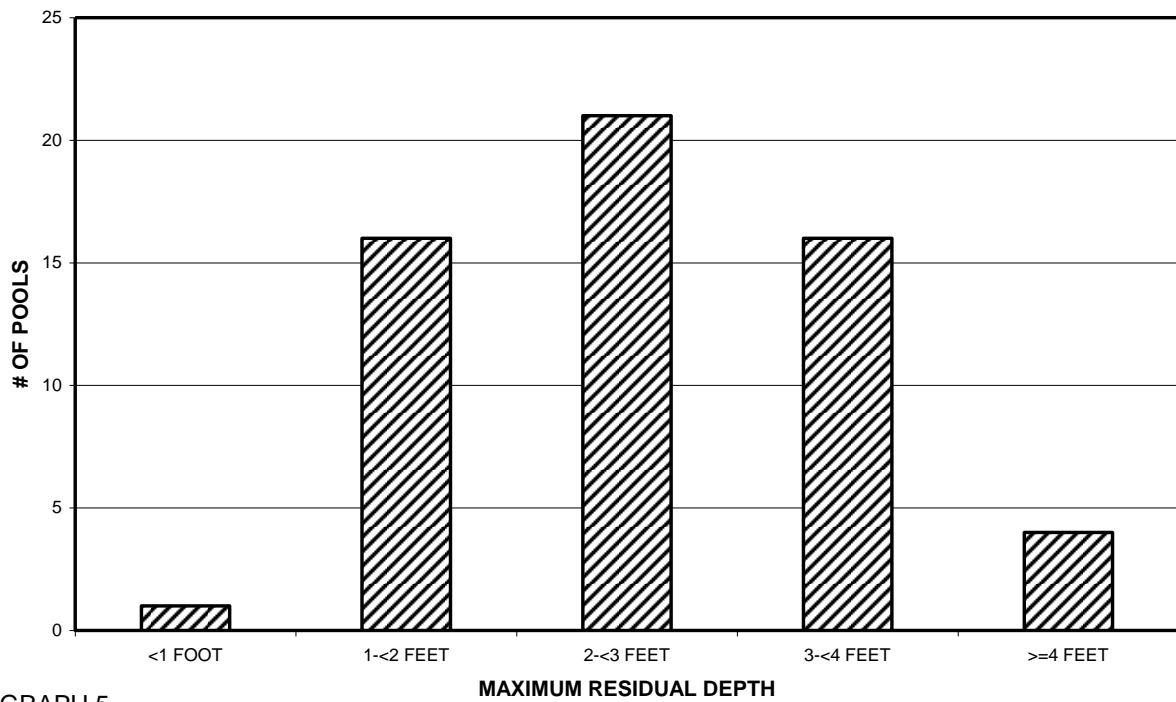
GRAPH 5

Table 4 is a summary of maximum residual pool depths by pool habitat types. Pool quality for salmonids increases with depth. Forty-one of the 58 pools (71%) had a residual depth of two feet or greater (Graph 5).

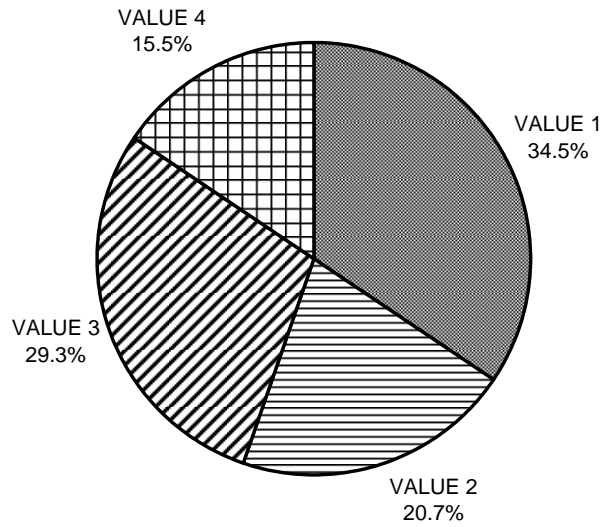
GRAPH 6

The depth of cobble embeddedness was estimated at pool tail-outs. Of the 58 pool tail-outs measured, 20 had a value of 1 (34.5%); 12 had a value of 2 (20.7%); 17 had a value of 3 (29.3%); and 9 had a value of 4 (15.5%) (Graph 6). On this scale, a value of 1 indicates the best spawning conditions and a value of 4 the worst. Additionally, a value of 5 was assigned to tail-outs deemed unsuited for spawning due to inappropriate substrate such as bedrock, log sills, boulders, or other considerations.

Thirty-two of the 58 pool tail-outs measured had embeddedness ratings of 1 or 2. Twenty-six of the pool tail-outs had embeddedness ratings of 3 or 4. None of the pool tail-outs had a rating of 5, which is considered unsuitable for spawning. Cobble embeddedness measured to be 25% or less, a rating of 1, is considered to indicate good quality spawning substrate for salmon and steelhead. Sediment sources in San Anselmo Creek should be mapped and rated according to their potential sediment yields, and control measures should be taken.

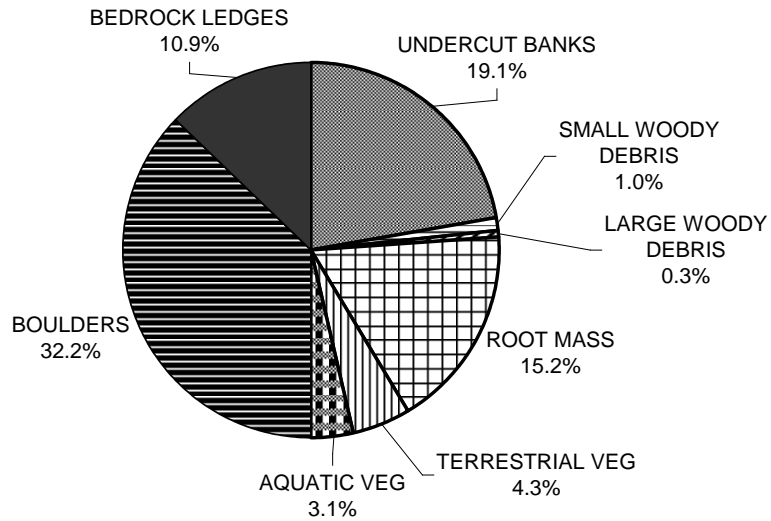
GRAPH 7

Table 5 summarizes mean percent cover by habitat type. Boulders are the dominant cover types in San Anselmo Creek. Graph 7 describes the pool cover in San Anselmo Creek. Boulders are the dominant pool cover type followed by undercut banks.

- 1) Increase woody cover in the pools and flatwater habitat units. Most of the existing cover in the pools is from Boulders. Adding high quality complexity with woody cover in the pools is desirable.

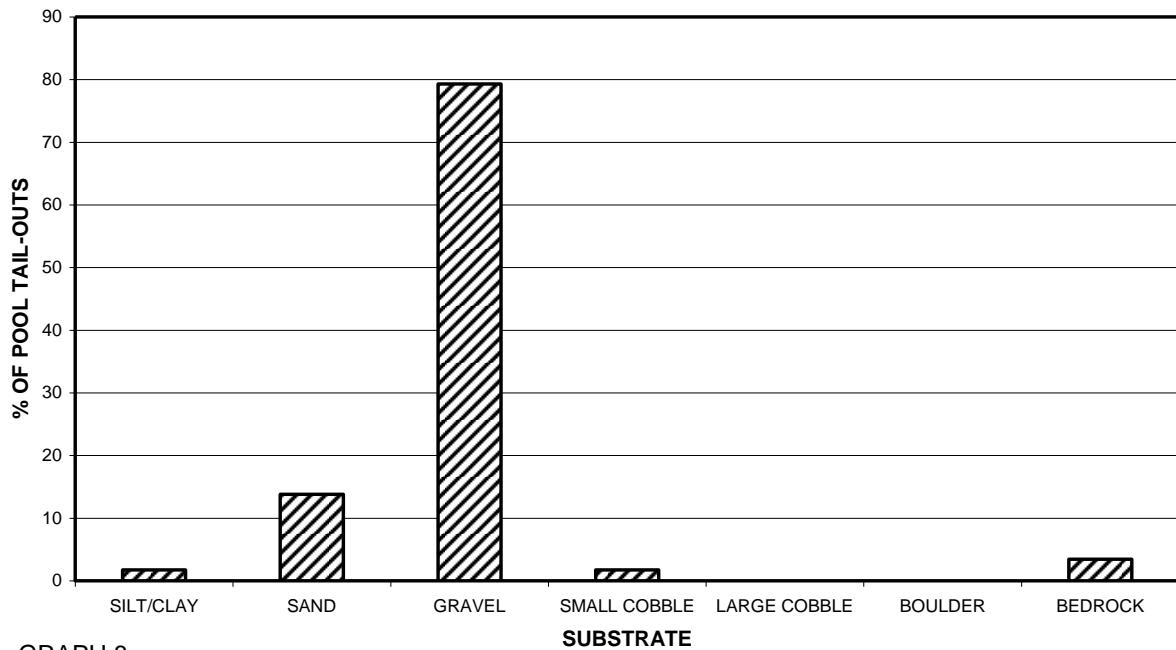
GRAPH 8

Table 6 summarizes the dominant substrate by habitat type. Graph 8 depicts the dominant substrate observed in pool tail-outs. Sand dominance was observed in 14% of pool tail-outs and gravel dominance was observed in 79% of pool tail-outs.

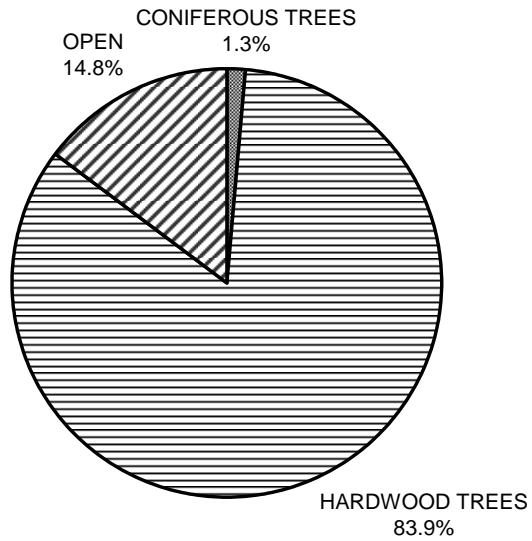
GRAPH 9

The mean percent canopy density for the surveyed length of San Anselmo Creek was 85%. The mean percentages of hardwood and coniferous trees were 98% and 2%, respectively. Fifteen percent of the canopy was open. Graph 9 describes the mean percent canopy in San Anselmo Creek.

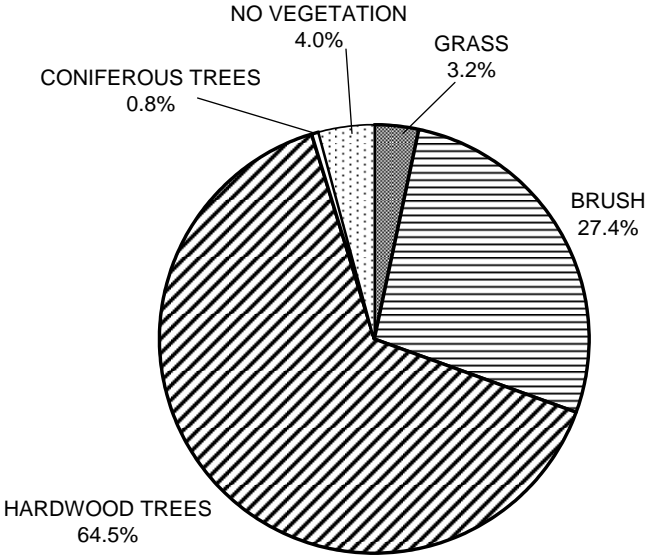
GRAPH 11

For the stream reach surveyed, the mean percent right bank vegetated was 49%. The mean percent left bank vegetated was 53%. The dominant elements composing the structure of the stream banks consisted of 28% bedrock, 3% boulder, and 69% sand/silt/clay (Graph 10). Hardwood trees were the dominant vegetation type observed in 65% of the units surveyed. Additionally, 27% of the units surveyed had brush as the dominant vegetation type, and 3% had grass as the dominant vegetation (Graph 11).
