California Department of Fish and Wildlife
Alameda County
South San Francisco Bay Watershed
Stream Habitat Assessment Reports

Alameda Creek

Surveyed 2010

STREAM INVENTORY REPORT

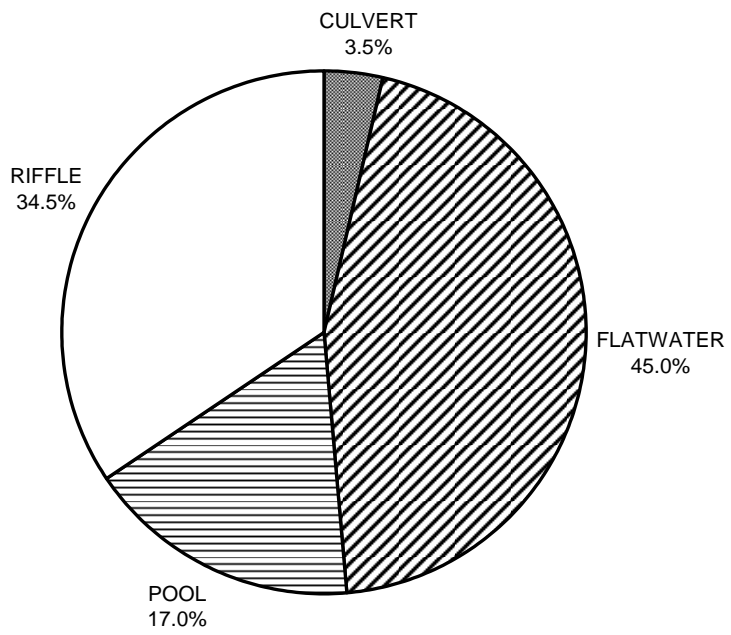
GRAPH 1

Table 1 summarizes the Level II riffle, flatwater, and pool habitat types. Based on frequency of occurrence there were 45% flatwater units, 34% riffle units, 17% pool

units, and 4% culvert units (Graph 1). Based on total length of Level II habitat types there were 60% flatwater units, 30% riffle units, 10% pool units, and 1% culvert units (Graph 2).

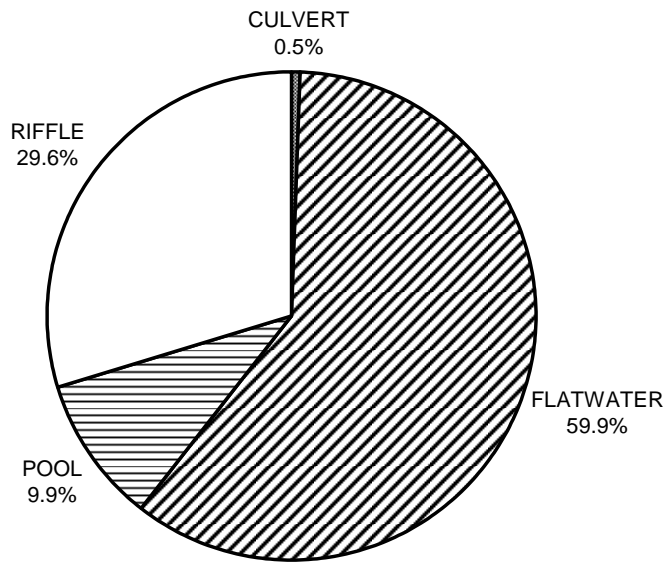
GRAPH 2

Flatwater habitat types comprised 60% of the total length of this survey, riffles 30%, and pools 10%. The pools are relatively shallow, with only 11 of the 32 (34%) pools having a maximum residual depth greater than three feet. In general, pool enhancement projects are considered when primary pools comprise less than 40% of the length of total stream habitat. In first and second order streams, a primary pool is defined to have a maximum residual depth of at least two feet, occupy at least half the width of the low flow channel, and be as long as the low flow channel width. Installing structures that will increase or deepen pool habitat is recommended for locations where their installation will not be threatened by high stream energy, or where their installation will not conflict with the modification of the numerous log debris accumulations (LDA's) in the stream.

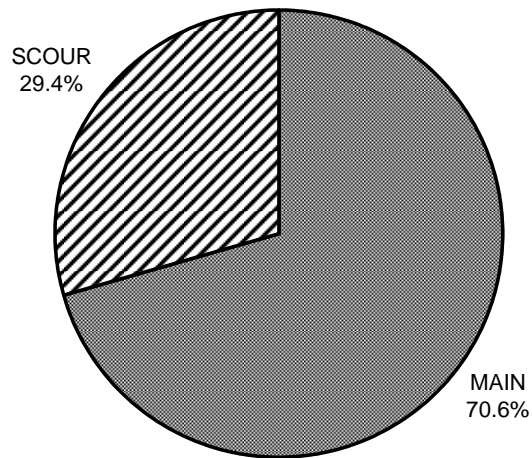
GRAPH 4

A total of 34 pools were identified (Table 3). Main Channel pools were the most frequently encountered, at 71%, and comprised 79% of the total length of all pools (Graph 4).

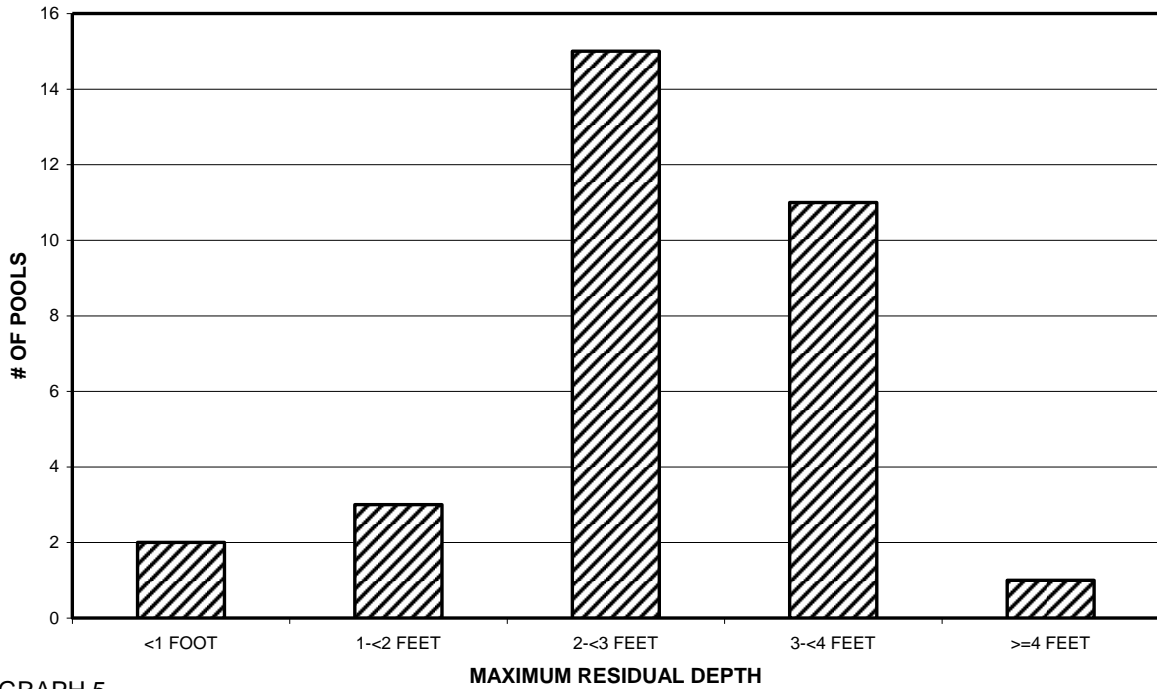
GRAPH 5

Table 4 is a summary of maximum residual pool depths by pool habitat types. Pool quality for salmonids increases with depth. Eleven of the 32 pools (34%) had a residual depth of three feet or greater (Graph 5).

- 4) Where feasible, design and engineer pool enhancement structures to increase the number of pools. This must be done where the banks are stable or in conjunction with stream bank armor to prevent erosion.

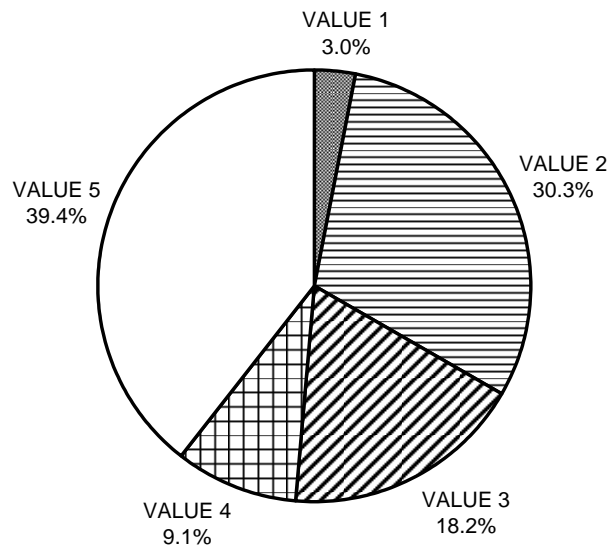
GRAPH 6

The depth of cobble embeddedness was estimated at pool tail-outs. Of the 33 pool tail-outs measured, 1 had a value of 1 (3%); 10 had a value of 2 (30.3%); 6 had a value of 3 (18.2%); 3 had a value of 4 (9.1%); and 13 had a value of 5 (39.4%) (Graph 6). On this scale, a value of 1 indicates the best spawning conditions and a value of 4 the worst. Additionally, a value of 5 was assigned to tail-outs deemed unsuited for spawning due to inappropriate substrate such as bedrock, log sills, boulders, or other considerations.

Eleven of the 33 pool tail-outs measured had embeddedness ratings of 1 or 2. Nine of the pool tail-outs had embeddedness ratings of 3 or 4. Thirteen of the pool tail-outs had a rating of 5, which is considered unsuitable for spawning. Cobble embeddedness measured to be 25% or less, a rating of 1, is considered to indicate good quality spawning substrate for salmon and steelhead. Sediment sources in Alameda Creek should be mapped and rated according to their potential sediment

- 5) Inventory and map sources of stream bank erosion and prioritize them according to present and potential sediment yield, particularly in Reach 1. Identified sites should then be treated to reduce the amount of fine sediments entering the stream. Active and potential sediment sources related to the urban road system need to be identified, mapped, and treated according to their potential for sediment yield to the stream and its tributaries.

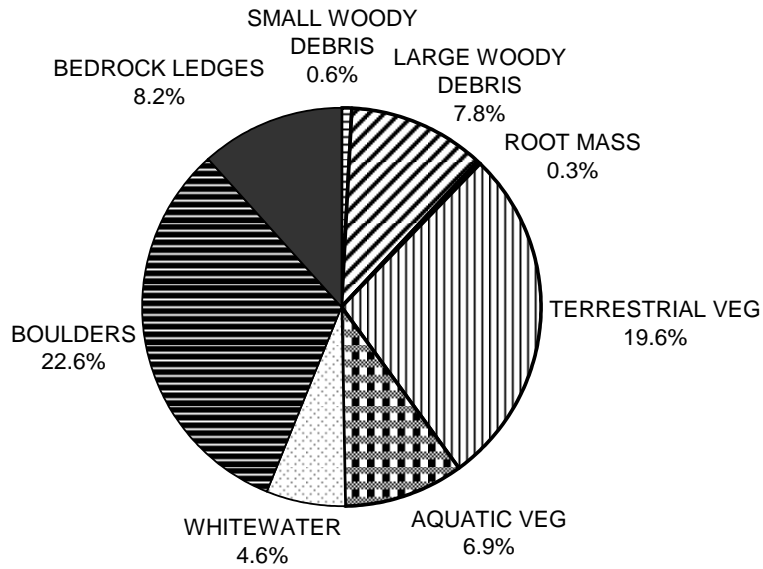
GRAPH 7

Table 5 summarizes mean percent cover by habitat type. Boulders are the dominant cover types in Alameda Creek. Graph 7 describes the pool cover in Alameda Creek. Boulders are the dominant pool cover type followed by terrestrial vegetation.

Boulders are the dominant cover type in pools followed by terrestrial vegetation . Log and root wad cover structures in the pool and flatwater habitats would enhance both summer and winter salmonid habitat. Log cover structure provides rearing fry with protection from predation, rest from water velocity, and also divides territorial units to reduce density related competition.

- 3) Increase woody cover in the pools and flatwater habitat units. Most of the existing cover in the pools is from Boulders and Terrestrial Vegetation. Adding high quality complexity with woody cover in the pools is desirable.

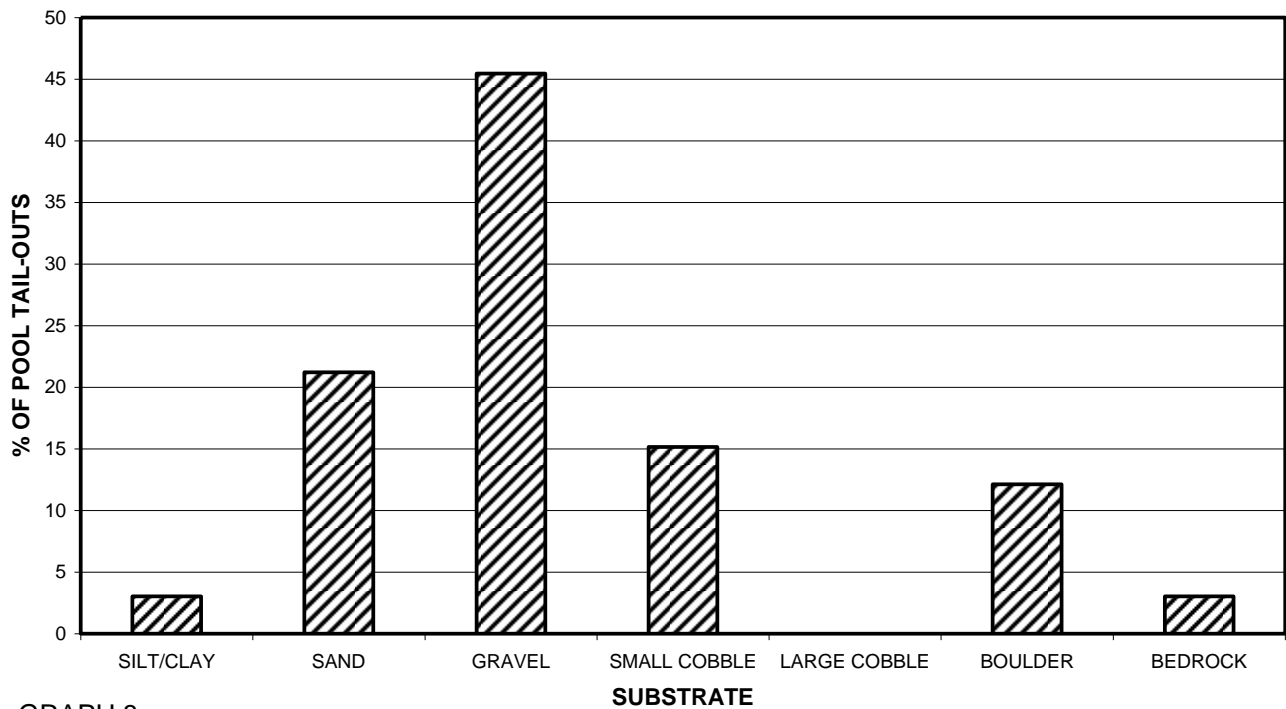
GRAPH 8

Table 6 summarizes the dominant substrate by habitat type. Graph 8 depicts the dominant substrate observed in pool tail-outs. A sand substrate was observed in 21% of pool tail-outs, and gravel observed in 45% of pool tail-outs.

Twenty of the 33 pool tail-outs measured had gravel or small cobble as the dominant substrate. This is generally considered good for spawning salmonids.

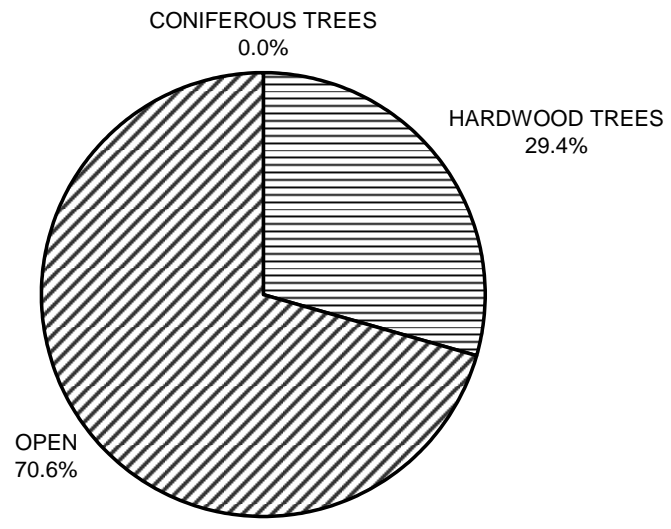
GRAPH 9

The mean percent canopy density for the surveyed length of Alameda Creek was 29%. The mean percentages of hardwood and coniferous trees were 100% and 0%, respectively. Seventy One percent of the canopy was open. Graph 9 describes the mean percent canopy in Alameda Creek.

The mean percent canopy density for the stream was 29%. Reach 1 had a canopy density of 21%, Reach 2 had a canopy density of 35%. In general, revegetation projects are considered when canopy density is less than 80%.

- 1) Increase the canopy throughout Alameda Creek by planting appropriate native vegetation like willow, alder, redwood, and Douglas fir along the stream where shade canopy is not at acceptable levels. The reaches above this survey section should be inventoried and treated as well, since the water flowing here is affected from upstream. In many cases, planting will need to be coordinated to follow bank stabilization or upslope erosion control projects.

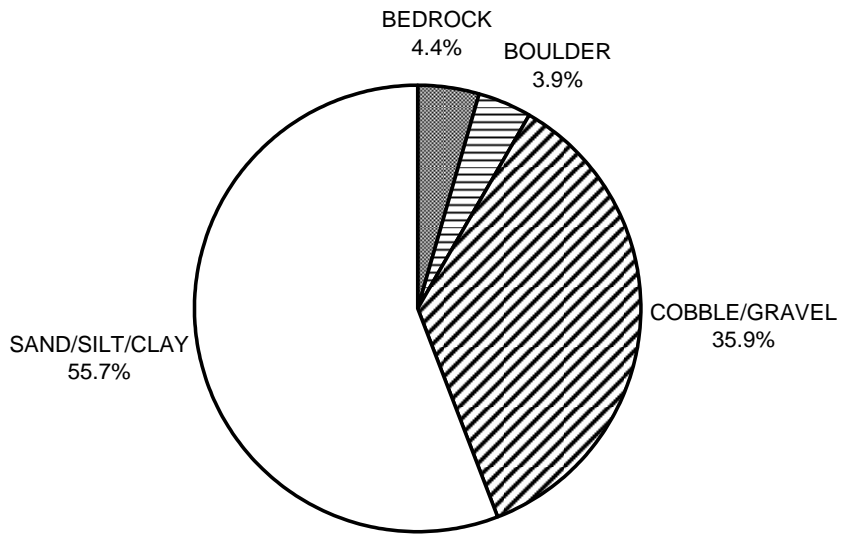
GRAPH 10

For the stream reach surveyed, the mean percent right bank vegetated was 77%. The mean percent left bank vegetated was 72%. The dominant elements composing the structure of the stream banks consisted of 4% bedrock, 4% boulder, 36% cobble/gravel, 56% sand/silt/clay, (Graph 10). Hardwood/ deciduous trees were the dominant vegetation type observed in 92% of the units surveyed. Additionally, 6% of the units surveyed had Brush as the dominant vegetation type, and 1% had grass as the dominant vegetation (Graph 11).

The percentage of right and left bank covered with vegetation was 77% and 72%, respectively. In areas of stream bank erosion or where bank vegetation is sparse, planting endemic species of coniferous and hardwood trees, in conjunction with bank stabilization, is recommended.
