**California Department of Fish and Game
Walker Creek Watershed
Stream Habitat Assessment Reports**

STREAM INVENTORY REPORT

Chileno Creek

Assessment Completed Septemeber 2008

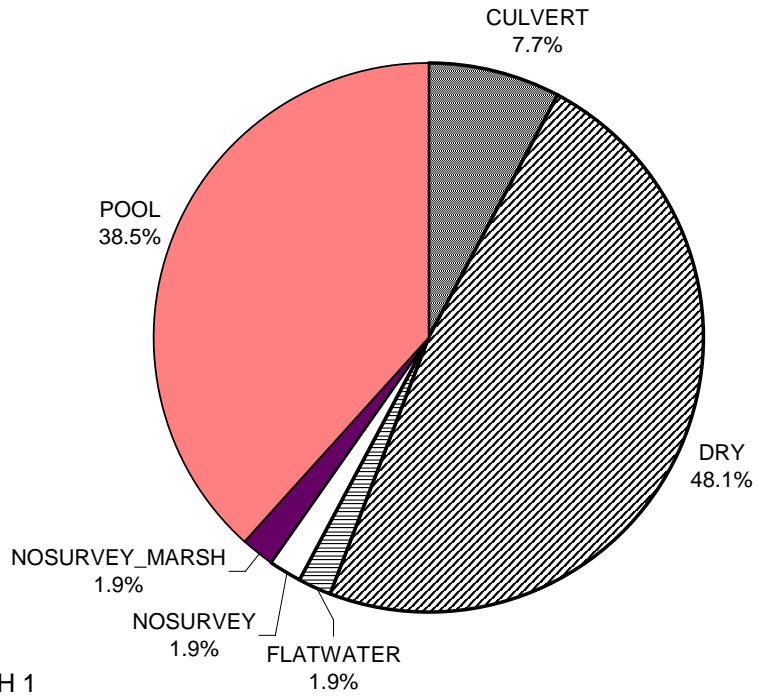
GRAPH 1

Table 1 summarizes the Level II riffle, flatwater, and pool habitat types. Based on frequency of occurrence there were 48% dry units, 38% pool units, and 8% culvert units (Graph 1). Based on total length of Level II habitat types there were 52% dry units, 43% no survey units, and 4% pool units (Graph 2).

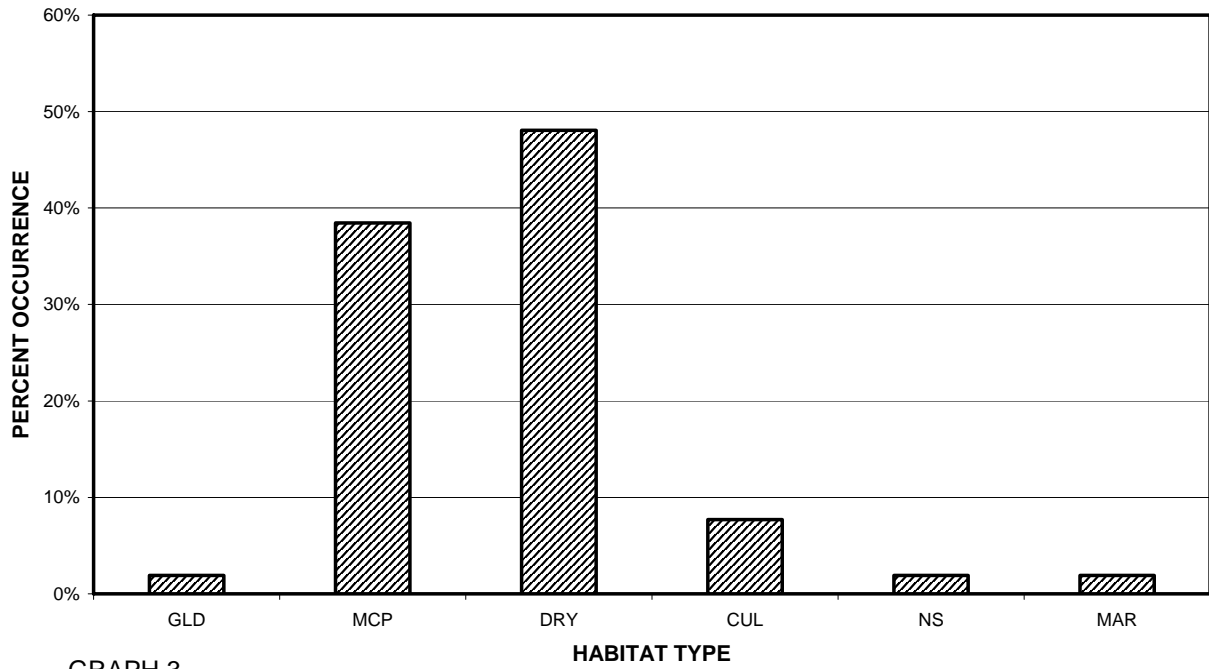
GRAPH 3

Three Level IV habitat types were identified (Table 2). The most frequent habitat types by percent occurrence were 48% Dry units, 38% Mid-Channel Pool units, and 8% Culvert units (Graph 3). Based on percent total length there were 52% Dry units, and 43% Not Surveyed units, and 4% Mid-Channel Pool units.

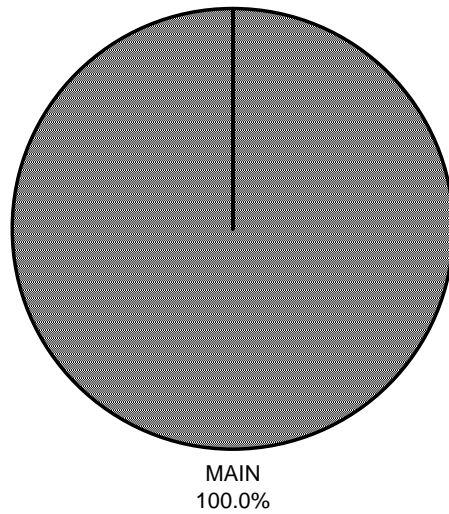
GRAPH 4

A total of 20 pools were identified (Table 3). Main Channel pools were the most frequently encountered, at 100%, and comprised 100% of the total length of all pools (Graph 4).

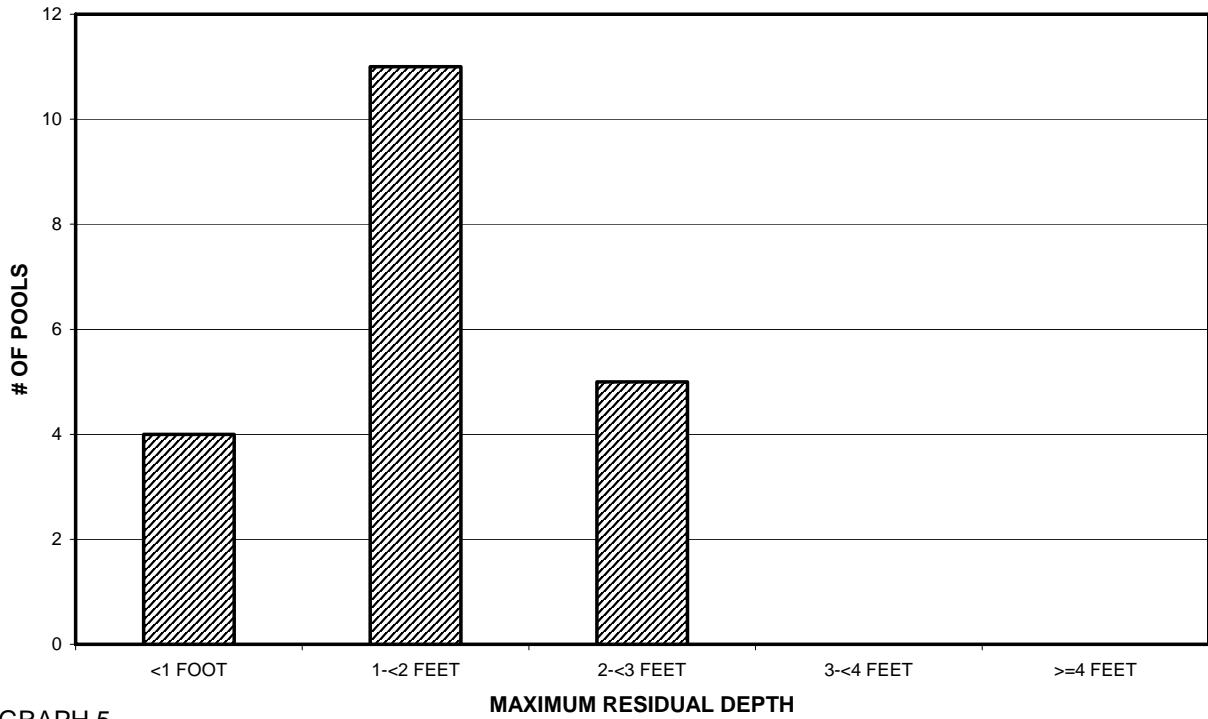
GRAPH 5

Table 4 is a summary of maximum residual pool depths by pool habitat types. Pool quality for salmonids increases with depth. None of the 20 pools (0%) had a residual depth of three feet or greater (Graph 5).

Flatwater habitat types comprised 0.2% of the total length of this survey, riffles 0%, and pools 4.4%. The pools are relatively shallow, with only 5 of the 20 (25%) pools having a maximum residual depth greater than 2 feet. In general, pool enhancement projects are considered when primary pools comprise less than 40% of the length of total stream habitat. In first and second order streams, a primary pool is defined to have a maximum residual depth of at least two feet, occupy at least half the width of the low flow channel, and be as long as the low flow channel width (NOTE: for 3rd and 4th order streams maximum residual depth is at least three feet). Installing structures that will increase or deepen pool habitat is recommended for locations where their installation will not be threatened by high stream energy, or where their installation will not conflict with the modification of the numerous log debris accumulations (LDA's) in the stream.

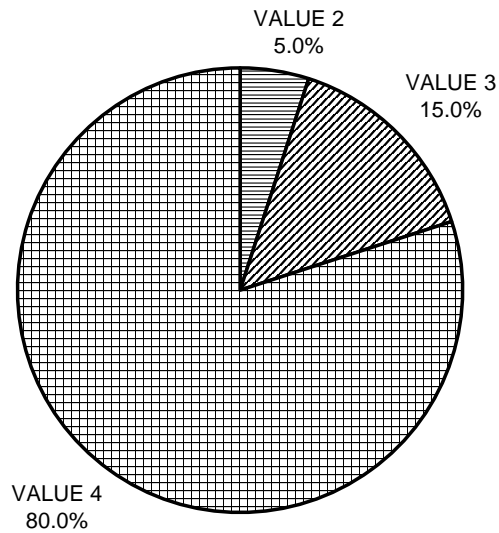
GRAPH 6

The depth of cobble embeddedness was estimated at pool tail-outs. Of the 20 pool tail-outs measured, 1 had a value of 2 (5%); 3 had a value of 3 (15%); and 16 had a value of 4 (80%), (Graph 6). On this scale, a value of 1 indicates the best spawning conditions and a value of 4 the worst. Additionally, a value of 5 was assigned to tail-outs deemed unsuited for spawning due to inappropriate substrate such as bedrock, log sills, boulders, or other considerations.

One of the 20 pool tail-outs measured had embeddedness ratings of 1 or 2. Nineteen of the pool tail-outs had embeddedness ratings of 3 or 4. None of the pool tail-outs had a rating of 5, which is considered unsuitable for spawning. Cobble embeddedness measured to be 25% or less, a rating of 1, is considered to indicate good quality spawning substrate for salmon and steelhead. Sediment sources in Chileno Creek should be mapped and rated according to their potential sediment yields, and control measures should be taken.

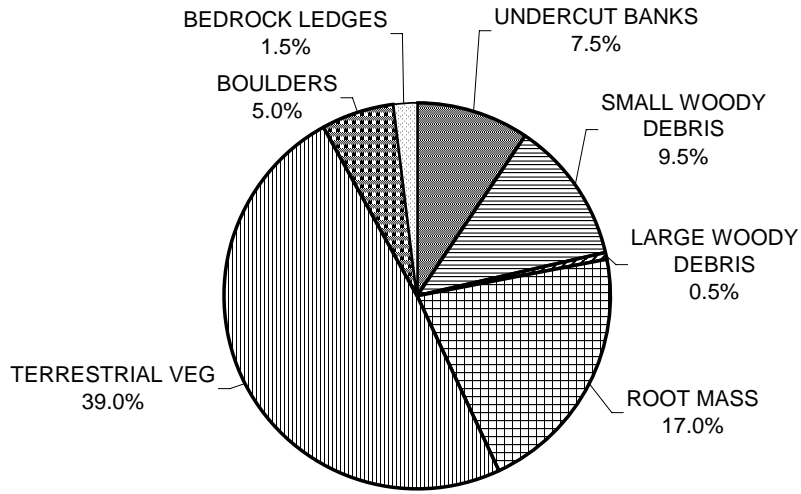
GRAPH 7

Table 5 summarizes mean percent cover by habitat type. Terrestrial Vegetation is the dominant cover types in Chileno Creek. Graph 7 describes the pool cover in Chileno Creek. Terrestrial Vegetation is the dominant pool cover type followed by root mass.

The mean shelter rating for pools was 4. The shelter rating in the flatwater habitats was 4. A pool shelter rating of approximately 100 is desirable. The amount of cover that now exists is being provided primarily by Terrestrial Vegetation in Chileno Creek. Terrestrial Vegetation is the dominant cover type in pools followed by root mass. Log and root wad cover structures in the pool and flatwater habitats would enhance both summer and winter salmonid habitat. Log cover structure provides rearing fry with protection from predation, rest from water velocity, and also divides territorial units to reduce density related competition.

- 4) Increase woody cover in the pools and flatwater habitat units. Most of the existing cover in the pools is from terrestrial vegetation. Adding high quality complexity with woody cover in the pools is desirable.
- 5) Where feasible, design and engineer pool enhancement structures to increase the number of pools. This must be done where the banks are stable or in conjunction with stream bank armor to prevent erosion.
- 6) Access for migrating salmonids should be assessed at all road crossings. Where needed crossings should be replaced or modified to improve fish passage.

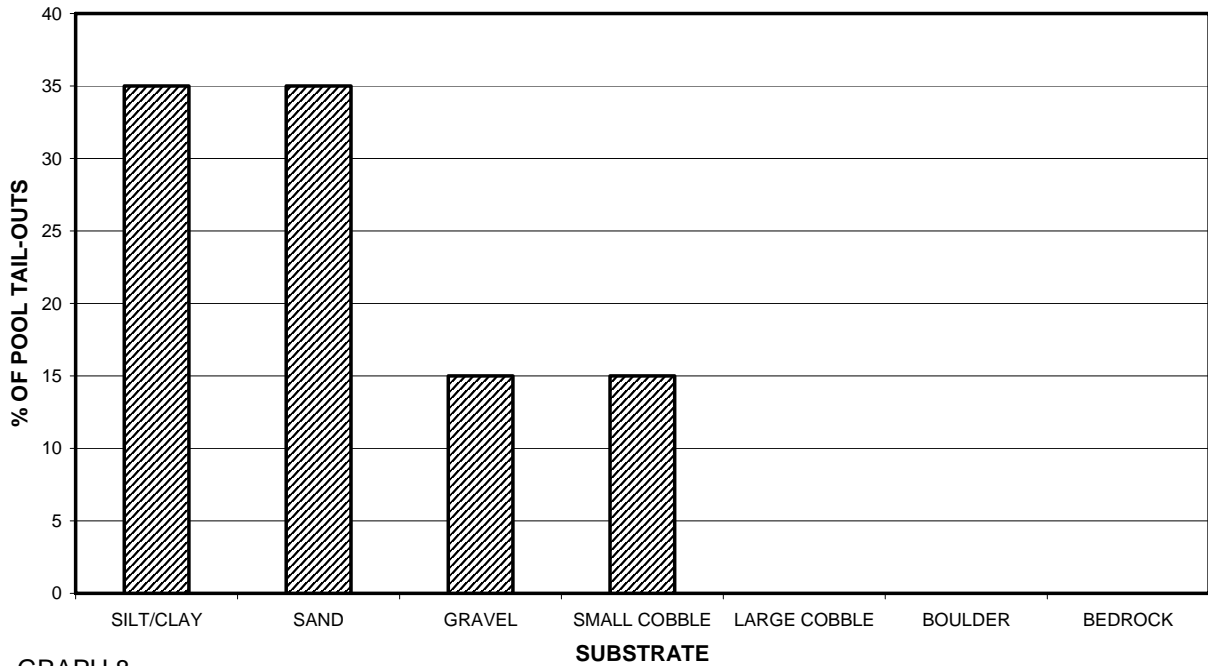
GRAPH 8

Table 6 summarizes the dominant substrate by habitat type. Graph 8 depicts the dominant substrate observed in pool tail-outs. Silt/clay and sand substrate types were each observed in 35% of pool tail-outs whereas gravel and cobble were each observed in 15% of pool tail-outs.

Fourteen of the 20 pool tail-outs had silt, sand, large cobble, boulders or bedrock as the dominant substrate. This is generally considered unsuitable for spawning salmonids.

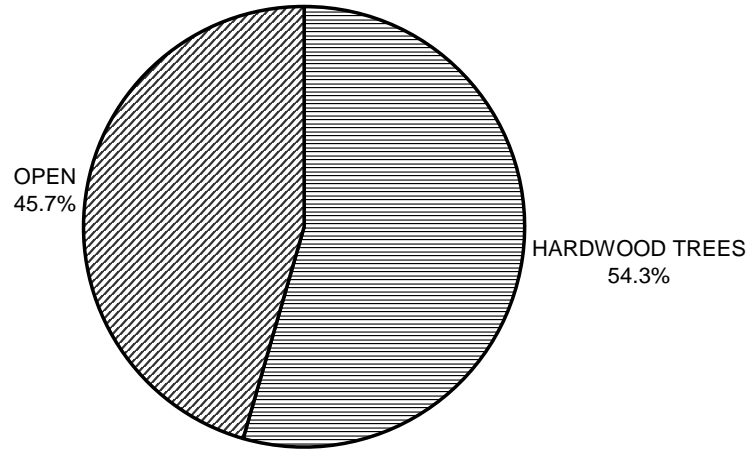
GRAPH 9

The mean percent canopy density for the surveyed length of Chileno Creek was 54%. The mean percentages of hardwood and coniferous trees were 100% and 0%, respectively. Forty-six percent of the canopy was open. Graph 9 describes the mean percent canopy in Chileno Creek.

The mean percent canopy density for the stream was 54%. Reach 1 had a canopy density of 50%, Reach 3 had a canopy density of 60%. In general, revegetation projects are considered when canopy density is less than 80%.

- 2) Increase the canopy on Chileno Creek by planting appropriate native vegetation like willow, alder, redwood, and Douglas fir along the stream where shade canopy is not at acceptable levels. The reaches above this survey section should be inventoried and treated as well, since the water flowing here is affected from upstream. In many cases, planting will need to be coordinated to follow bank stabilization or upslope erosion control projects.

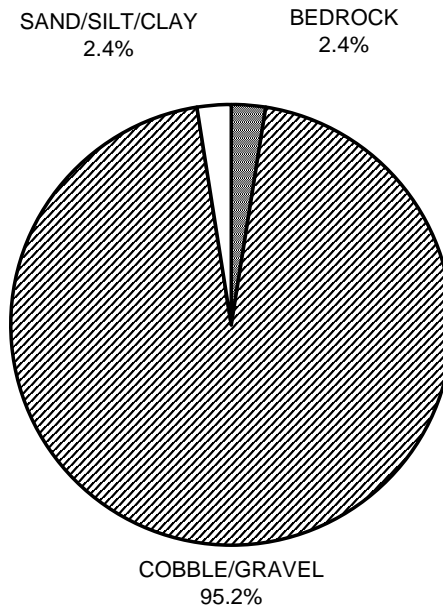
GRAPH 10

For the stream reach surveyed, the mean percent right bank vegetated was 90%. The mean percent left bank vegetated was 88%. The dominant elements composing the structure of the stream banks consisted of 95% cobble/gravel, 2% bedrock, and 2% sand/silt/clay. (Graph 10). Hardwood trees were the dominant vegetation type observed in 98% of the units surveyed. Additionally, 2% of the units surveyed had grass as the dominant vegetation type (Graph 11).
