**California Department of Fish and Wildlife
Marin County
Lagunitas Creek Watersheds
Stream Habitat Assessment Reports**

Unnamed Tributary # 1 of Lagunitas Creek

Surveyed 2011

STREAM INVENTORY REPORT

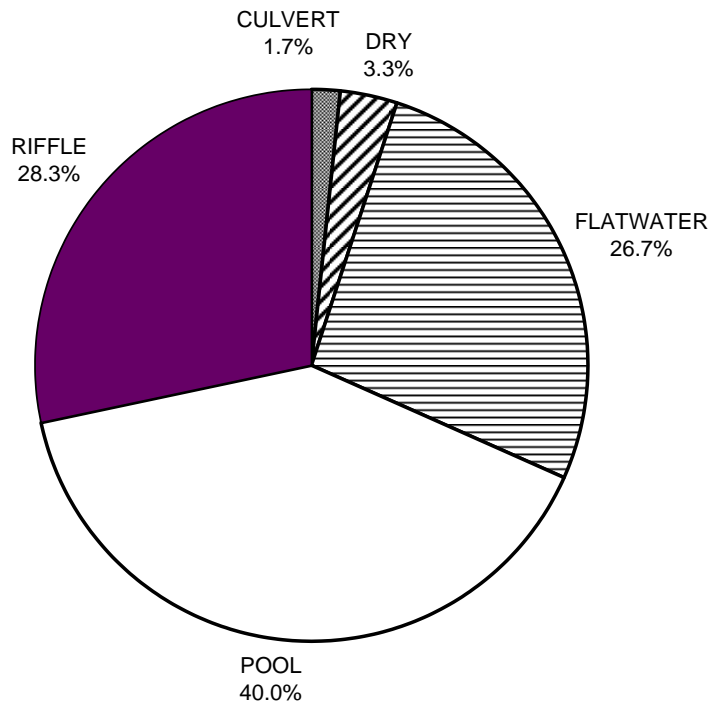
GRAPH 1

Table 1 summarizes the Level II riffle, flatwater, and pool habitat types. Based on frequency of occurrence there were 40% pool units, 28% riffle units, 27% flatwater units, 3% dry units, 2% culvert units, (Graph 1). Based on total length of Level II habitat types, there were 54% flatwater units, 21% riffle units, 21% pool units, 3% culvert units, 2% dry units, (Graph 2).

**1227456380355 2011
HABITAT TYPES BY PERCENT OCCURRENCE**

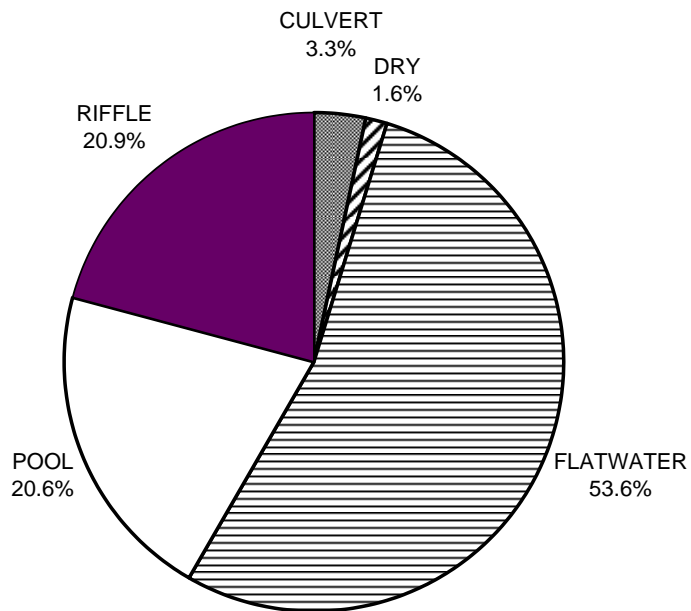
GRAPH 2

Flatwater habitat types comprised 54% of the total length of this survey, riffles 21%, and pools 21%. The pools are relatively shallow, with 0 of the 24 pools having a maximum residual depth greater than two feet. In general, pool enhancement projects are considered when primary pools comprise less than 40% of the length of total stream habitat. In first and second order streams, a primary pool is defined to have a maximum residual depth of at least two feet, occupy at least half the width of the low flow channel, and be as long as the low flow channel width. Installing structures that will increase or deepen pool habitat is recommended for locations where their installation will not be threatened by high stream energy, or where their installation will not conflict with the modification of the numerous log debris accumulations (LDA's) in the stream.

**1227456380355 2011
HABITAT TYPES BY PERCENT TOTAL LENGTH**

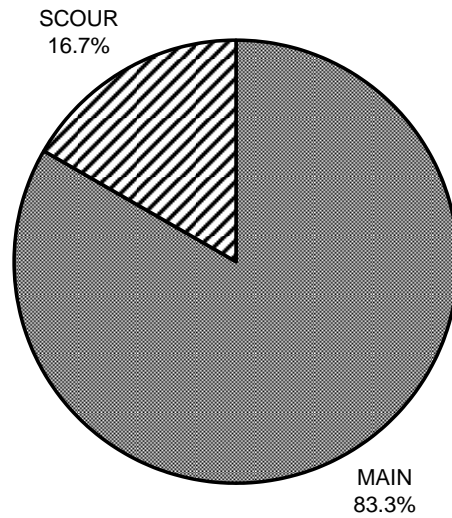
GRAPH 4

A total of 24 pools were identified (Table 3). Main channel pools were the most frequently encountered at 83% (Graph 4), and comprised 83% of the total length of all pools (Table 3).

**1227456380355 2011
POOL TYPES BY PERCENT OCCURRENCE**

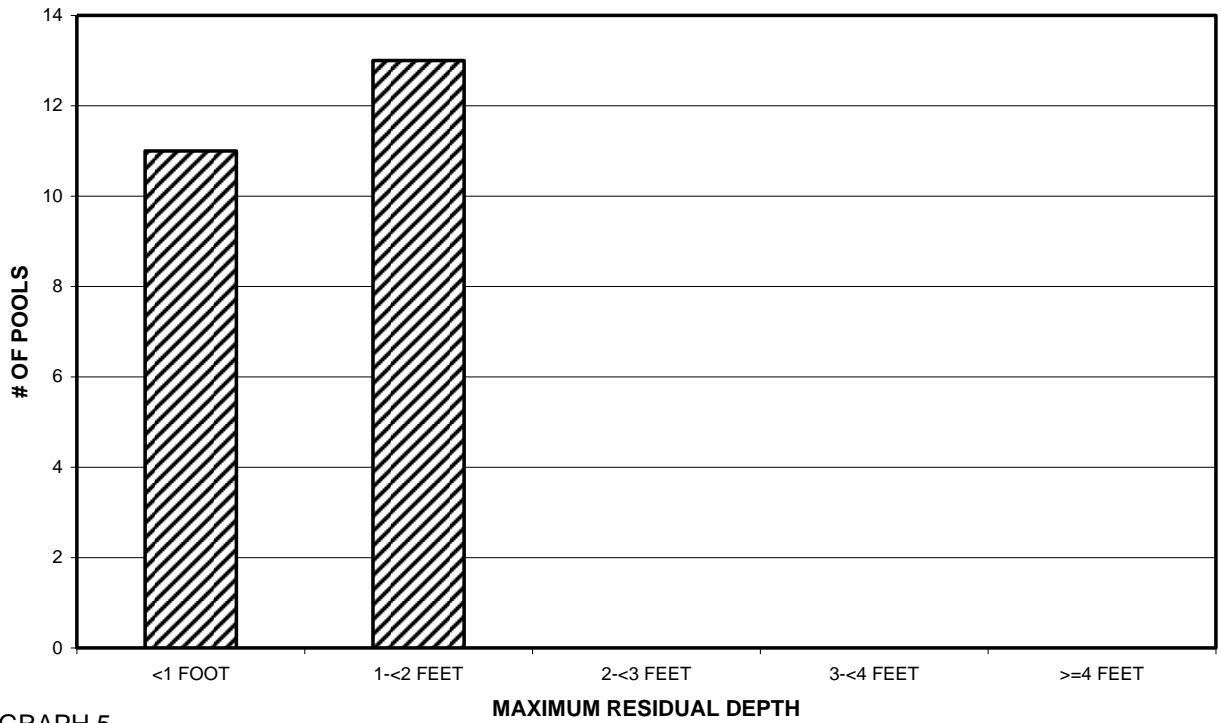
GRAPH 5

Table 4 is a summary of maximum residual pool depths by pool habitat types. Pool quality for salmonids increases with depth. None of the 24 pools had a residual depth of two feet or greater (Graph 5).

**1227456380355 2011
MAXIMUM DEPTH IN POOLS**

- 2) Where feasible, design and engineer pool enhancement structures to increase the number of pools. This must be done where the banks are stable or in conjunction with stream bank armor to prevent erosion.

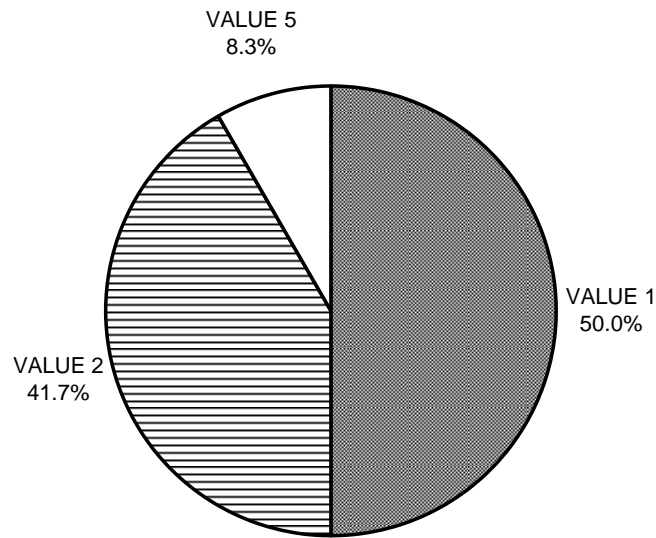
GRAPH 6

The depth of cobble embeddedness was estimated at pool tail-outs. Of the 24 pool tail-outs measured, 12 had a value of 1 (50%), 10 had a value of 2 (42%), 2 had a value of 5 (8%) (Graph 6). On this scale, a value of 1 indicates the best spawning conditions and a value of 4 the worst. Additionally, a value of 5 was assigned to tail-outs deemed unsuited for spawning due to inappropriate substrate such as bedrock, log sills, boulders, or other considerations.

Twenty-two of the 24 pool tail-outs measured had embeddedness ratings of 1 or 2. None of the pool tail-outs had embeddedness ratings of 3 or 4. Two of the pool tail-outs had a rating of 5, which is considered unsuitable for spawning. Cobble embeddedness measured to be 25% or less, a rating of 1, is considered to indicate good quality spawning substrate for salmon and steelhead. Sediment sources in Unnamed Tributary #1 of Lagunitas creek should be mapped and rated according to their potential sediment yields, and control measures should be taken.

**1227456380355 2011
PERCENT EMBEDDEDNESS**

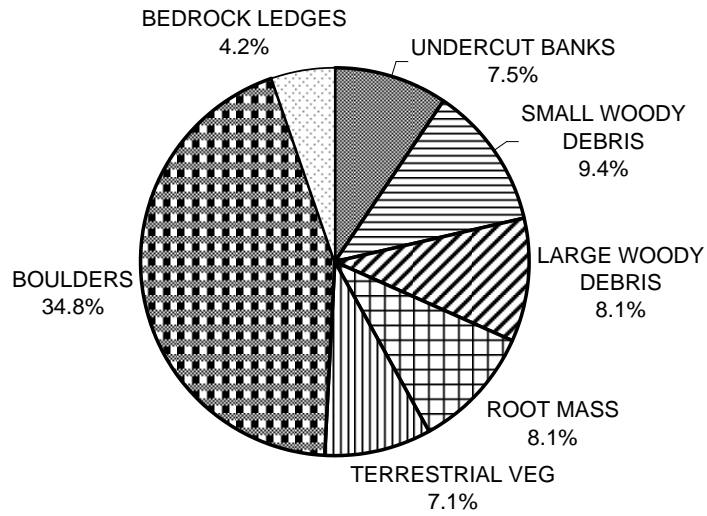
GRAPH 7

Table 5 summarizes mean percent cover by habitat type. Boulders are the dominant cover type in Unnamed Tributary #1 of Lagunitas creek. Graph 7 describes the pool cover in Unnamed Tributary #1 of Lagunitas creek. Boulders are the dominant pool cover type, followed by small woody debris.

1227456380355 2011
MEAN PERCENT COVER TYPES IN POOLS

- 3) Increase woody cover in the pools and flatwater habitat units. Most of the existing cover in the pools is from Boulders. Adding high quality complexity with woody cover in the pools is desirable.

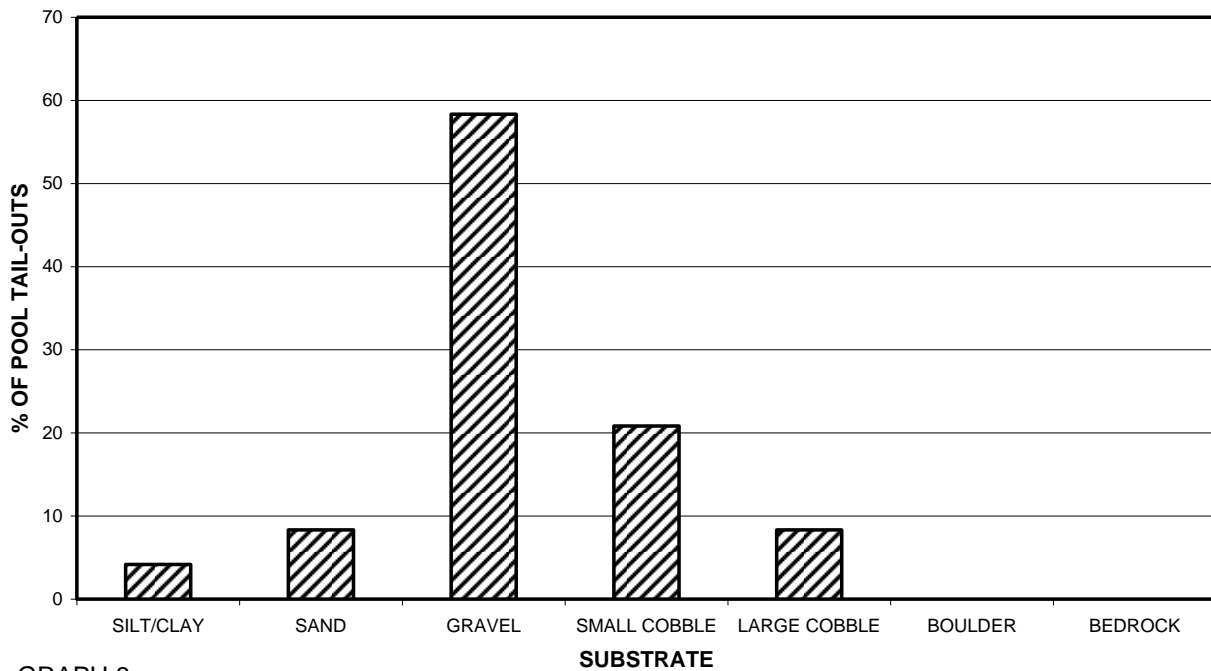
GRAPH 8

dominant substrate observed in pool tail-outs. Gravel substrate was observed in 58% of pool tail-outs and small cobble in 21%.

Nineteen of the 24 pool tail-outs measured had gravel and small cobble as the dominant substrate. This is generally considered good for spawning salmonids.

1227456380355 2011
SUBSTRATE COMPOSITION IN POOL TAIL-OUTS

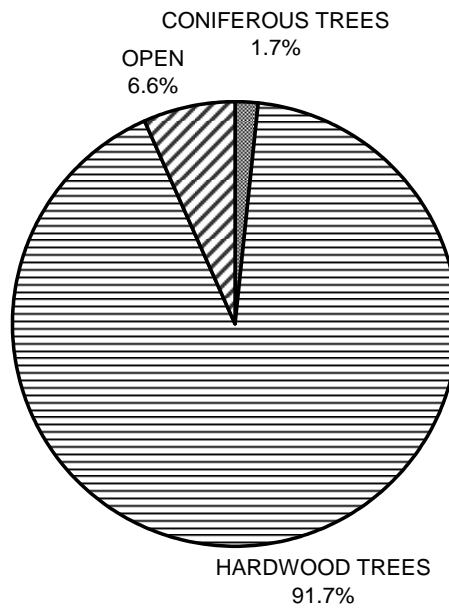
GRAPH 9

The mean percent canopy density for the surveyed length of Unnamed Tributary #1 of Lagunitas creek was 93%. Of the canopy present, the mean percentages of hardwood and coniferous trees were 98% and 2%, respectively. Graph 9 describes the mean percent canopy in Unnamed Tributary #1 of Lagunitas creek .

The mean percent canopy density for the stream was 93%. Reach 1 had a canopy density of 92.5%, Reach 2 had a canopy density of 94.2%, Reach 3 had a canopy density of 92.9%. In general, revegetation projects are considered when canopy density is less than 80%.

**1227456380355 2011
MEAN PERCENT CANOPY**

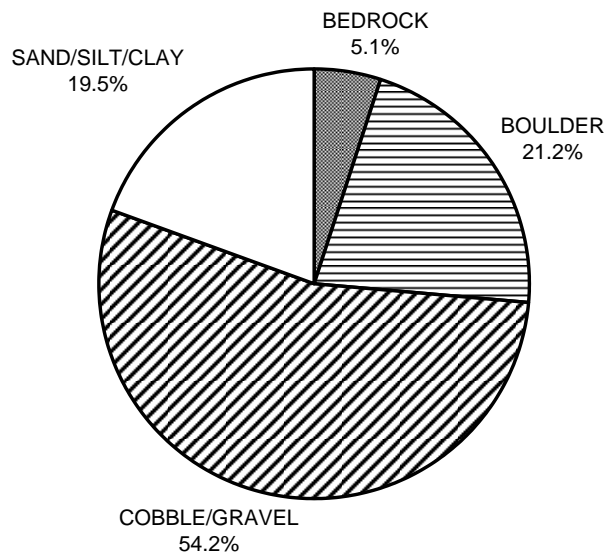
GRAPH 10

For the stream reach surveyed, the mean percent right bank vegetated was 87%. The mean percent left bank vegetated was 95% (Table 7). The dominant elements composing the structure of the stream banks consisted of 54% cobble/gravel, 21% boulder, 19% sand/silt/clay and 5% bedrock, (Graph 10). Brush was the dominant vegetation type observed in 53% of the units surveyed. Additionally, 41% of the units surveyed had deciduous trees as the dominant vegetation type, and 6% had grass as the dominant vegetation type (Graph 11).

**1227456380355 2011
DOMINANT BANK COMPOSITION IN SURVEY REACH**

The percentage of right and left bank covered with vegetation was 87% and 95%, respectively. In areas of stream bank erosion or where bank vegetation is sparse, planting endemic species of coniferous and hardwood trees, in conjunction with bank stabilization, is recommended.

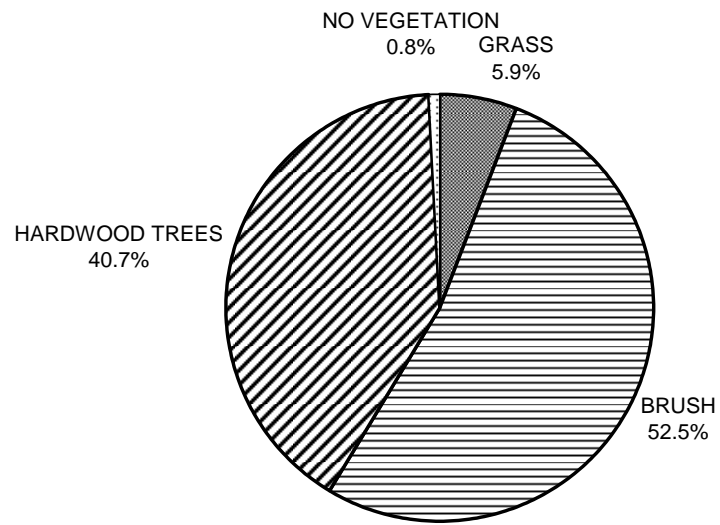
GRAPH 11

1227456380355 2011
DOMINANT BANK VEGETATION IN SURVEY REACH
