**California Department of Fish and Wildlife
Marin County
Lagunitas Creek Watershed
Stream Habitat Assessment Reports**

**Unnamed Tributary #2
of Lagunitas Creek**

Surveyed 2011

STREAM INVENTORY REPORT

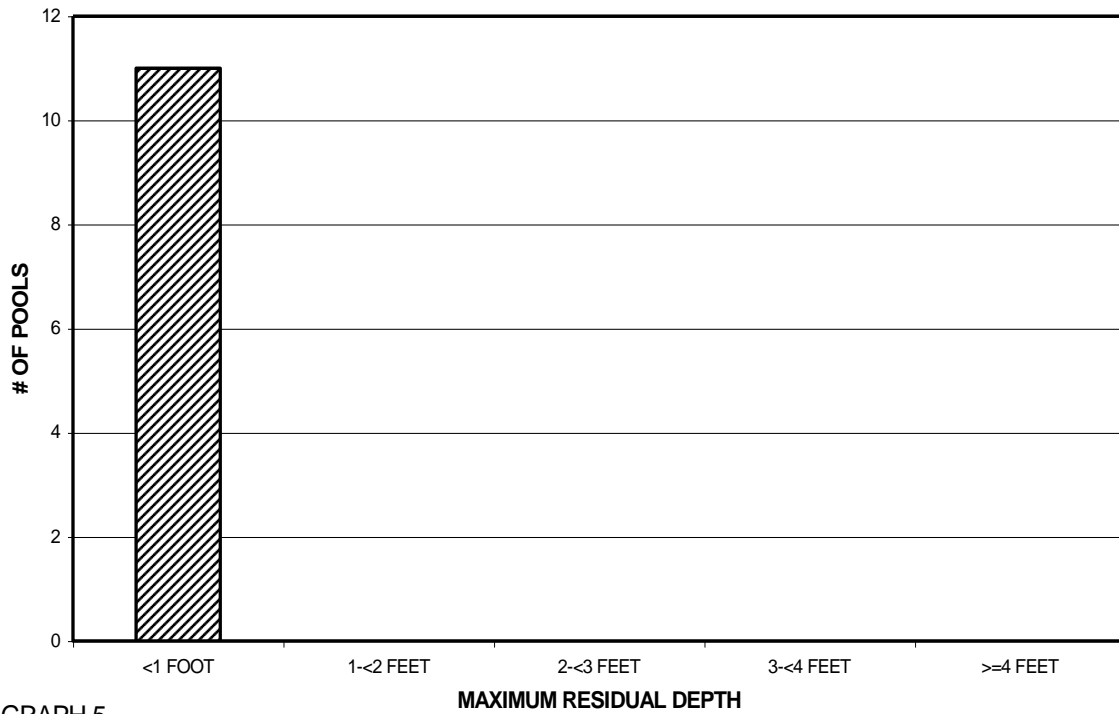
GRAPH 5

Table 4 is a summary of maximum residual pool depths by pool habitat types. Pool quality for salmonids increases with depth. Zero of the 11 pools had a residual depth of two feet or greater (Graph 5).

Flatwater habitat types comprised 31% of the total length of this survey, riffles 23%, and pools 13%. The pools are relatively shallow, with 0 of the 11 pools having a maximum residual depth greater than two feet. In general, pool enhancement projects are considered when primary pools comprise less than 40% of the length of total stream habitat. In first and second order streams, a primary pool is defined to have a maximum residual depth of at least two feet, occupy at least half the width of the low flow channel, and be as long as the low flow channel width. Installing structures that will increase or deepen pool habitat is recommended for locations where their installation will not be threatened by high stream energy, or where their installation will not conflict with the modification of the numerous log debris accumulations (LDA's) in the stream.

- 2) Where feasible, design and engineer pool enhancement structures to increase the number of pools. This must be done where the banks are stable or in conjunction with stream bank armor to prevent erosion.

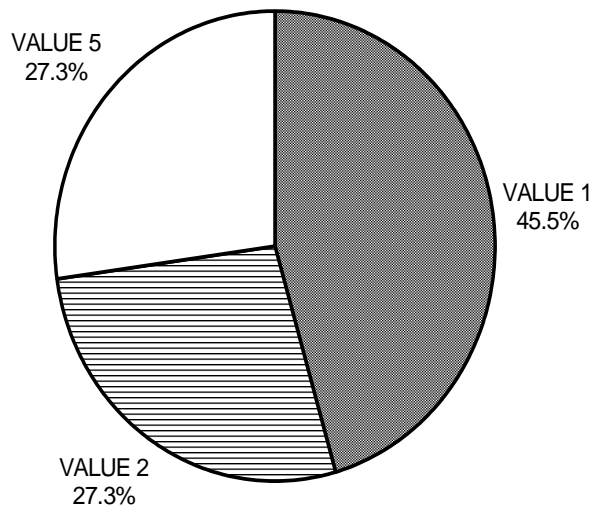
GRAPH 6

The depth of cobble embeddedness was estimated at pool tail-outs. Of the 11 pool tail-outs measured, 5 had a value of 1 (45%), 3 had a value of 2 (27%), and 3 had a value of 5 (27%) (Graph 6). On this scale, a value of 1 indicates the best spawning conditions and a value of 4 the worst. Additionally, a value of 5 was assigned to tail-outs deemed unsuited for spawning due to inappropriate substrate such as bedrock, log sills, boulders, or other considerations.

Eight of the 11 pool tail-outs measured had embeddedness ratings of 1 or 2. Zero of the pool tail-outs had embeddedness ratings of 3 or 4. Three of the pool tail-outs had a rating of 5, which is considered unsuitable for spawning. Cobble embeddedness measured to be 25% or less, a rating of 1, is considered to indicate good quality spawning substrate for salmon and steelhead. Sediment sources in Unnamed Tributary # 2 of Lagunitas creek should be mapped and rated according to their potential sediment yields, and control measures should be taken.

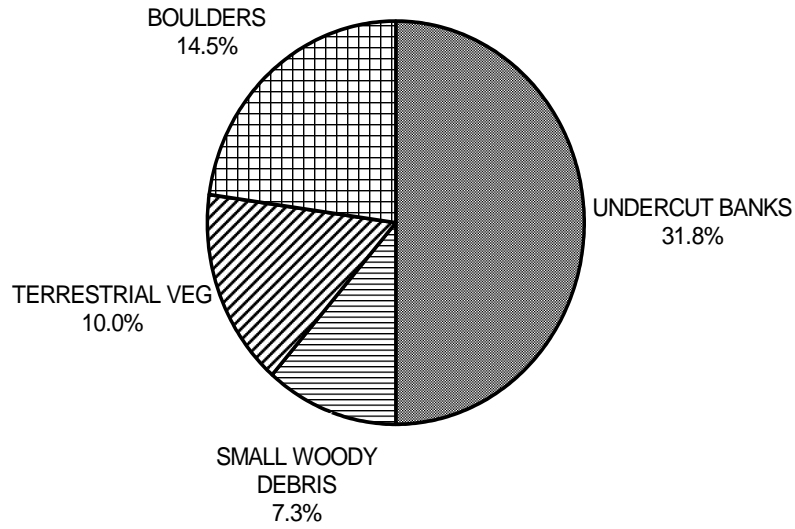
GRAPH 7

Table 5 summarizes mean percent cover by habitat type. Undercut banks are the dominant cover type in Unnamed Tributary # 2 of Lagunitas. Graph 7 describes the pool cover in Unnamed Tributary # 2 of Lagunitas. Undercut banks are the dominant pool cover type, followed by boulders.

The mean shelter rating for pools is 7. The shelter rating in the flatwater habitats is 4. A pool shelter rating of approximately 100 is desirable. The amount of cover that now exists is being provided primarily by undercut banks in Unnamed Tributary # 2 of Lagunitas. Undercut banks is the dominant cover type in pools, followed by boulders. Log and root wad cover structures in the pool and flatwater habitats would enhance both summer and winter salmonid habitat. Log cover structure provides rearing fry with protection from predation, rest from water velocity, and also divides territorial units to

- 4) Increase woody cover in the pools and flatwater habitat units. Most of the existing cover in the pools is from Undercut Banks. Adding high quality complexity with woody cover in the pools is desirable.

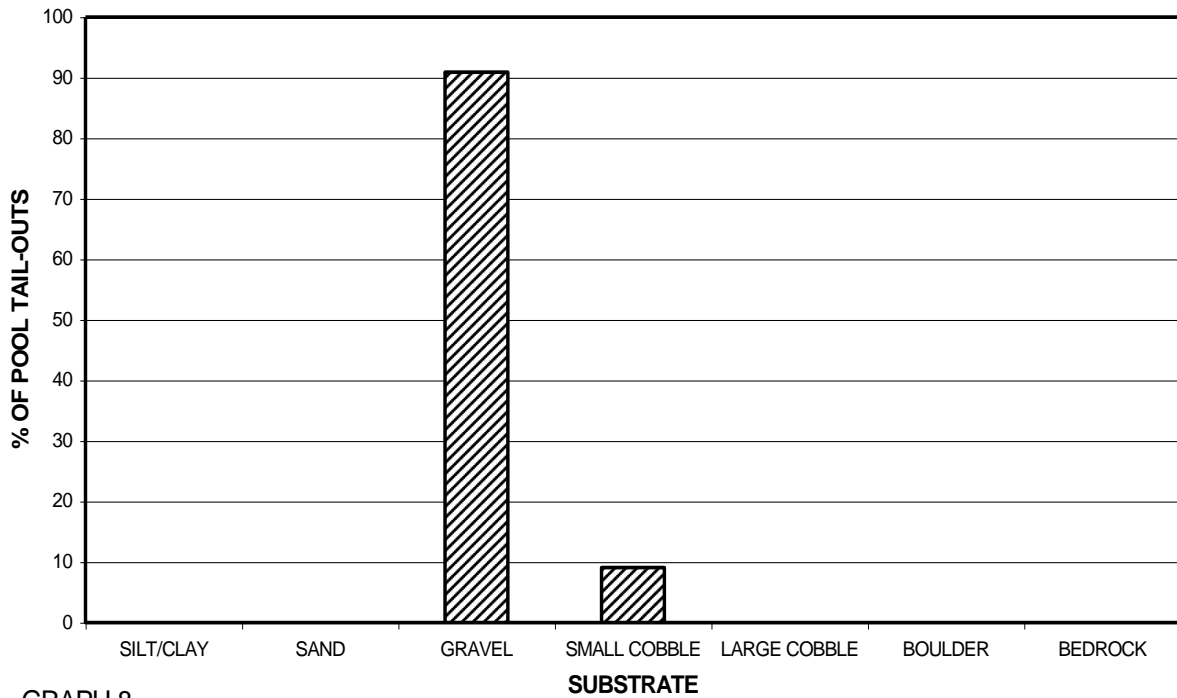
GRAPH 8

Table 6 summarizes the dominant substrate by habitat type. Graph 8 depicts the dominant substrate observed in pool tail-outs. Gavel substrate was observed in 91% of pool tail-outs, and small cobble observed in 9% of pool tail-outs.

Eleven of the 11 pool tail-outs measured had gravel and small cobble as the dominant substrate. This is generally considered good for spawning salmonids.

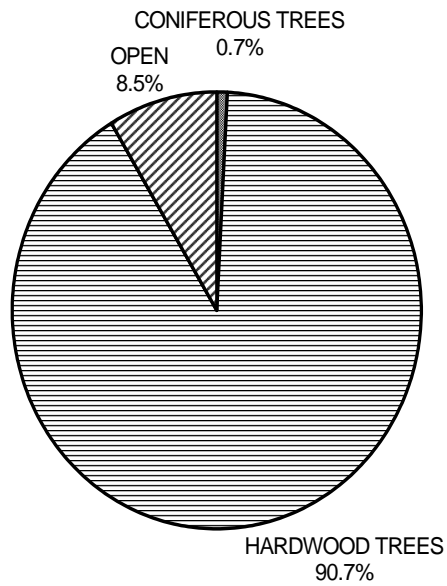
GRAPH 9

The mean percent canopy density for the surveyed length of Unnamed Tributary # 2 of Lagunitas creek was 91%. Of the canopy present, the mean percentages of hardwood and coniferous trees were 99% and 1%, respectively. Nine percent of the canopy was open. Graph 9 describes the mean percent canopy in Unnamed Tributary # 2 of Lagunitas creek.

The mean percent canopy density for the stream was 91%. In general, revegetation projects are considered when canopy density is less than 80%.
