**California Department of Fish and Wildlife  
Marin County  
Lagunitas Creek Watershed  
Stream Habitat Assessment Reports**

# **Unnamed Tributary # 3 of Lagunitas Creek**

*Surveyed 2011*

### **STREAM INVENTORY REPORT**

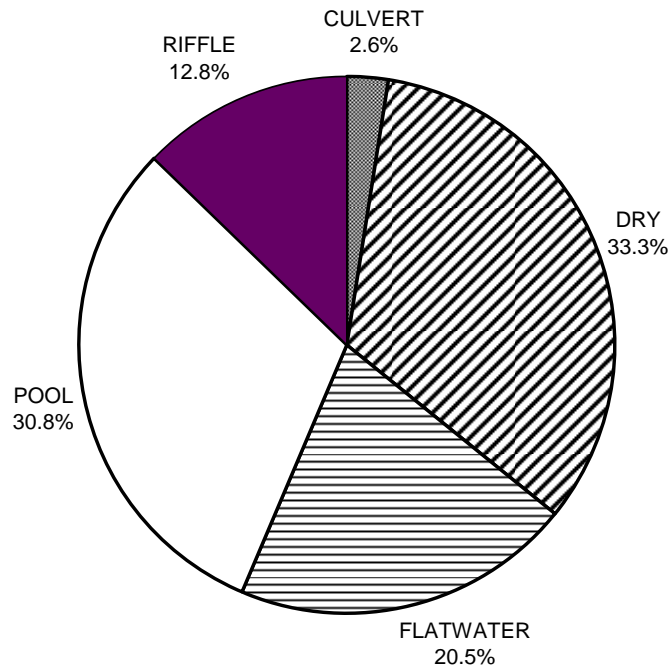
GRAPH 1

Table 1 summarizes the Level II riffle, flatwater, and pool habitat types. Based on frequency of occurrence there were 33% dry units, 31% pool units, 21% flatwater units, 13% riffle units, and 3% culvert units (Graph 1). Based on total length of Level II habitat types there were 53% dry units, 20% flatwater units, 11% riffle units, 10% pool units , and 5% culvert units (Graph 2).

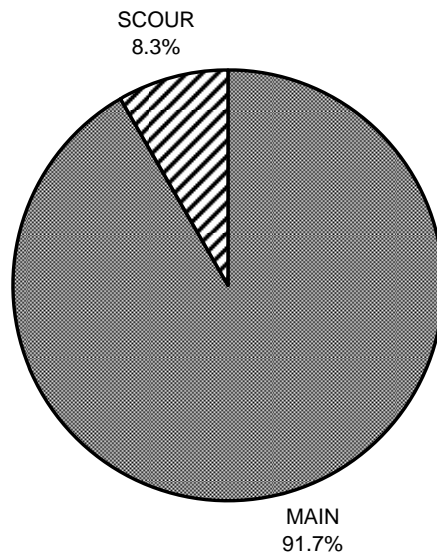
GRAPH 4

A total of 12 pools were identified (Table 3). Main Channel pools were the most frequently encountered, at 92%, and comprised 91% of the total length of all pools (Graph 4).

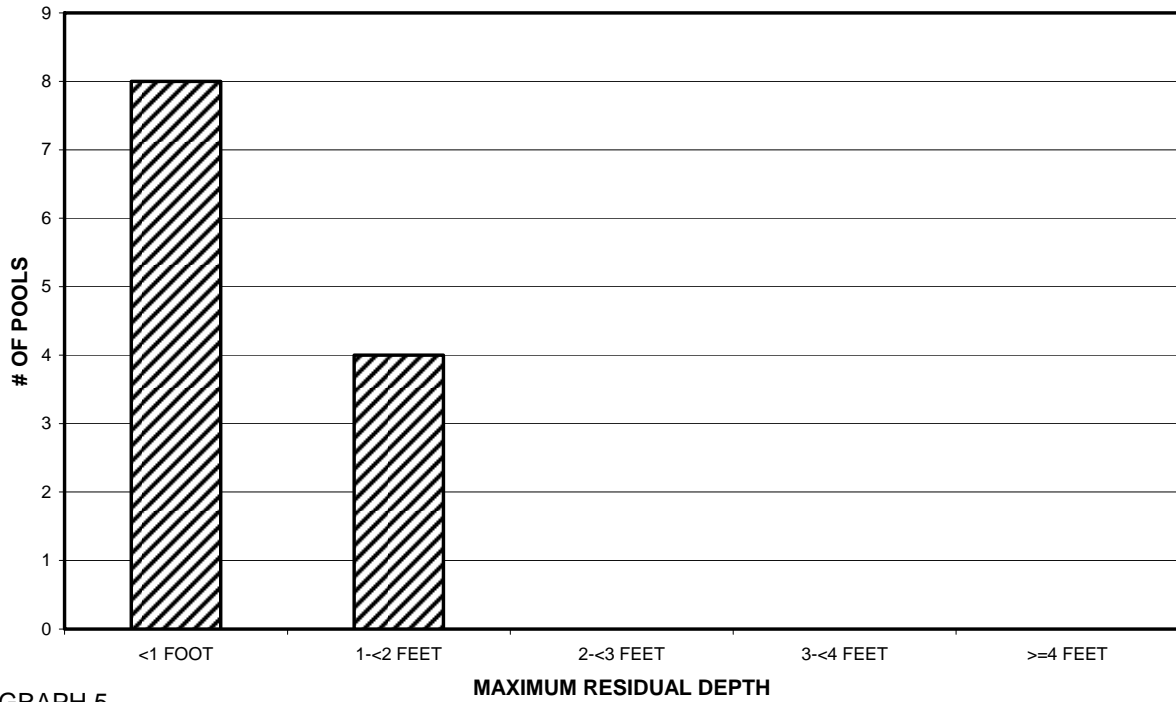
GRAPH 5

salmonids increases with depth. Zero of the 12 pools (0% ) had a residual depth of two feet or greater (Graph 5).

Flatwater habitat types comprised 20% of the total length of this survey, riffles 11%, and pools 10%. The pools are relatively shallow, with 0 of the 12 (0%) pools having a maximum residual depth greater than 2 feet. In general, pool enhancement projects are considered when primary pools comprise less than 40% of the length of total stream habitat. In first and second order streams, a primary pool is defined to have a maximum residual depth of at least two feet, occupy at least half the width of the low flow channel, and be as long as the low flow channel width. Installing structures that will increase or deepen pool habitat is recommended for locations where their installation will not be threatened by high stream energy, or where their installation will not conflict with the modification of the numerous log debris accumulations (LDA's) in the stream.

- 2) Where feasible, design and engineer pool enhancement structures to increase the number of pools. This must be done where the banks are stable or in conjunction with stream bank armor to prevent erosion.

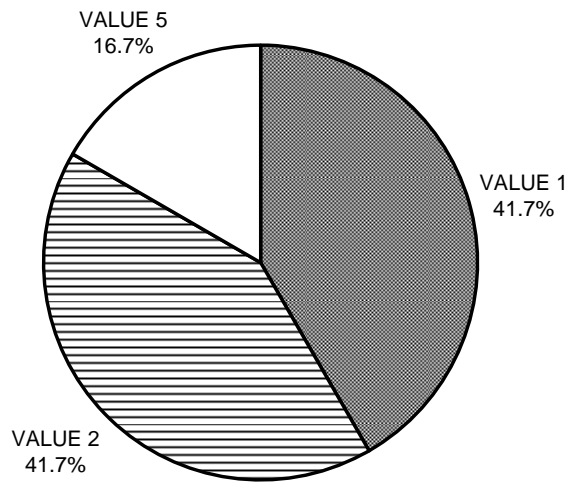
GRAPH 6

The depth of cobble embeddedness was estimated at pool tail-outs. Of the 12 pool tail-outs measured, 5 had a value of 1 (41.7%); 5 had a value of 2 (41.7%); 2 had a value of 5 (16.7%); (Graph 6). On this scale, a value of 1 indicates the best spawning conditions and a value of 4 the worst. Additionally, a value of 5 was assigned to tail-outs deemed unsuited for spawning due to inappropriate substrate such as bedrock, log sills, boulders, or other considerations.

Ten of the 12 pool tail-outs measured had embeddedness ratings of 1 or 2. Zero of the pool tail-outs had embeddedness ratings of 3 or 4. Two of the pool tail-outs had a rating of 5, which is considered unsuitable for spawning. Cobble embeddedness measured to be 25% or less, a rating of 1, is considered to indicate good quality spawning substrate for salmon and steelhead. Sediment sources in Unnamed Tributary # 3 of Lagunitas should be mapped and rated according to their potential sediment yields, and control measures should be taken.

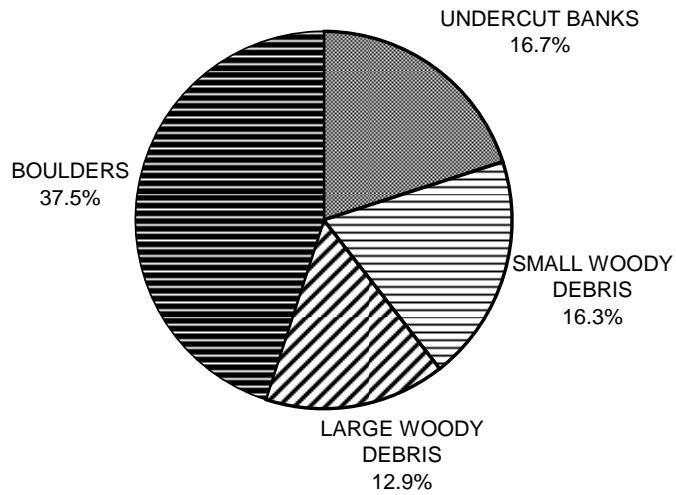
GRAPH 7

Table 5 summarizes mean percent cover by habitat type. Boulders are the dominant cover types in Unnamed Tributary # 3 of Lagunitas. Graph 7 describes the pool cover in Unnamed Tributary # 3 of Lagunitas. Boulders are the dominant pool cover type followed by undercut banks.

The mean shelter rating for pools was 40. The shelter rating in the flatwater habitats was 3. A pool shelter rating of approximately 100 is desirable. The amount of cover that now exists is being provided primarily by boulders in Unnamed Tributary # 3 of Lagunitas. Boulders are the dominant cover type in pools followed by undercut banks. Log and root wad cover structures in the pool and flatwater habitats would enhance both summer and winter salmonid habitat. Log cover structure provides rearing fry with protection from predation, rest from water velocity, and also divides territorial units to reduce density related competition.

- 4) Increase woody cover in the pools and flatwater habitat units. Most of the existing cover in the pools is from Boulders. Adding high quality complexity with woody cover in the pools is desirable.

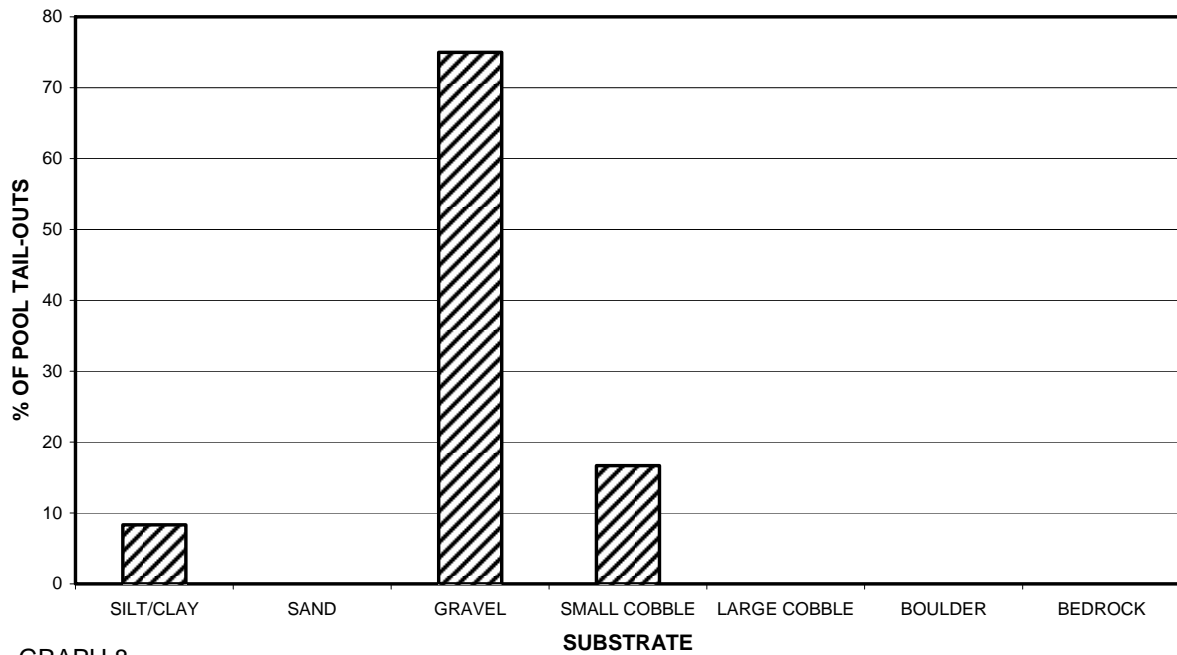
GRAPH 8

Table 6 summarizes the dominant substrate by habitat type. Graph 8 depicts the dominant substrate observed in pool tail-outs. Gravel was observed in 75% of pool tail-outs and small Cobble observed in 17% of pool tail-outs

Eleven of the 12 pool tail-outs measured had gravel or small cobble as the dominant substrate. This is generally considered good for spawning salmonids.

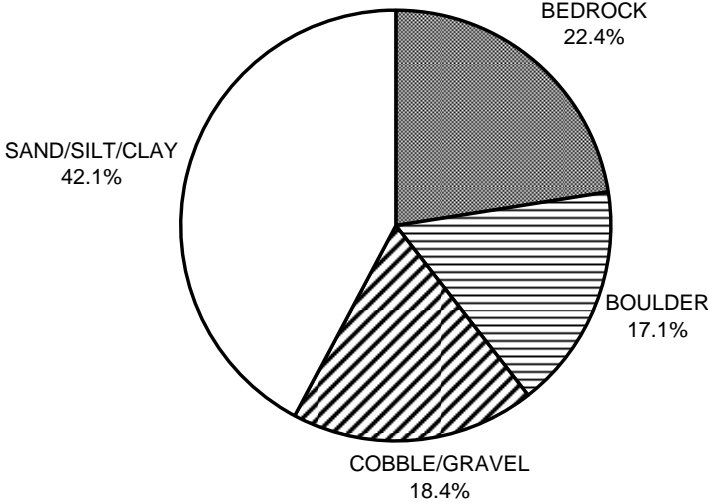
GRAPH 10

For the stream reach surveyed, the mean percent right bank vegetated was 95%. The mean percent left bank vegetated was 96%. The dominant elements composing the structure of the stream banks consisted of 42% sand/silt/clay, 22% bedrock, 18% cobble/gravel, and 17% boulder (Graph 10). Hardwood Trees were the dominant vegetation type observed in 51.3% of the units surveyed. Additionally, 39.5% of the units surveyed had Brush as the dominant vegetation type, and 9.2% had Coniferous Trees as the dominant vegetation (Graph 11).

The percentage of right and left bank covered with vegetation was 95% and 96%, respectively. In areas of stream bank erosion or where bank vegetation is sparse, planting endemic species of coniferous and hardwood trees, in conjunction with bank stabilization, is recommended.
