STREAM INVENTORY REPORT

Larsen Creek

A stream inventory was conducted on 9/14/2005 on Larsen Creek. The survey began at the confluence with San Geronimo Creek and extended upstream 0.5 miles.

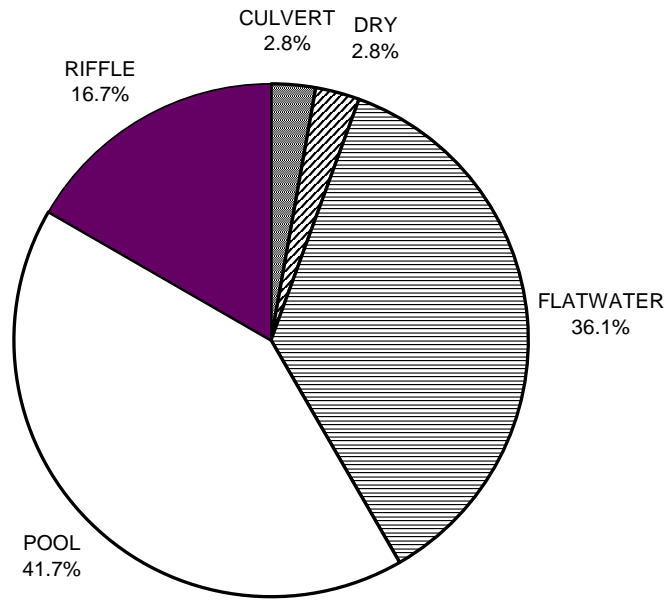
GRAPH 1

Table 1 summarizes the Level II riffle, flatwater, and pool habitat types. Based on frequency of occurrence there were 42% pool units, 36% flatwater units, 17% riffle units, 3% dry units and 3% culvert units (Graph 1). Based on total length of Level II habitat types there were 67% flatwater units, 19% pool units, 10% riffle units, 3% culvert units and 1% dry units (Graph 2).

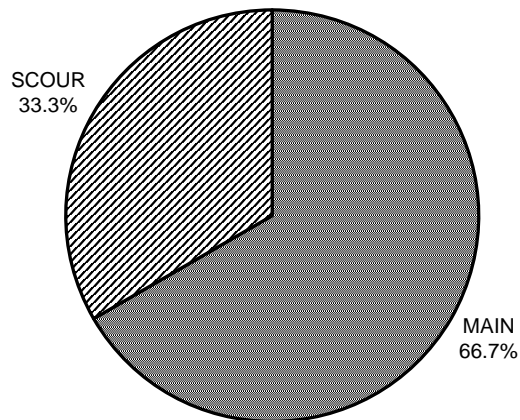
GRAPH 4

A total of 15 pools were identified (Table 3). Main Channel pools were the most frequently encountered, at 67%, and comprised 70% of the total length of all pools (Graph 4).

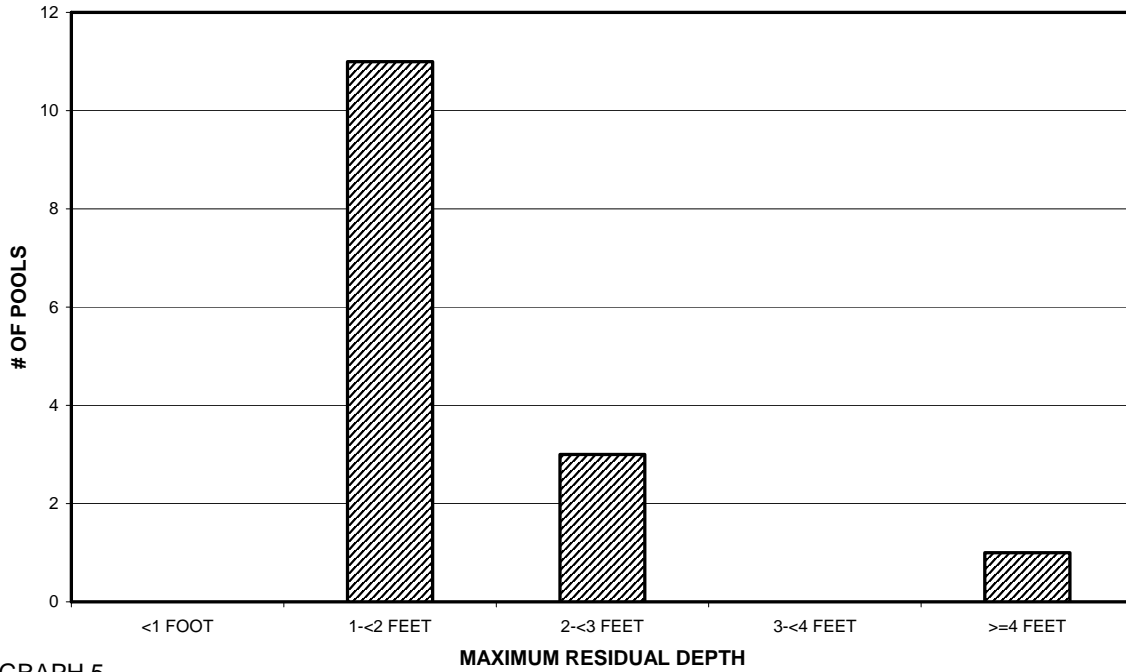
GRAPH 5

Table 4 is a summary of maximum residual pool depths by pool habitat types. Pool quality for salmonids increases with depth. Four of the 15 pools (27%) had a residual depth of two feet or greater (Graph 5).

Flatwater habitat types comprised 67% of the total length of this survey, riffles 10%, and pools 19%. The pools are relatively shallow, with only 4 of the 15 (27%) pools having a maximum residual depth greater than 2 feet. In general, pool enhancement projects are considered when primary pools comprise less than 40% of the length of total stream habitat. In first and second order streams, a primary pool is defined to have a maximum residual depth of at least two feet, occupy at least half the width of the low flow channel, and be as long as the low flow channel width. Installing structures that will increase or deepen pool habitat is recommended for locations where their installation will not be threatened by high stream energy, or where their installation will not conflict with the modification of the numerous log debris accumulations (LDA's) in the stream.

- 4) Where feasible, design and engineer pool enhancement structures to increase the number of pools. This must be done where the banks are stable or in conjunction with stream bank armor to prevent erosion.

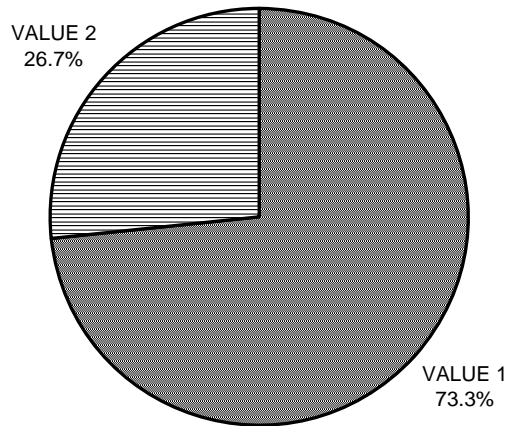
GRAPH 6

The depth of cobble embeddedness was estimated at pool tail-outs. Of the 15 pool tail-outs measured, 11 had a value of 1 (73.3%); 4 had a value of 2 (26.7%) (Graph 6). On this scale, a value of 1 indicates the best spawning conditions and a value of 4 the worst. Additionally, a value of 5 was assigned to tail-outs deemed unsuited for spawning due to inappropriate substrate such as bedrock, log sills, boulders, or other considerations.

All of the 15 pool tail-outs measured had embeddedness ratings of 1 or 2. None of the pool tail-

outs had embeddedness ratings of 3 or 4. None of the pool tail-outs had a rating of 5, which is considered unsuitable for spawning. Cobble embeddedness measured to be 25% or less, a rating of 1, is considered to indicate good quality spawning substrate for salmon and steelhead. Sediment sources in Larsen Creek should be mapped and rated according to their potential sediment yields, and control measures should be taken.

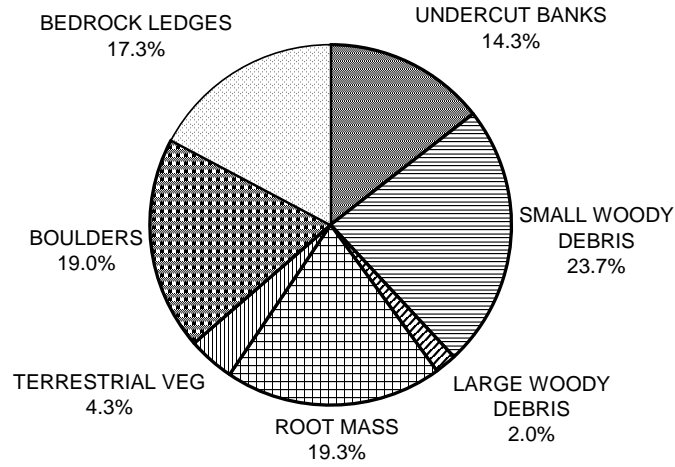
GRAPH 7

Table 5 summarizes mean percent cover by habitat type. Small Woody Debris is the dominant cover types in Larsen Creek. Graph 7 describes the pool cover in Larsen Creek. Small Woody Debris is the dominant pool cover type followed by root mass.

The mean shelter rating for pools was 27. A pool shelter rating of approximately 100 is desirable. The amount of cover that now exists is being provided primarily by Small Woody Debris in Larsen Creek. Small Woody Debris is the dominant cover type in pools followed by root mass and boulders. Log and root wad cover structures in the pool and flatwater habitats would enhance both summer and winter salmonid habitat. Log cover structure provides rearing fry with protection from predation, rest from water velocity, and also divides territorial units to reduce density related competition.

- 5) Increase woody cover in the pools and flatwater habitat units. Most of the existing cover in the pools is from Small Woody Debris. Adding high quality complexity with woody cover in the pools is desirable.

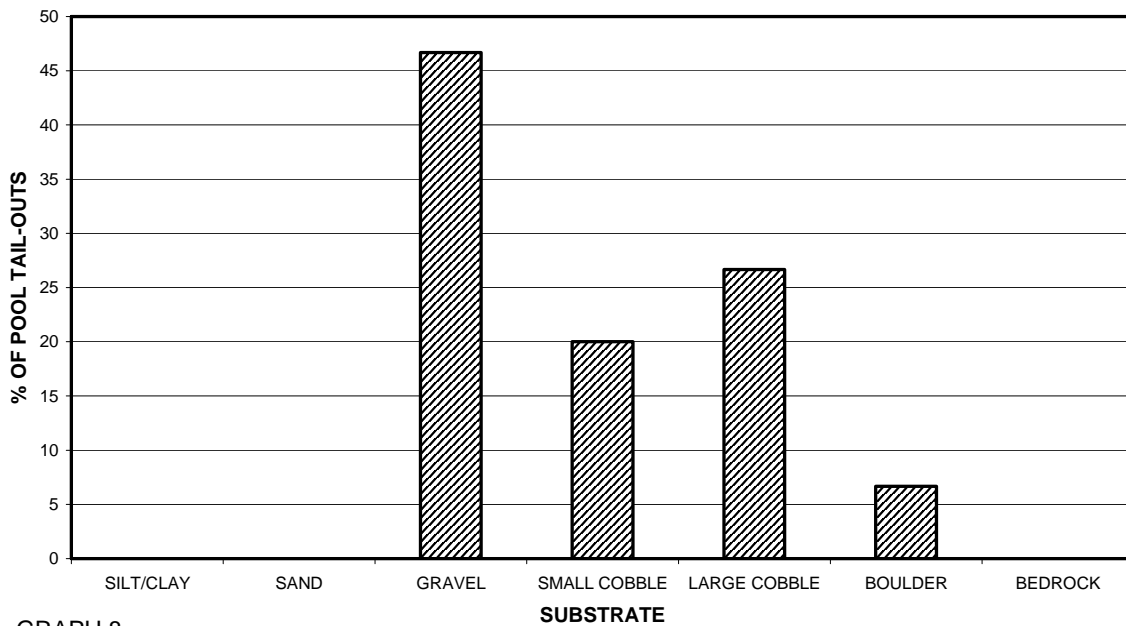
GRAPH 8

Table 6 summarizes the dominant substrate by habitat type. Graph 8 depicts the dominant substrate observed in pool tail-outs. Gravel was observed in 47% while large cobble was observed in 27% of pool tail-outs.

Ten of the 15 pool tail-outs measured had gravel or small cobble as the dominant substrate. This is generally considered good for spawning salmonids.

- 8) Suitable size spawning substrate on Larsen Creek is limited to relatively few reaches. Projects should be designed at suitable sites to trap and sort spawning gravel.

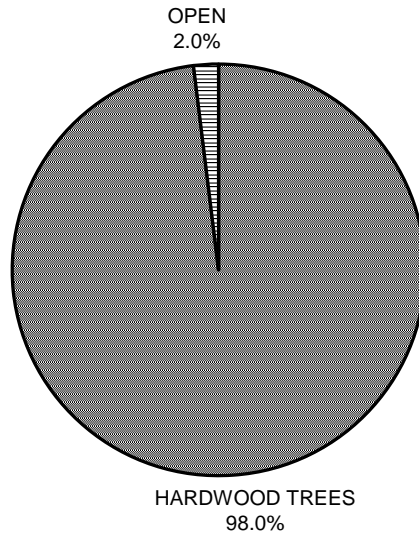
GRAPH 9

The mean percent canopy density for the surveyed length of Larsen Creek was 98% The mean percentages of hardwood and coniferous trees were 100% and 0%, respectively (Table 7). Two percent of the canopy was open. Graph 9 describes the mean percent canopy in Larsen Creek.

The mean percent canopy density for the stream was 98%. Reach 1 had a canopy density of 97.9%, Reach 2 had a canopy density of 98.2%. In general, revegetation projects are considered when canopy density is less than 80%.

- 3) Increase the canopy on Larsen Creek, specifically on through the golf course corridor, by planting appropriate native vegetation like willow, alder, redwood, and Douglas fir along the stream where shade canopy is not at acceptable levels. The reaches above this survey section should be inventoried and treated as well, since the water flowing here is affected from upstream. In many cases, planting will need to be coordinated to follow bank stabilization or upslope erosion control projects.

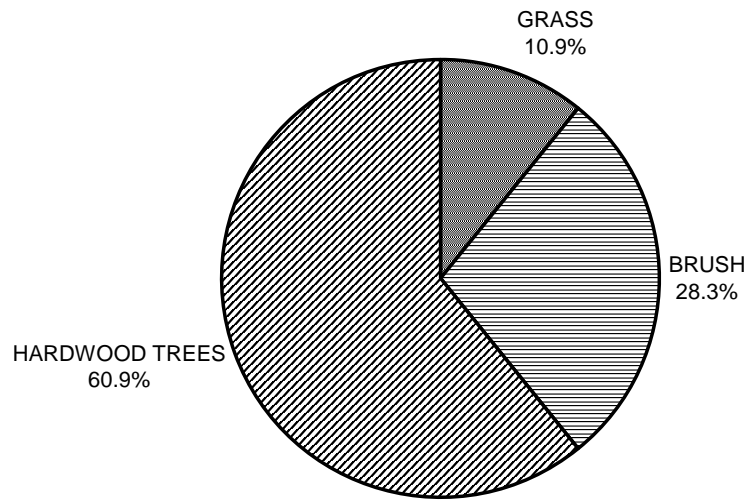
GRAPH 11

For the stream reach surveyed, the mean percent right bank vegetated was 68%. The mean percent left bank vegetated was 74% (Table 7) The dominant elements composing the structure of the stream banks consisted of 67% sand/silt/clay 17% bedrock, 13% boulder and 2% cobble/gravel (Graph 10). Hardwood trees were the dominant vegetation type observed in 61% of the units surveyed. Additionally, 28% of the units surveyed had brush as the dominant vegetation type, and 11% had grass as the dominant vegetation (Graph 11).

The percentage of right and left bank covered with vegetation was high at 68% and 74%, respectively. In areas of stream bank erosion or where bank vegetation is sparse, planting endemic species of coniferous and hardwood trees, in conjunction with bank stabilization, is recommended.
