**California Department of Fish and Game
Walker Creek Watershed
Stream Habitat Assessment Reports**

Salmon Creek

STREAM INVENTORY REPORT

Assessment October 2008

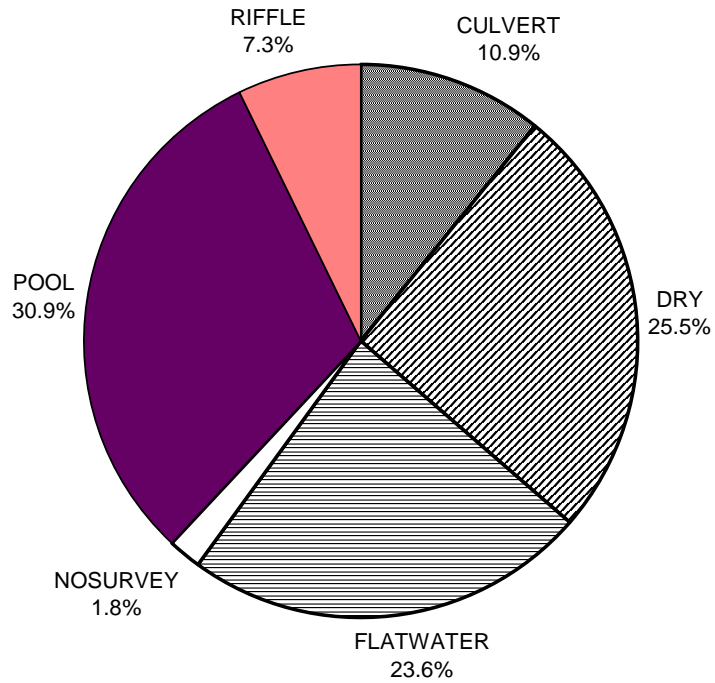
GRAPH 1

Table 1 summarizes the Level II riffle, flatwater, and pool habitat types. Based on frequency of occurrence there were 31% pool units, 25% dry units, 24% flatwater units, 11% culvert units (Graph 1). Based on total length of Level II habitat types there were 44% no-survey units, 41% dry units, and 7% flatwater units (Graph 2).

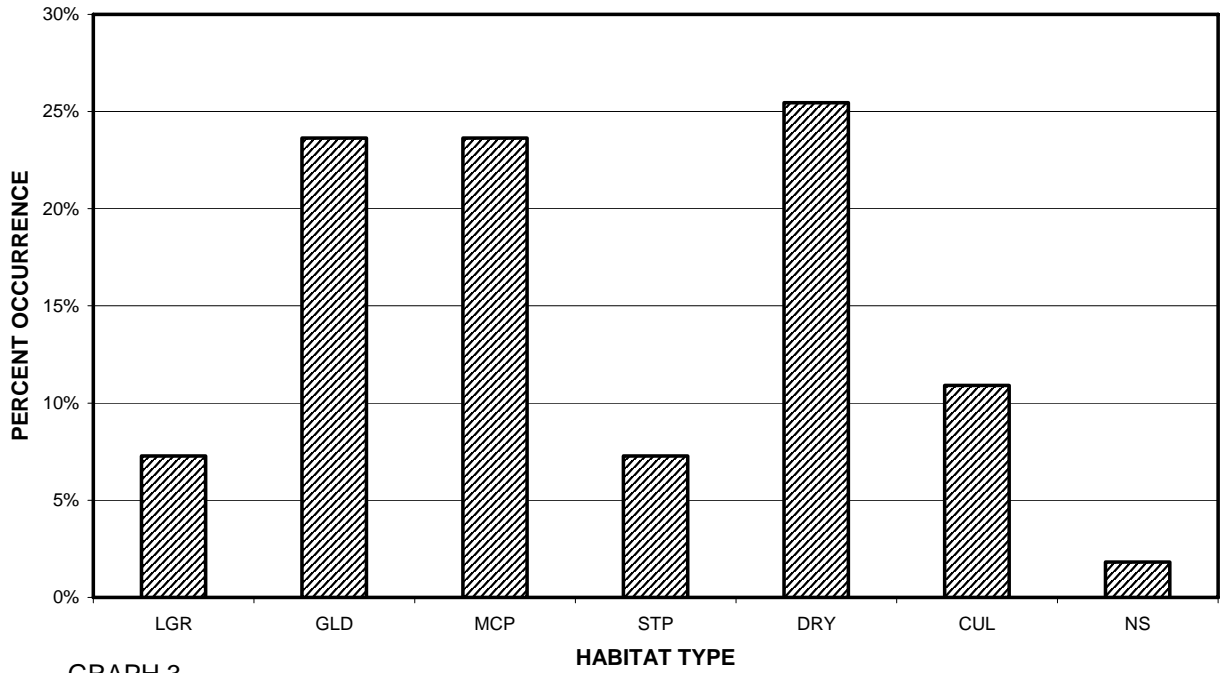
GRAPH 3

Five Level IV habitat types were identified (Table 2). The most frequent habitat types by percent occurrence were 25% Dry units, 24% Mid-Channel Pool units and 24% Glide units (Graph 3). Based on percent total length, 44% were Not Surveyed unit, 41% were Dry units and 7% were Glide units.

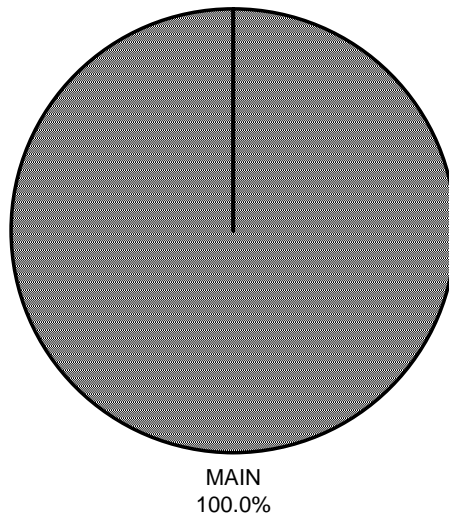
GRAPH 4

A total of 17 pools were identified (Table 3). Main Channel pools were the most frequently encountered, at 100%, and comprised 100% of the total length of all pools (Graph 4).

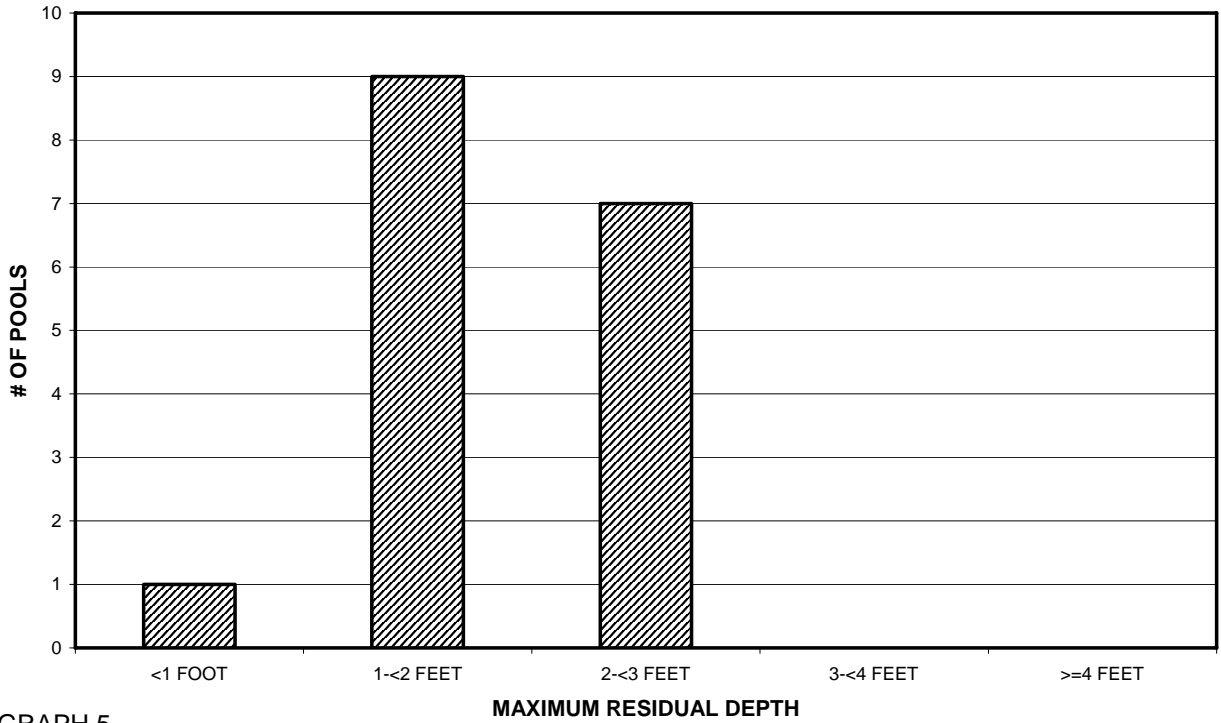
GRAPH 5

Table 4 is a summary of maximum residual pool depths by pool habitat types. Pool quality for salmonids increases with depth seven of the 17 pools (41%) had a residual depth of two feet or greater (Graph 5).

Flatwater habitat types comprised 7% of the total length of this survey, riffles 1%, dry units 41%, no survey unit 44% and pools 5%. The pools are relatively shallow, with only 7 of the 17 (41%) pools having a maximum residual depth greater than 2 feet. In general, pool enhancement projects are considered when primary pools comprise less than 40% of the length of total stream habitat. In first and second order streams, a primary pool is defined to have a maximum residual

depth of at least two feet, occupy at least half the width of the low flow channel, and be as long as the low flow channels width. Installing structures that will increase or deepen pool habitat is recommended for locations where their installation will not be threatened by high stream energy, or where their installation will not conflict with the modification of the numerous log debris accumulations (LDA's) in the stream.

4. Where feasible, design and engineer pool enhancement structures to increase the number of pools. This must be done where the banks are stable or in conjunction with stream bank armor to prevent erosion.

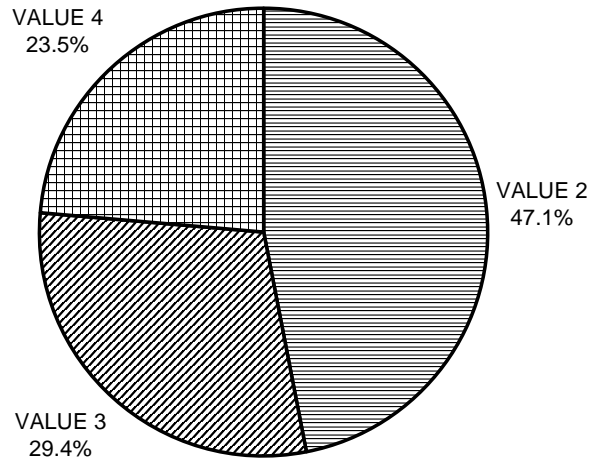
GRAPH 6

The depth of cobble embeddedness was estimated at pool tail-outs. Of the 17 pool tail-outs measured, 8 had a value of 2 (47.1%); 5 had a value of 3 (29.4%) and 4 had a value of 4 (23.5%) (Graph 6). On this scale, a value of 1 indicates the best spawning conditions and a value of 4 the worst. Additionally, a value of 5 was assigned to tail-outs deemed unsuited for spawning due to inappropriate substrate such as bedrock, log sills, boulders, or other considerations.

Eight of the 17 pool tail-outs measured had embeddedness ratings of 1 or 2. Nine of the pool tail-outs had embeddedness ratings of 3 or 4. None of the pool tail-outs had a rating of 5, which is considered unsuitable for spawning. Cobble embeddedness measured to be 25% or less, a rating of 1, is considered to indicate good quality spawning substrate for salmon and steelhead. Sediment sources in Salmon Creek should be mapped and rated according to their potential sediment yields, and control measures should be taken.

5. Active and potential sediment sources related to the road system need to be identified, mapped, and treated according to their potential for sediment yield to the stream and its tributaries.

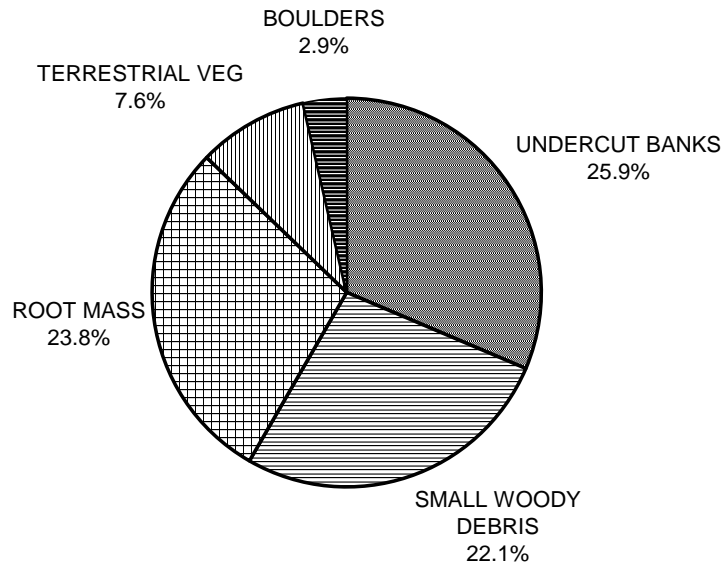
GRAPH 7

Table 5 summarizes mean percent cover by habitat type. Undercut Banks are the dominant cover types in Salmon Creek. Graph 7 describes the pool cover in Salmon Creek. Undercut Banks are the dominant pool cover type followed by root mass.

The mean shelter rating for pools was 7. The shelter rating in the flatwater habitats was 4. A pool shelter rating of approximately 100 is desirable. The amount of cover that now exists is being provided primarily by undercut banks in Salmon Creek. Undercut banks are the dominant cover type in pools followed by root mass. Log and root wad cover structures in the pool and flatwater habitats would enhance both summer and winter salmonid habitat. Log cover structure provides rearing fry with protection from predation, rest from water velocity, and also divides territorial units to reduce density related competition.

3. Increase woody cover in the pools and flatwater habitat units. Most of the existing cover in the pools is from Undercut Banks. Adding high quality complexity with woody cover in the pools is desirable.

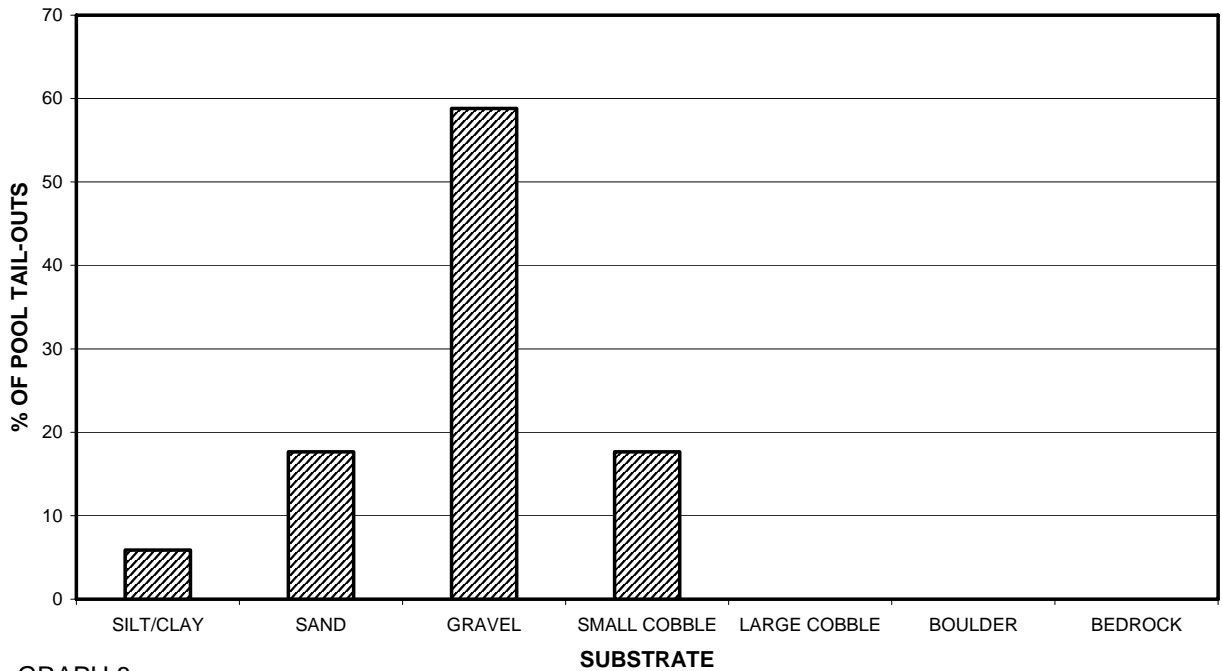
GRAPH 8

Table 6 summarizes the dominant substrate by habitat type. Graph 8 depicts the dominant substrate observed in pool tail-outs. a silt/clay substrate type was observed in 6% of pool tail-outs, sand observed in 18% of pool tail-outs, gravel observed in 59% of pool tail-outs, small Cobble observed in 18% of pool tail-outs, (Use these numbers to choose 2 types).

Thirteen of the 17 pool tail-outs measured had gravel or small cobble as the dominant substrate. This is generally considered good for spawning salmonids.

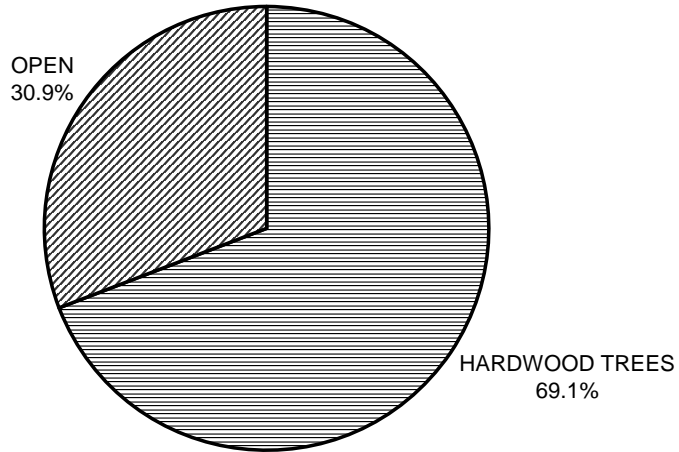
GRAPH 9

The mean percent canopy density for the surveyed length of Salmon Creek was 69%. The mean percentages of hardwood and coniferous trees were 100% and 0%, respectively. Thirty one percent of the canopy was open. Graph 9 describes the mean percent canopy in Salmon Creek.

The mean percent canopy density for the stream was 69%. Reach 1 had a canopy density of 66% and Reach 3 had a canopy density of 87%. In general, revegetation projects are considered when canopy density is less than 80%.

6. Increase the canopy on Salmon Creek by planting appropriate native vegetation like willow, alder, redwood, and Douglas fir along the stream where shade canopy is not at acceptable levels. The reaches above this survey section should be inventoried and treated as well, since the water flowing here is affected from upstream. In many cases, planting will need to be coordinated to follow bank stabilization or upslope erosion control projects.
