California Department of Fish and Game
Lagunitas Watershed
Stream Habitat Assessment Reports

Upper San Geronimo Creek

STREAM INVENTORY REPORT

Assessment completed 2007

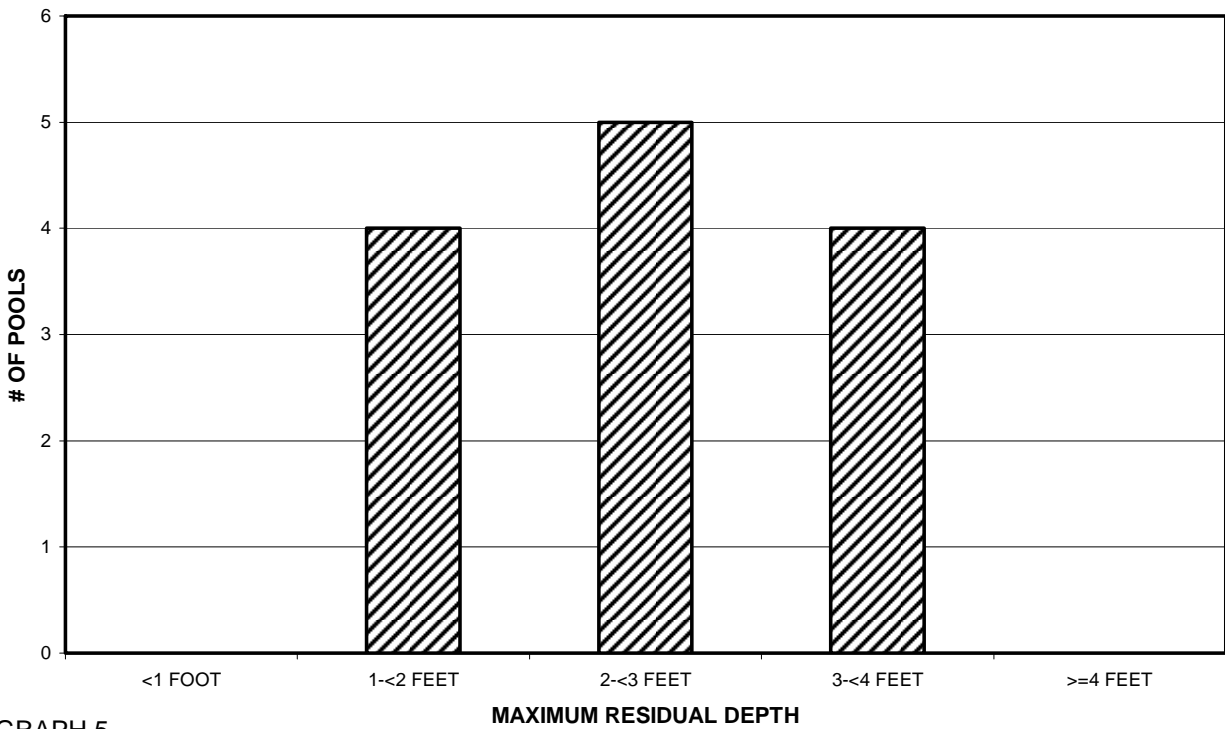
GRAPH 5

Table 4 is a summary of maximum residual pool depths by pool habitat types. Pool quality for salmonids increases with depth. Nine of the 13 pools (69%) had a residual depth of two feet or greater (Graph 5).

riffles less than 1%. The pools are relatively deep, with only 9 of the 13 (69%) pools having a maximum residual depth greater than 2 feet. In general, pool enhancement projects are considered when primary pools comprise less than 40% of the length of total stream habitat. In first and second order streams, a primary pool is defined to have a maximum residual depth of at least two feet, occupy at least half the width of the low flow channel, and be as long as the low flow channel width. Installing structures that will increase or deepen pool habitat is recommended for locations where their installation will not be threatened by high stream energy, or where their installation will not conflict with the modification of the numerous log debris accumulations (LDA's) in the stream.

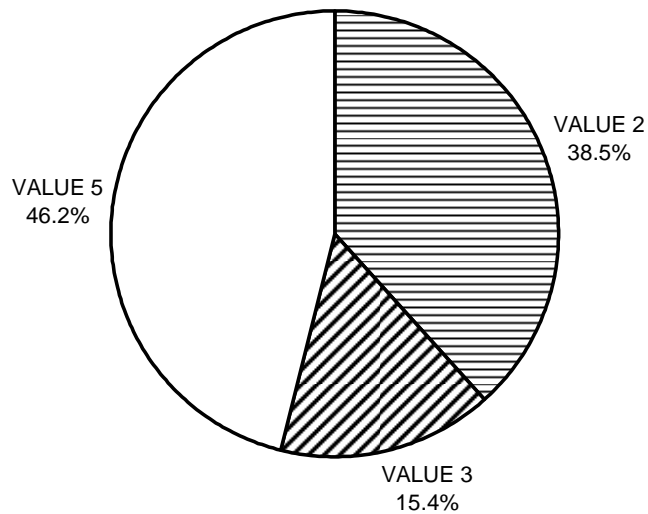
GRAPH 6

The depth of cobble embeddedness was estimated at pool tail-outs. Of the 13 pool tail-outs measured, 5 had a value of 2 (38.5%); 2 had a value of 3 (15.4%); 6 had a value of 5 (46.2%); (Graph 6). On this scale, a value of 1 indicates the best spawning conditions and a value of 4 the worst. Additionally, a value of 5 was assigned to tail-outs deemed unsuited for spawning due to inappropriate substrate such as bedrock, log sills, boulders, or other considerations.

Five of the 13 pool tail-outs measured had embeddedness ratings of 1 or 2. Two of the pool tail-outs had embeddedness ratings of 3 or 4. Six of the pool tail-outs had a rating of 5, which is considered unsuitable for spawning. Cobble embeddedness measured to be 25% or less, a rating of 1, is considered to indicate good quality spawning substrate for salmon and steelhead. Sediment sources in Upper San Geronimo Creek should be mapped and rated according to their potential sediment yields, and control measures should be taken.

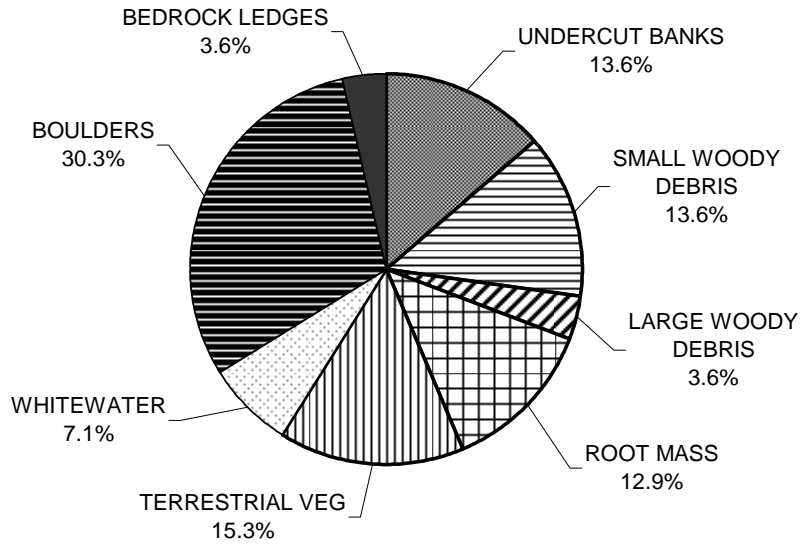
GRAPH 7

Table 5 summarizes mean percent cover by habitat type. Boulders are the dominant cover types in Upper San Geronimo Creek. Graph 7 describes the pool cover in Upper San Geronimo Creek. Boulders are the dominant pool cover type followed by terrestrial vegetation.

The mean shelter rating for pools was 18. The shelter rating in the flatwater habitats was 7. A pool shelter rating of approximately 100 is desirable. The amount of cover that now exists is being provided primarily by Boulders in Upper San Geronimo Creek. Boulders are the dominant cover type in pools followed by terrestrial vegetation. Log and root wad cover structures in the pool and flatwater habitats would enhance both summer and winter salmonid habitat. Log cover structure provides rearing fry with protection from predation, rest from water velocity, and also divides territorial units to reduce density related competition.

-Increase woody cover in the pools and flatwater habitat units. Most of the existing cover in the pools is from Boulders. Adding high quality complexity with woody cover in the pools is desirable.

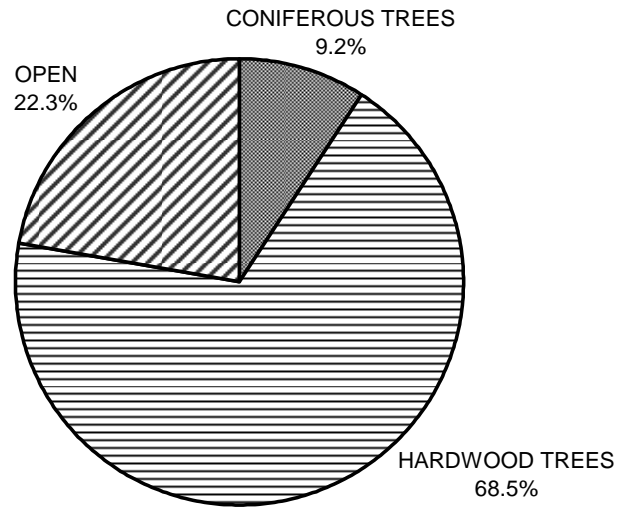
GRAPH 9

The mean percent canopy density for the surveyed length of Upper San Geronimo Creek was 78%. The mean percentages of hardwood and coniferous trees were 88% and 12%, respectively. Twenty-two percent of the canopy was open. Graph 9 describes the mean percent canopy in Upper San Geronimo Creek.

The mean percent canopy density for the stream was 78%. Reach 1 had a canopy density of 73%, Reach 2 had a canopy density of 89%, Reach 3 had a canopy density of 33%, and Reach 4 had a canopy density of 91%. In general, revegetation projects are considered when canopy density is less than 80%.

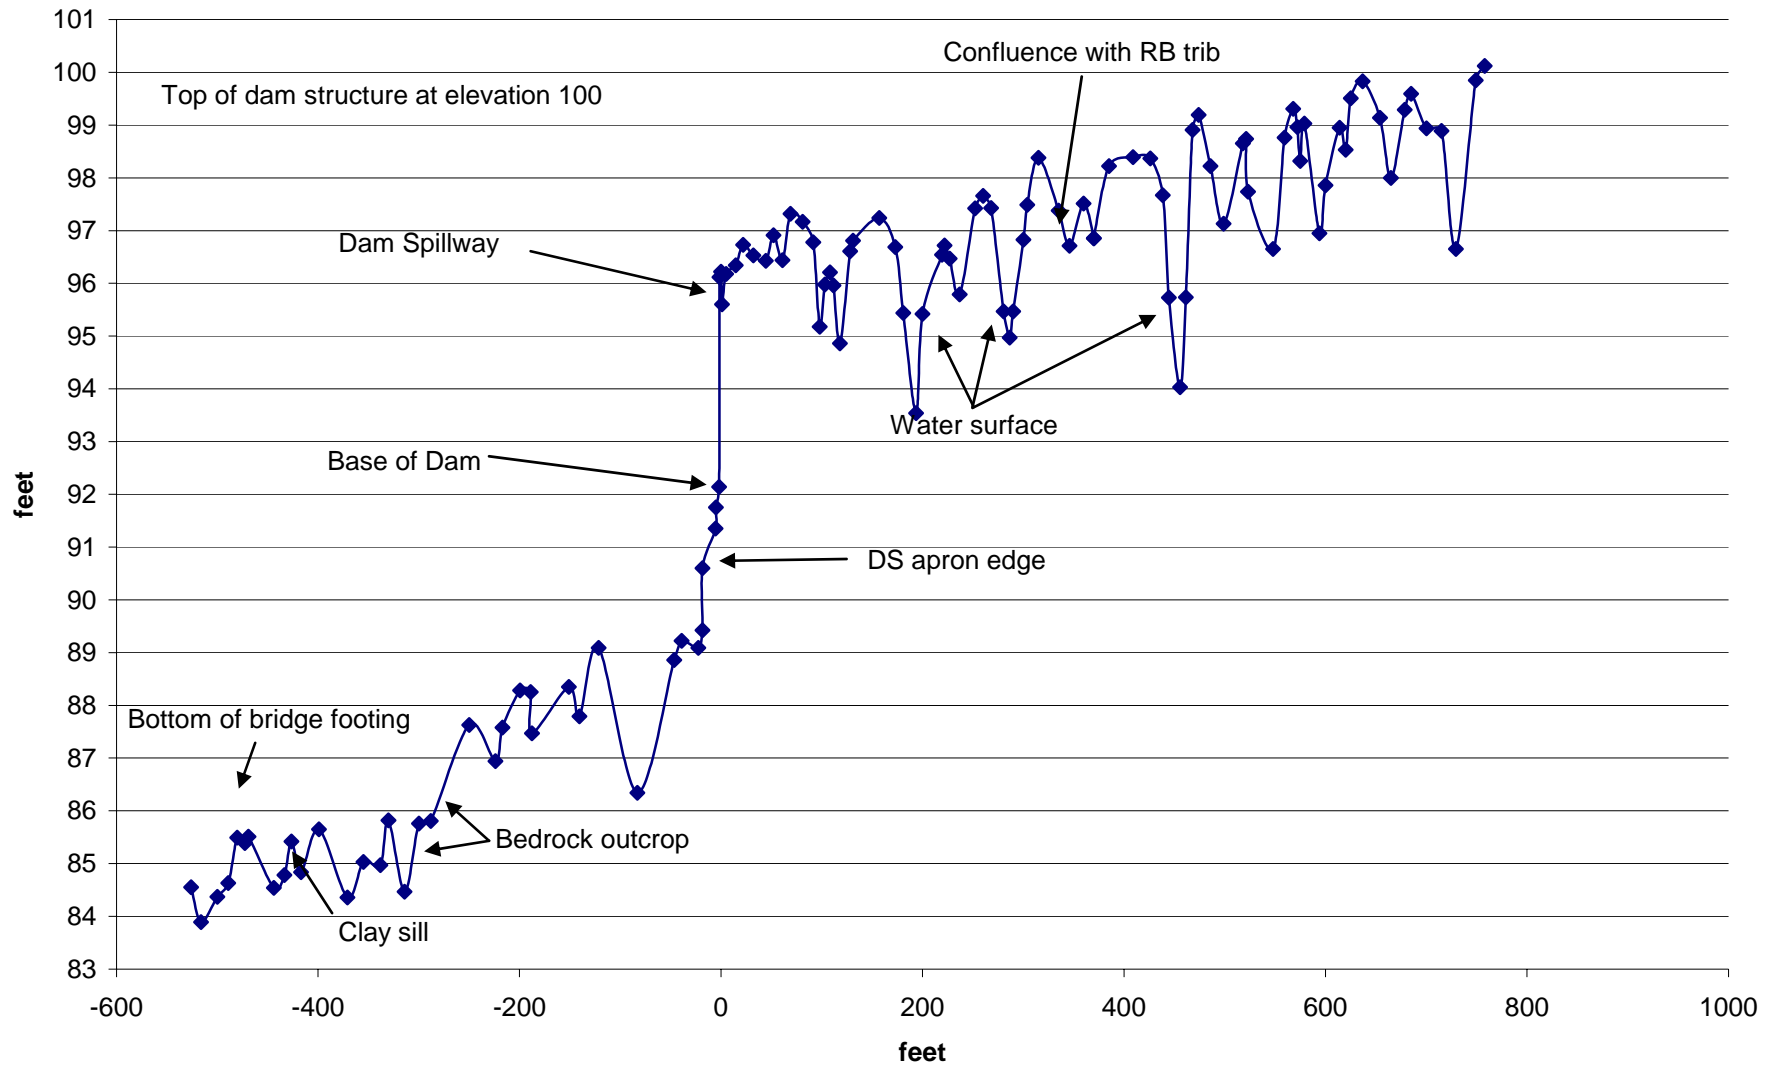
Dam #1 Long Profile, HU 035, Upper San Geronimo Creek

1835	0035.00	Structures: Dam #1, H.: 4.5' (in center), L.: 1', W. (O): 4.5', W. (D): 26', no flash boards, downcutting at sill: 1', H. sill to H2O level: 4.5', 8' high on the sides, there is a 17' long apron below the Dam.
2062	0038.00	Tributaries: Trib #1 on right bank at top of unit, not flowing, accessible to fish, checked up the tributary for ~100', slope <2%, no fish observed.
2302	0041.00	Tributaries: Trib #2 on right bank, not flowing, accessible to fish, slope <2%, no fish observed.
3159	0045.00	Tributaries: Trib #3 on right bank at top of unit, not flowing, slope < 2%, no fish observed.
4052	0048.00	Fish Passage: (LDA) Debris accumulation #1, D.: 9', L.: 27', W.: 15', not retaining gravel, no fish observed upstream, scour pool under LDA, no erosion/down cutting, there is not much gravel above the accumulation but there are boulders. Below there is bedrock.

-The grade control weir in habitat unit 0035 is a fish barrier and should be removed or modified to allow fish passage of all life stages of salmonids. Designs should address stream bed instability and should prevent downcutting of the upstream stream channel which could cause bank instability and loss of mature riparian trees upstream of the weir.
