**California Department of Fish and Game  
Walker Creek Watershed  
Stream Habitat Assessment Reports**

**Verde Canyon Creek**

## STREAM INVENTORY SUB-REPORT

*Assessment Completed August 2008*

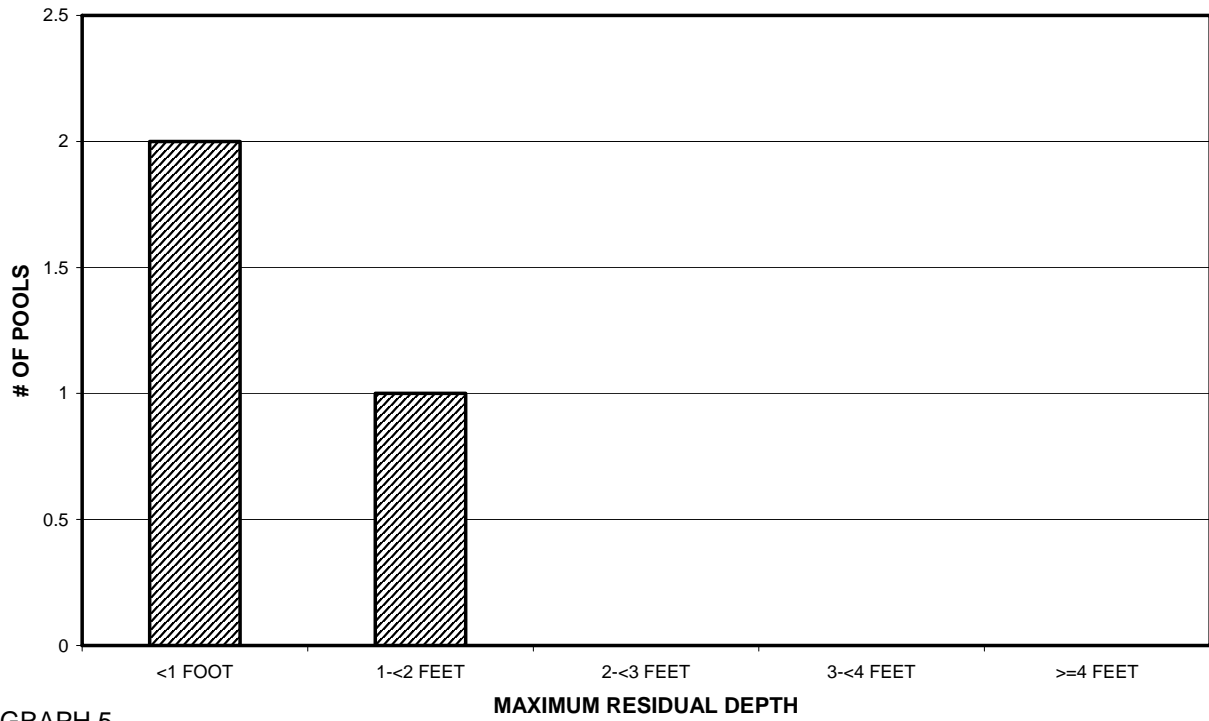
GRAPH 5

Based on the total length of this survey, Level II habitat units consisted of 64% dry units, 31% nosurvey units, 2% culvert units, 2% pool units and 1% flatwater units. The pools are relatively shallow, with none of the 3 pools having a maximum residual depth greater than 2 feet.

- 2) Where feasible, design and engineer pool enhancement structures to increase the number of pools. This must be done where the banks are stable or in conjunction with stream bank armor to prevent erosion.

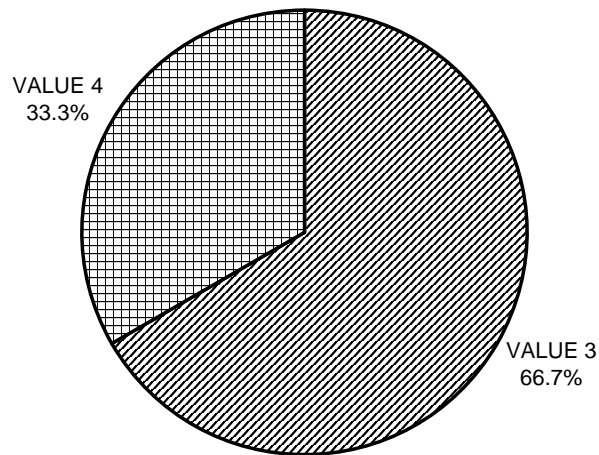
GRAPH 6

None of the 3 pool tail-outs measured had embeddedness ratings of 1 or 2. Three of the pool tail-outs had embeddedness ratings of 3 or 4. Cobble embeddedness of 25% or less, a rating of 1, is considered best for the needs of salmon and steelhead. In Verde Canyon, sediment sources should be mapped and rated according to their potential sediment yields, and control measures should be taken.

- 4) Active and potential sediment sources related to the road system need to be identified, mapped, and treated according to their potential for sediment yield to the stream and its tributaries.

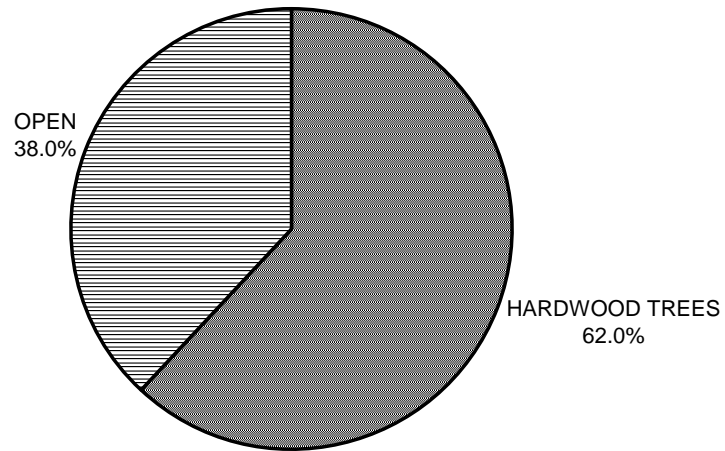
GRAPH 9

The mean percent canopy density for the stream was 62%. In general, revegetation projects are considered when canopy density is less than 80.

- 5) Increase the canopy on Verde Canyon by planting appropriate native vegetation like willow, alder, redwood, and Douglas fir along the stream where shade canopy is not at acceptable levels. The reaches above this survey section should be inventoried and treated as well, since the water flowing here is affected from upstream. In many cases, planting will need to be coordinated to follow bank stabilization or upslope erosion control projects.
