**California Department of Fish and Game
Stream Habitat Assessment Report**

STREAM INVENTORY REPORT

Woodacre Creek

Survey Completed Summer 2006

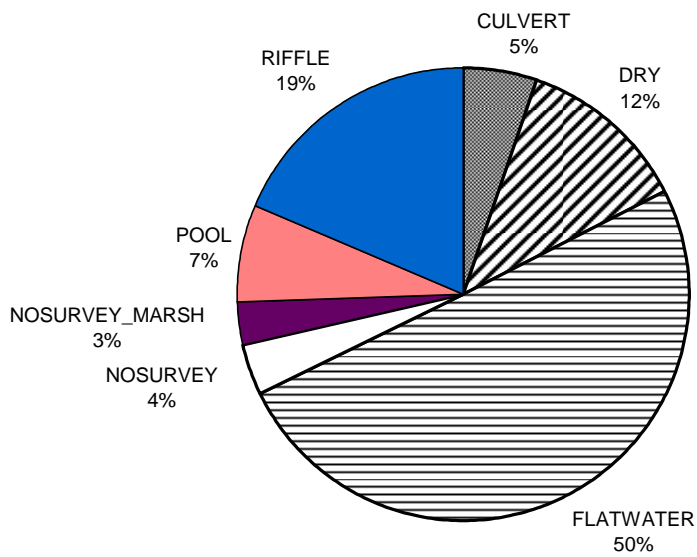
GRAPH 2

Table 1 summarizes the Level II riffle, flatwater, and pool habitat types. Based on frequency of occurrence there were 30% riffle units, 13% pool units, 45% flatwater units, 6% culvert units, 1% nosurvey_marsh units, 1% nosurvey units, and 4% dry units (Graph 1). Based on total length of Level II habitat types there were 19% riffle units, 7% pool units, 50% flatwater units, 5% culvert units, 3% nosurvey_marsh units, 4% nosurvey units, and 12% dry units (Graph 2).

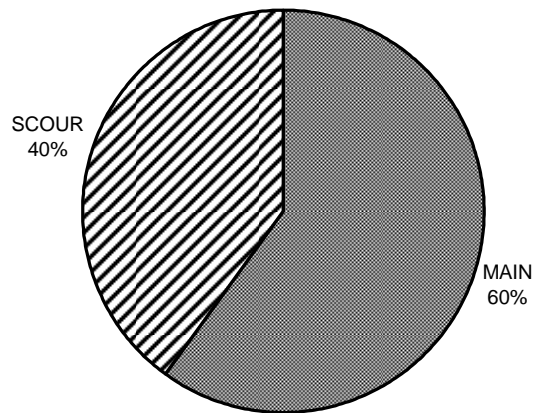
GRAPH 4

A total of 15 pools were identified (Table 3). Main Channel pools were the most frequently encountered, at 60%, and comprised 58% of the total length of all pools (Graph 4).

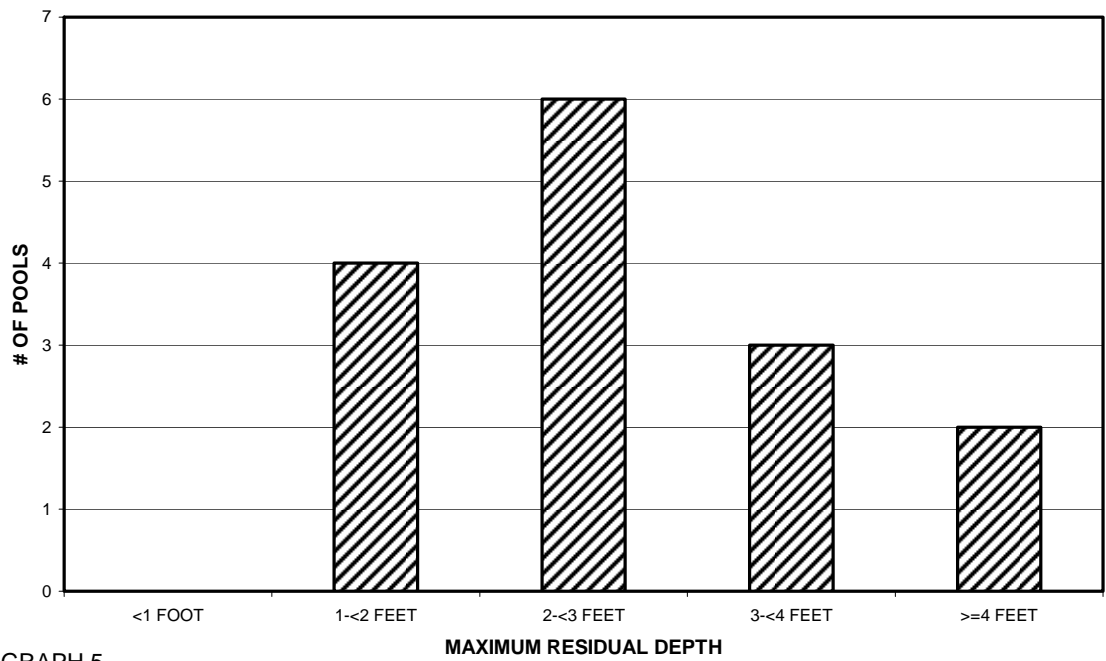
GRAPH 5

Table 4 is a summary of maximum residual pool depths by pool habitat types. Pool quality for salmonids increases with depth. Eleven of the 15 pools (73%) had a residual depth of two feet or greater (Graph 5).

Flatwater habitat types comprised 50% of the total length of this survey, riffles 19%, and pools 7%. The pools are relatively shallow, with only 11 of the 15 (73%) pools having a maximum residual depth greater than 2 feet. In general, pool enhancement projects are considered when primary pools comprise less than 40% of the length of total stream habitat. In first and second order streams, a primary pool is defined to have a maximum residual depth of at least two feet, occupy at least half the width of the low flow channel, and be as long as the low flow channel width. Installing structures that will increase or deepen pool habitat is recommended for locations where their installation will not be threatened by high stream energy, or where their installation will not conflict with the modification of the numerous log debris accumulations (LDA's) in the stream.

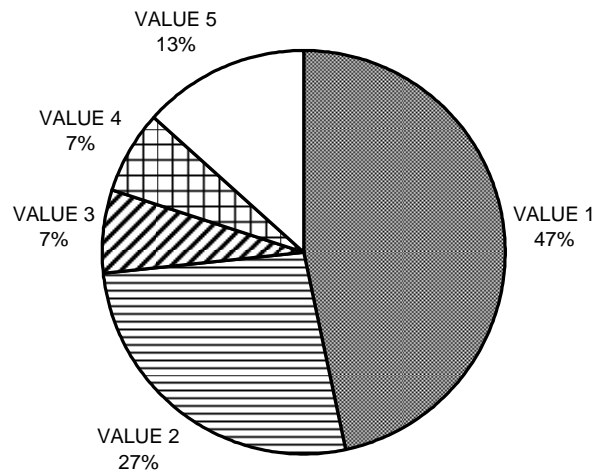
GRAPH 6

The depth of cobble embeddedness was estimated at pool tail-outs. Of the 15 pool tail-outs measured, 7 had a value of 1 (46.7%); 4 had a value of 2 (26.7%); 1 had a value of 3 (6.7%); 1 had a value of 4 (6.7%); and 2 had a value of 5 (13.3%) (Graph 6). On this scale, a value of 1 indicates the best spawning conditions and a value of 4 the worst. Additionally, a value of 5 was assigned to tail-outs deemed unsuited for spawning due to inappropriate substrate such as bedrock, log sills, boulders, or other considerations.

Eleven of the 15 pool tail-outs measured had embeddedness ratings of 1 or 2. Two of the pool tail-outs had embeddedness ratings of 3 or 4. Two of the pool tail-outs had a rating of 5, which is considered unsuitable for spawning. Cobble embeddedness measured to be 25% or less, a rating of 1, is considered to indicate good quality spawning substrate for salmon and steelhead. Sediment sources in Woodacre Creek should be mapped and rated according to their potential sediment yields, and control measures should be taken.

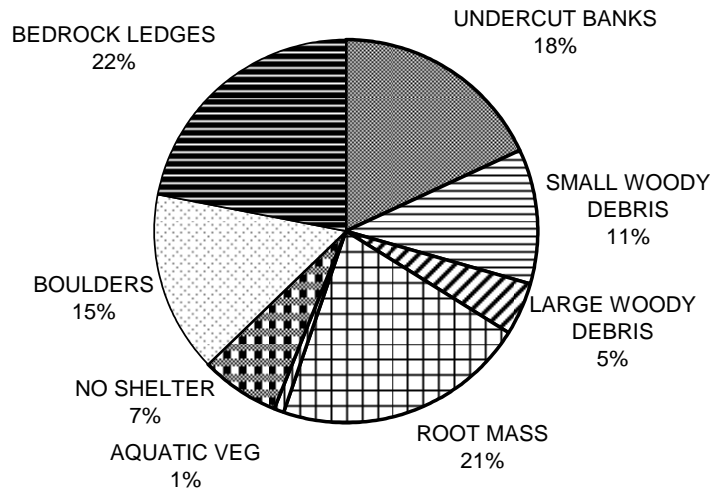
GRAPH 7

Table 5 summarizes mean percent cover by habitat type. Boulders are the dominant cover types in Woodacre Creek. Graph 7 describes the pool cover in Woodacre Creek. Bedrock Ledges are the dominant pool cover type followed by root mass.

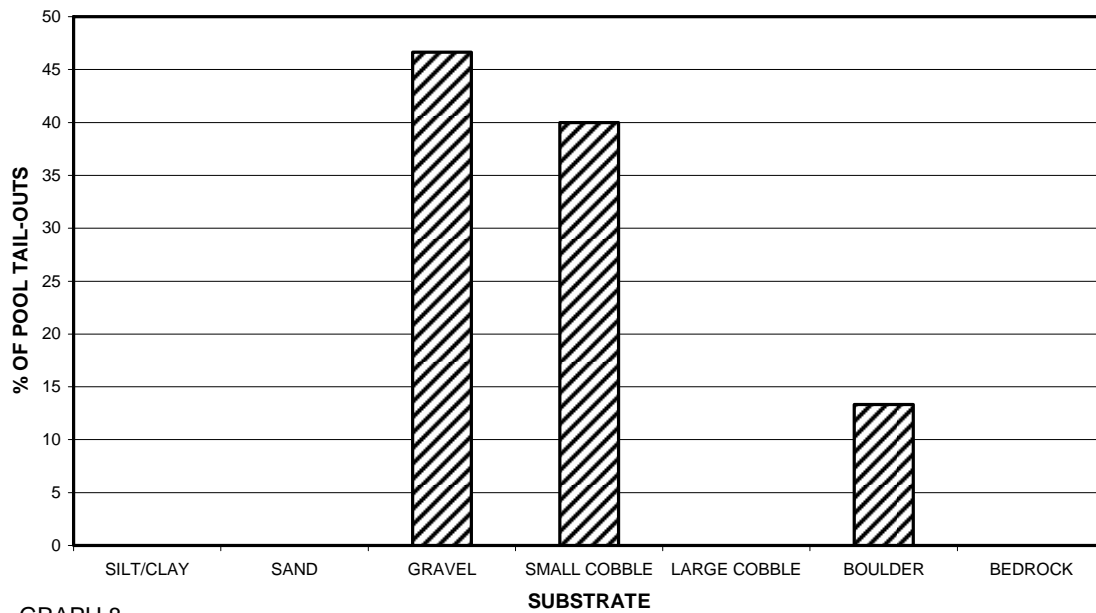
GRAPH 8

Table 6 summarizes the dominant substrate by habitat type. Graph 8 depicts the dominant substrate observed in pool tail-outs. Gravel was observed in 47% of pool tail-outs and small Cobble was observed in 40% of pool tail-outs.

Thirteen of the 15 pool tail-outs measured had gravel or small cobble as the dominant substrate. This is generally considered good for spawning salmonids.

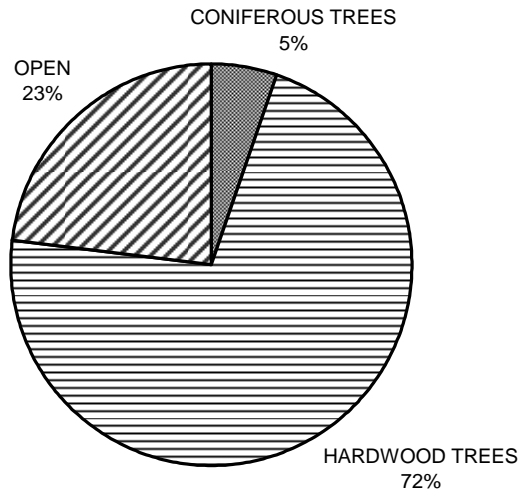
GRAPH 9

The mean percent canopy density for the surveyed length of Woodacre Creek was 77%. The mean percentages of hardwood and coniferous trees were 93% and 7%, respectively. Twenty-three percent of the canopy was open. Graph 9 describes the mean percent canopy in Woodacre Creek.

The mean percent canopy density for the stream was 77%. Reach 1 had a canopy density of 80.9% and Reach 2 had a canopy density of 66.9%. In general, revegetation projects are considered when canopy density is less than 80%.

- 6) Increase the canopy on Woodacre Creek by planting appropriate native vegetation like willow, alder, redwood, and Douglas fir along the stream where shade canopy is not at acceptable levels. The reaches above this survey section should be inventoried and treated as well, since the water flowing here is affected from upstream. In many cases, planting will need to be coordinated to follow bank stabilization or upslope erosion control projects.

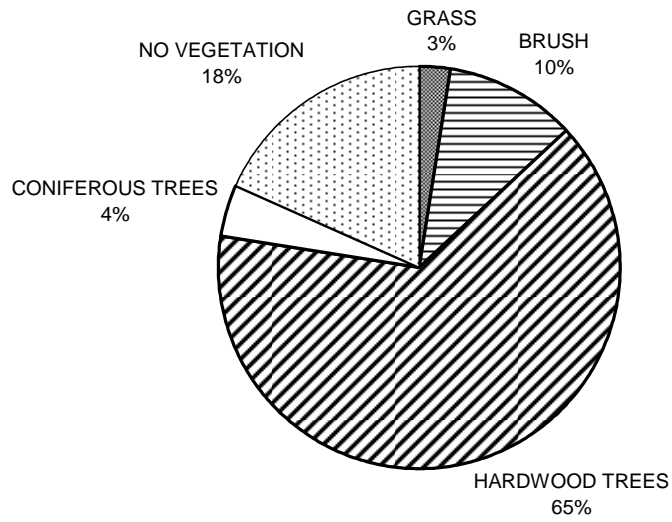
GRAPH 11

For the stream reach surveyed, the mean percent right bank vegetated was 28% and mean percent left bank vegetated was 30%. The dominant elements composing the structure of the stream banks consisted of 25% bedrock, 11% boulder, 37% cobble/gravel and 28% sand/silt/clay (Graph 10). Hardwood trees made up the dominant vegetation type and they were observed in 65% of the units surveyed. Additionally, 10% of the units surveyed had brush as the dominant vegetation type and 4% had coniferous trees as the dominant vegetation (Graph 11).

The percentage of right and left bank covered with vegetation was low at 28% and 30%, respectively. In areas of stream bank erosion or where bank vegetation is sparse, planting endemic species of coniferous and hardwood trees, in conjunction with bank stabilization, is recommended.
