Aug. 16, 1952

El Dorado Co.

Highland Lake

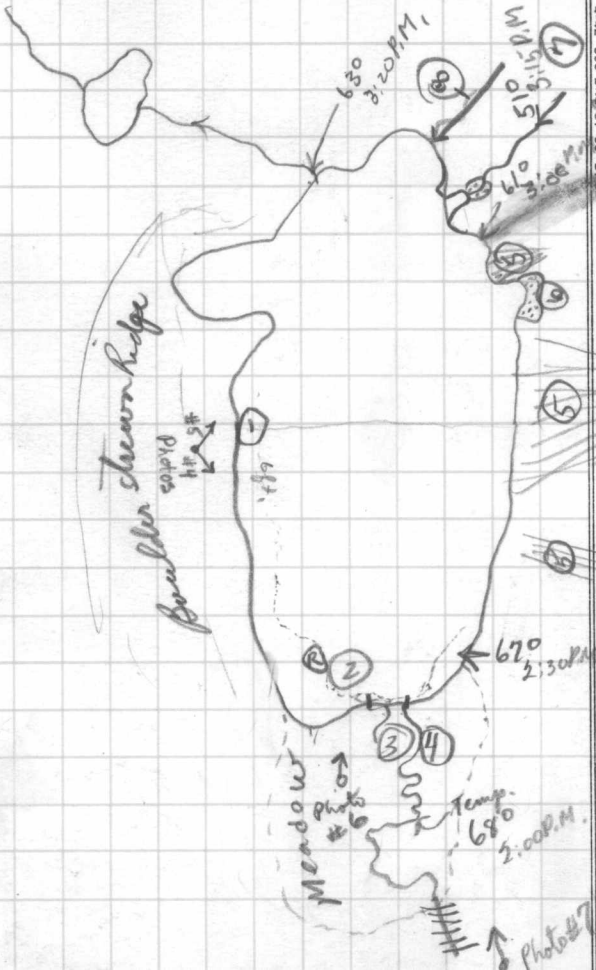
Highland Lakes

① Water crystal clear. bottom in this area slopes off steeply into 8-10 ft of water. bottom decomposed granitic sand, granite rubble and boulders. Sml. amts of silt.

② Huge boulders + smaller rocks + bedrock bottom some sand + sml. amts of silt.

③ Sandy beach - beautiful sand. - almost like plaster sand. Large numbers of medge pupae cases washed upon shore here. Also large numbers of Caddis larval all around life. Great numbers of frogs + tadpoles

④ Inlet accessible for 200 yds then comes down over steep bare granite impassable. Good Sparrow

areas. Stream is in meadow
deep cut part of way w/ sand
& rubble bottom. Flow approx.
 $\frac{1}{2}$ c.f.s. There might be some
question of this stream going
dry in low ppt. years. But
there are several large snowbanks
on the drainage high above
this lake and it does not appear
that it ~~would~~ ^{will} go dry this year.

- ⑤ Huge ^{granite} boulder talus slides
- ⑥ Very steep snowbank into
water.
- ⑦ Inlet flowing 70 ¹⁰⁰ gals/min. —
no spawning areas — precipitation
from lake shore. —

- ⑧ Inlet 30 gal/min.
no spanning impassable.
- ⑨ Outlet flowing good
i.e.f.s. has good
damsite for a dam
about 4 ft high
(might squeeze 5 ft out
of it) any higher would
require very long
& expensive dam.

Would suggest 4-5,000
EB. — 1951 — 4,000 thereafter
annually — airplane
plant.
