# City of Carlsbad Wildlife Movement Analysis Final Report

Local Assistance Grant Agreement No.  
P1282107

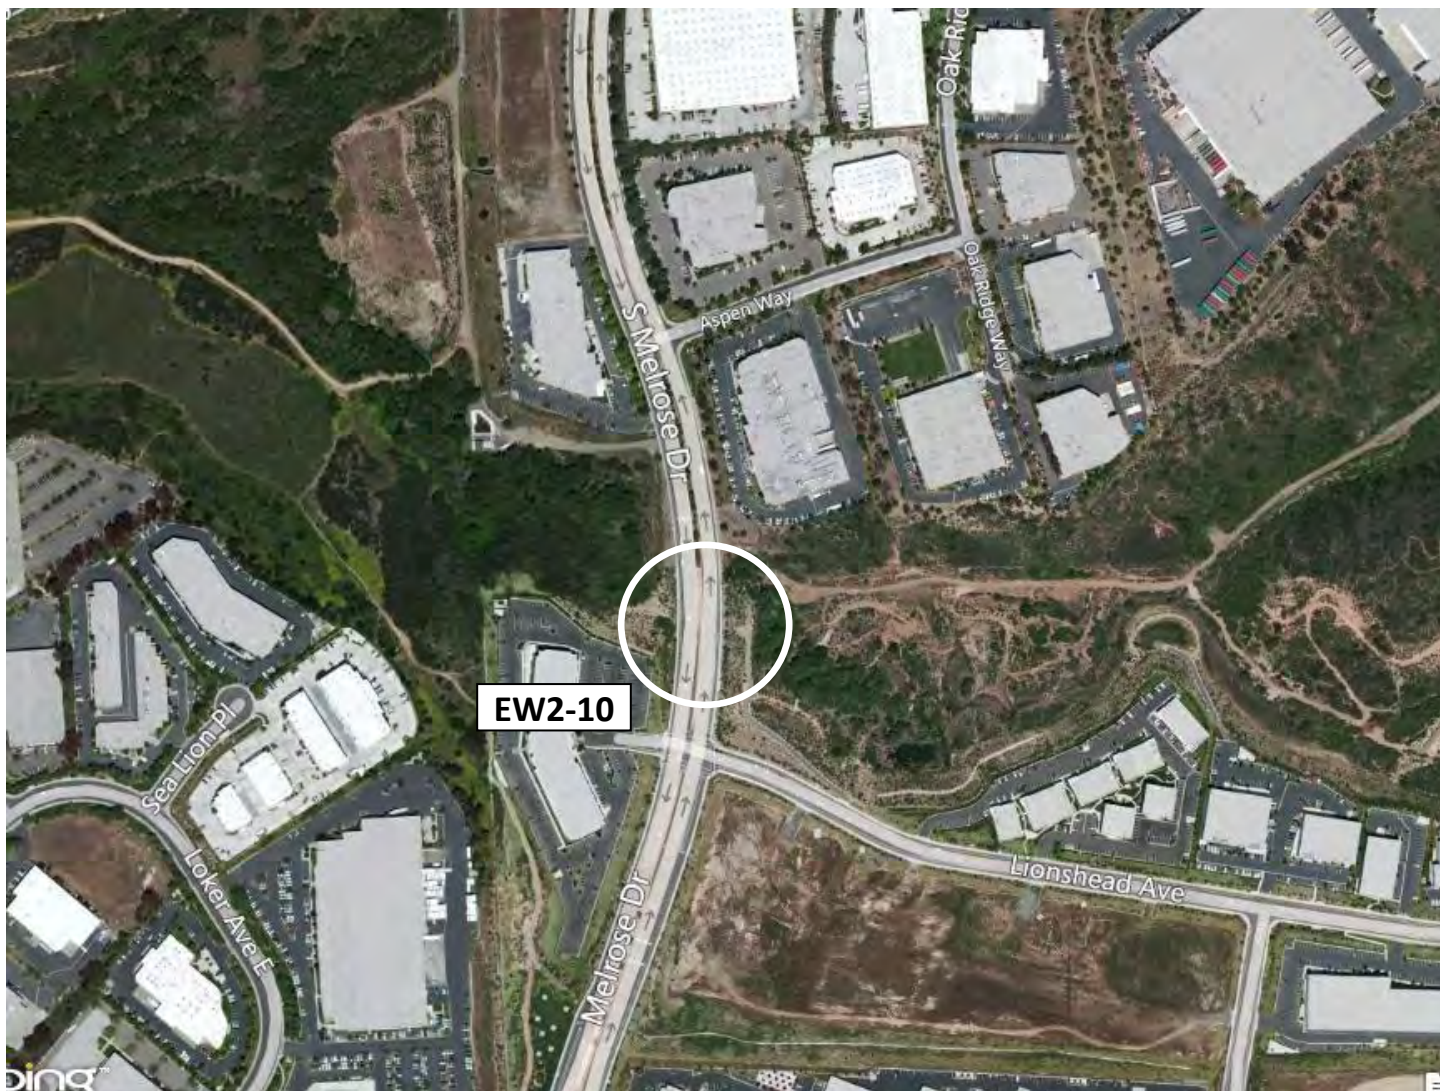
**EW2-10. High Priority.** Does not appear to be any fencing.

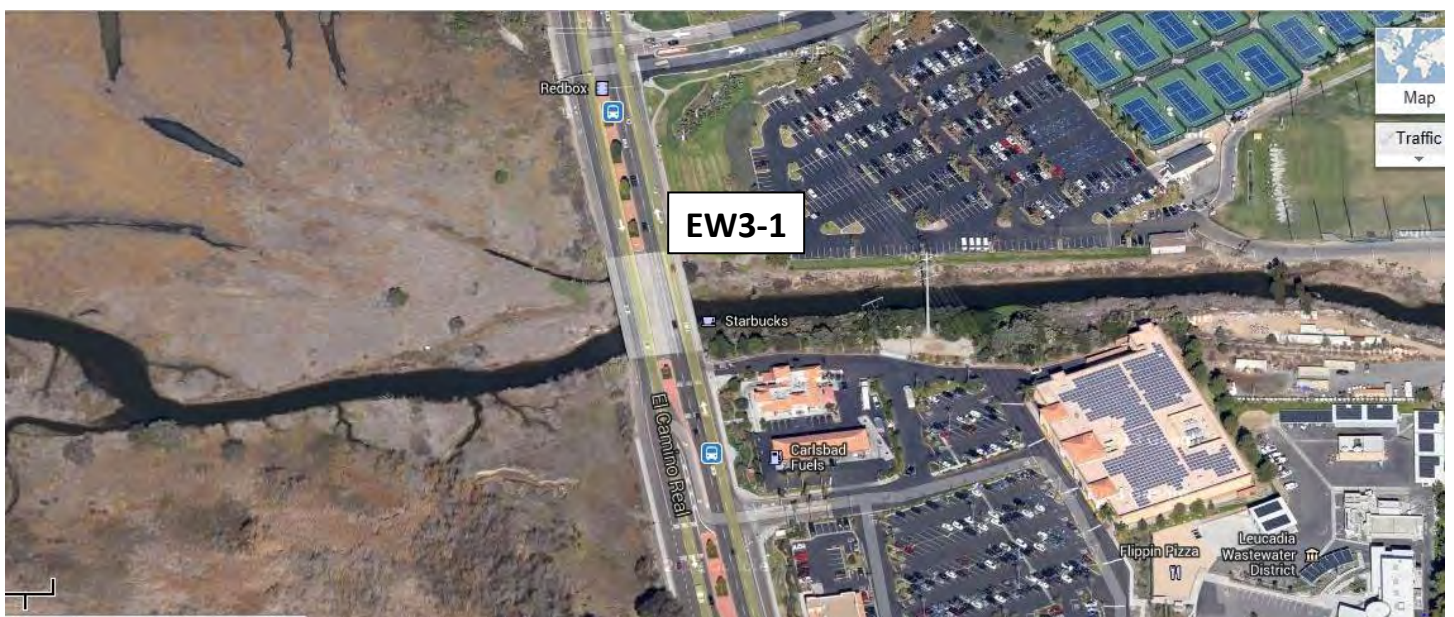
**EW3-1.** East side of El Camino Real, facing E

**EW3-1, High Priority.** Batiquitos Lagoon/San Marcos Creek and El Camino Real. MHCP-recommended monitoring location. Undercrossing may be completely inundated at times. Channelized E of ECR, but a narrow strip of upland habitat along the creek.

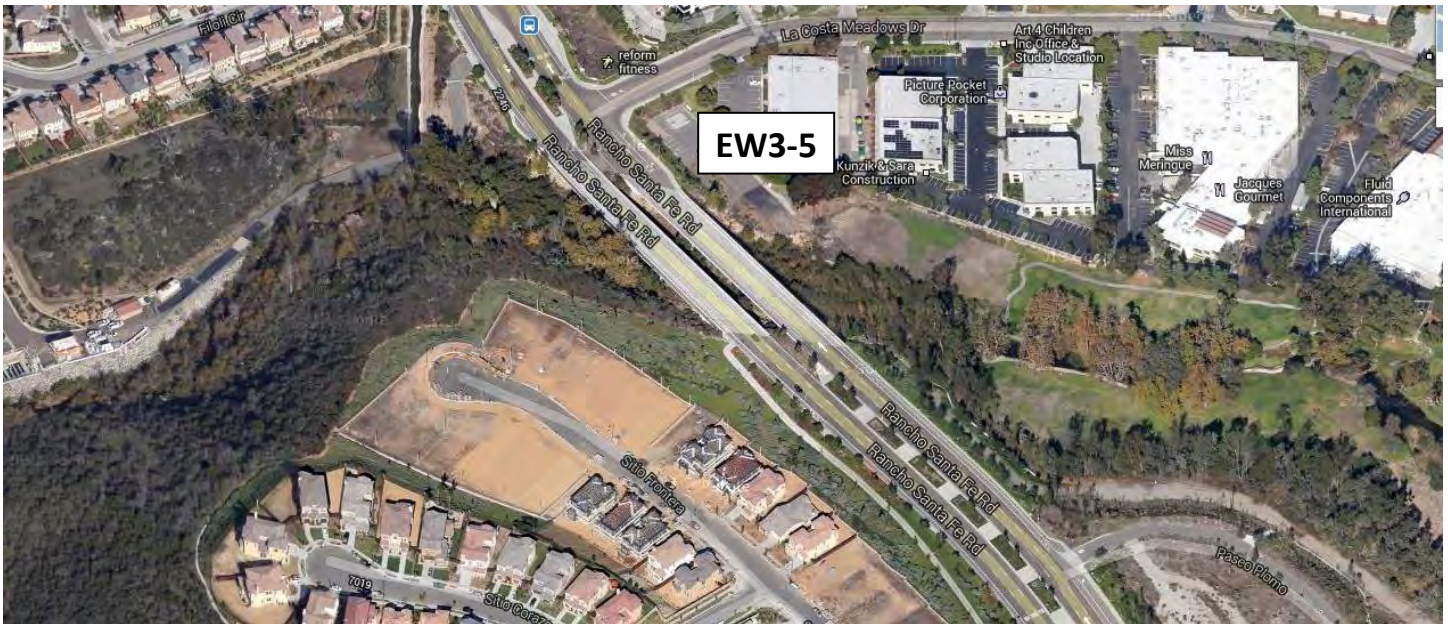
**EW3-5.** W side of Rancho Santa Fe Rd, facing WSW

**EW3-5. High Priority;** MHCP-recommended monitoring location. San Marcos Creek and Ranch Santa Fe Road.

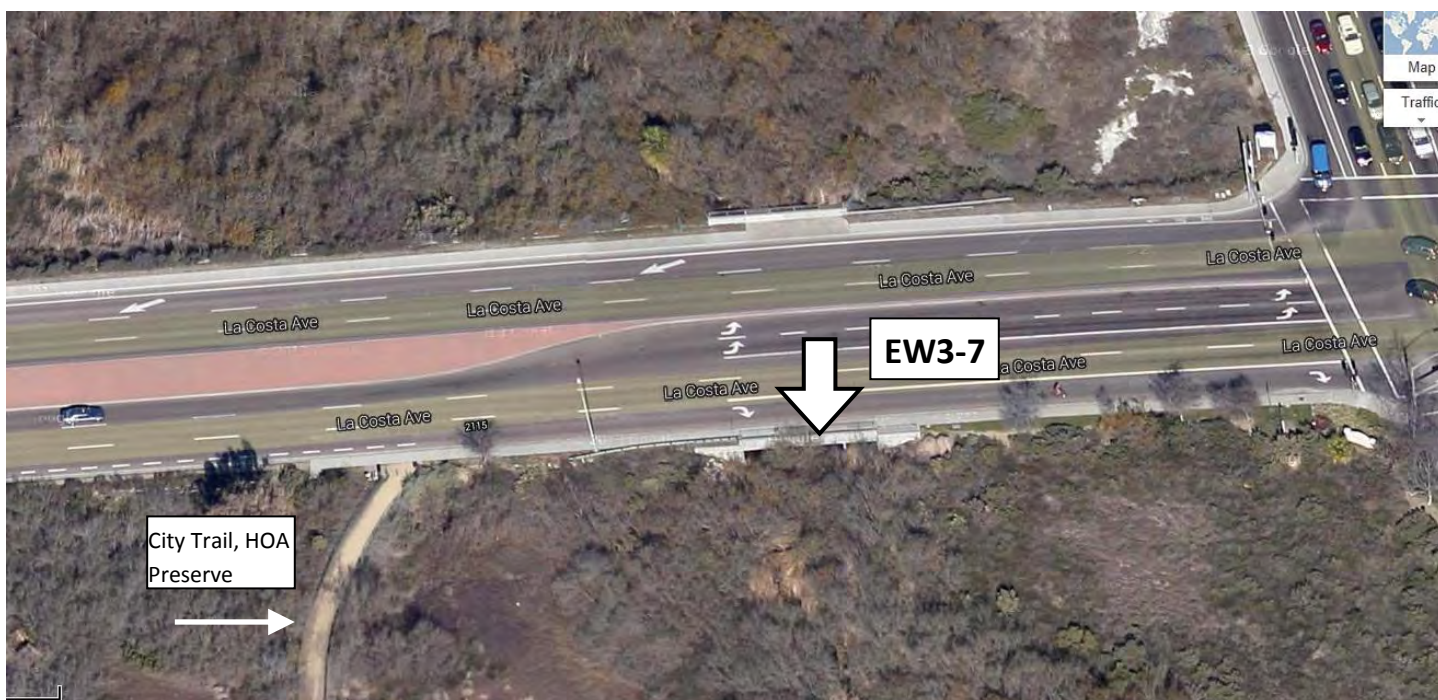
**EW3-7.** S side La  
Costa Ave. facing SW

**EW3-7. High Priority;** MHCP-recommended monitoring location. Encinitas Creek and La Costa Avenue, near intersection with El Camino Real. No obvious fencing in this area
