California Department of Fish and Wildlife
North Central Region

Summary of Fish Rescues Conducted within the Yolo and Sutter Bypasses

July 2016

Prepared for the United States Bureau of Reclamation

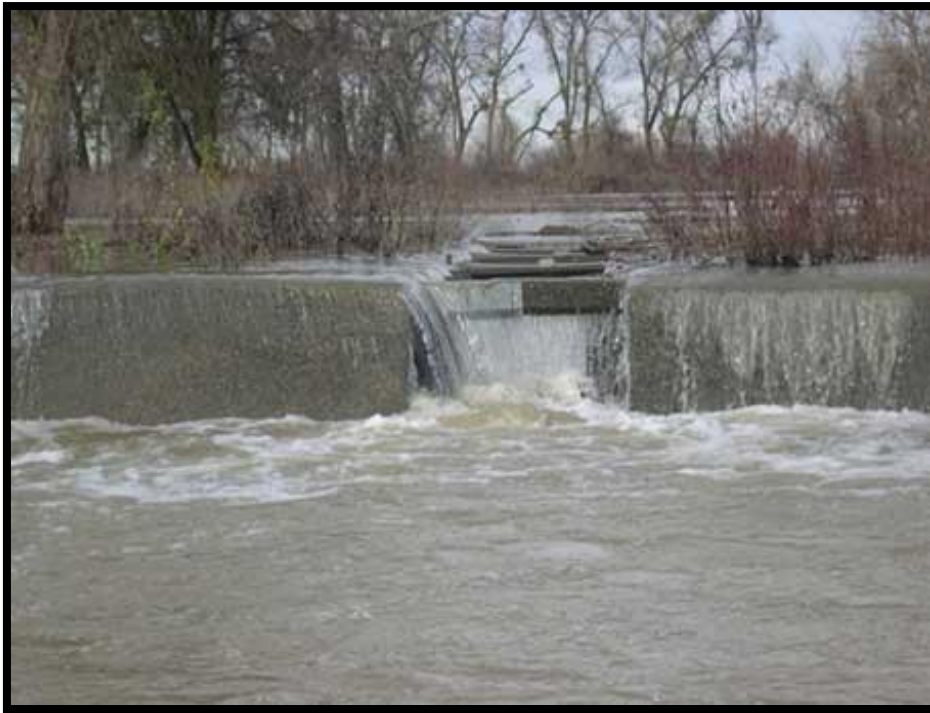
Figure 4. View of Fremont Weir Denil fish ladder during overtopping event in January 2006. Flash boards are left in place until overtopping of the weir ceases.

A Denil fish ladder (a 1.2 meter-wide notch in the eastern portion of the Fremont Weir) was constructed in 1966 to facilitate adult fish passage back into the Sacramento River following several years of Chinook salmon stranding in the Yolo Bypass. CDFW operates the fish ladder which is opened by removal of the upstream flash boards when overtopping of the Fremont Weir ceases during the descending curve of the hydrograph. The timing of the flashboard removal is mandated by the Central Valley Flood Protection Board permit number 4899 issued to CDFW on 1 April 1965 (Central Valley Flood Protection Board 2016) (**Figures 4 and 5**).

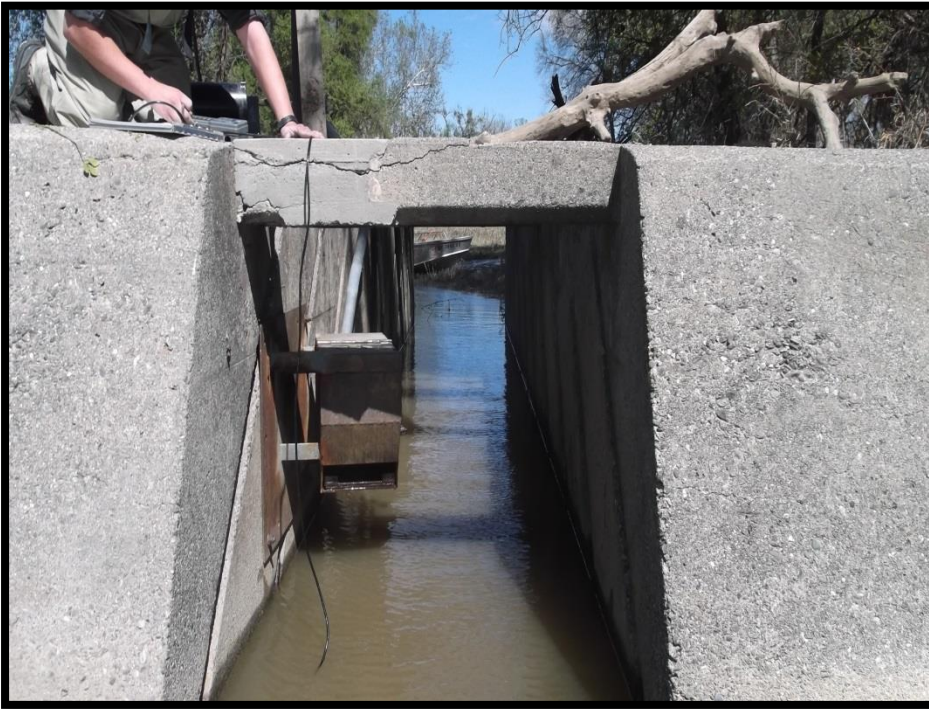
Figure 5. View of Fremont Weir Denil fish ladder after cessation of an overtopping event in March 2016. Note that flash boards have been removed to facilitate fish passage through the weir.

Based on the number of adult sturgeon stranded in the weir apron, the design, configuration, and operation of the fish ladder may have been ineffective to facilitate passage of adult sturgeon (CDFW unpublished data, USBR and DWR 2012). The Denil fish ladder infrastructure was removed to facilitate sturgeon passage in 2012. However; there has been only one overtopping event since the removal of the ladder infrastructure (late March 2016) so there is insufficient data to determine if the modification of the ladder has resulted in an increase in sturgeon passage. In addition to the weir apron, isolation and subsequent stranding also occurs in various ponds, scour pools, drainages, and swales downstream of the Fremont Weir.

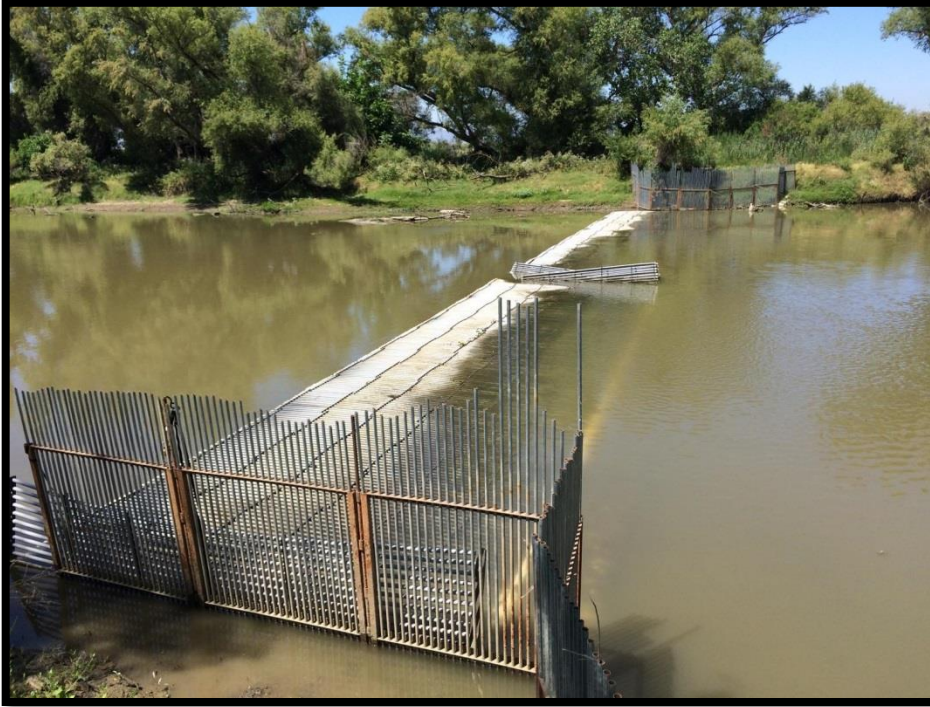
Figure 6. View of the Colusa Basin Drainage Canal Resistance Weir and Fish Trap.

The Colusa Basin Drainage Canal (CBDC) fish trapping site is located at N 38°54’10.78” and W121°54’54.71”. The CBDC fish trap consists of a resistance weir designed to funnel fish into a trap (Figure 5). The CBD fish trapping site was fished from 2 November 2013 through 5 June 2014 and

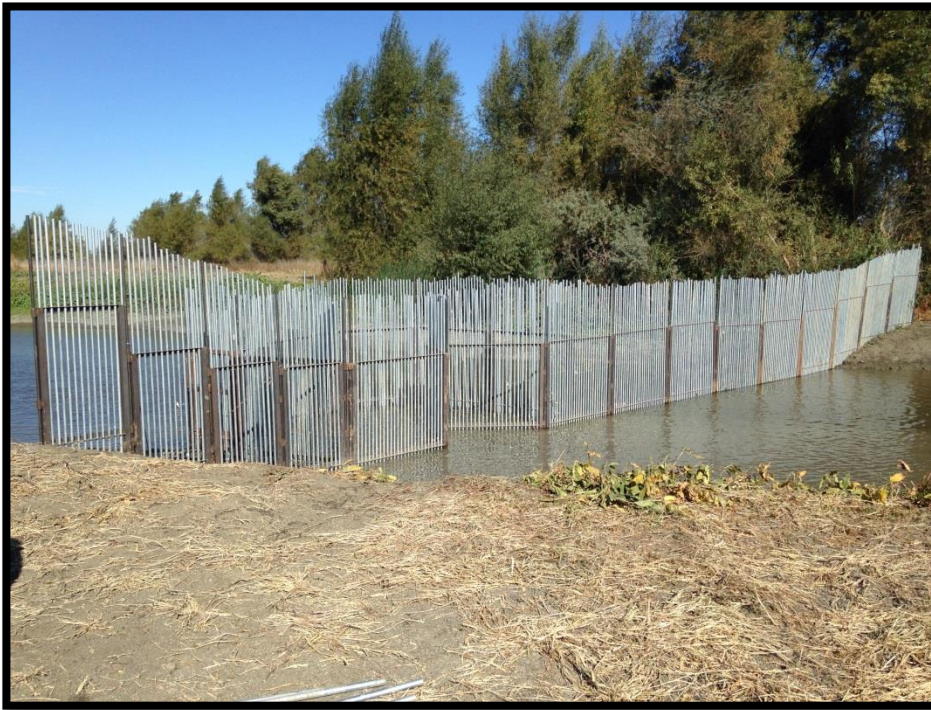
Figure 7. View of the Wallace Weir Fish Trap. Photo Taken 5 October 2015.

The Wallace Weir trapping site is located approximately 250 meters downstream of the Wallace Weir at 38°43’09.24”N and 121°39’40.24”W. Initially a fyke trap was utilized to capture fish and was fished for 156 days beginning September 9, 2014 and ending June 8, 2015. The fyke trap was replaced by a fish barrier trap (**Figure 6**) on October 19, 2015 and fished almost continuously through January 19, 2016 until high flows within the channel damaged the trap. The trap was repaired and began fishing on 23 February 2016, however; it was removed after nine days of fishing effort prior to the flooding of the Yolo Bypass in early March. Salmonids captured at the Wallace Weir site were placed in fish transport trailers and released into the Sacramento River at the Elkhorn boat launch facility. All other fish species captured were released in the channel upstream of the trap and therefore were not considered as “rescued” and are not included in Table 3. Rescue efforts at this location included capture and relocation of federal and state threatened Sacramento River winter run Chinook salmon and Central Valley spring-run Chinook salmon (**Table 3**).

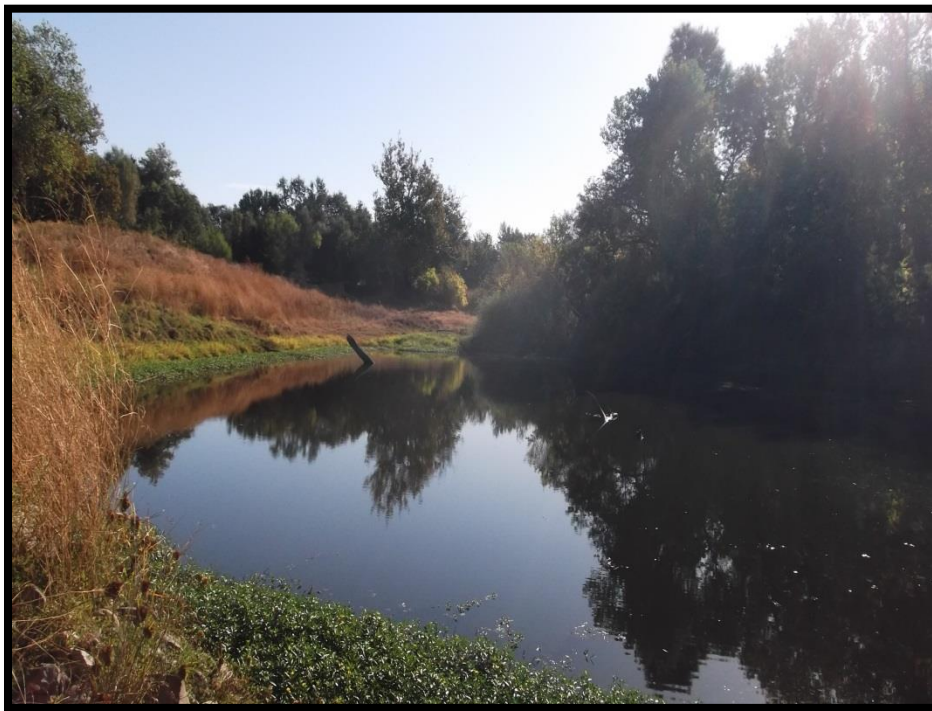
Figure 9. View of an oxbow pond south of the west section of the Fremont Weir. Bank gradient and presence of woody debris reduce the likelihood of rescuing fish isolated within this feature. Photo taken 5 October 2015.

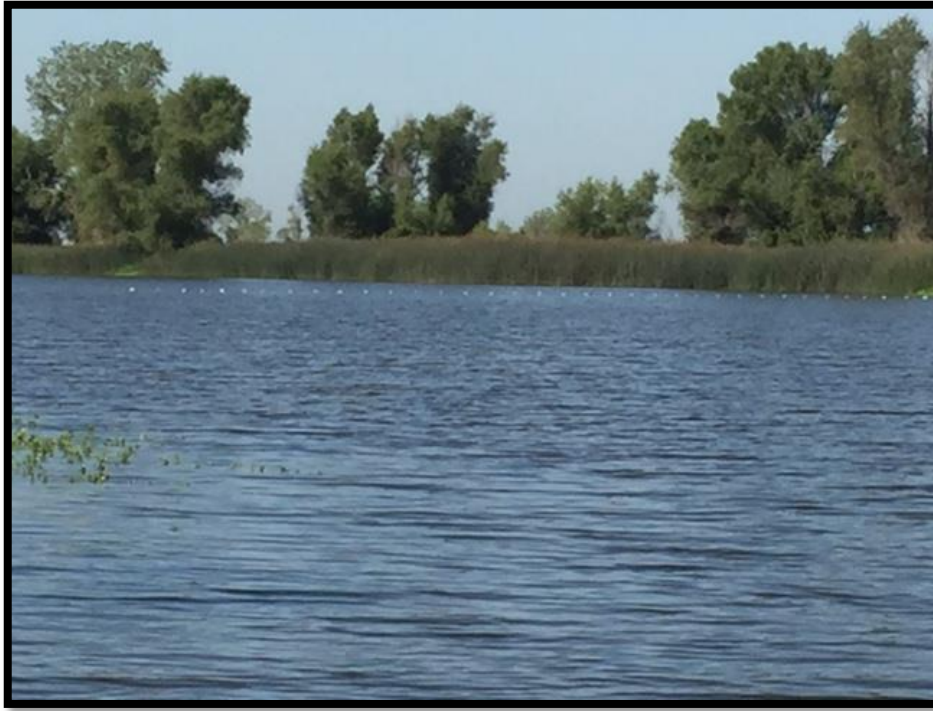
Figure 10. View of the “Tule Pond” in the Yolo Bypass southeast of the Fremont Weir. Sturgeon, Chinook salmon, steelhead, and other fish species may become isolated within the Tule Pond when hydrological connectivity to the Tule Canal is lost during receding flows.

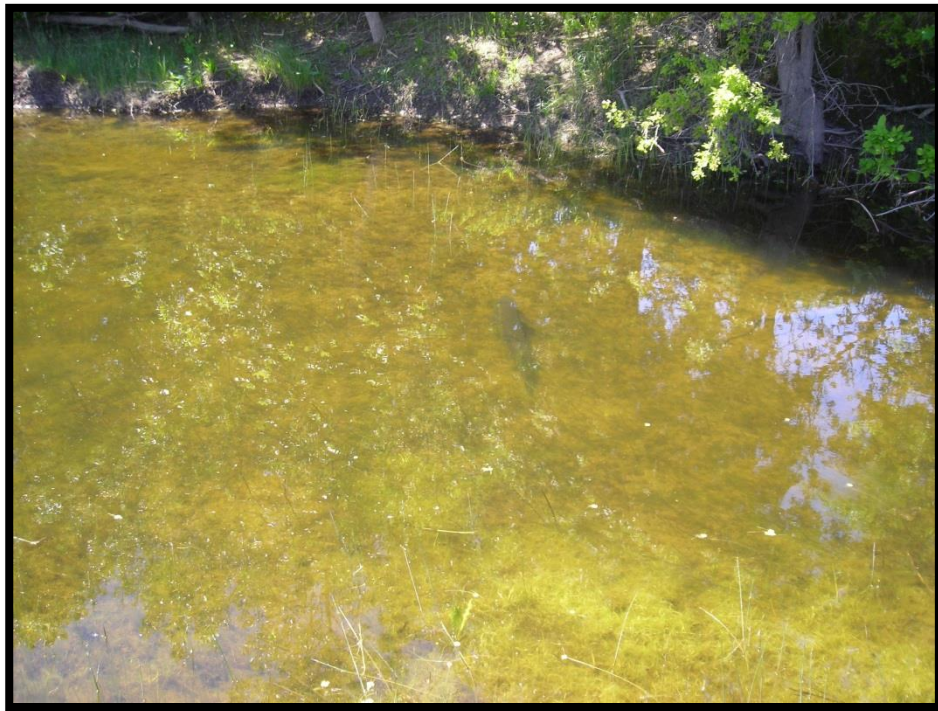
Figure 11. View isolated pool southeast of the Fremont Weir. An adult green sturgeon is visible in the upper portion of the photo.

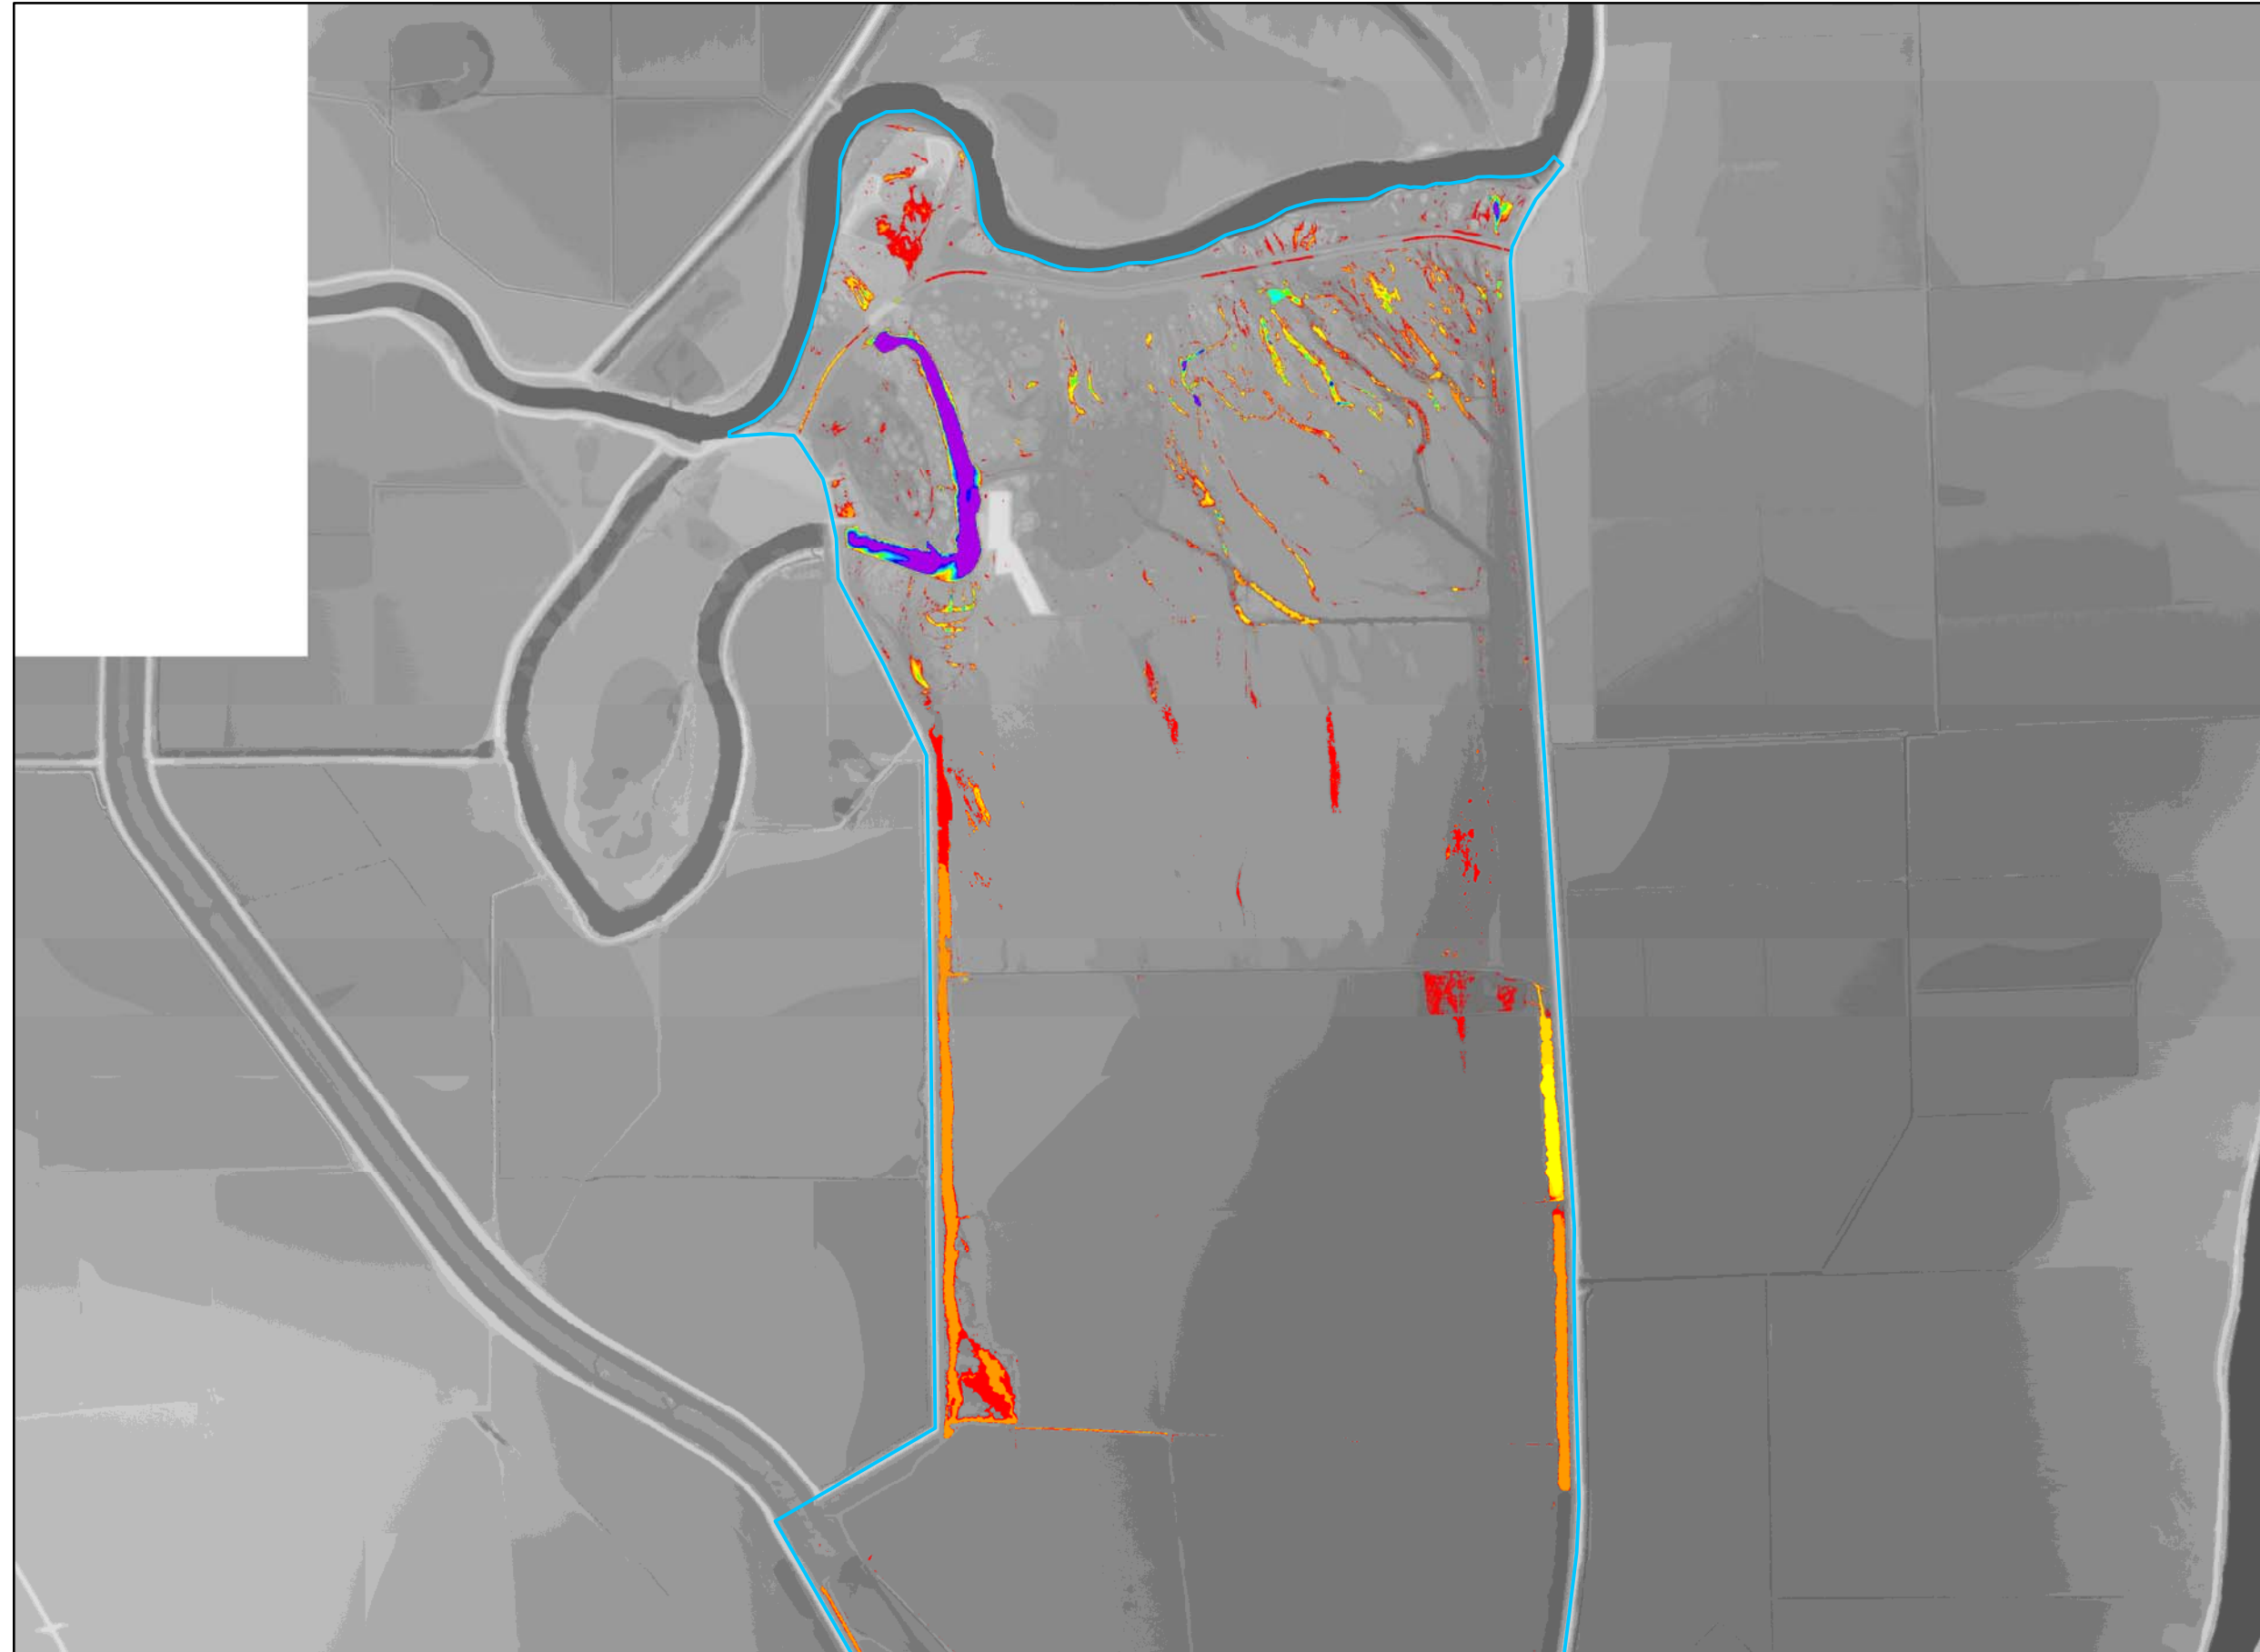
Attachment 1. Potential Isolation and Stranding Areas within the Yolo Bypass - Tile 1 of 12

Background image:
CVFED Digital Elevation Model
(from Lidar acquired March/April 2008
for Sacramento River and 2007 for
the Delta)

Potential stranding sites within the Yolo Bypass are shown in **Attachment 1, Tiles 1 through 12**. GIS analysis shows that most of the potential stranding spots are located in the northern portion of the Yolo Bypass, based on factors such as feature size, maximum depth, and proximity to perennially inundated water bodies (**Tiles 1 through 3**). While ground truthing efforts to document stranding throughout the bypasses have been minimal, it is likely that actual stranding and isolation areas vary with each overtopping event and are influenced by factors such as distance from the weir or perennial channels, timing of overtopping events, flow duration, and flow magnitude. All of the fish rescues documented within the Yolo Bypass were conducted either in the Fremont Weir apron or within the immediate vicinity of the Fremont Weir (**Attachment 1, Tile 1**). Inundation depth of features where fish rescues were conducted typically ranged from two to four feet. Features with inundation depths of greater than four feet provide challenges for successful fish rescues as they are not readily wadeable; and often contain large quantities of woody debris which limit the effective use of beach seines, dip nets, and crowder racks. **Attachment 2** shows several known and potential isolation and stranding areas within the vicinity of the Tisdale Weir overlaid on an aerial photograph.

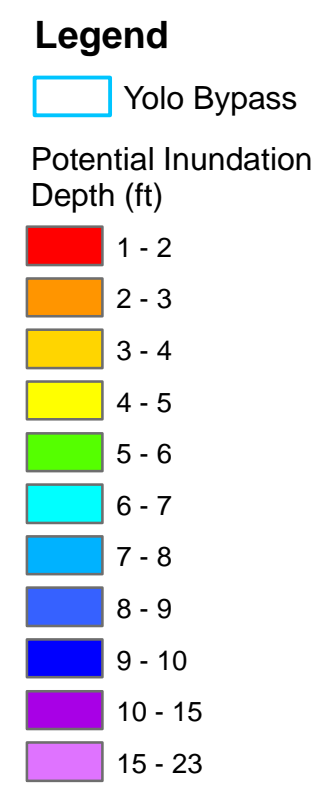
Attachment 1. Potential Isolation and Stranding Areas within the Yolo Bypass - Tile 3 of 12

Background image:
CVFED Digital Elevation Model
(from Lidar acquired March/April 2008
for Sacramento River and 2007 for
the Delta)

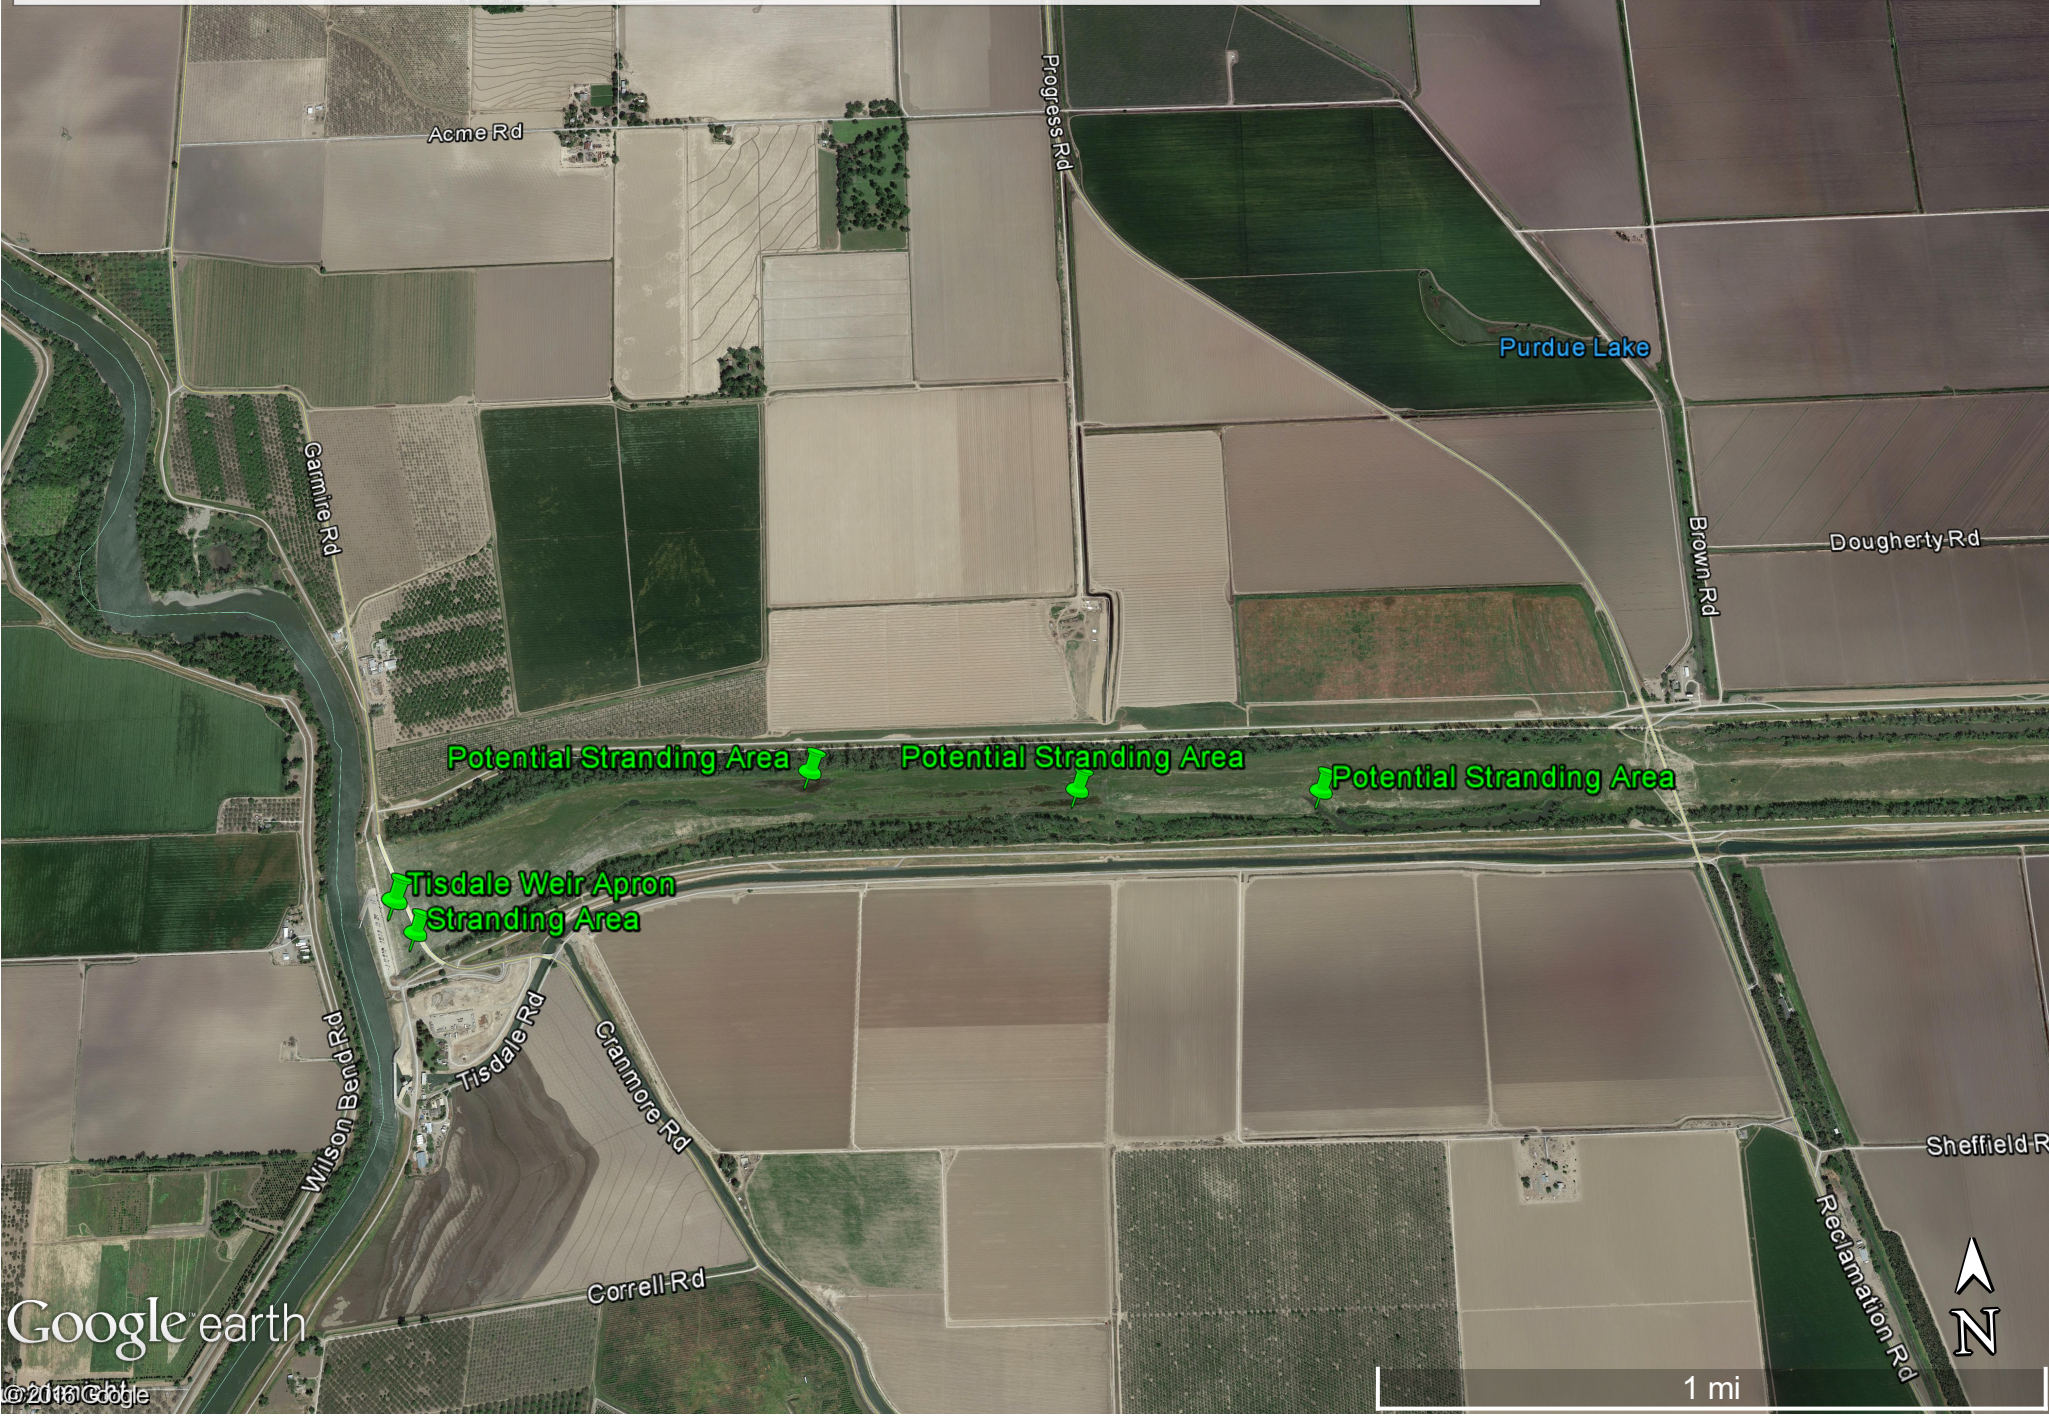
Attachment 2. Tisdale Bypass Fish Isolation and Stranding Locations

Legend
📍 Stranding Area
