California Department of Fish and Wildlife

**Colusa Basin Drain and Wallace Weir
Fish Trapping and Relocation Efforts
November 2013 – June 2014**

August 2016

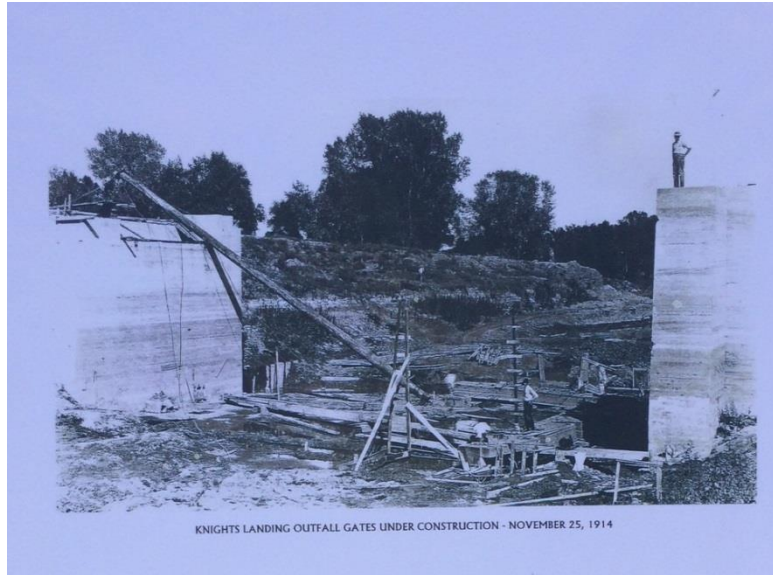
Figure 3. Knights Landing outfall gates under construction in 1914.

Originally known as Sycamore Slough Outfall Gates, KLOG was constructed around 1914 (Figure 3). The structure was modified again in 1929, 1930, and 1949. The outfall gates were updated most recently in 2012. However, these updates did not include any measures to reduce the likelihood of fish entrainment.

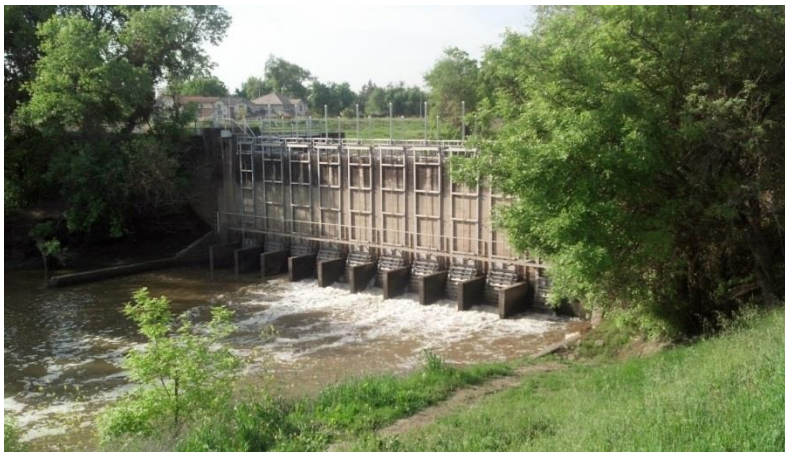
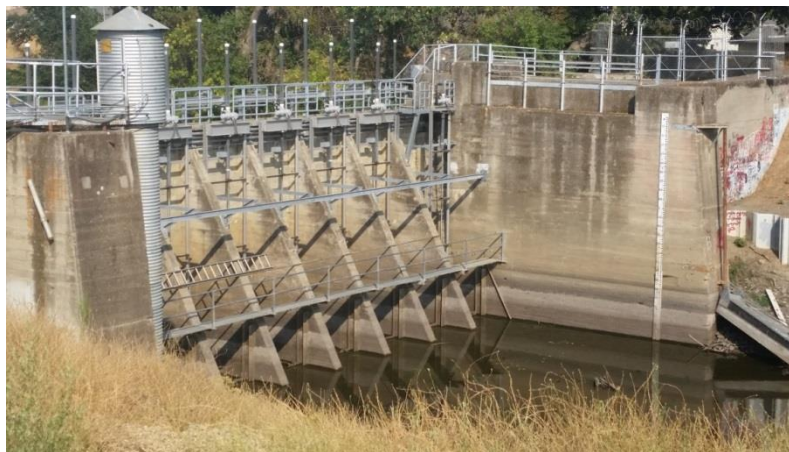
Figure 4. Knights Landing outfall gates on April 8, 2014. Downstream (top) and upstream (bottom).

The KLOG structure is operated by the DWR and consists of a concrete barrier wall at the terminus of CBD canal with 10 automated round gated openings. These gates allow water to drain from the CBD to the Sacramento River during river flows up to approximately 27 feet and also prevent water from the Sacramento River from entering the CBD during periods of river flow with stage height greater than 27 feet. During high flows in the Sacramento River (with gates closed), all CBD water is shunted through the KLRC into the Yolo Bypass (Navigant

Consulting, 2004). Eight of the KLOG gate openings are 5.5 feet in diameter and two are 3.5 feet in diameter. All have a centerline elevation of 21 feet and are equipped with automated slide gates on the upstream (canal) side and a flap gate on the downstream (river) side. Automated slide gates allow water level in the canal to be regulated at an elevation above river level and flap gates prevent Sacramento River water from passing into CBD when the river is higher than the water level in the canal. The gate structure has a concrete slab at 17' elevation extending downstream of the gate openings for approximately 40 feet to prevent bed erosion from water discharging through the gates (Heise, 2014). Operations at KLOG also allow for regulation of CBD water elevations for irrigation use in the agricultural lands around the CBD and ridge cut. Stage height is kept at a relatively constant level, approximately 25 feet above the U.S. Army Corps of Engineers geodetic datum upstream in CBD (Yolo Bypass Working Group 2001) (Figure 4).

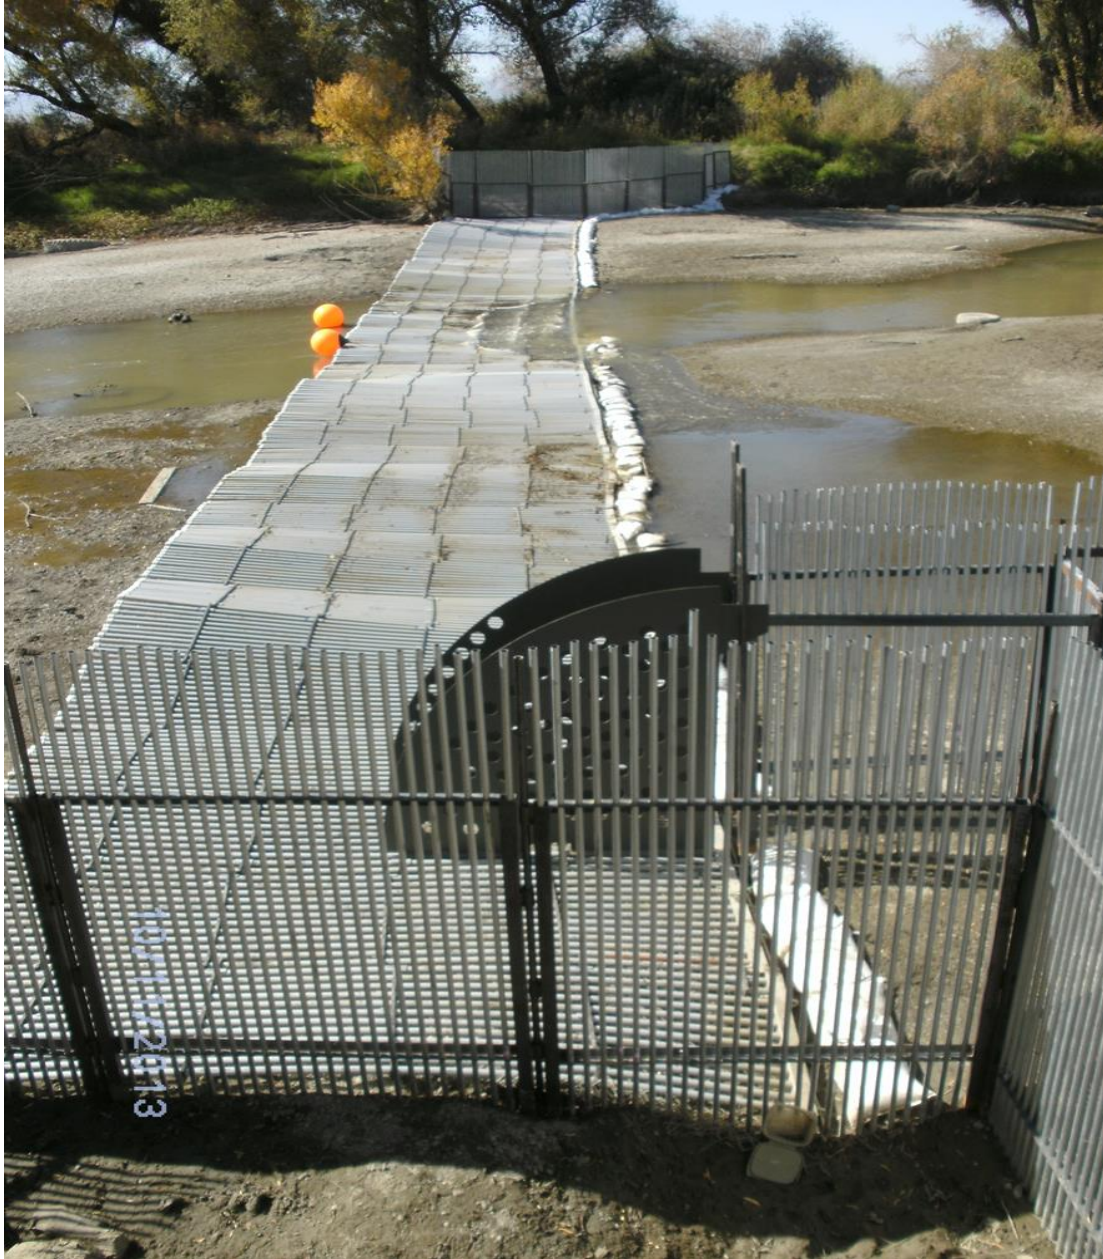
Figure 6. Photo of the Colusa Basin Drain weir and trap entrance.

On 2 November 2013, DFW installed a 125-ft wide resistance board-style weir and associated fish trap in CBD (38°54'10.78"N, 121°54'54.71"W) approximately 14 miles upstream from Knights Landing (Figure 5; Figure 6). This trapping site was operated through 22 May 2014. The site was selected based on security, access, stable bank characteristics, and channel uniformity. Design, construction, and installation of the weir were based on methods developed by the Alaska Department of Fish and Game and the United States Fish and Wildlife Service (Stewart 2002, Stewart 2003, and Tobin 1994). The weir had three major components: panels, an anchored substrate platform, and a fixed picket section (Figure 7).

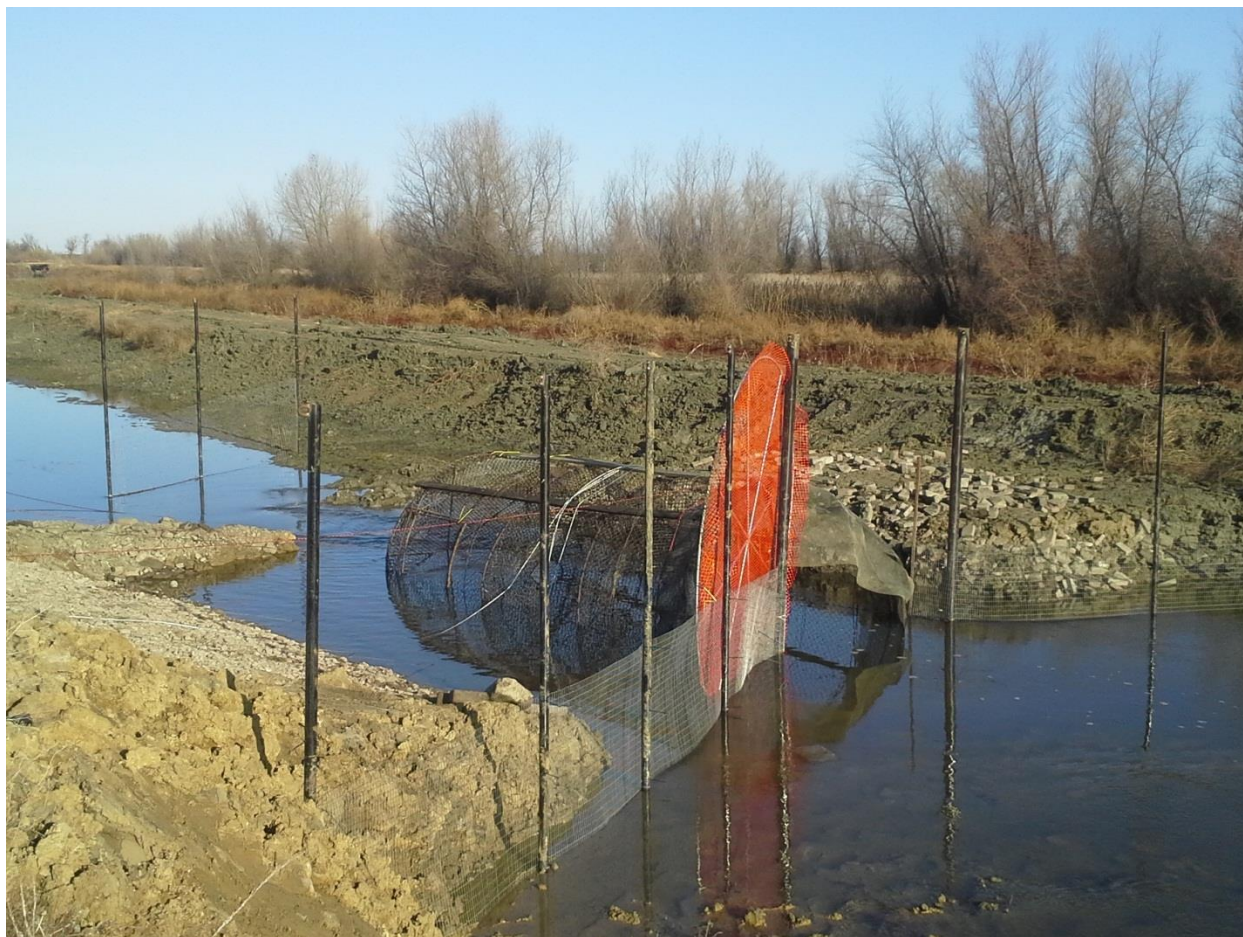
Figure 8. Photo of the Wallace Weir fyke trap.

A 10' x 20' fyke trap was installed a few hundred yards downstream from Wallace Weir on 22 January 2014 in the KLRC (38°43'4.353"N, 121°39'35.4672"W) (Figure 5; Figure 8). The fyke trap was constructed of 2" x 4" wood cross beams, circular piping, and 2" diameter plastic and wire mesh. The trap was open at one end and contained two funnels which act as behavioral one-way shoots within the trap. Once past the funnels, fish were held in enclosed spaces between the funnels inside the trap. The trap was constructed with three openings covered with strap-on doors which allowed staff to access the holding area to gather catch. The trap was fished with the back, or open end, facing downstream (Figure 8). To increase capture efficiency, the trap was positioned in the KLRC between two wing wall structures that were 33' x 9' and constructed from $\frac{1}{4}$ " gauge galvanized steel hog wire paneling with 2" x 4" openings on the downstream end of the trap to prevent fish from bypassing the trap (Figure 9).
