**Field Note:** Juvenile Coho Salmon detections in an Unnamed Tributary to the Smith River, Smith River, California.

**Objectives:** Establish baseline juvenile salmonid distribution throughout the stream section occurring below Fred Haight Drive and identify any possible migration barriers.

**Survey Date:** February 27, 2013

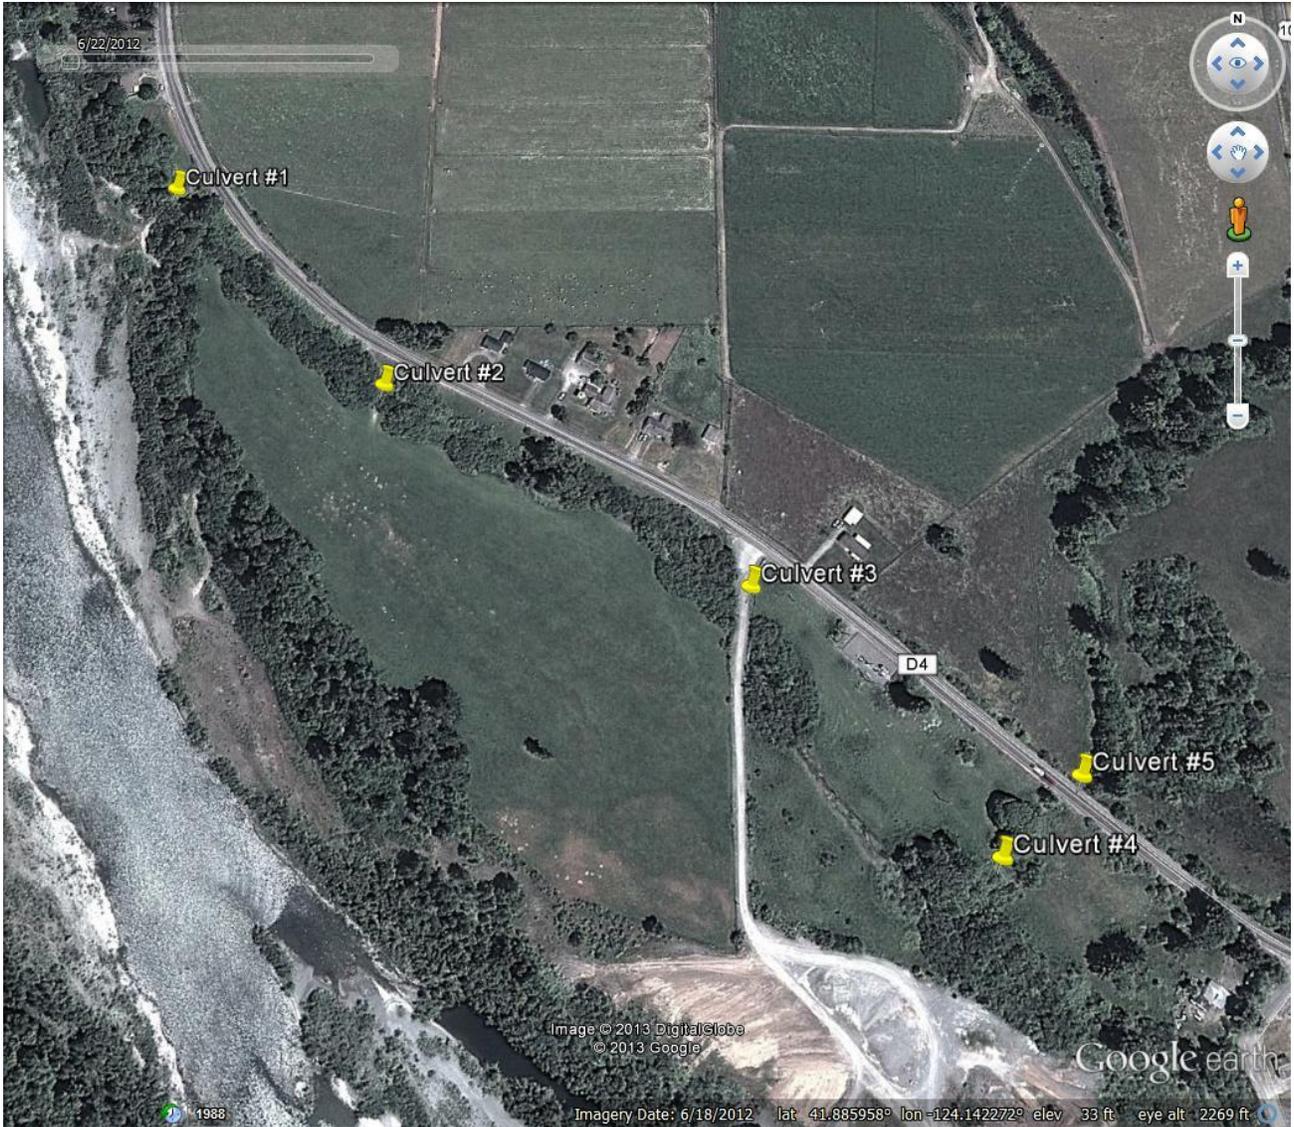
A total of five road crossings with culverts were located throughout the survey reach (Figure 2). All crossings were identified as temporal juvenile salmonid barriers due to culverts being undersized, perched, improperly aligned with the stream channel, plugging with debris, and/or failing (culvert invert rusting out). The largest culvert crossing (Culvert #3 in Figure 2) occur at a residential driveway and contains four perched pipes (Figure 3). Three other culvert crossings serve as livestock crossings, and the furthest crossing upstream is a county road facility on Fred Haight Drive.

Figure 2. Approximate culvert locations on Unnamed Tributary to the Smith River.

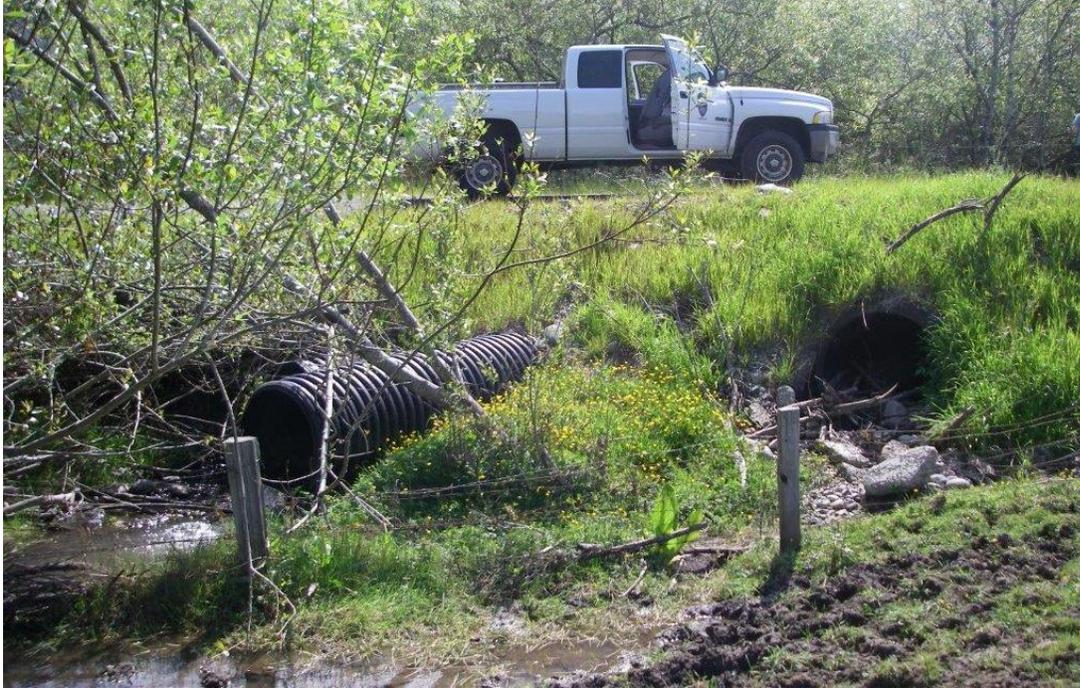
**Figure 3.** Driveway stream crossing (Culvert #3) containing four separate culverts on the Unnamed Tributary to the Smith River. All three culverts are temporal upstream barriers to juvenile salmonids.

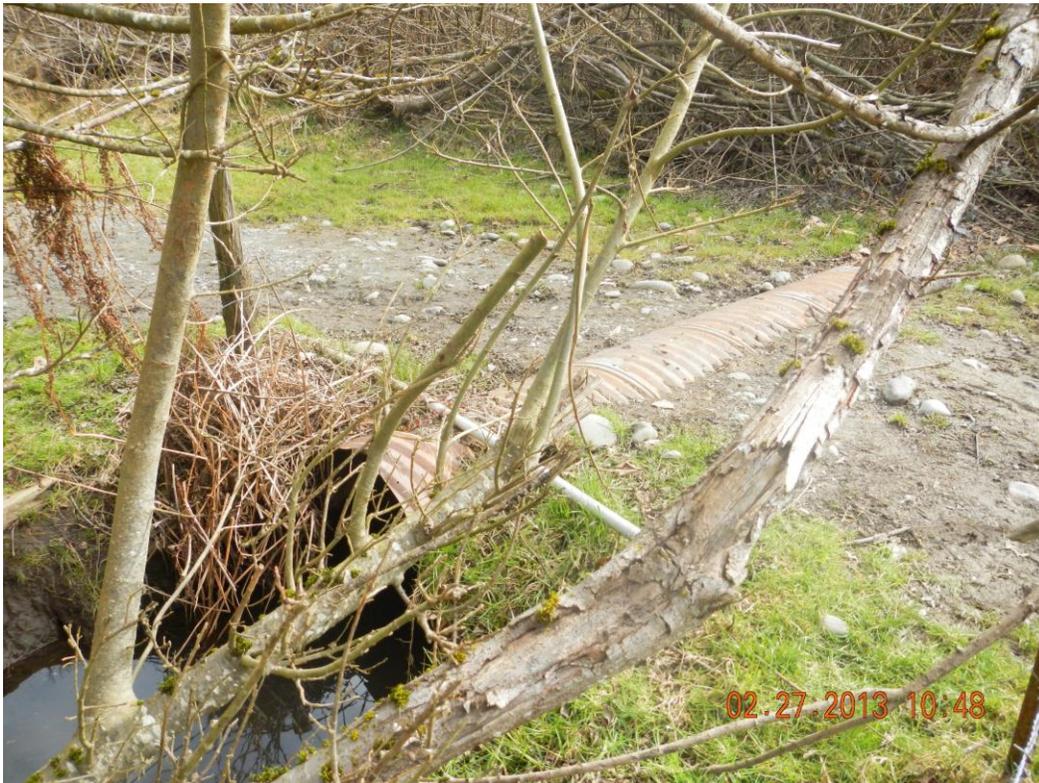
**Figure 4.** Livestock culvert crossing (Culvert #2). The culvert is undersized and the inlet was plugged with woody debris at the time of the survey.
