CALIFORNIA DEPARTMENT OF FISH AND WILDLIFE

STREAM INVENTORY REPORT

Atwell Creek

A stream inventory was conducted from June 6 to June 19, 2017. The survey began at the confluence with Howe Creek and extended upstream 1.9 miles.

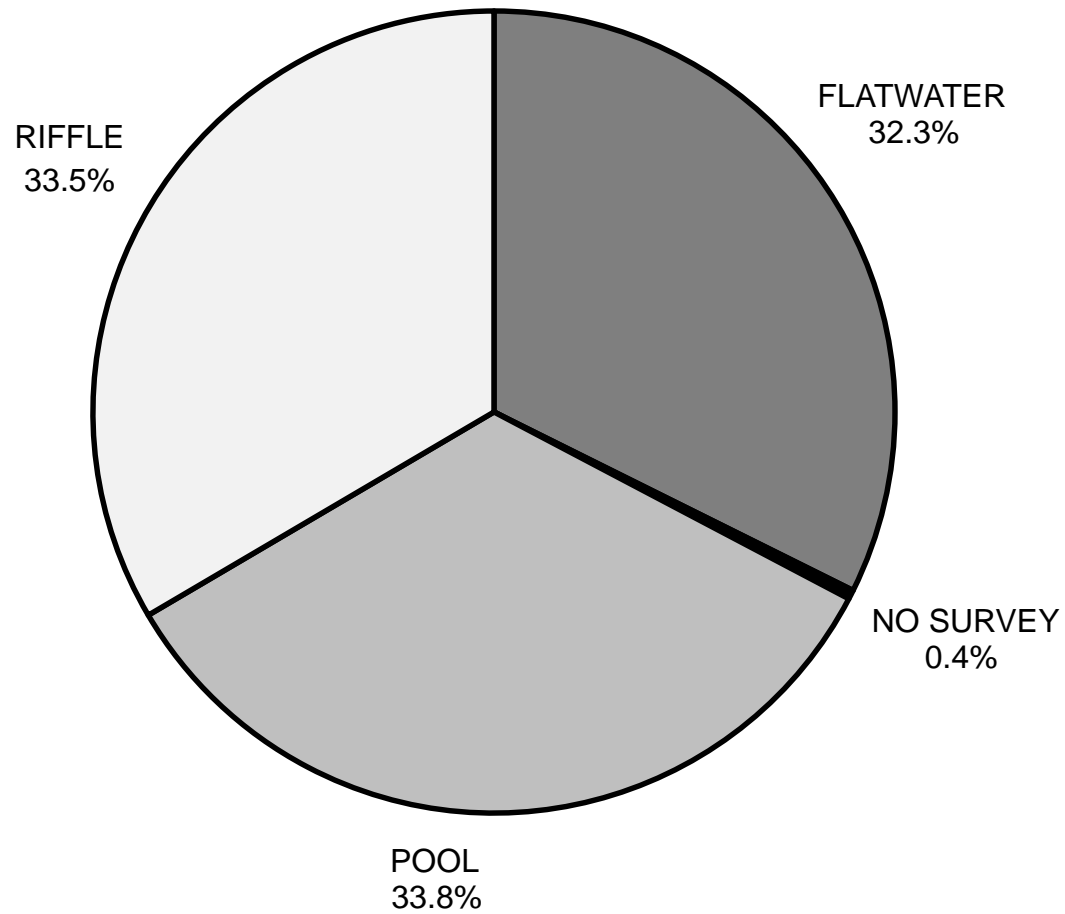
GRAPH 1

Table 1 summarizes the Level II riffle, flatwater, and pool habitat types. Based on frequency of occurrence there were 34% pool units, 33% riffle units, and 32% flatwater units (Graph 1). Based on total length of Level II habitat types there were 38% flatwater units, 32% riffle units, 29% pool units, and 1% no-survey units (Graph 2).

ATWELL CREEK 2017 HABITAT TYPES BY PERCENT OCCURRENCE

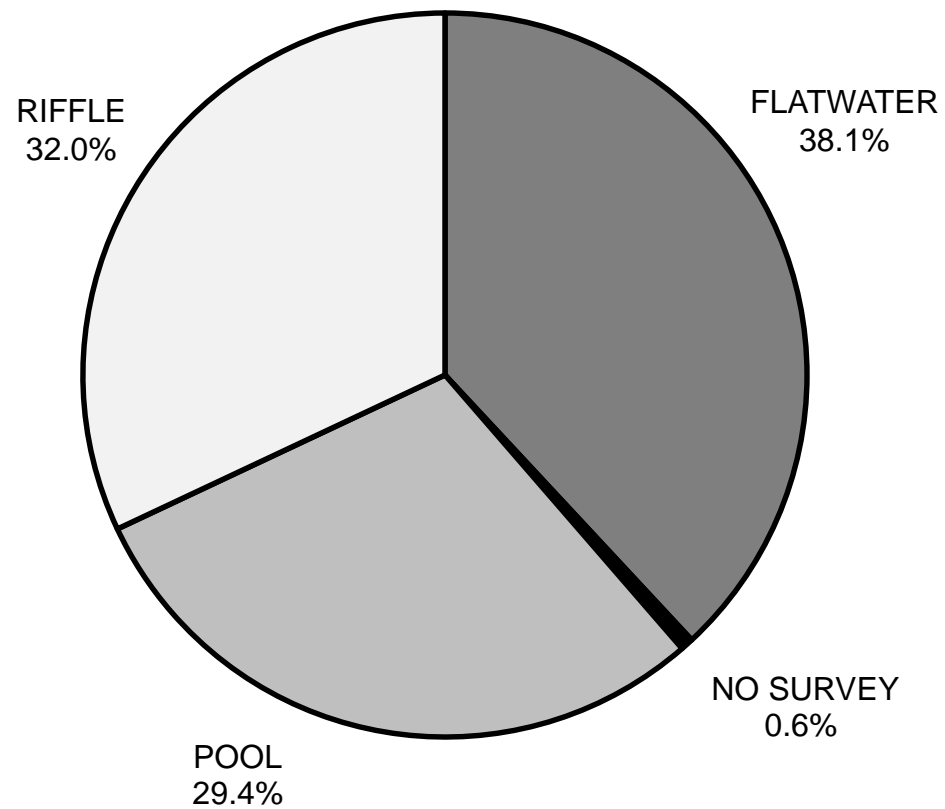
ATWELL CREEK 2017
HABITAT TYPES BY PERCENT TOTAL LENGTH

Flatwater habitat types comprised 38% of the total length of this survey, riffles 32%, and pools 29%. Thirty-two of the 85 (38%) pools had a maximum residual depth greater than 2 feet. In general, pool enhancement projects are considered when primary pools comprise less than 40% of the length of total stream habitat. In first and second order streams, a primary pool is defined to have a maximum residual depth of at least two feet, occupy at least half the width of the low flow channel, and be as long as the low flow channel width. Installing structures that will increase or deepen pool habitat is recommended.

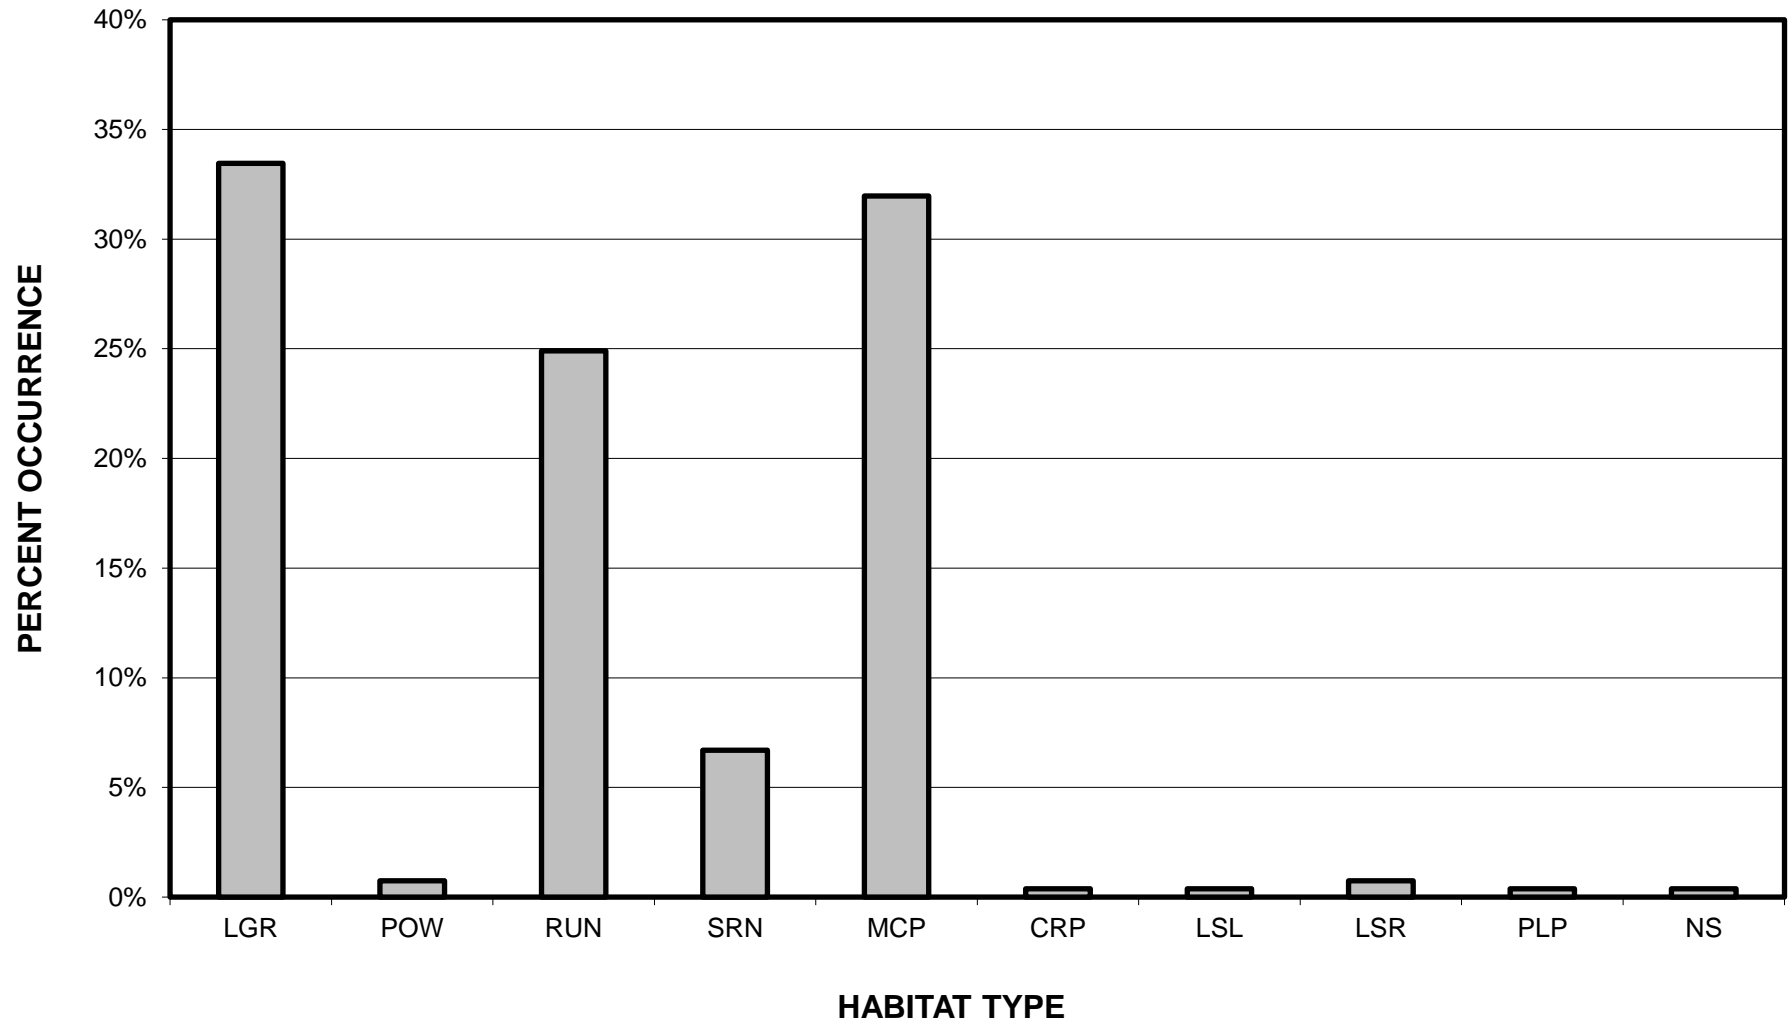
GRAPH 3

Nine Level IV habitat types were identified (Table 2). The most frequent habitat types by percent occurrence were 33% low gradient riffle units, 32% mid-channel pool units, and 25% run units. Based on percent total length low gradient riffle units made up 32%, mid-channel pool units 27%, and run units 26%.

HABITAT TYPES BY PERCENT OCCURRENCE

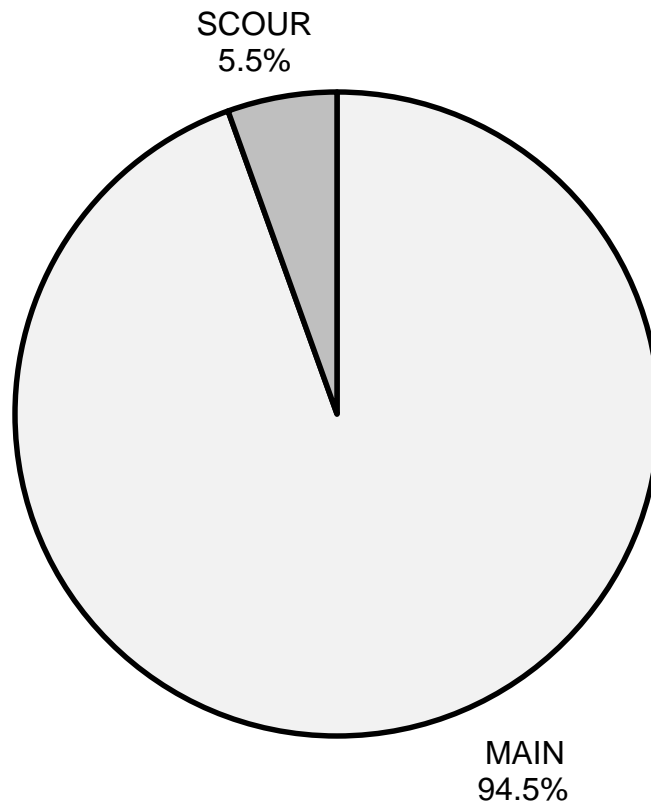
A total of 91 pools were identified (Table 3). Main channel pools were the most frequently encountered at 95% (Graph 4), and comprised 93% of the total length of all pools (Table 3).

**ATWELL CREEK 2017
POOL TYPES BY PERCENT OCCURRENCE**

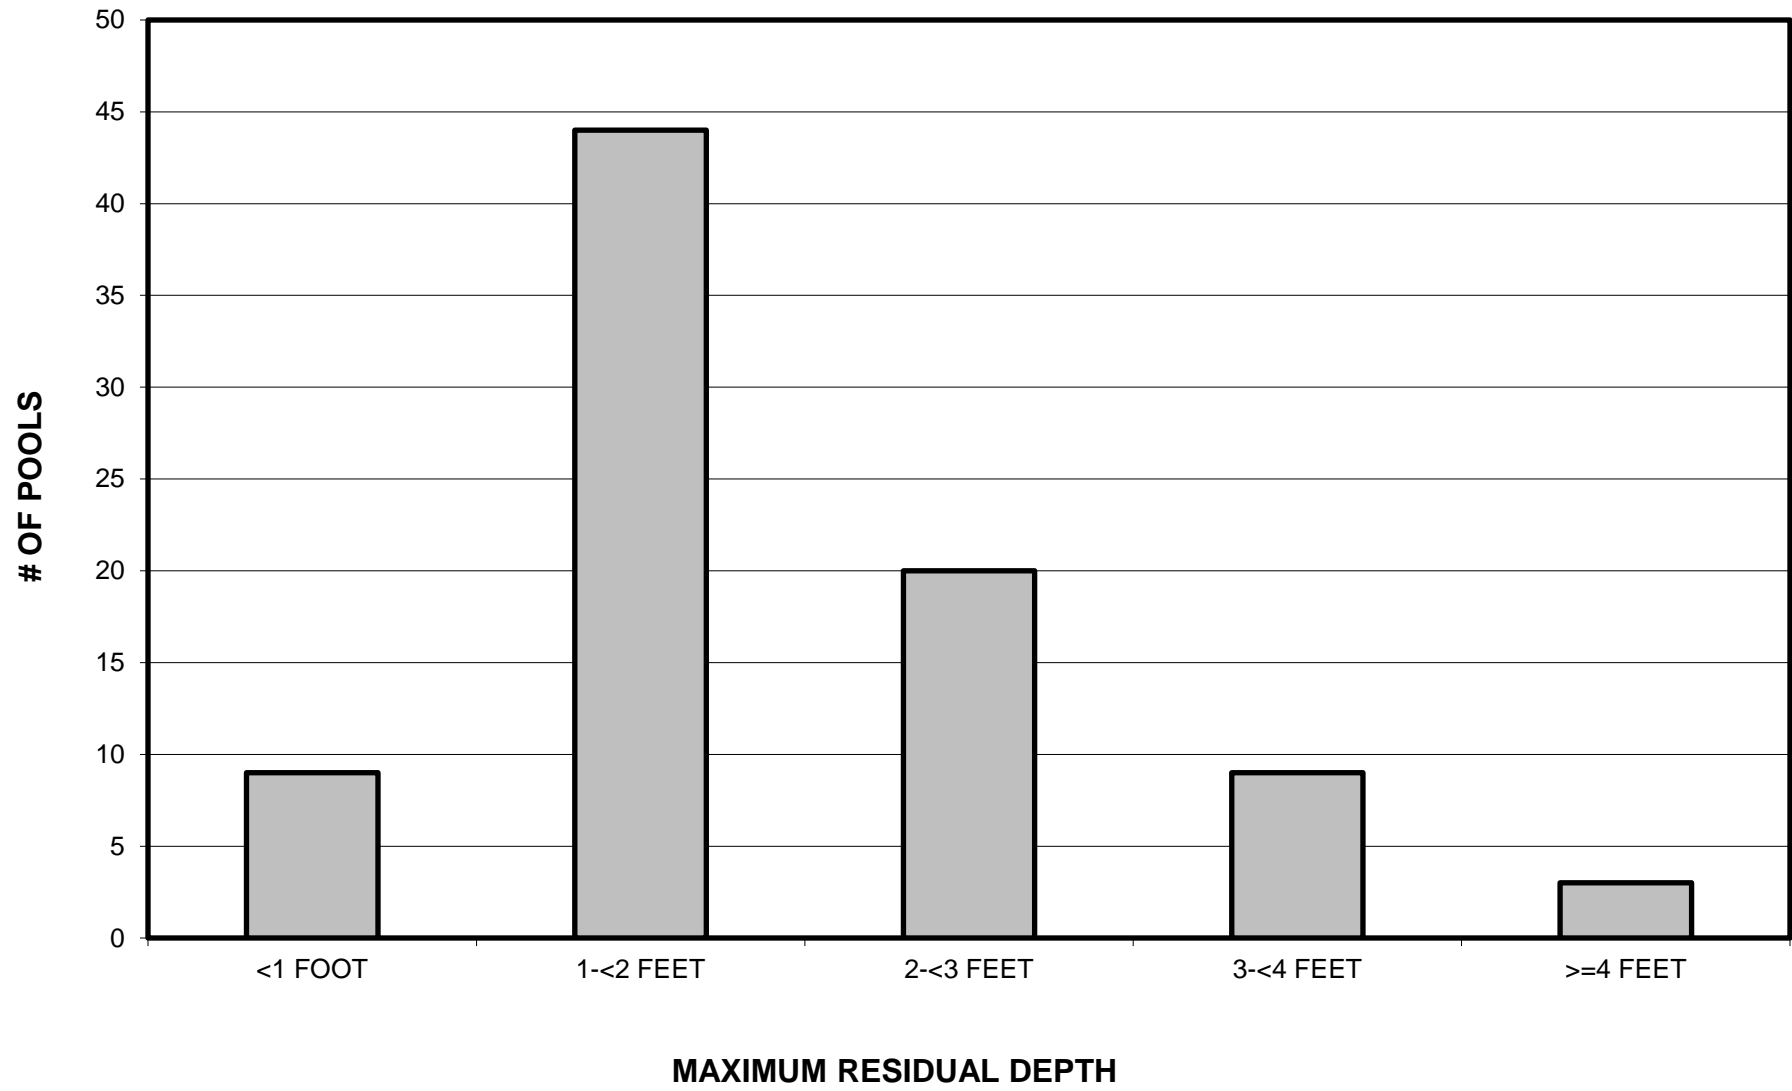
Table 4 is a summary of maximum residual pool depths by pool habitat types. Pool quality for salmonids increases with depth. Thirty-two of the 85 pools (38%) had a residual depth of two feet or greater (Graph 5).

ATWELL CREEK 2017 MAXIMUM DEPTH IN POOLS

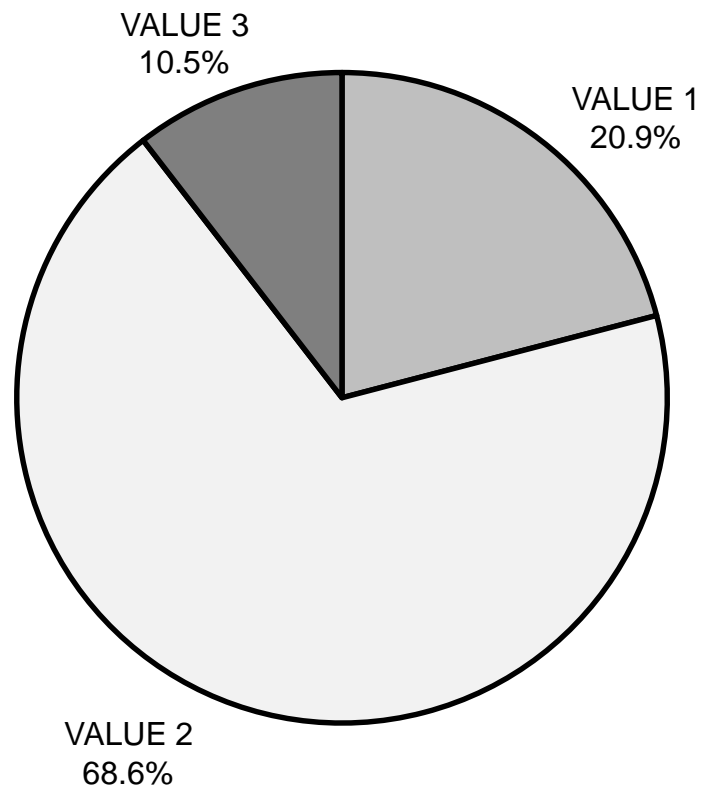
The depth of cobble embeddedness was estimated at pool tail-outs. Of the 86 pool tail-outs measured, 18 had a value of 1 (20.9%), 59 had a value of 2 (68.6%), and 9 had a value of 3

(10.5%) (Graph 6). On this scale, a value of 1 indicates the highest quality of spawning substrate.

ATWELL CREEK 2017 PERCENT EMBEDDEDNESS

Seventy-seven of the 86 pool tail-outs measured had embeddedness ratings of 1 or 2. Nine of the pool tail-outs had embeddedness ratings of 3 or 4. None of the pool tail-outs had a rating of 5, which is considered unsuitable for spawning. Cobble embeddedness measured to be 25% or less, a rating of 1, is considered to indicate good quality spawning substrate for salmon and steelhead.

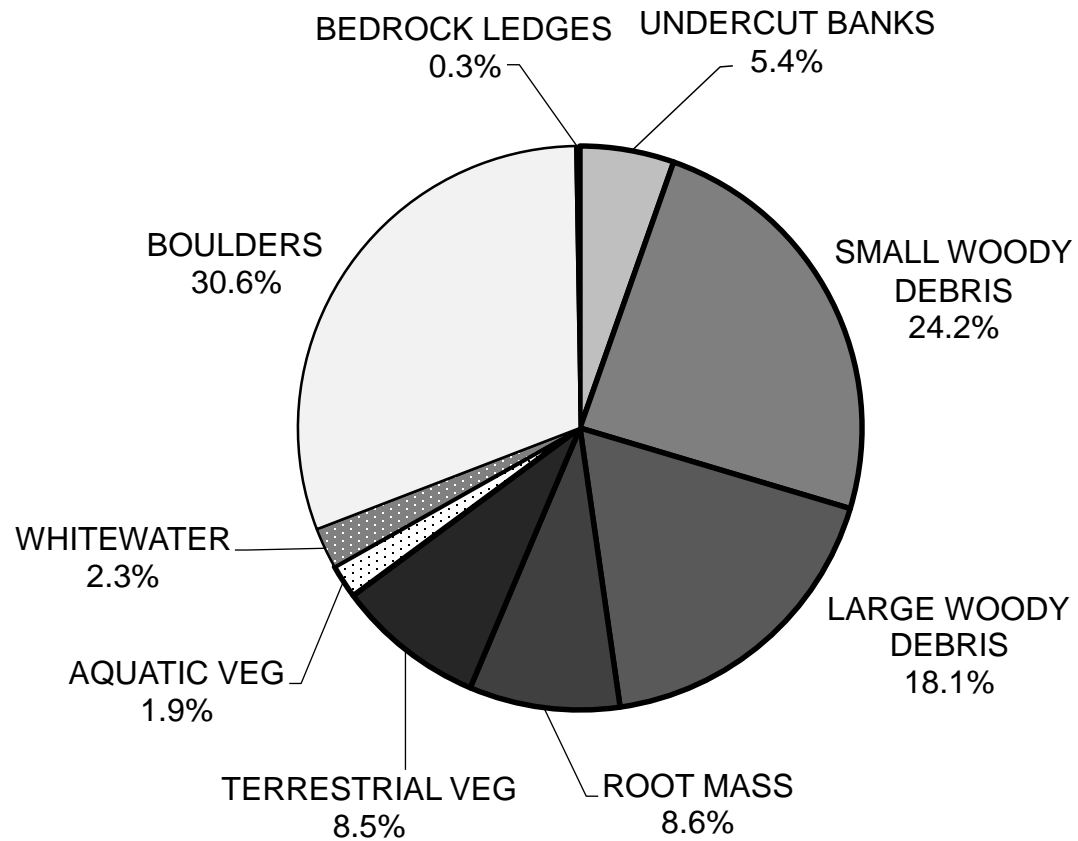
Table 5 summarizes mean percent cover by habitat type. Boulders are the dominant cover type in Atwell Creek. Graph 7 describes the pool cover in Atwell Creek. Boulders are the dominant pool cover type, followed by small woody debris.

ATWELL CREEK 2017 MEAN PERCENT COVER TYPES IN POOLS

The mean shelter rating for pools is 19. The shelter rating in the flatwater habitats is 19. A pool shelter rating of approximately 100 is desirable. The amount of cover that now exists is being provided primarily by boulders in Atwell Creek. Boulders are the dominant cover type in pools followed by small woody debris. Log and rootwad cover structures in the pool and flatwater habitats would enhance both summer and winter salmonid habitat. Log cover structure provides rearing fry with protection from predation, rest from water velocity, and also divides territorial units to reduce density related competition.

- 1) Increase woody cover in the pools and flatwater habitat units. Most of the existing cover in the pools is from boulders. Adding high quality complexity with woody cover in the pools is desirable.
- 2) The limited water temperature data available suggest that maximum temperatures are within the acceptable range for juvenile salmonids. To establish more complete and meaningful temperature regime information, 24-hour monitoring during the July and August temperature extreme period should be performed for 3 to 5 years.

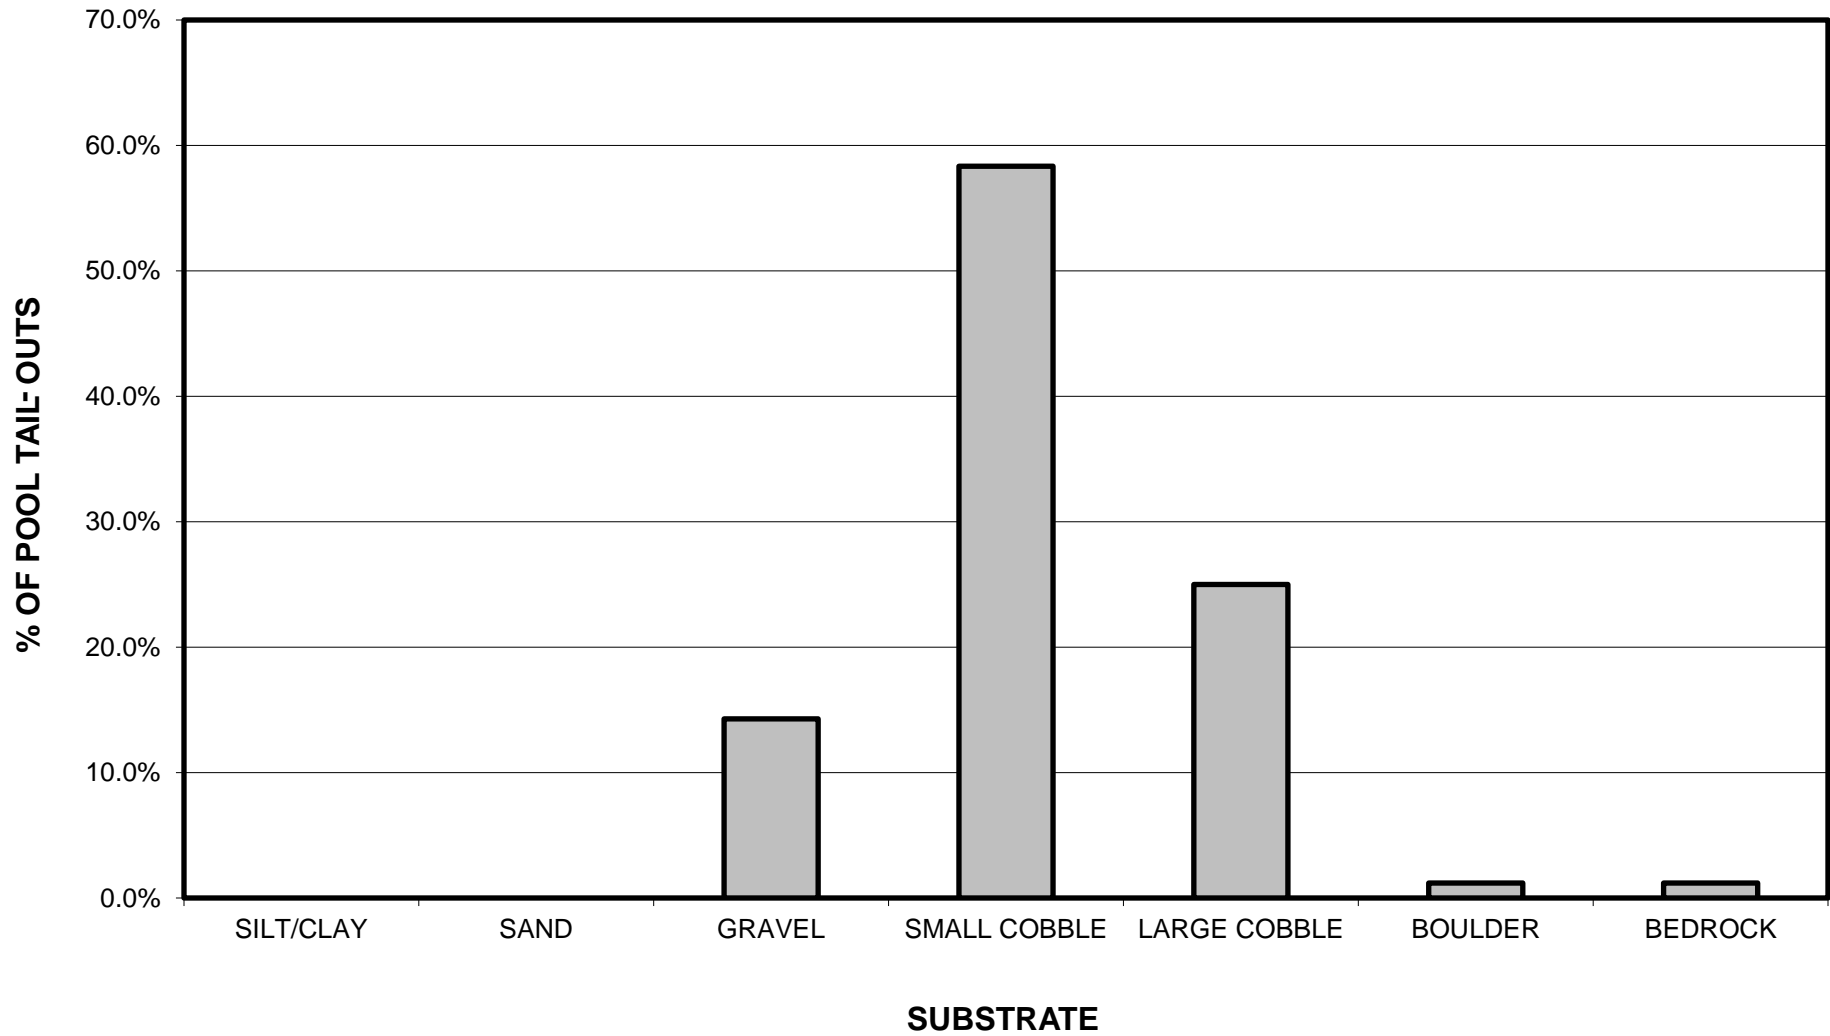
GRAPH 8

Table 6 summarizes the dominant substrate by habitat type. Graph 8 depicts the dominant substrate observed in pool tail-outs. Small cobble was the dominant substrate, observed in 58% of pool tail-outs. Large cobble was the next most frequently observed dominant substrate type and occurred in 25% of the pool tail-outs.

ATWELL CREEK 2017 SUBSTRATE COMPOSITION IN POOL TAIL-OUTS

Sixty-one of the 84 pool tail-outs measured had gravel or small cobble as the dominant substrate. This is generally considered good for spawning salmonids.

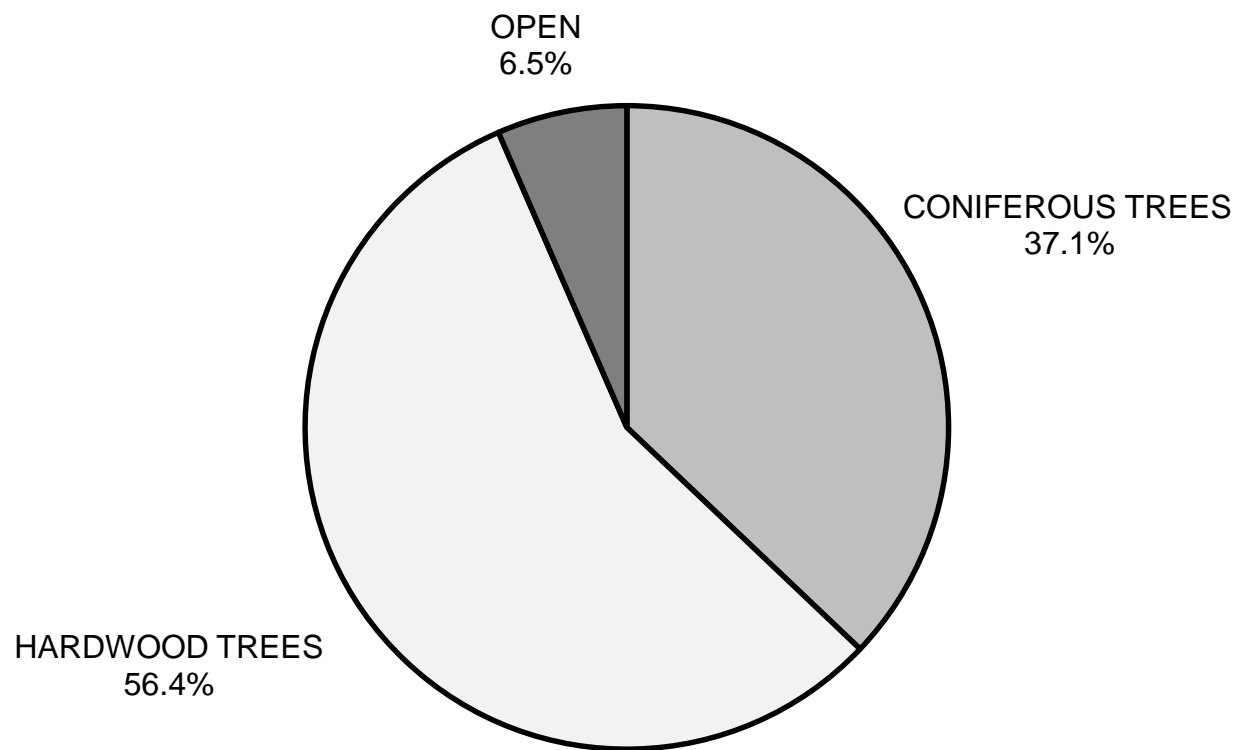
The mean percent canopy density for the surveyed length of Atwell Creek was 93%. Seven percent of the canopy was open. Of the canopy present, the mean percentages of hardwood and coniferous trees were 60% and 40%, respectively. Graph 9 describes the mean percent canopy in Atwell Creek.

ATWELL CREEK 2017 MEAN PERCENT CANOPY

The mean percent canopy density for the stream was 93%. In general, revegetation projects are considered when canopy density is less than 80%.

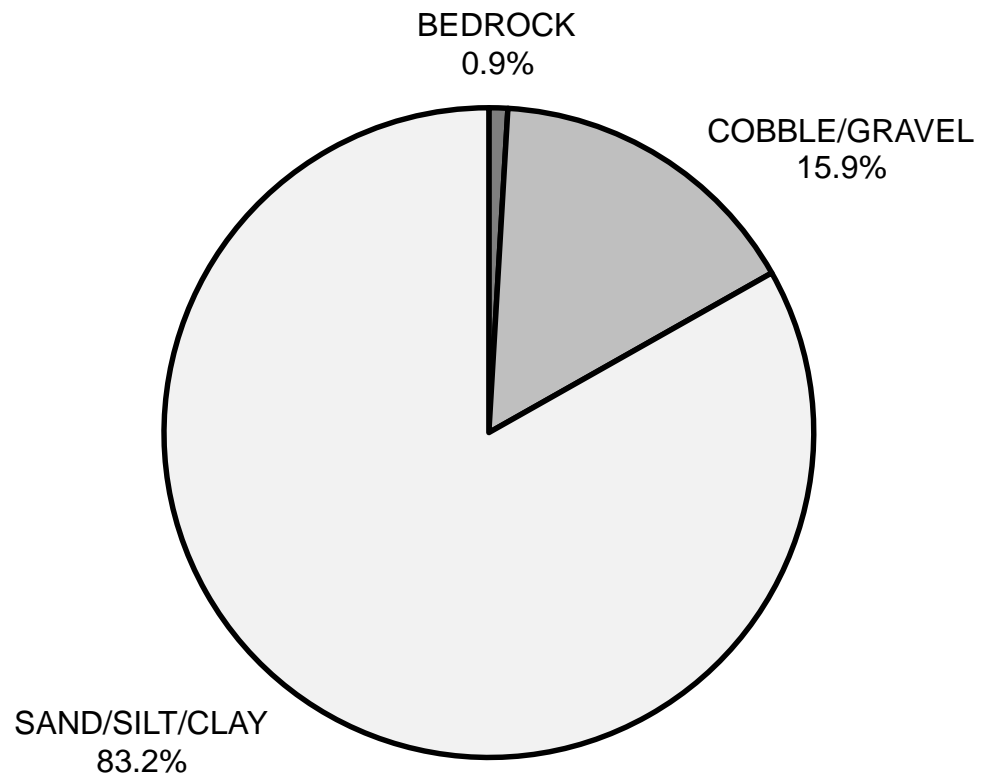
For the stream reach surveyed, the mean percent right bank vegetated was 96%. The mean percent left bank vegetated was 92%. The dominant elements composing the structure of the stream banks consisted of 83% sand/silt/clay, 16% cobble/gravel, and 1% bedrock (Graph 10). Coniferous trees were the dominant vegetation type, observed in 39% of the units surveyed. Additionally, 38% of the units surveyed had deciduous trees as the dominant vegetation type, and 18% had brush as the dominant vegetation type (Graph 11).

ATWELL CREEK 2017
DOMINANT BANK COMPOSITION IN SURVEY REACH

The percentage of right and left bank covered with vegetation was 96% and 92%, respectively. In areas of stream bank erosion or where bank vegetation is sparse, planting endemic species of coniferous and hardwood trees, in conjunction with bank stabilization, is recommended.

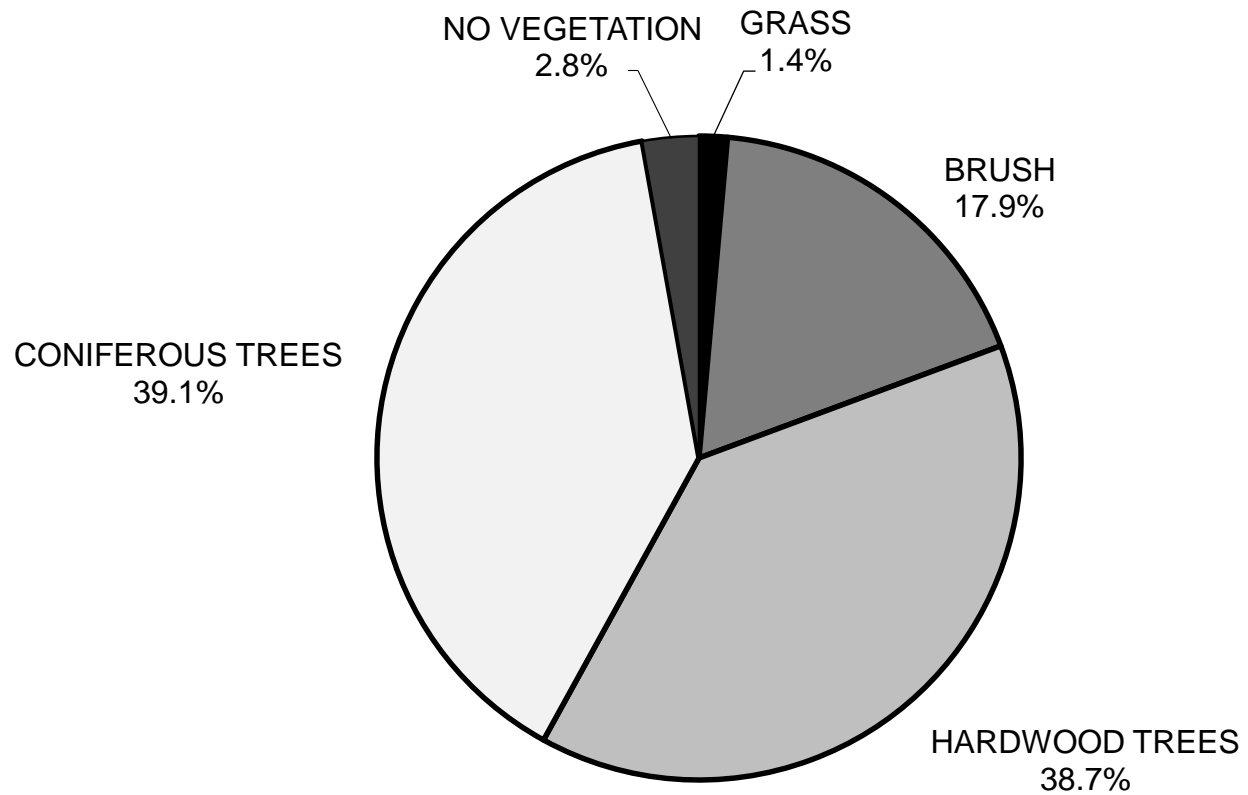
**ATWELL CREEK 2017
DOMINANT BANK VEGETATION IN SURVEY REACH**

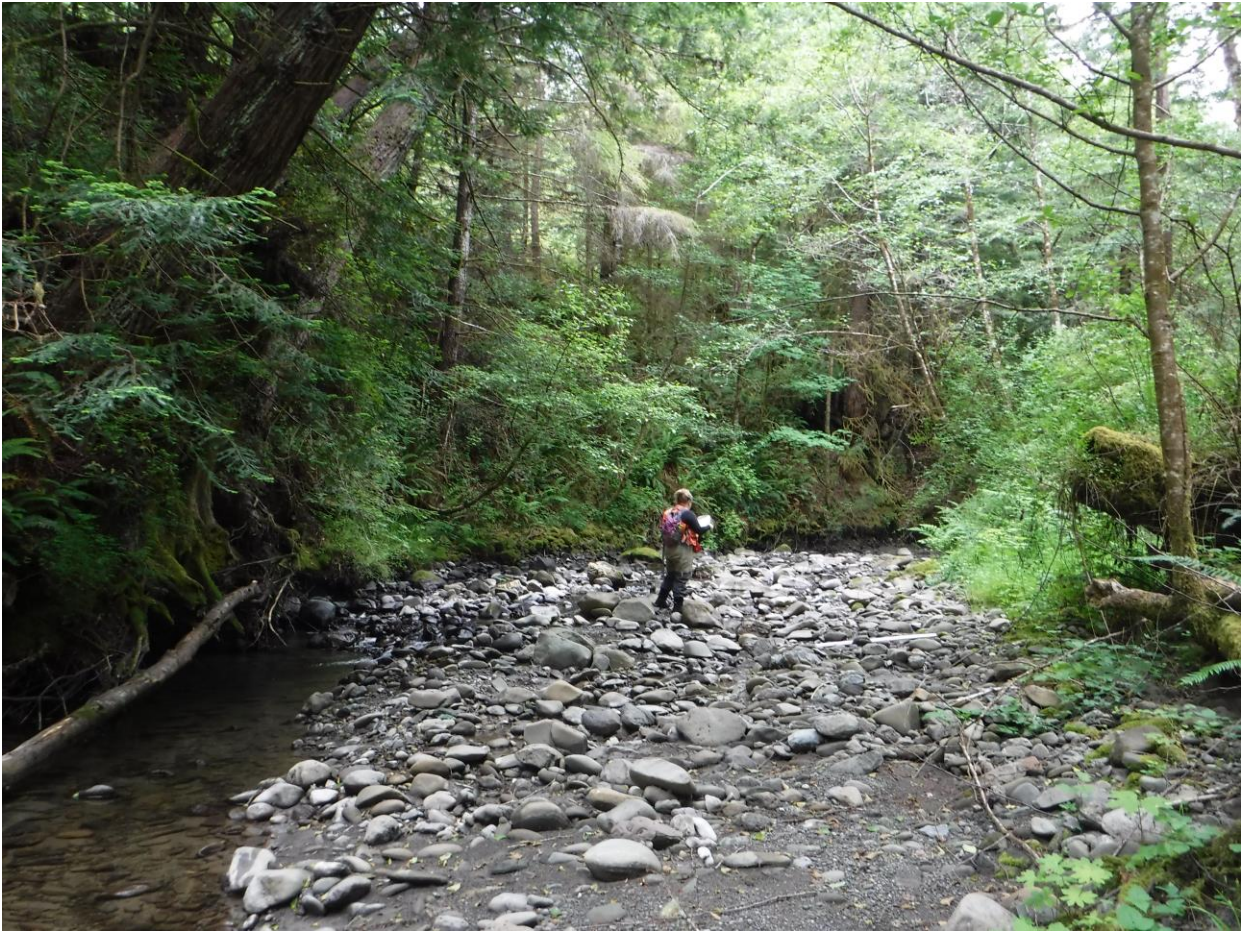
Photo 1: A pool followed by a riffle at habitat units #012 and #013, 547' upstream of the start of survey. Kori Roberts pictured. (Photo taken 6/07/2017)

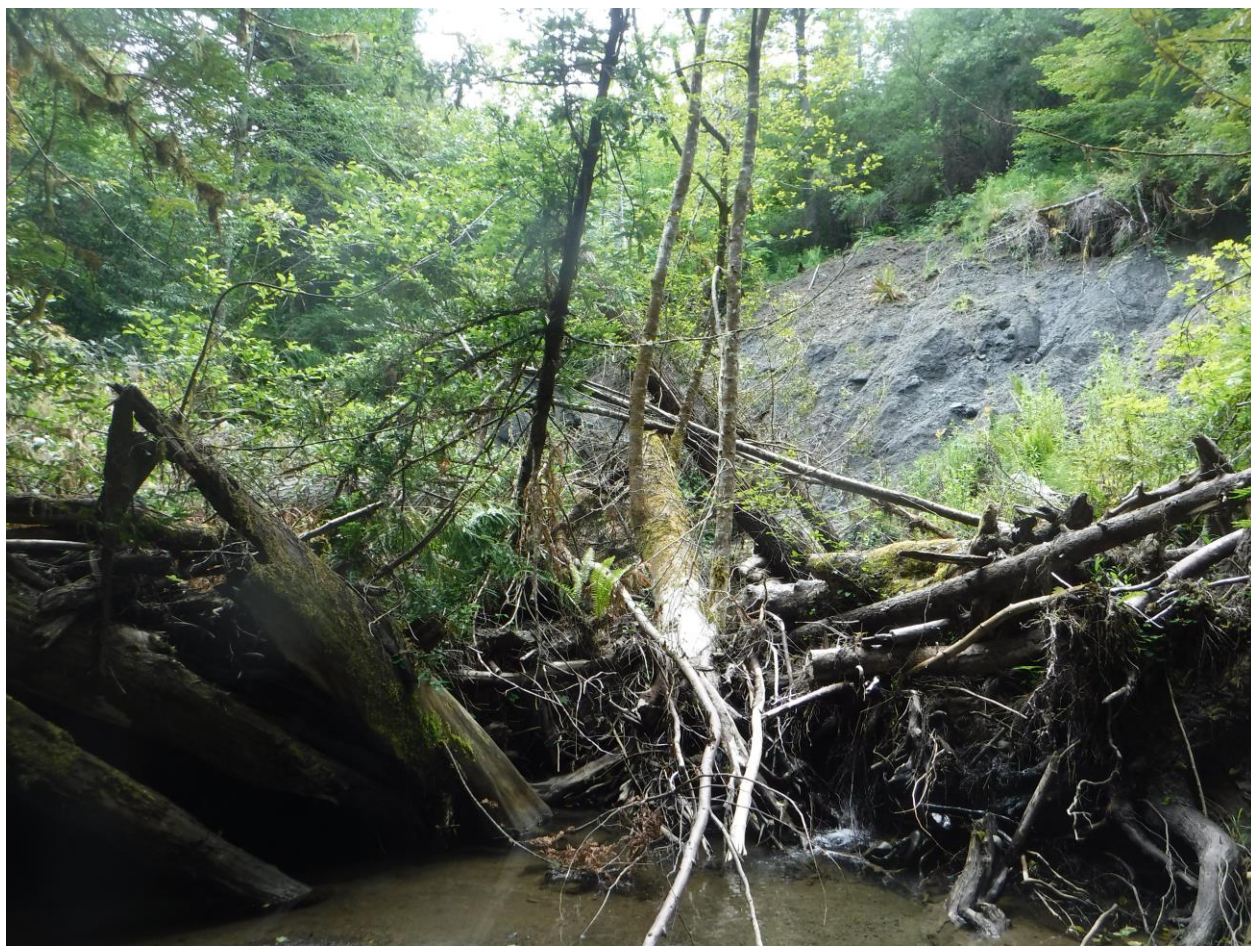
Photo 2: Large debris accumulation #6 and landslide at habitat unit #173, 6,527' upstream of start of survey. (Photo taken 6/12/2017)

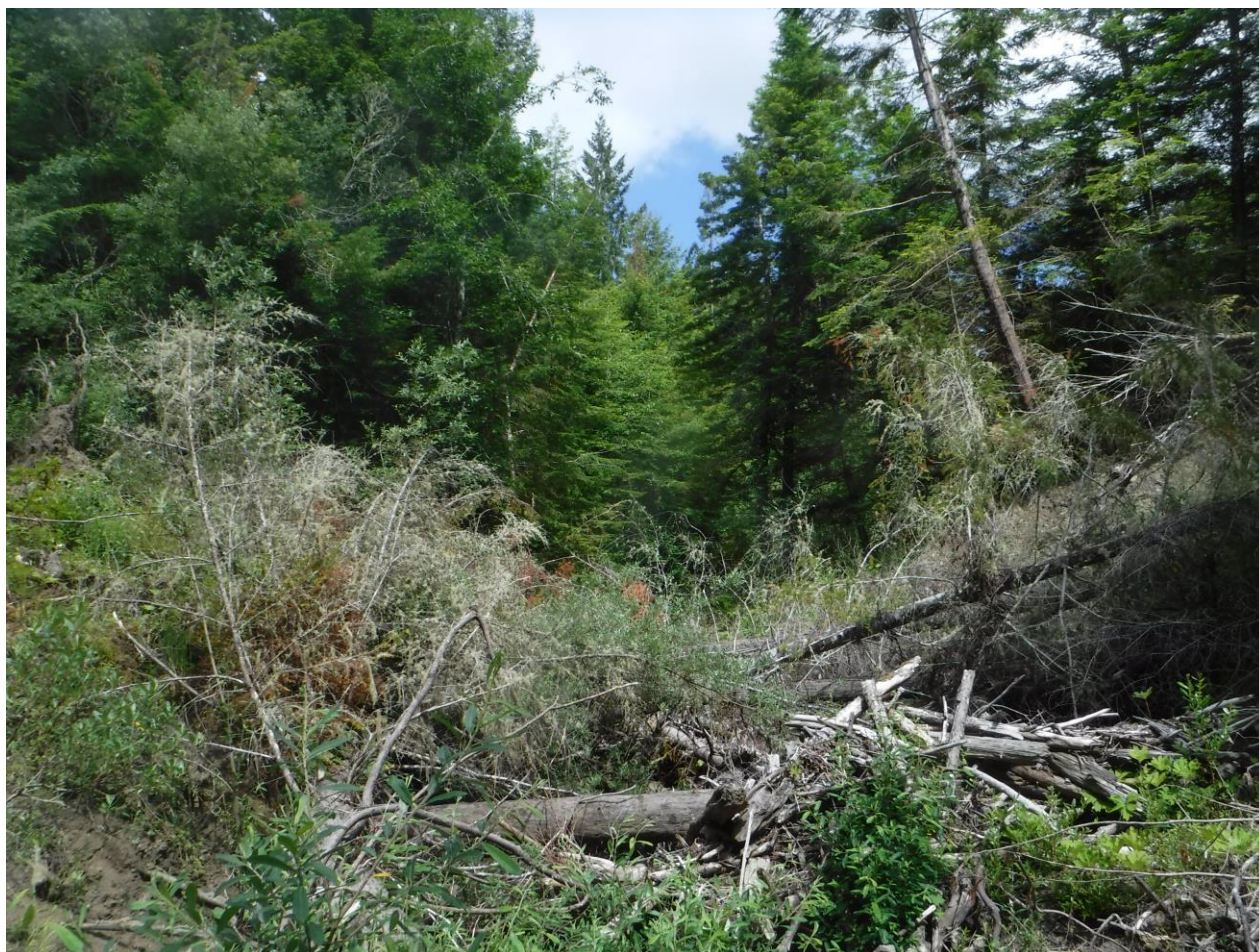
Photo 3: Landslide at unknown distance from start of survey. (Photo taken 6/12/17)
