Site Name: Concrete Dam #3 (Bear Creek #3)

Stream Name: Bear Creek

PAD ID: 705763

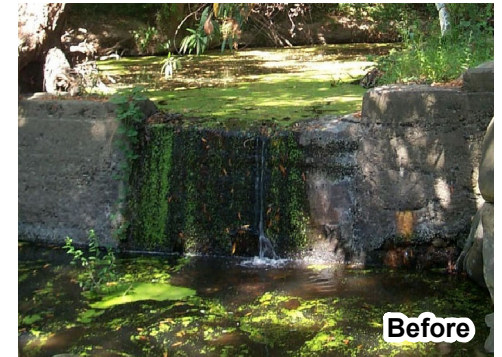
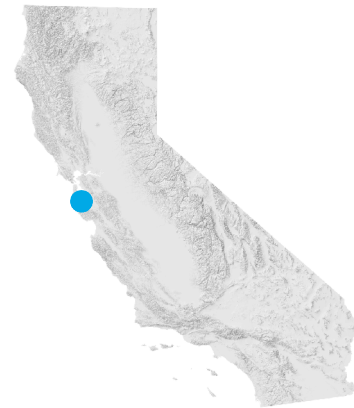
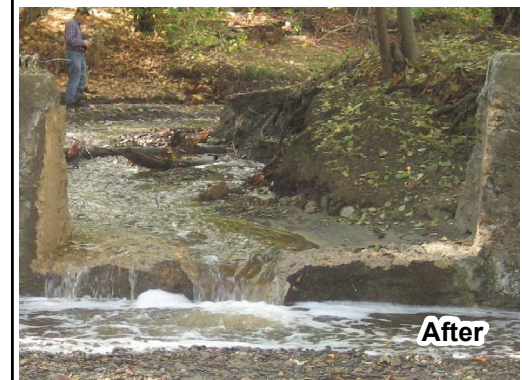
Notes: 7ft tall dam was notched by CDFW (by 4 feet) to provide passage over the lower range of flows. Before: partial barrier. DFG grant pending. The worst passable barrier in the entire watershed. Passable only at very high winter flows, and very difficult even under most flood flows. Pending landowner permission (2003). 300099: Concrete block removed from downstream pool in 2000; still needs lowering or ideally full removal. DFG enforcement possible. DFG currently working on a solution with landowner.
