**CALIFORNIA BAT MITIGATION
TECHNIQUES, SOLUTIONS, AND EFFECTIVENESS**

California Department of Transportation (Caltrans)
Office of Biological Studies and Technical Assistance
Sacramento, California

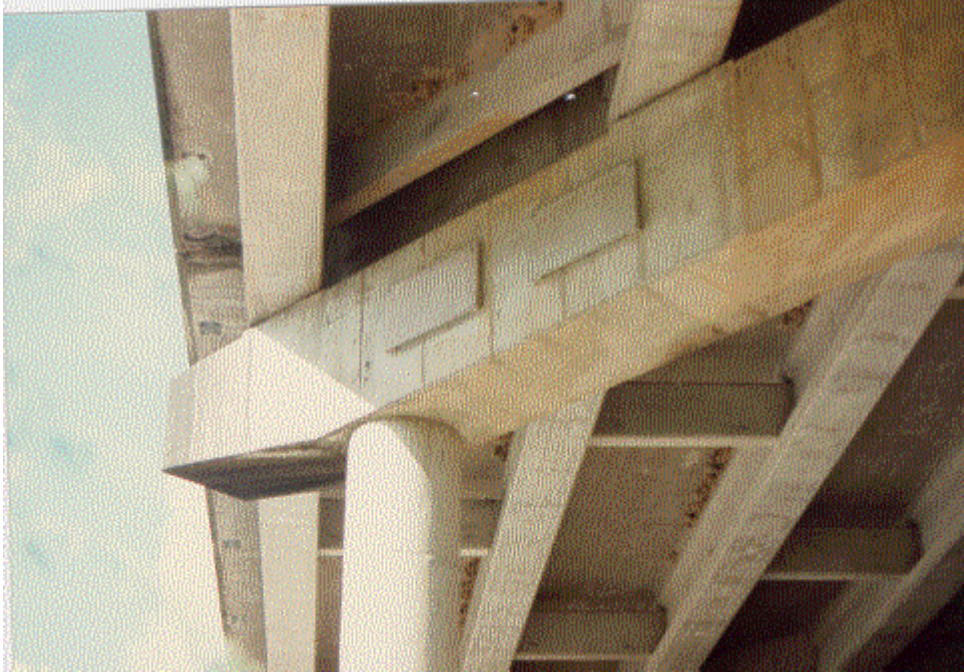
Figure 9-1. Add-on Panels (Brian Keeley)

The 1-meter tall panels are bolted on to the structure and must be sealed at the top to prevent rain from entering. The opportunity for limited ventilation should be provided at the top to allow temperature control. The surface should remain rough; it should not be smoothed.

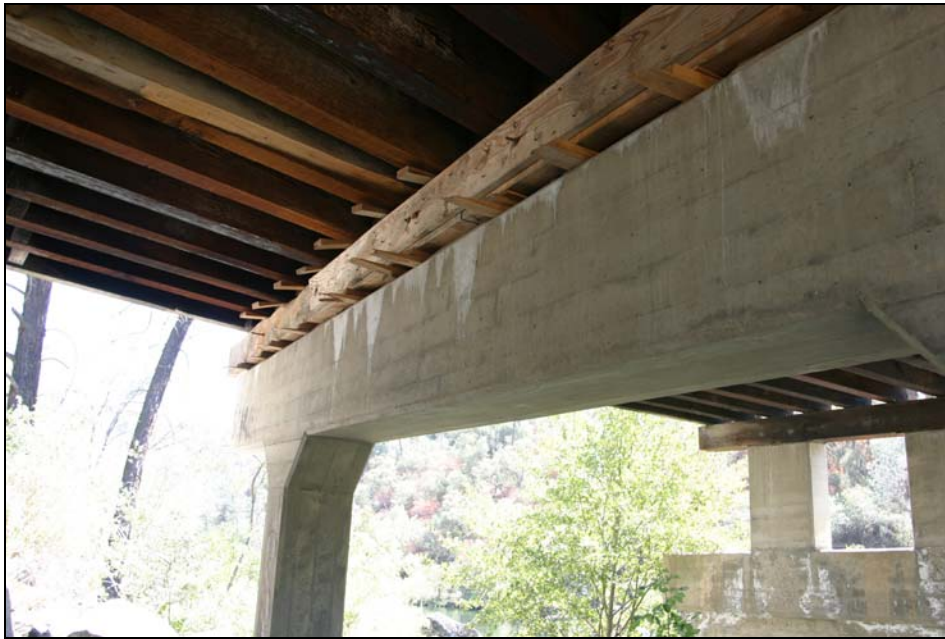
Photo 1. Image taken from under wooden abutment of original Auberry Road Bridge. Notice the urine staining on the concrete beam. Photo by Dave Johnston.

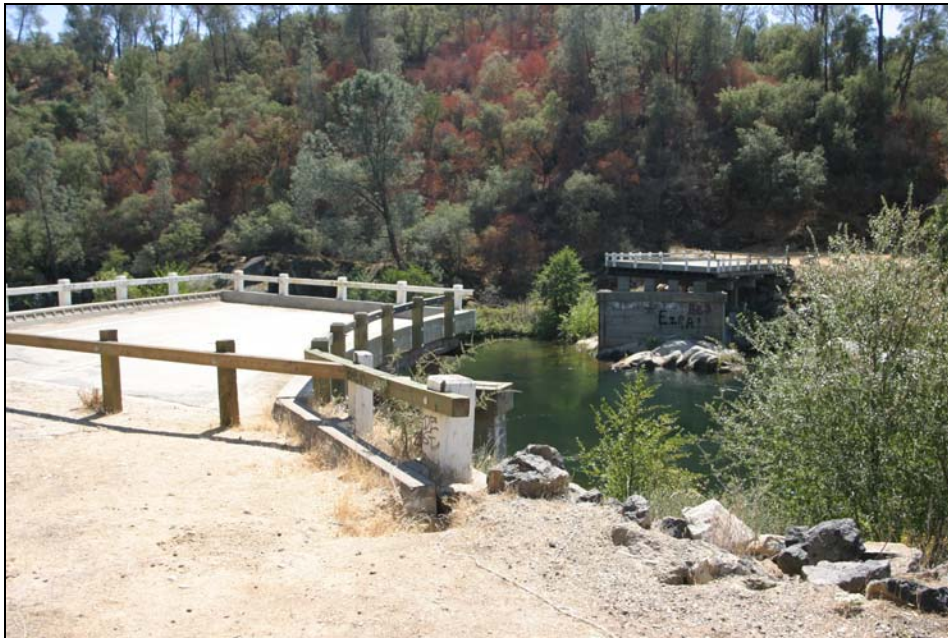
Photo 2. Abutments left with new railing around top. If railing in the immediate foreground is removed, these structures could allow handicap access to a beautiful view of the river. Photo by Dave Johnston.

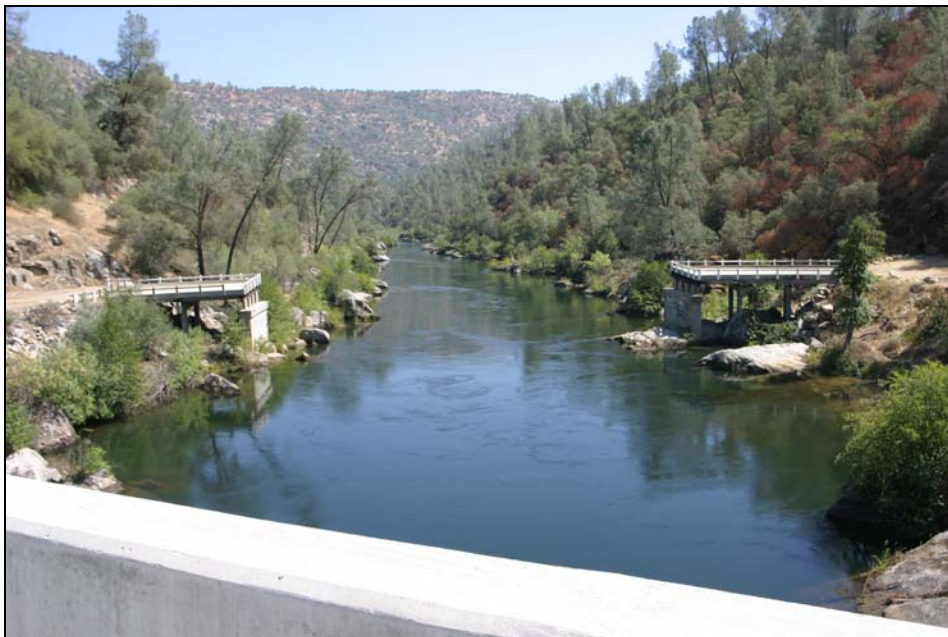
Photo 3. View of the abutments from the new Auberry Road Bridge. Photo by Dave Johnston.

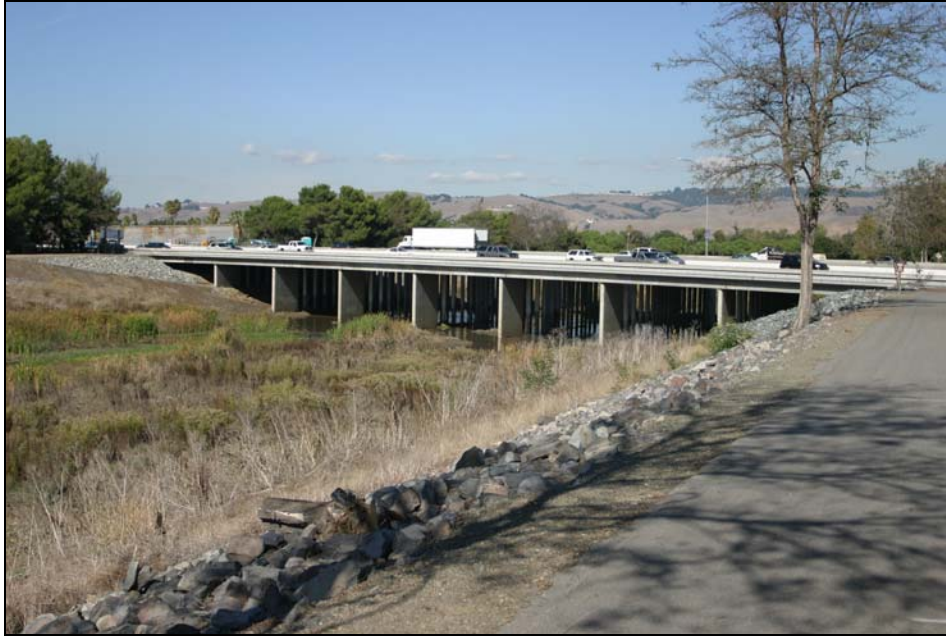
Photo 1. U.S. Interstate 880/Alameda Creek Bridge over Patterson Slough in Alameda County.

The large U.S. Interstate 880/Alameda Creek Bridge over Patterson Slough comprises a box girder bridge with two large expansion joints occurring over the water. The northbound side of the bridge needed a replacement deck, the southbound side needed grinding and resurfacing of the top of the deck, and many piers needed reinforcing. Bats were not observed during the original biological surveys of the bridge; however, a bat biologist did not conduct these surveys. A colony of 1,000 Mexican free-tailed bats was observed in January 2004 when the construction contractor installed netting to prevent birds from nesting on the bridge. After a failure to find suitable alternative roosting habitat for these bats before they were excluded from the bridge, approximately 950 of the Mexican free-tailed bats left the winter roost. The approximate fifty individuals left were not likely breeding (at least all those examined were either non-breeding males or females, or compromised physically because of old injuries). Although the contractor preferred to exclude all bats and birds from the bridge, bat biologists suggested that to move bats without knowing if other roosts occurred in the area could lead to the loss of those individuals and possible the loss of a maternity colony of Yuma bats. Netting was pulled back from known roosts on the southbound side of the bridge to provide roosts to bats that were about to be excluded from the northbound side. One-way doors were then installed on the northbound roosts, and bats were observed in southbound roosts thereafter. Bat biologists argued that the abandonment of filling expansion joints with Styrofoam for the Monterey Bridge #450 (Bradley Road Bridge) should set a precedence. In Spring of 2004 Caltrans engineers approved leaving the expansion joints void of any filler, such as Styrofoam.

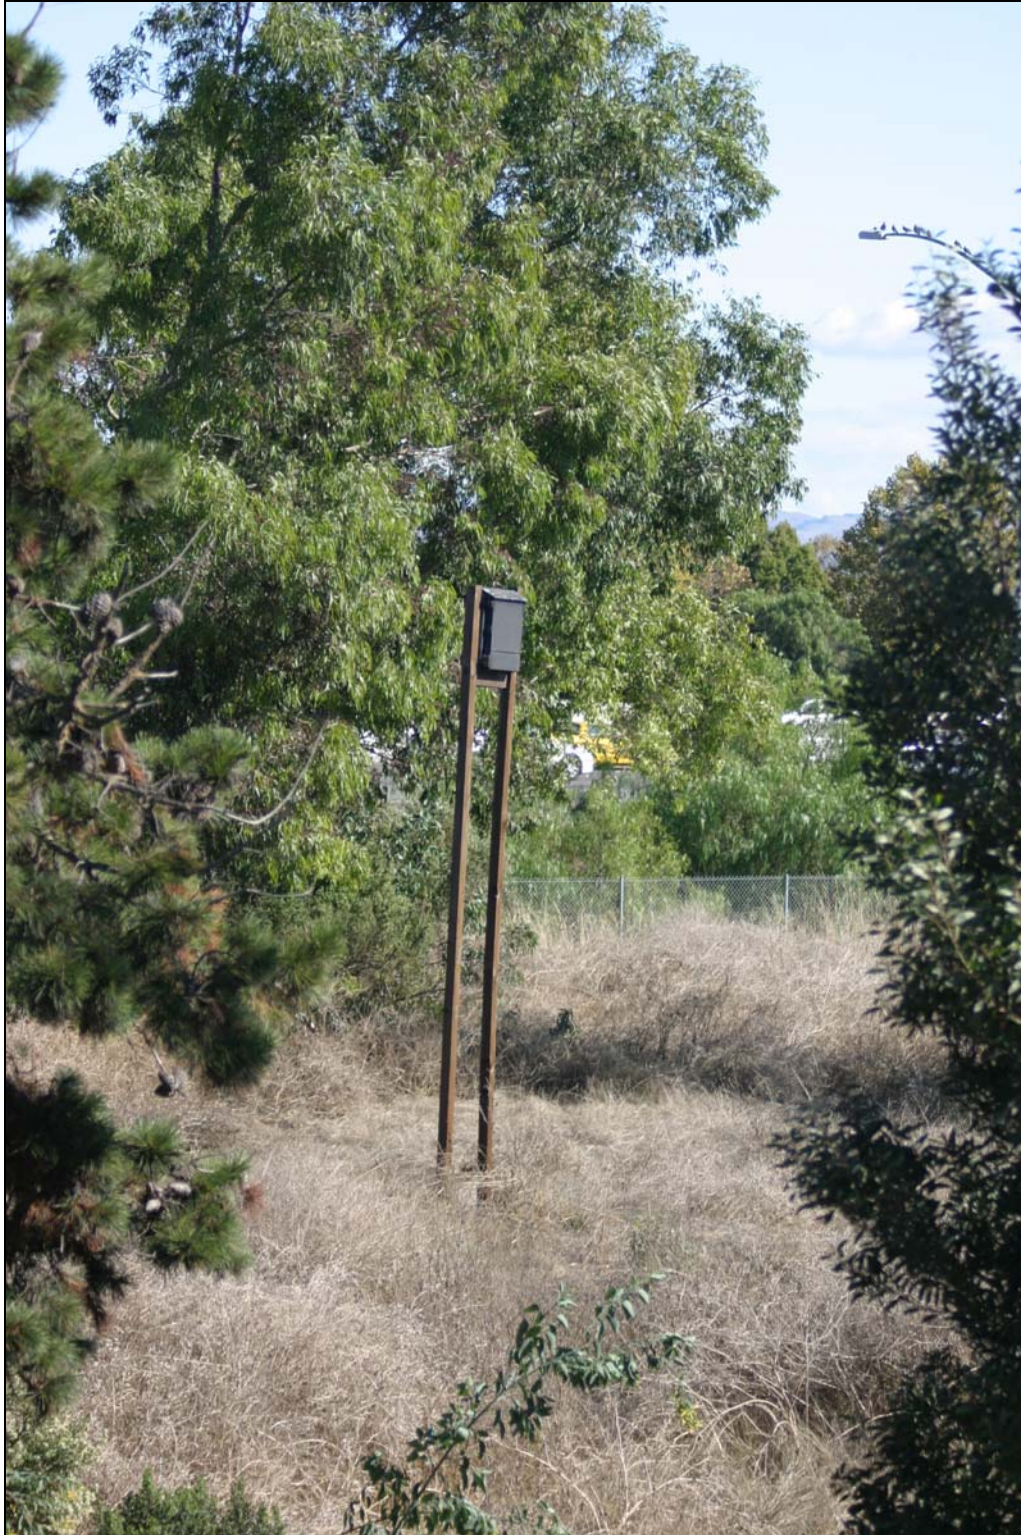
Photo 2. About 200 feet from the bridge, a bat box had been placed in a wetlands mitigation site. No bats or any evidence that there were bats, were observed in the bat box. Bat biologists rejected the concept that this bat box could provide habitat for the over-wintering bats in the bridge. Photo by Dave Johnston.

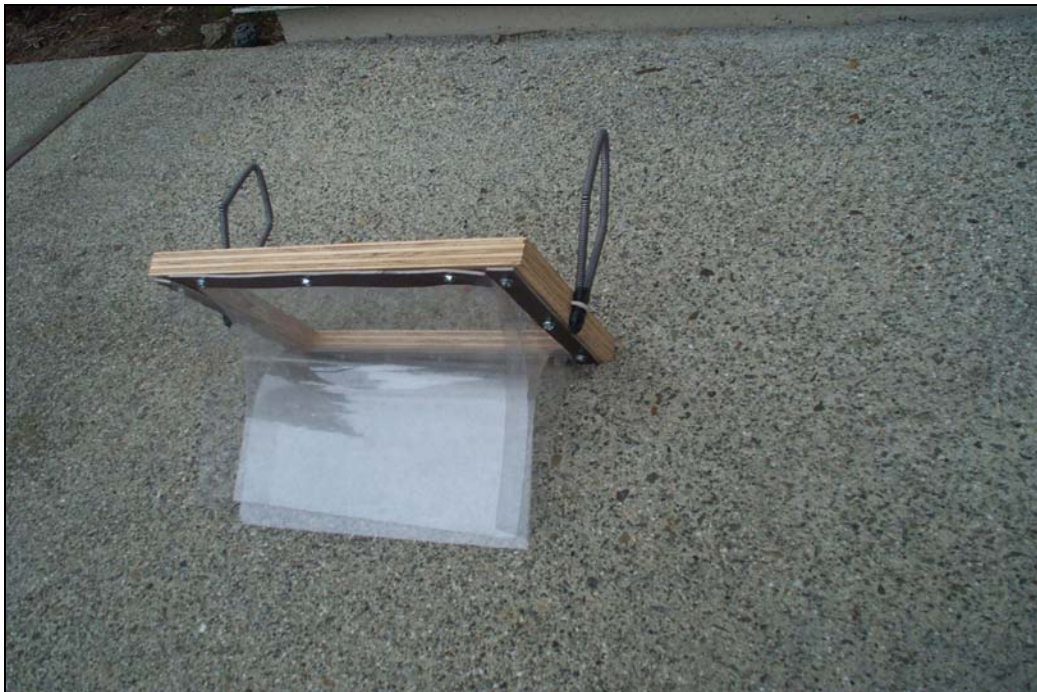
Photo 3. One of several one-way doors (designed by Dave Johnston) used to move bats away from the impact areas of a bridge to another side of the bridge. Photo by Dave Johnston.

After bats were found to roost in the bridge in January, plans were drawn to exclude all bats from the bridge. However, no alternative roosts, or even suitable roosts, were found within a few miles. Plans to retrofit nearby bridges failed because other government agencies would not provide permission to alter bridges in anyway. After much discussion, nets were pulled back to a point that bats could re-enter a roost on the southernmost expansion joint on the southbound side of the bridge. Bats in the northbound expansion were then excluded with one-way door devices. In March, approximately 80 Yuma myotis occupied a section of the northbound bridge and were excluded and moved from this impact area. Both Yuma bats and Mexican free-tailed bats occurred in the westernmost sections of the expansion joints (in the southbound bridge).

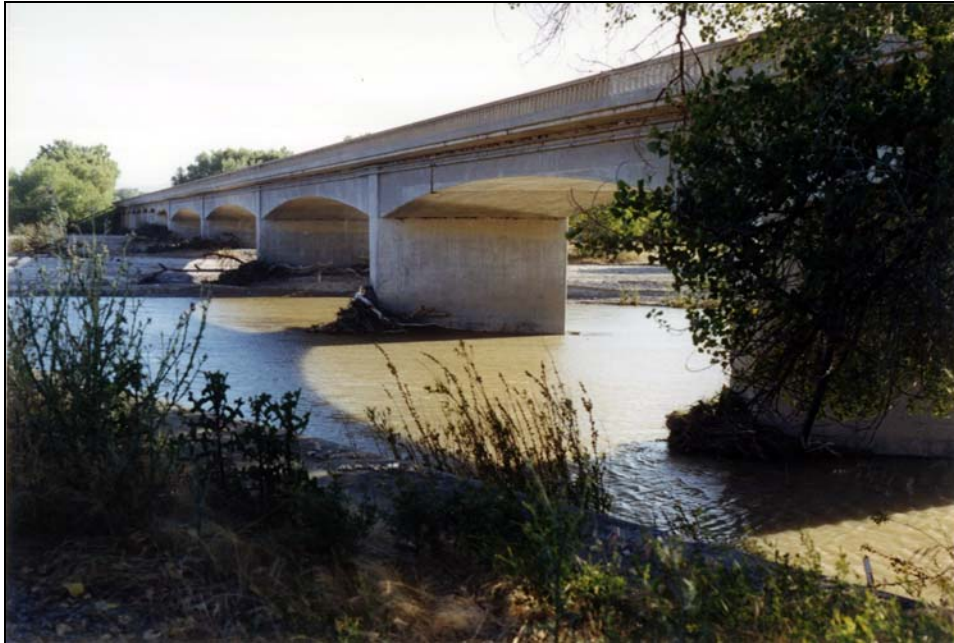
Photo 1. Bradley Bridge located over the Salinas River at the southern end of Monterey County. Photo by Dave Johnston.

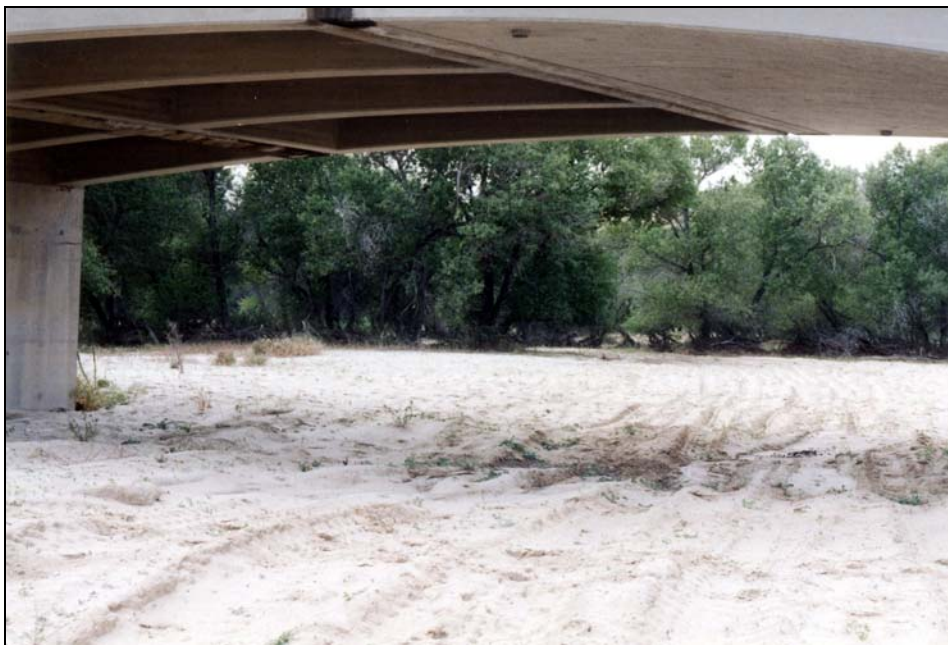
Photo 2. Bradley Bridge showing hinge providing day roosting and maternity colony habitat. The box girder construction to the left of the hinge provides night roosting habitat. Photo by Dave Johnston.

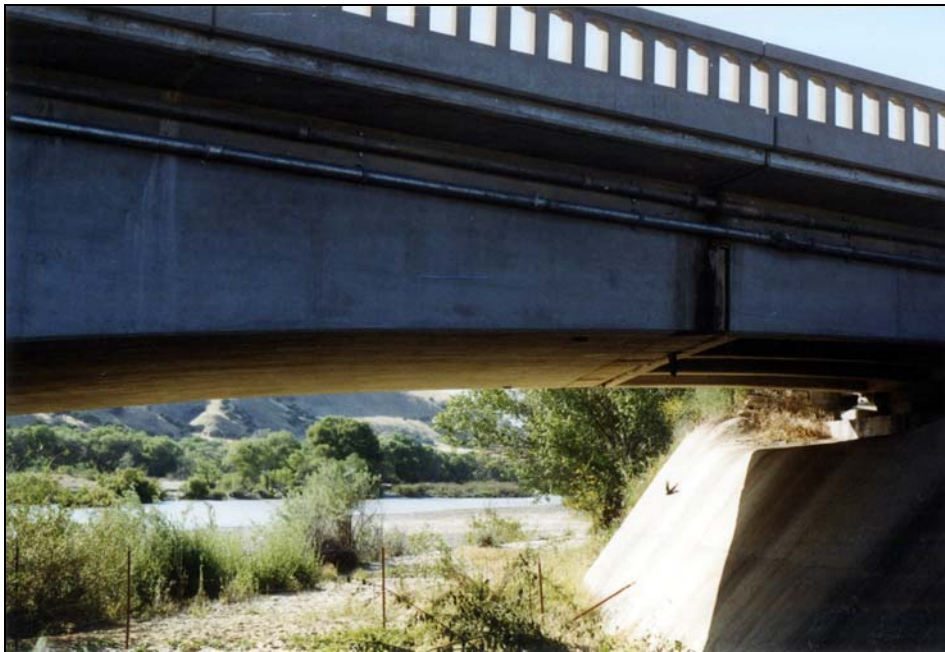
Photo 4. Location of a pallid bat colony in June 1999. Seen flying on the right side of the photograph is a White-throated Swift (*Aeronautes saxatalis*) exiting from the crevice. Photo by Dave Johnston.

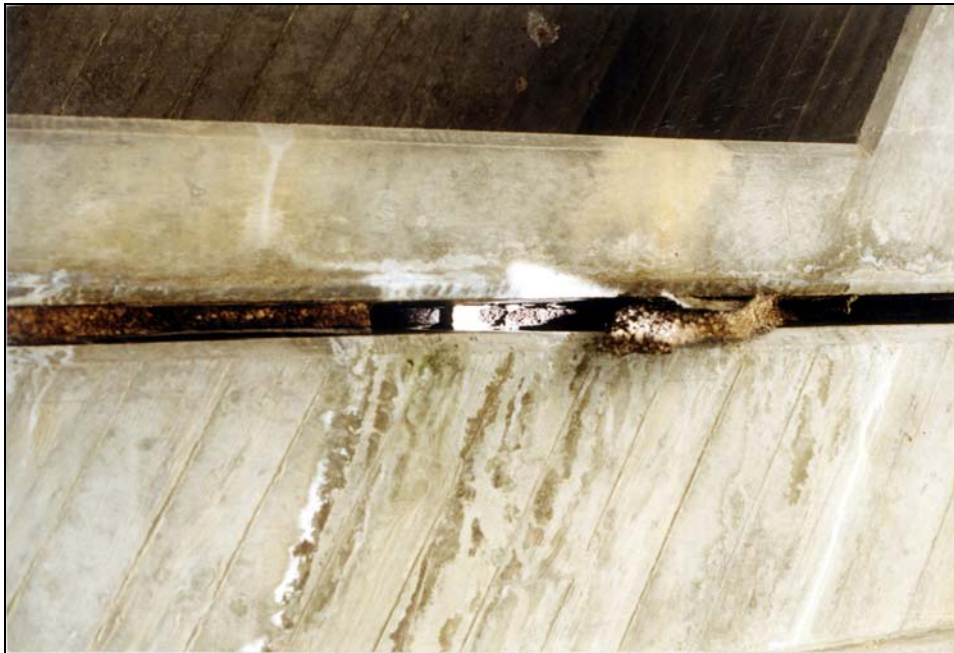
Photo 5. Detail of the roost site for pallid bats. White-throated Swifts were roosting only about 25 cm from the pallid bat colony. Notice urine staining and cork material falling out of the crevice. No animals were present at the time the photograph taken in August 1999. Photo by Dave Johnston.

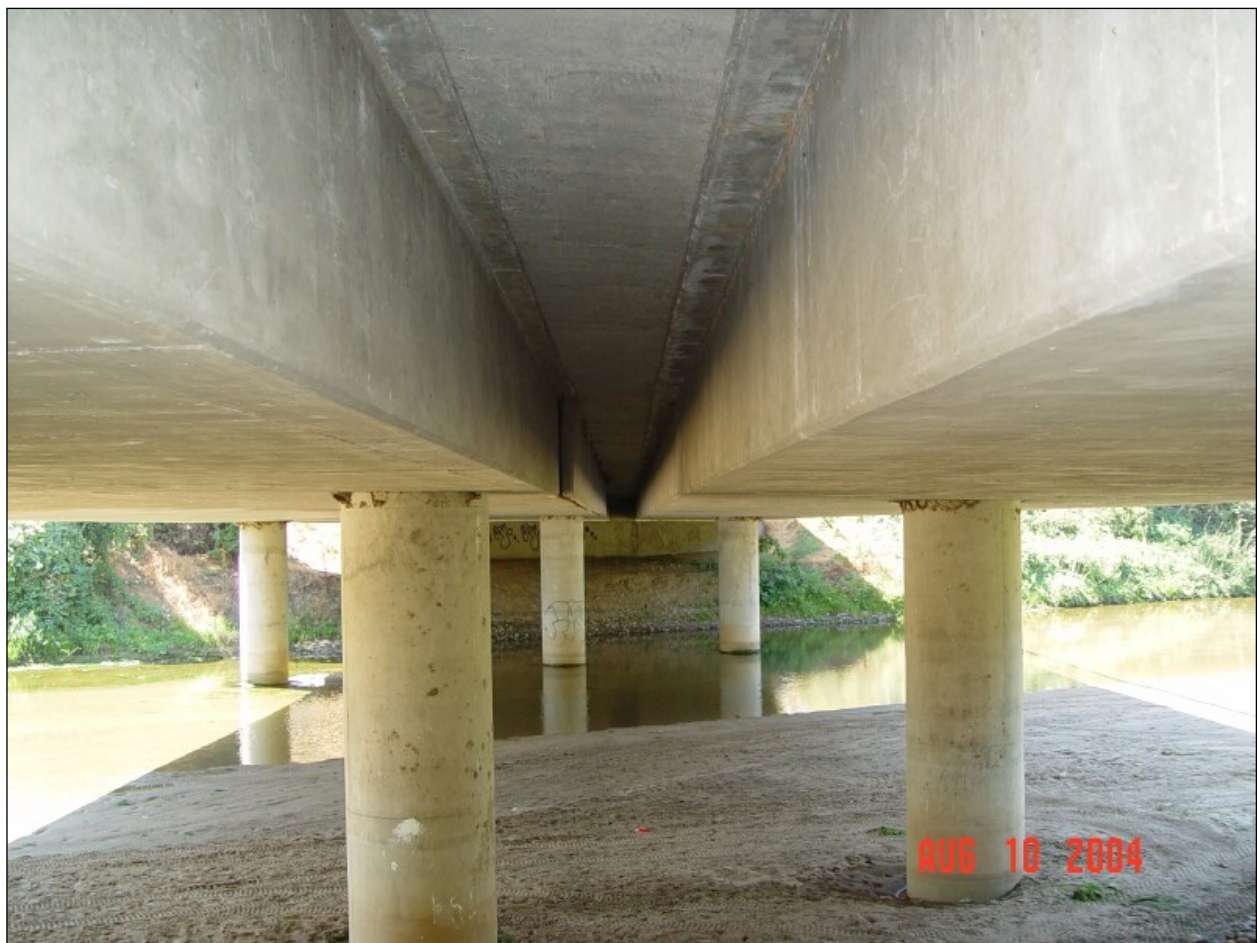
Photo 1. New bridge with closure pour recess and bat roost habitat panel at left. Photograph by Greg Tatarian.

The replacement bridge was opened in the winter of 2003, and that spring, day and night roosting bats were observed. The replacement bridge design is being used increasingly for new bridges, and consists of two separate box girder structures, with a separation of several feet between the two structures, which is finally sealed with a closure pour. This closure pour connects the bridge deck, but not the bottom surface of the box girders, so a vertical recess remains between the two sections.

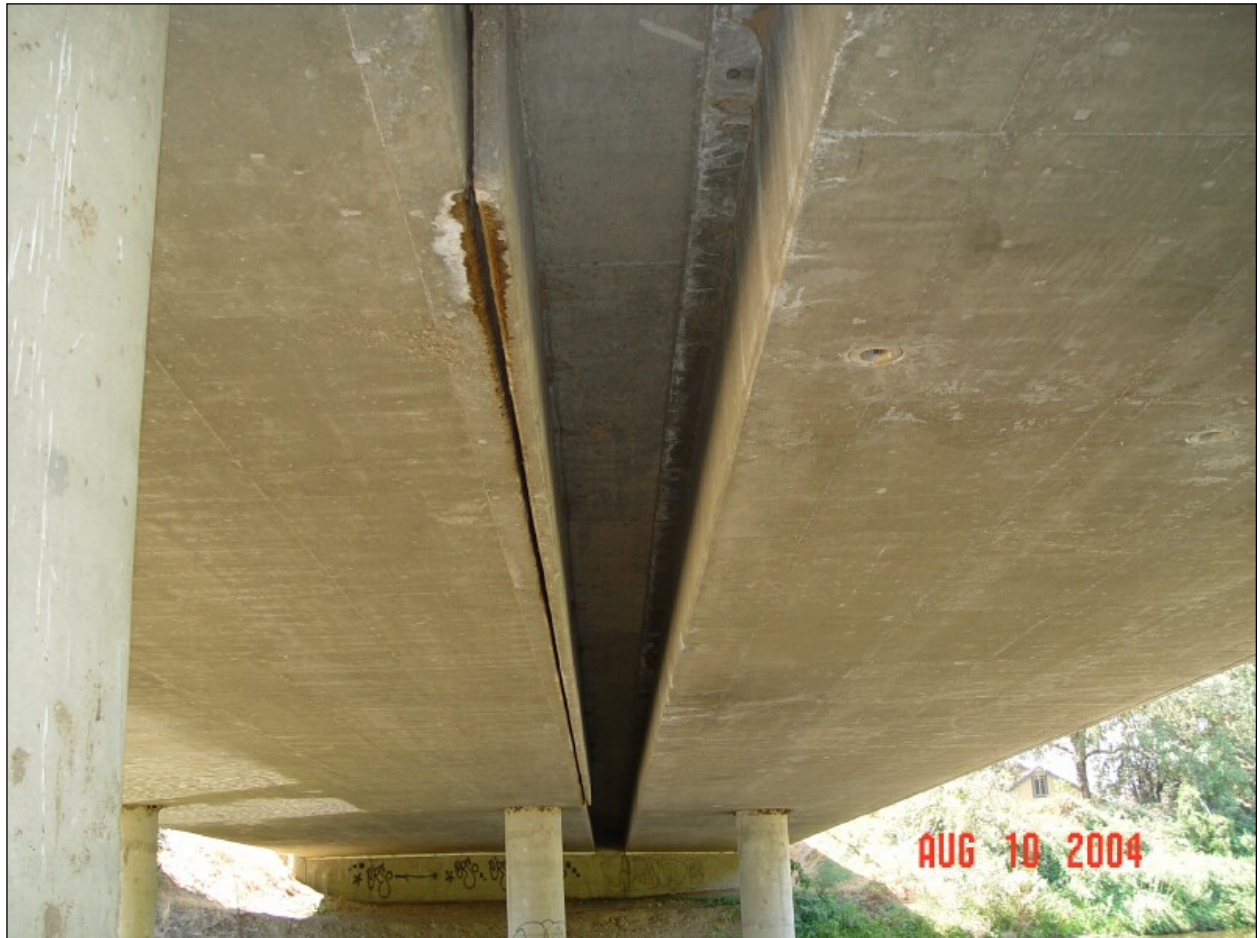
Photo 2. Closer view of roost panel, showing staining signs of bat roosting activity. Photograph by Greg Tatarian.

A lightweight concrete panel approximately 2" thick, running the full height of the closure pour recess, was installed in the portion of the bridge that is situated mostly above the water. The roost area created by the panel provides 3-4 times that of the original expansion joint.

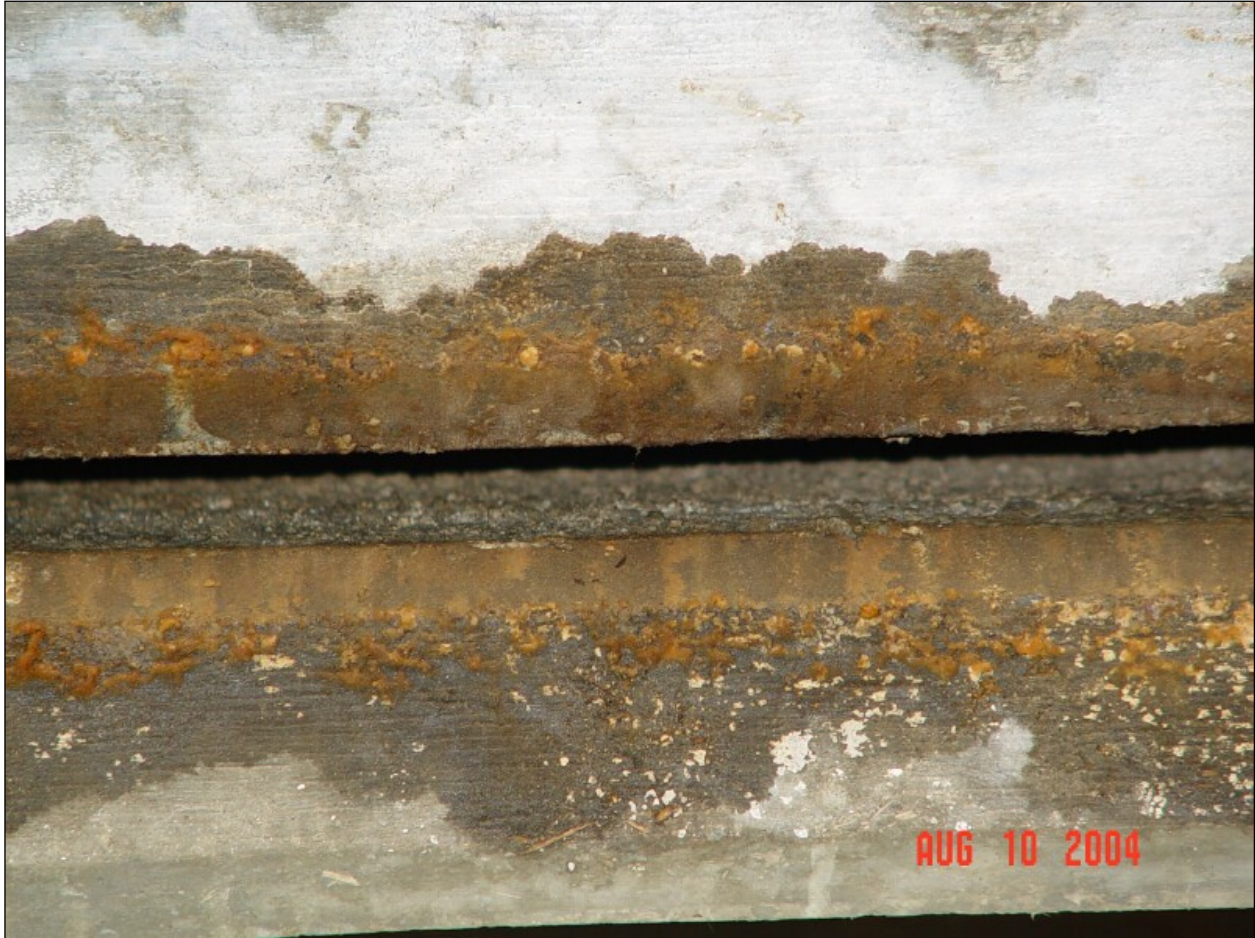
Photo 3. Closeup of urine staining showing active roosting by bats. Photograph by Greg Tatarian.

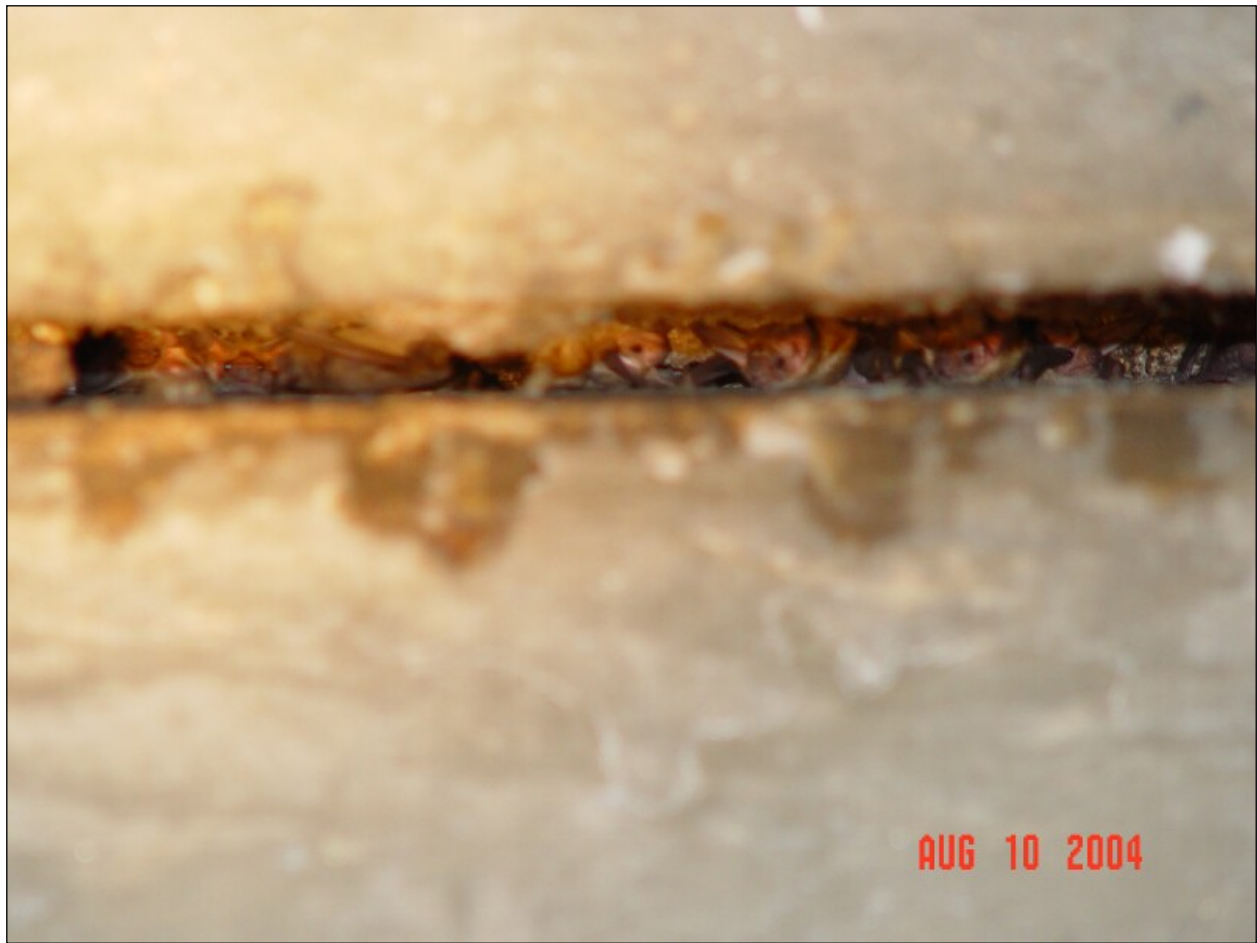
Photo 4. Pallid bats day-roosting in the panel crevice. Photograph by Greg Tatarian.

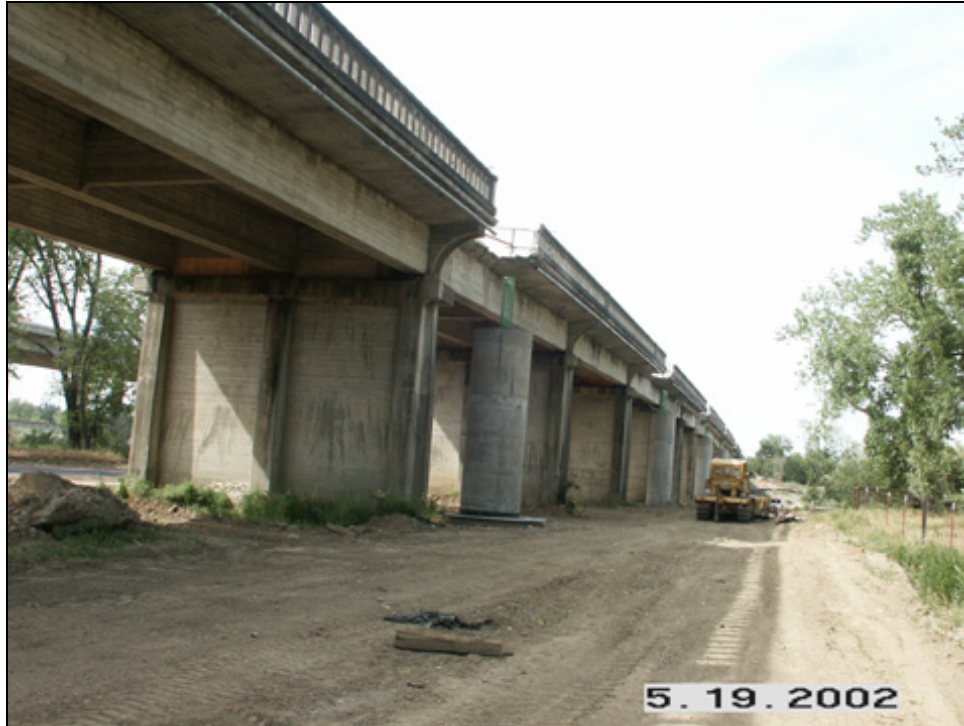
Photo 1. Old bridge early in demolition. Piers for new bridge are being installed under the old bridge. Photo by William E. Rainey.

The Main Street Bridge over Cottonwood Creek, just south of the Town of Cottonwood, was built in 1930, and was replaced for structural reasons (Photo 1).

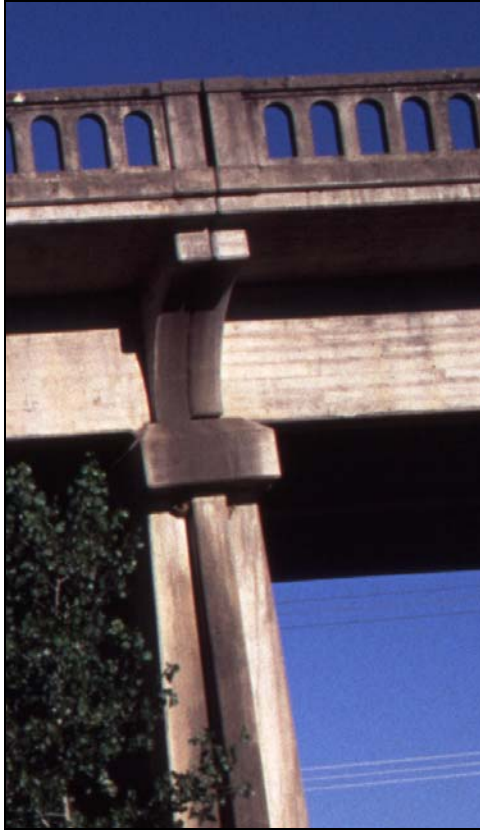
Photo 2. Corbel used by bats as entry point to expansion joint roost in the old bridge. Photo by William E. Rainey.

The Main Street Bridge over Cottonwood Creek served as an important day roost and maternity site for three species, and was used by occasional individuals of one or two additional species. Bats primarily used the expansion joints, each extending about 2 meters deep and located over each of the 20 bents that supported the bridge deck (Photo 2). Some night-roosting also took place among the concrete girders under the deck.

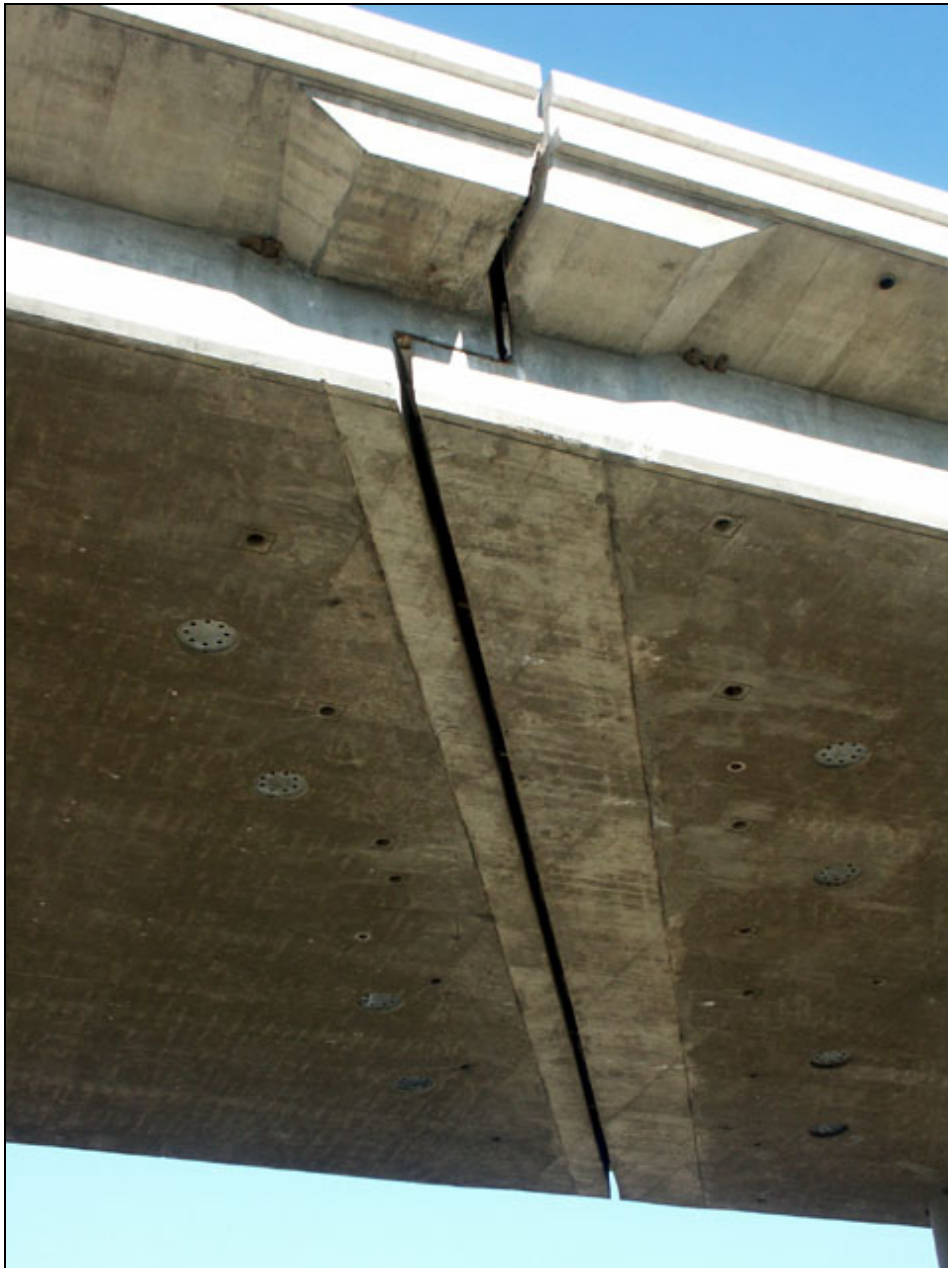
Photo 3. Bat roost located in expansion joint on U.S. Interstate 5 Bridge.
Photograph by William E. Rainey.

Two other nearby bridges were used by bats prior to the removal of the old bridge, and used more extensively after that roost structure was removed. The roost in the I-5 structure is located in a single large expansion joint (Photo 3). Use of this site varied seasonally, and at times was only used as a night roost.

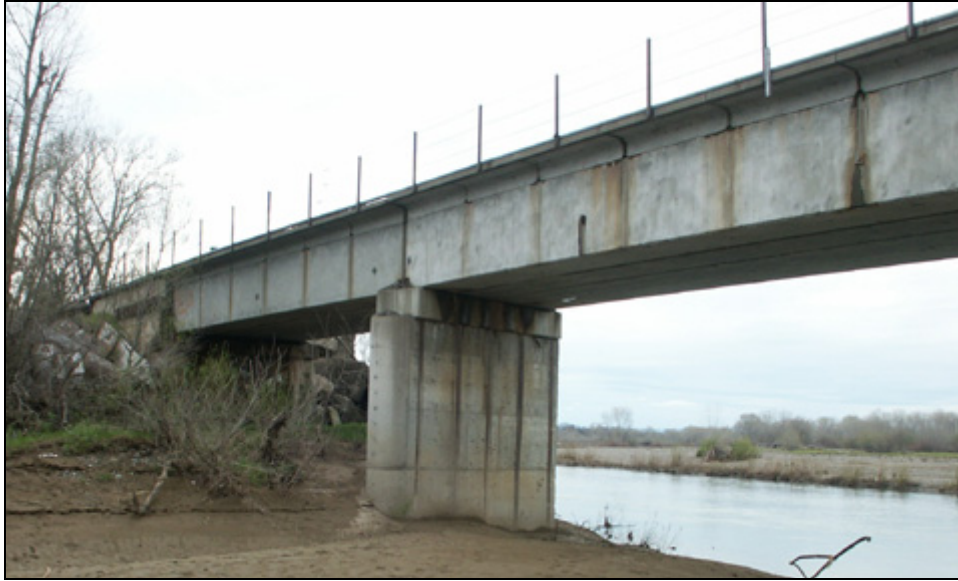
Photo 4. Railroad trestle showing longitudinal crevices used as bat roosts. Photography by William E. Rainey.

The railroad trestle, to the west of the I-5 Bridge, is composed of a series of four longitudinal pre-cast beams and has three longitudinal crevices that run the length of the trestle within each segment. The upper portion of each crevice had been previously filled with foam, so that the crevices were largely sealed against precipitation from above. While this structure is used year-round by bats, it is the only local winter roost currently known in the area for Mexican free-tailed bats (Photo 4).

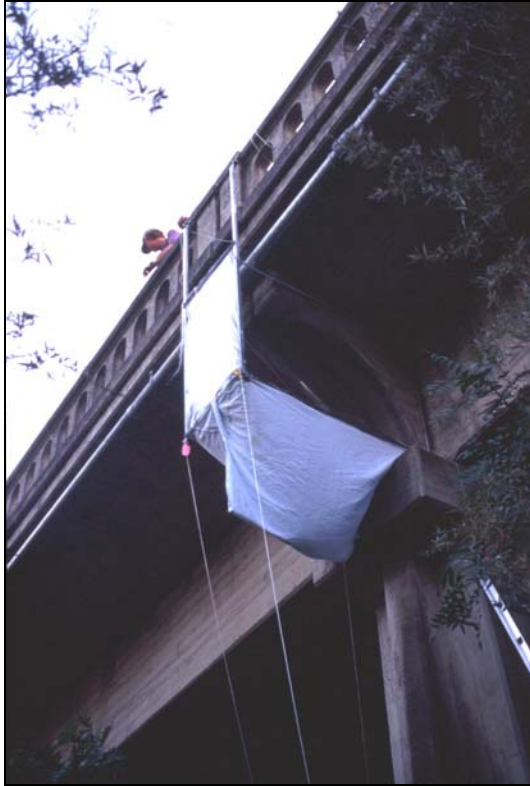
Photo 5. Custom adapted harp trap installation, designed for capturing pallid bats. Photograph by William E. Rainey.

The existing bridge was monitored nine times between July 2000 and August 2001 to establish seasonal patterns of bat use, and gather data for planning effective mitigation. In two capture efforts (May and August), 106 *E. fuscus* and 71 *A. pallidus* were captured upon emergence from the roost, and banded with numbered, colored bands. Both commercial harp traps and custom traps designed to fit the corbel were used in the capture (Photo 5).

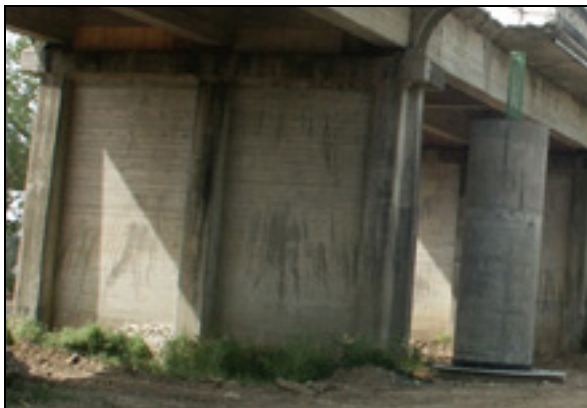
Photo 6. Plywood panels installed over bents to exclude bats from expansion joints. Photograph by William E. Rainey.

In early January 2002, when no bats were present in the bridge, foam backer rod was installed in the deck crevices by the consulting biologists and plywood panels were installed on the bents by the contractor to exclude access to roosting areas (Photo 6). These installations were subsequently checked by the consulting biologists and bat activity around the structure was evaluated during deck demolition.

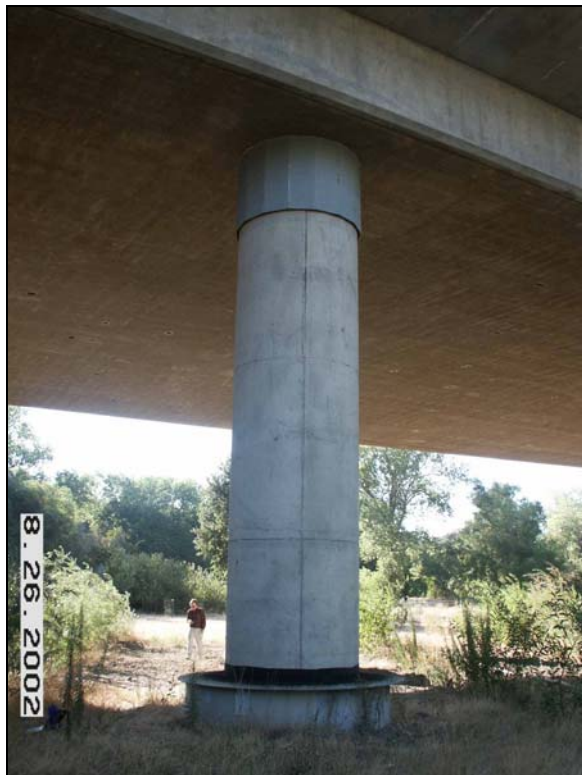
Photo 7. Interim collar roost installed on U.S. Interstate 5 bridge piers. Photograph by William E. Rainey.

Temporary Roost. Four temporary roosts were installed at the tops of four round piers on the adjacent I-5 structure (Photo 7). These were collars made of fitted plywood sections, lined with polyurethane mesh, and positioned one to two inches from the column surface by wood spacers.

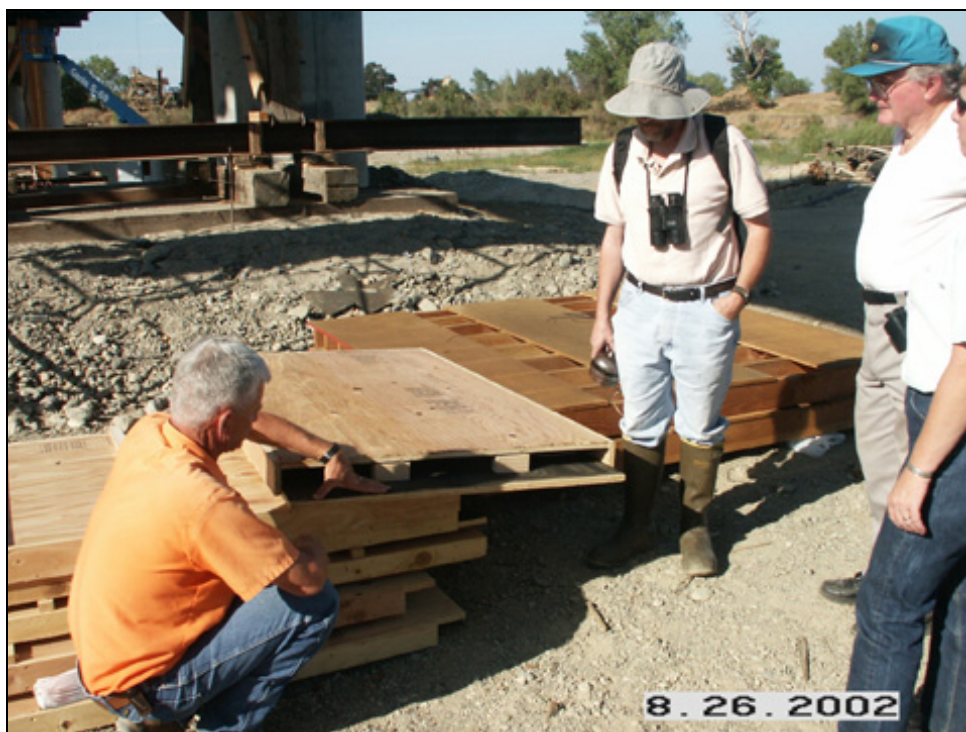
Photo 8. Bat crevice forms prior to incorporation into structure of new bridge. Photograph by William E. Rainey.

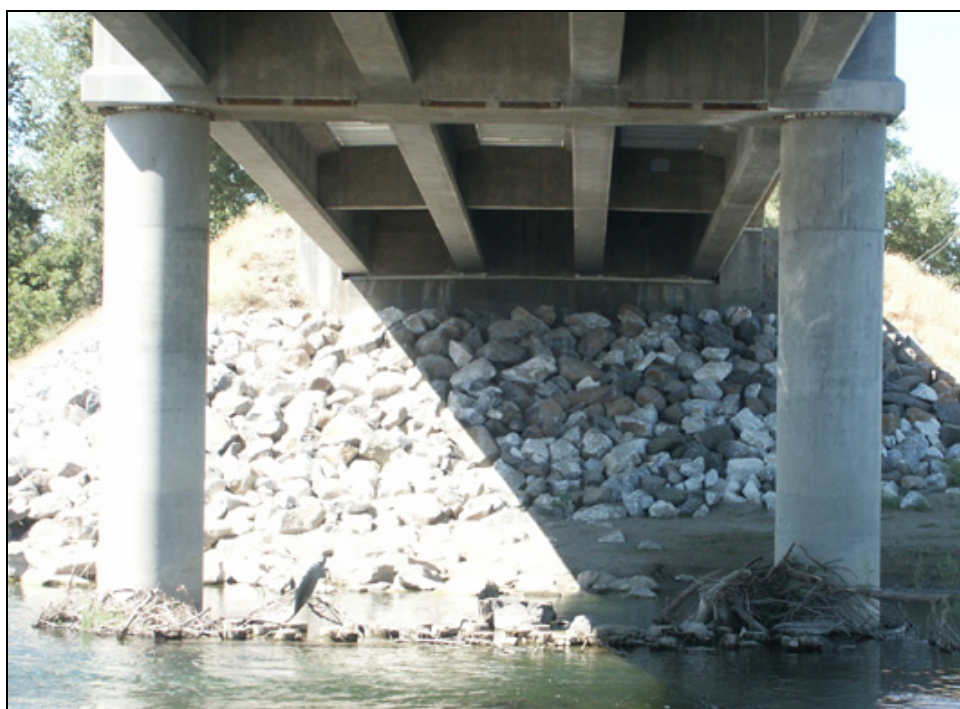
Photo 9. Bat crevices as installed in bents of new bridge. Photograph by William E. Rainey.

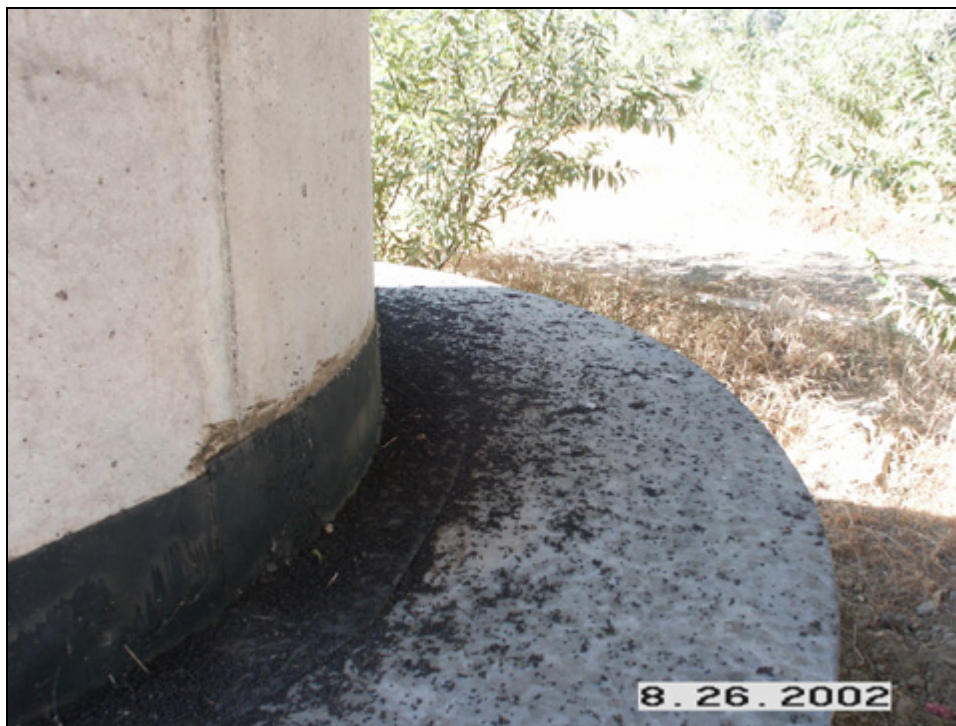
Photo 10. Guano below U.S. Interstate 5 collar roost, showing evidence of bat use. Photo by William E. Rainey.

U.S. Interstate 5 Interim Mitigation Roost. The four interim collar roosts installed on the I-5 bridge were modeled after an artificial roost design that had proven effective for *Myotis* species in the southeastern United States (Clawson and Gardner 1992, 1993). Because it can take up to three years for bats to occupy a new roost (Tuttle and Hensley 1993), the fact that bats were present within 5 months indicates this roost design has considerable potential (Photo 10). *E. fuscus*, *T. brasiliensis*, and a *Myotis* species roosted in these collars during the first year of installation. By the end of August, there were >200 *T. brasiliensis* using these sites. These roosts were removed once the new bridge was completed during the winter of 2002.

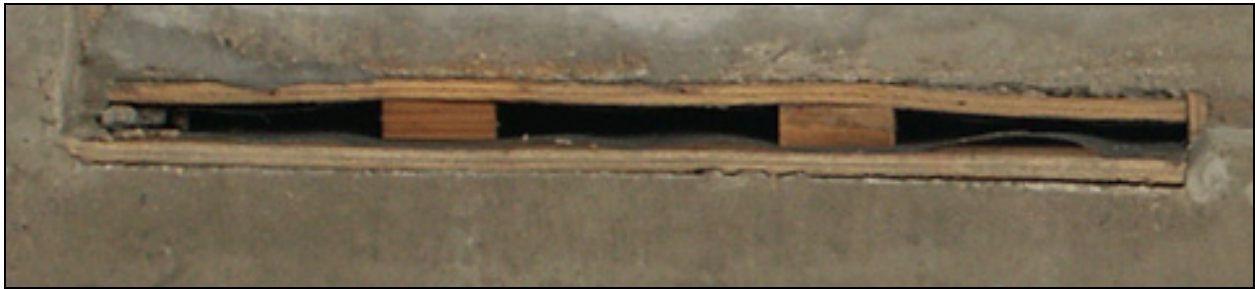
Photo 11. Bat crevice showing compression of plywood and buckling of polyurethane mesh. Photo by William E. Rainey.

Two minor problems were evident after installation. The contractor lined the bat boxes with a more open mesh material and used a lower density of staples for attachment than recommended by the consulting biologists. Consequently, in some cases, the mesh buckled into the cavity interior, partly occluding it. Also, a few of the refuge sites had experienced compression during installation (Photo 11).

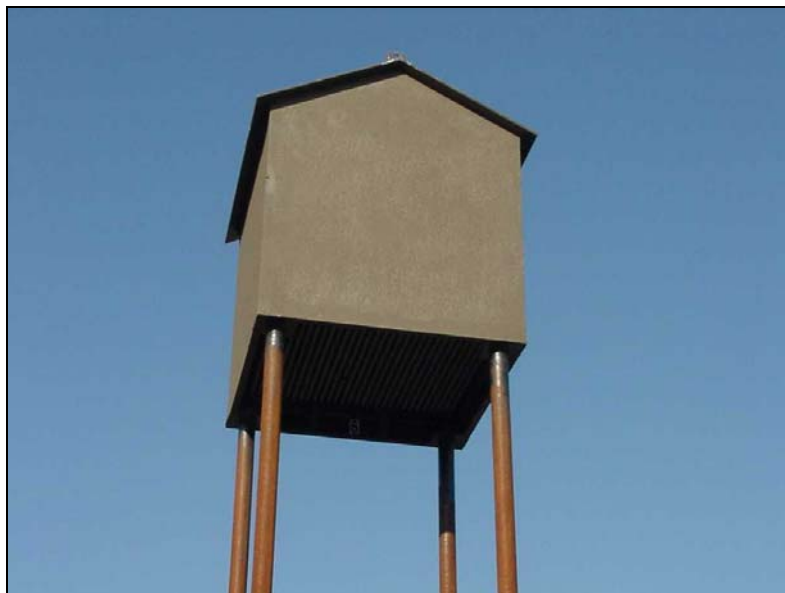
Photo 1. Bat House #6 at the Cosumnes Preserve, before modifications, used as temporary mitigation for lost roosting habitat. Photo by Eric Stackhouse.
