**CALIFORNIA BAT MITIGATION
TECHNIQUES, SOLUTIONS, AND EFFECTIVENESS**

California Department of Transportation (Caltrans)
Office of Biological Studies and Technical Assistance
Sacramento, California

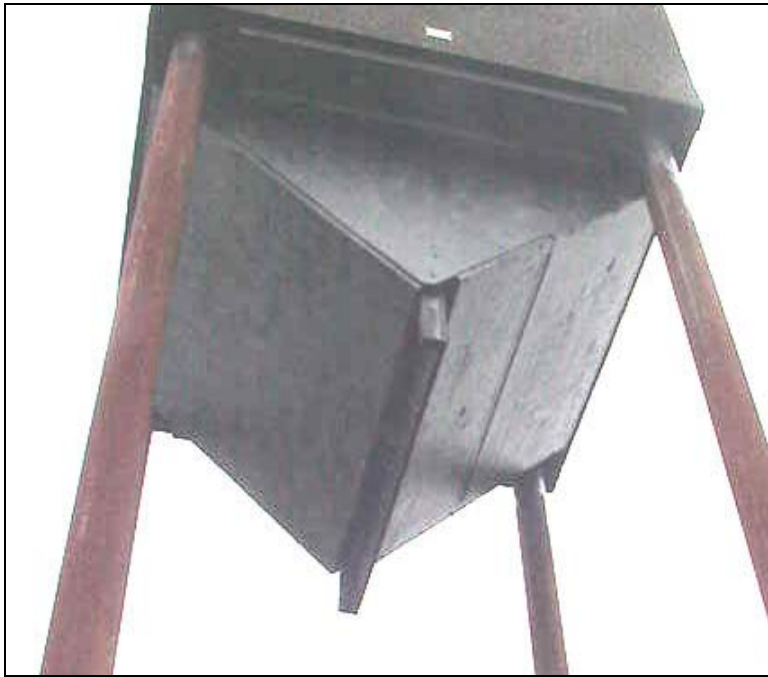
Photo 2. Bat House #6, with experimental modifications as of April 3, 2002 to hopefully increase use by bats for more successful mitigation results. Photo by Eric Stackhouse.

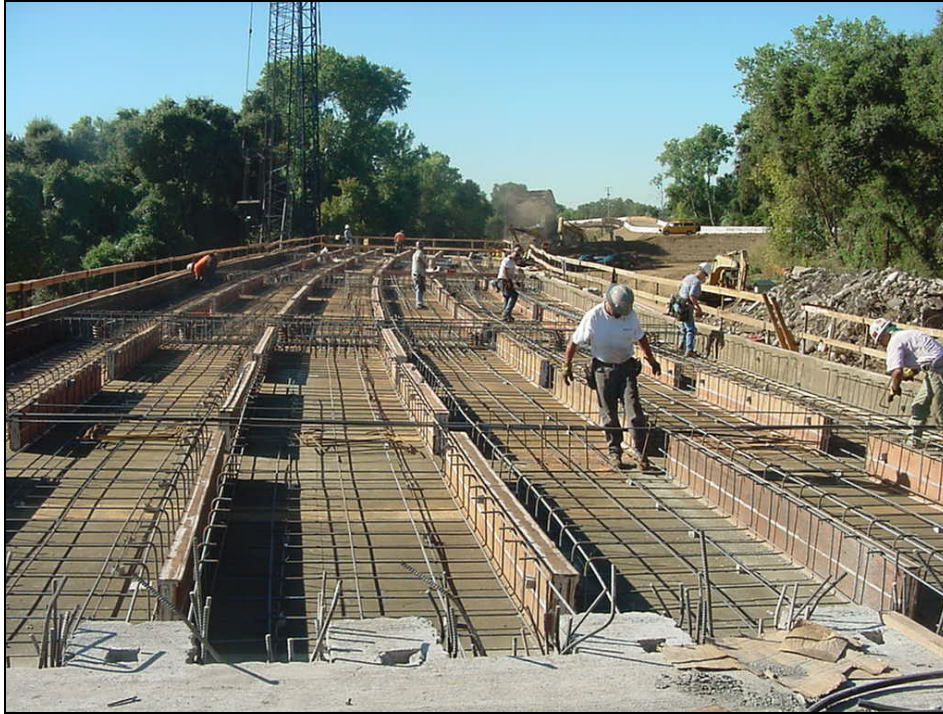
Photo 4. Placement of the roosting habitat inserts just prior to the pour. Photo courtesy Sacramento County Public Works.

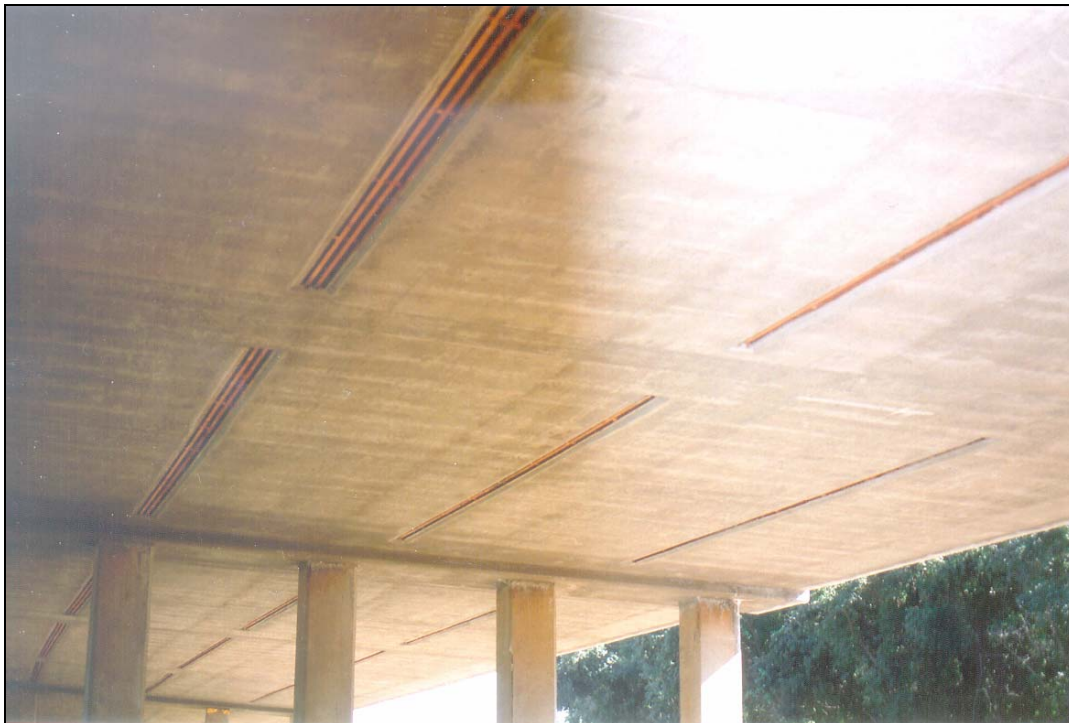
Photo 5. Section of completed bridge and causeway replacement with new roosting habitat. Three of the five rows of roosting habitat inserts are shown. The outer two rows of each side comprise two slots (crevices) and the third or middle cast-in-place insert has three slots. Photo by Dave Johnston.

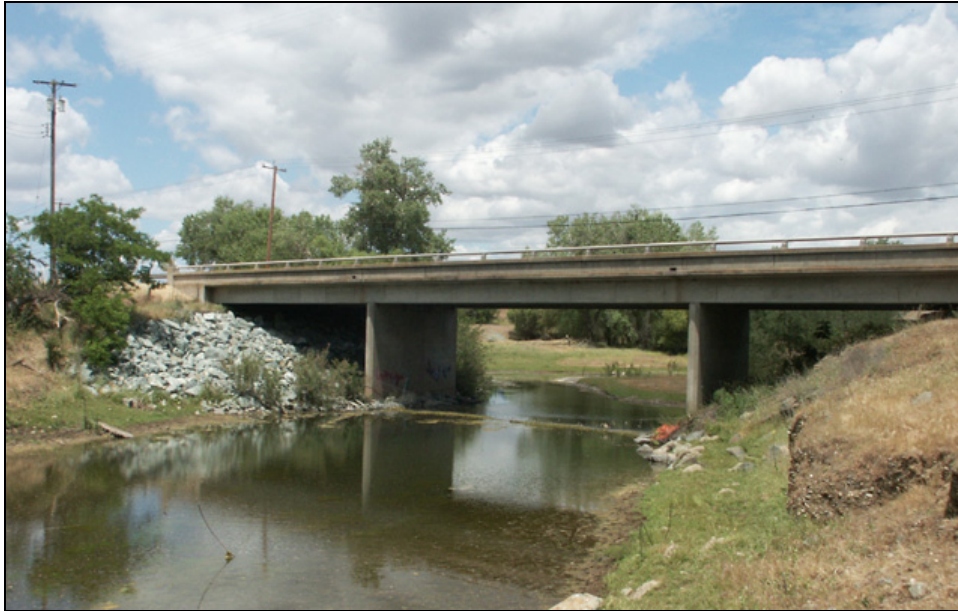
Photo 1. The SR104 Bridge over Dry Creek, Amador County. Photograph by Elizabeth D. Pierson.

This bridge over Dry Creek is located in Amador County, 3.5 km north of the town of Ione on State Route 104 – Bridge #26-007) (Photo 1).

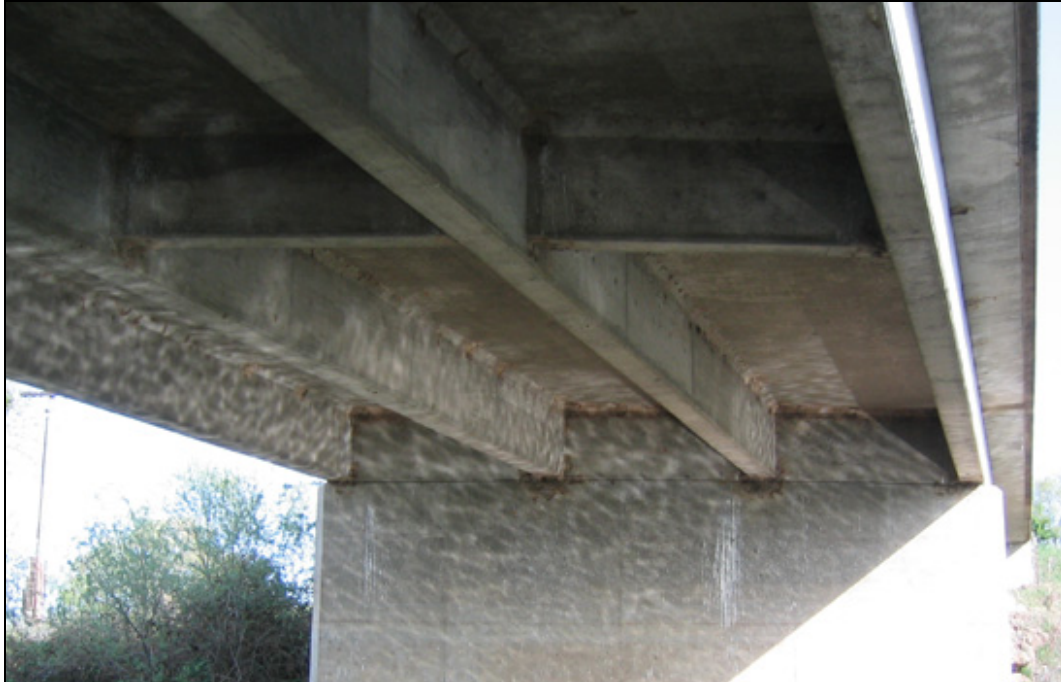
Photo 2. Underside of Dry Creek Bridge showing the concrete girder construction. Photograph by Elizabeth D. Pierson.

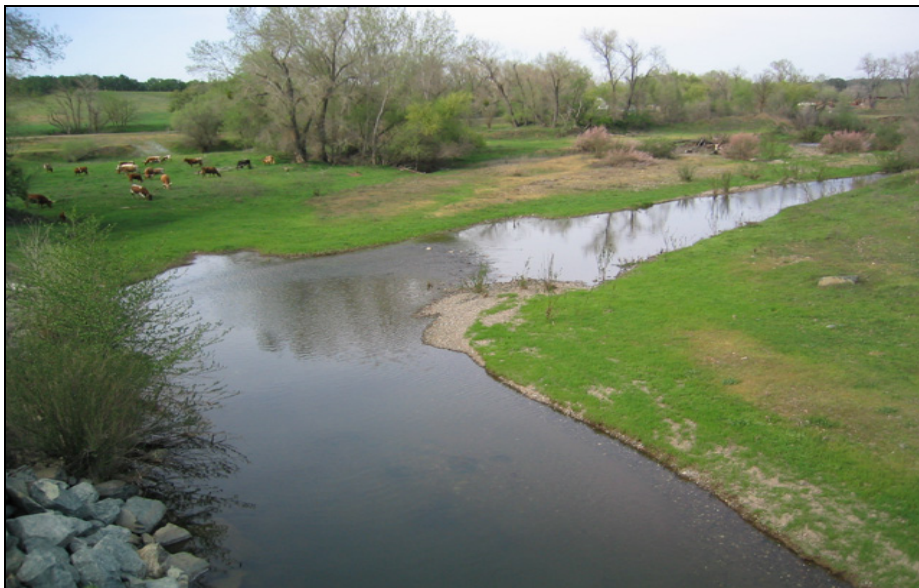
Photo 3. View of habitat looking north from the Dry Creek Bridge. Photograph by Elizabeth D. Pierson.

Cottonwood riparian, oak savannah, and non-native grassland near this site provided habitat for pallid bats (Photo 3).

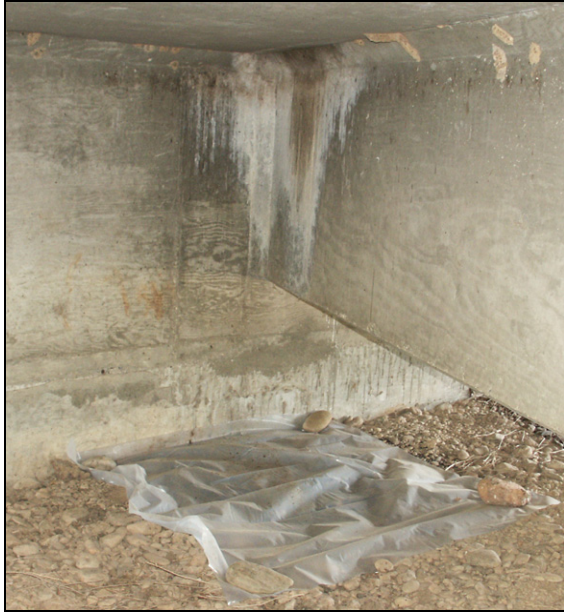
Photo 5. Plastic sheeting placed below night roost to collect guano and culled insect parts. Photograph by Elizabeth D. Pierson.

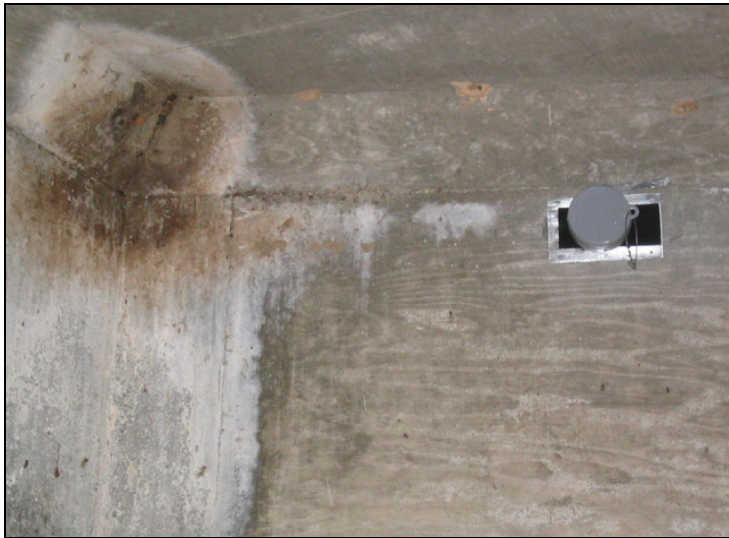
Photo 6. Temperature logger inside tin can, secured to bridge surface with Velcro, placed adjacent to stained area of night-roost. Photograph by Elizabeth D. Pierson.

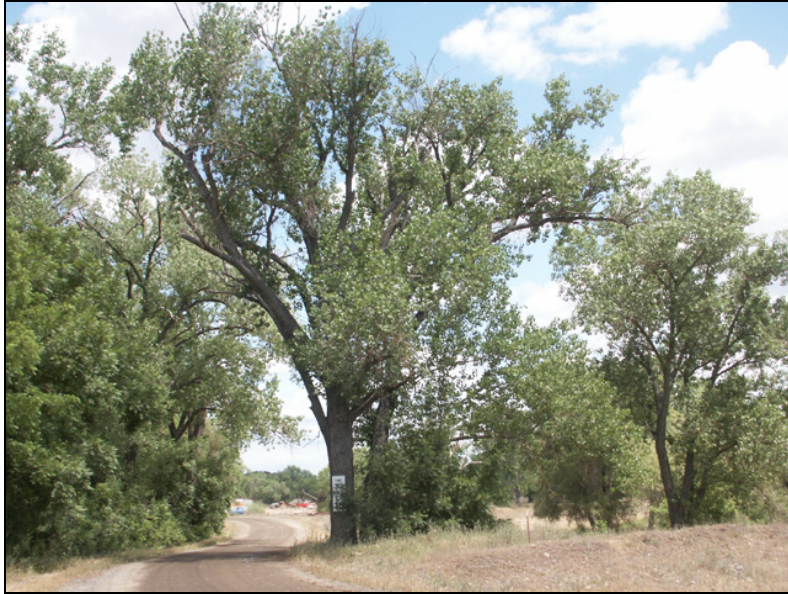
Photo 7. Cottonwood tree that was the primary day roost for radio-tagged pallid bats. Photograph by Elizabeth D. Pierson.

Radio-tracking Study. Five different day roosts were identified during the radio-tracking study: four trees (cottonwood and valley oak) and one private dwelling. All roosts were located between 0.15 and 2.8 km from the night-roost. The primary roost was an old cottonwood tree located about 150 m upstream from the bridge, where the bats were roosting in a cavity formed at a broken limb about 6 m above the ground (Photo 7).

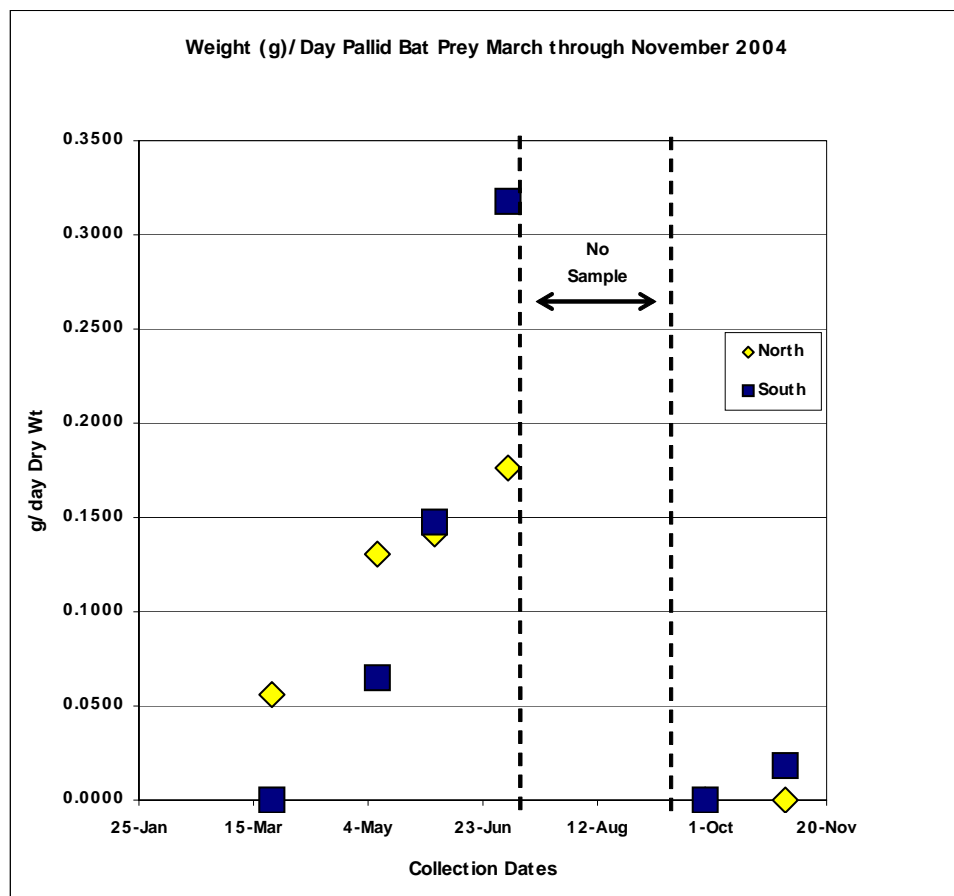
Figure 1. Scatter plot showing the g/day dry weight of prey items collected from beneath pallid bat roosting sites under Dry Creek Bridge. North and south ends of the bridge are depicted separately. The interval of no sampling reflects the removal of all sampling equipment on July 5 in anticipation of the beginning of construction. It was replaced at the south end of the bridge only on September 14.

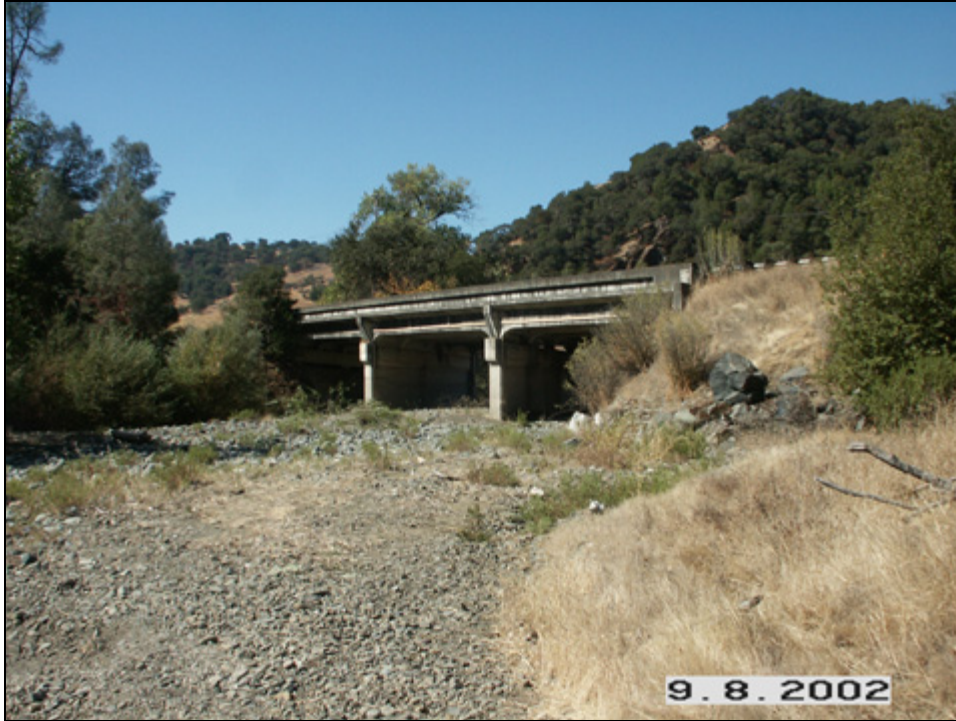
Photo 1. SR101 Bridge 10-83 over Pieta Creek, showing surrounding oak habitat. Photograph by William E. Rainey

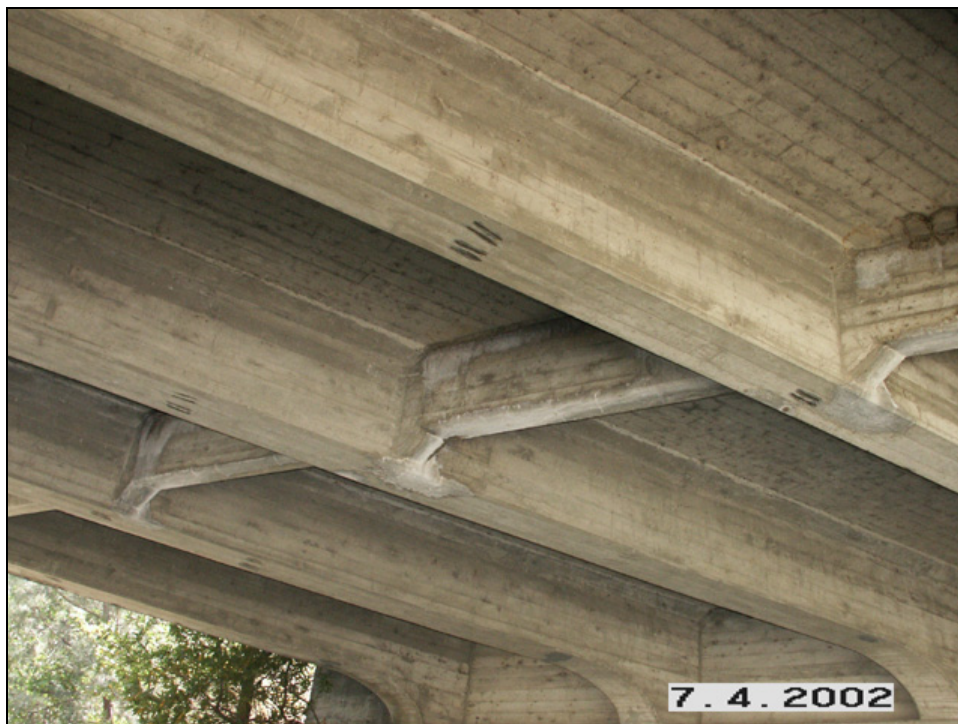
Photo 2. Concrete girder construction, and urine staining from pallid bats.
Photograph by William E. Rainey

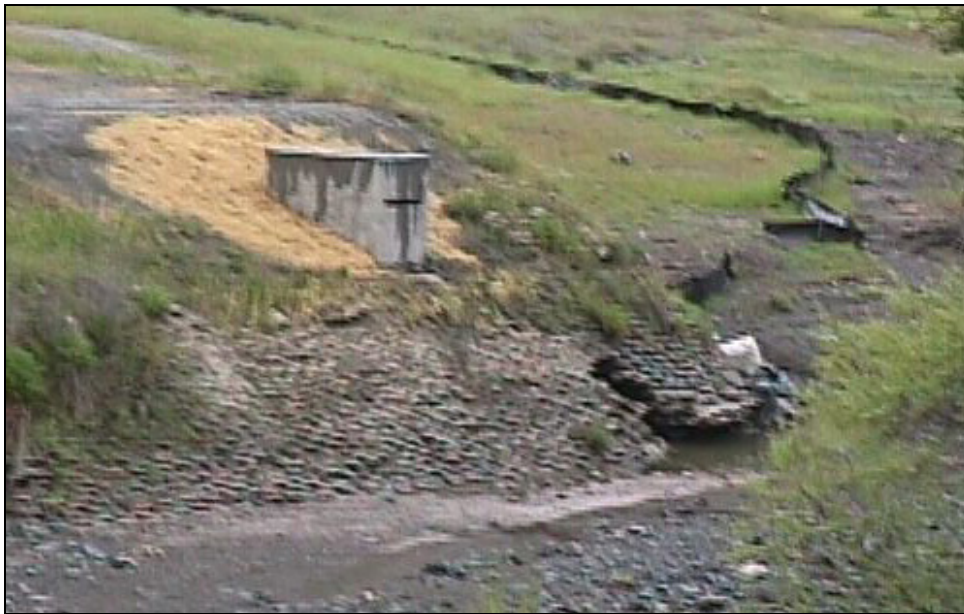
Photo 3. Mitigation roost at site of old bridge abutment. Photograph by Caltrans Staff.

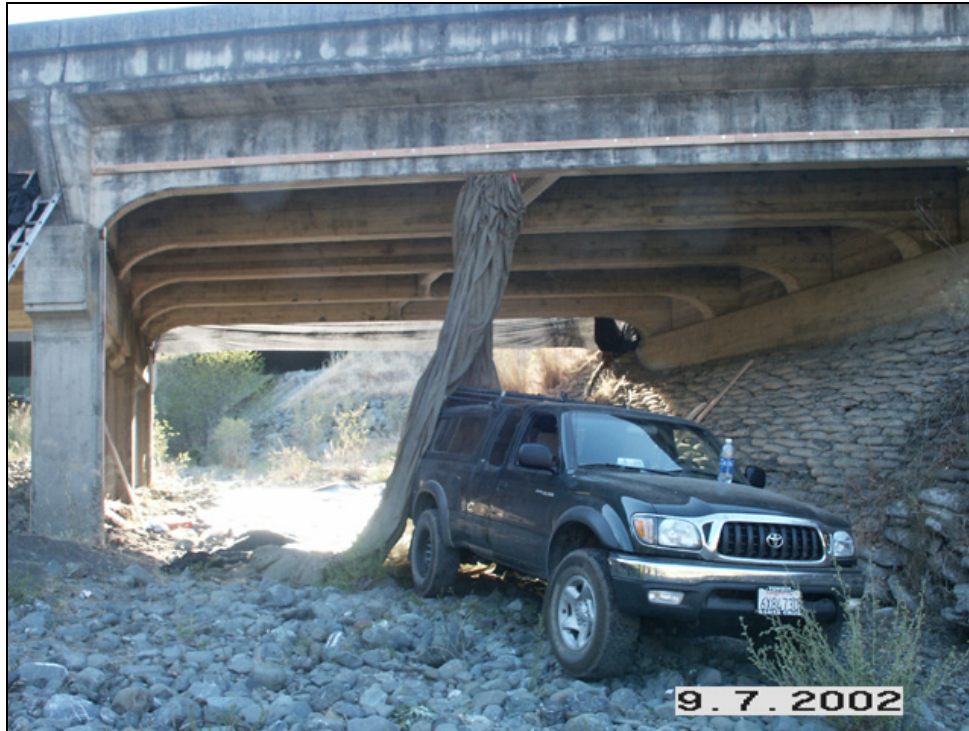
Photo 4. Curtain made from parachute silk, used to contain bats within night roost and facilitate capture. Photograph by William E. Rainey
