FINAL REPORT • APRIL 2015

Cow Creek and Mill Creek Riparian Mapping and Conditions Assessment

ABSTRACT

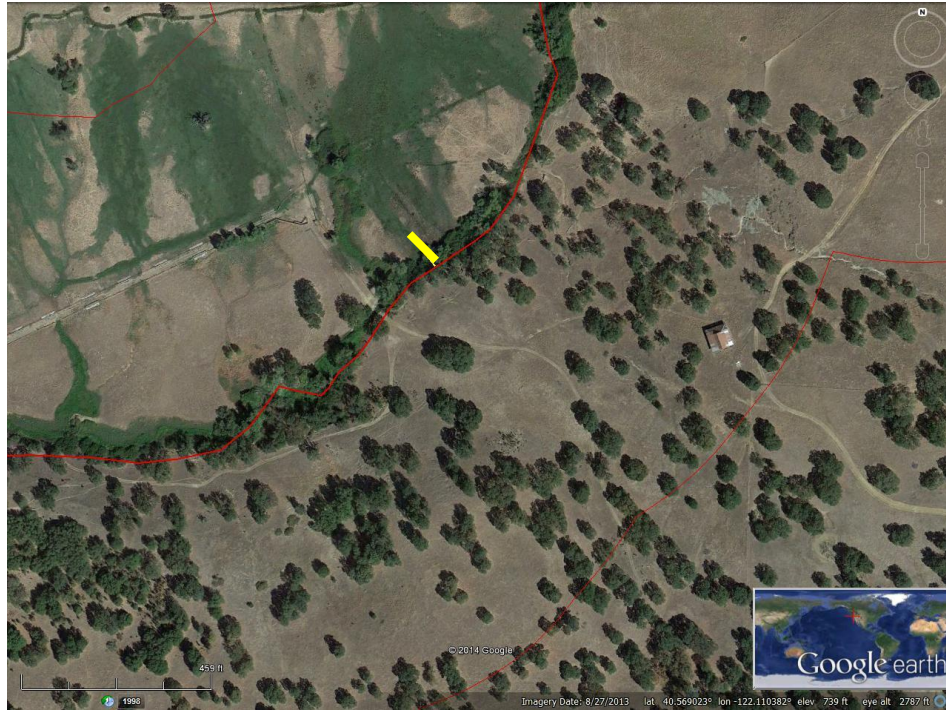
Figure 5-3. Low density oak woodlands in landscape surrounding Basin Hollow riparian area in Cow Creek watershed have naturally low woody vegetation cover within the 100-ft buffer (yellow line).

Careful review of imagery in conjunction with the GIS summary data revealed that the most informative GIS-derived information on reach condition was percent of buffer area dominated by non-native vegetation. As mentioned above in section 5.2.3. GIS analysis, other summary data on the riparian vegetation map attributes were not consistently indicative of observed riparian vegetation conditions. For example, percent of buffered area mapped as woody vegetation could be low in healthy reaches that naturally had very low vegetation cover, such as low density oak woodland areas in the mid-elevation reaches of Basin Hollow (Figure 5-3). Similarly, vegetation height was not indicative of riparian conditions since some areas were surrounded by native shrublands while others supported (native or non-native) forests (Figure 5-4).

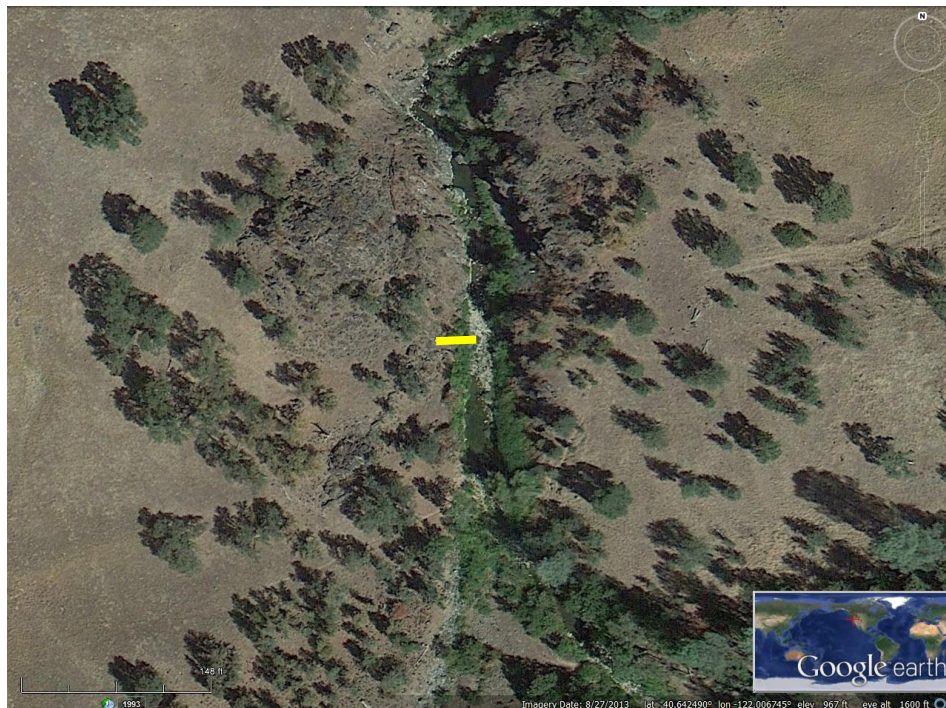
Figure 5-4. Low density oak woodlands with narrow strip of riparian shrubs in landscape surrounding upper Clover Creek riparian area in Cow Creek watershed have naturally low woody vegetation cover low and stature shrubs within the 30 ft buffer (yellow line).

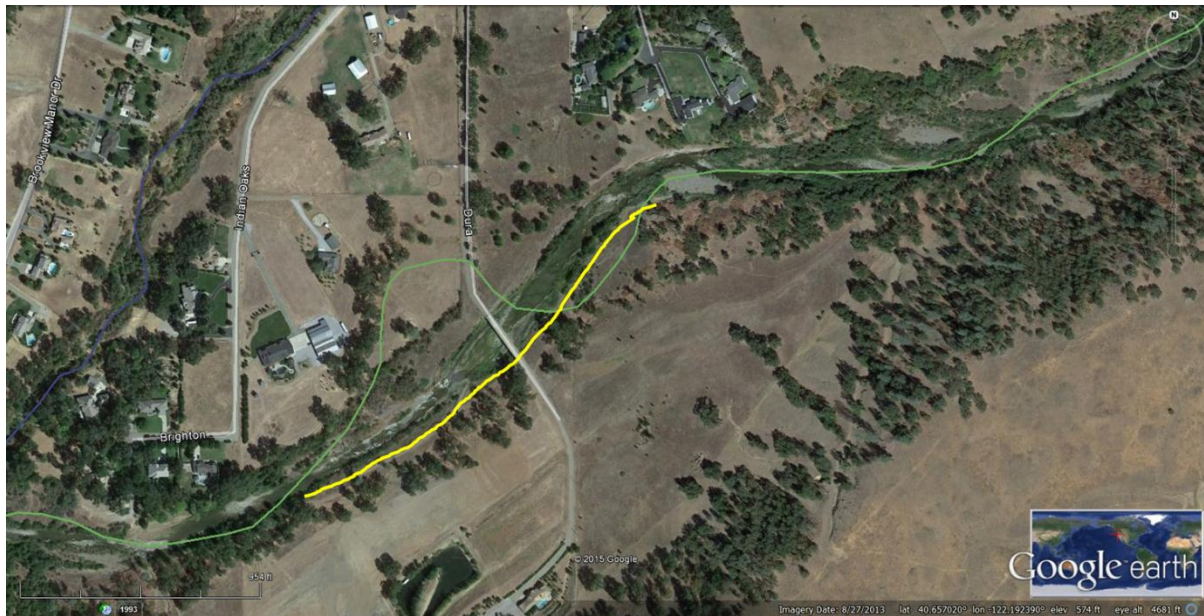
Figure 6-3. Condition reach 2c, site 1 along Little Cow Creek. Recommendation is to protect floodplain and banks and explore options to increase woody riparian cover along the south bank.

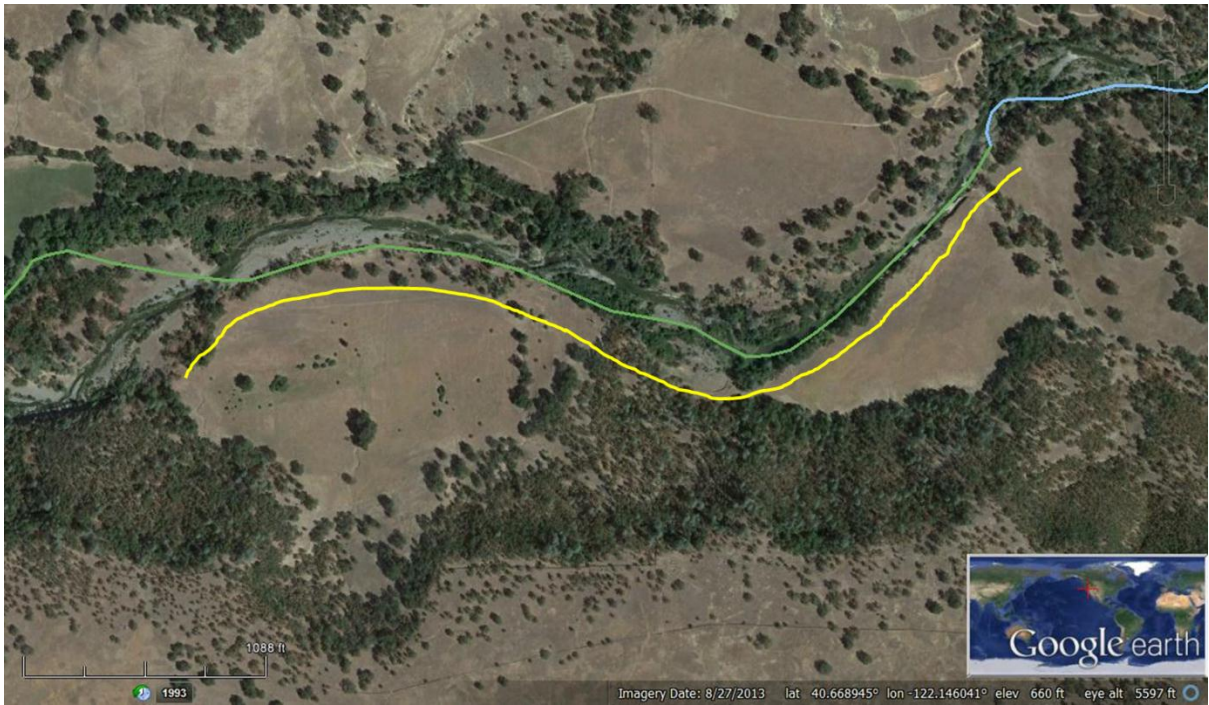
Figure 6-4. Condition reach 2c, site 2 along Little Cow Creek. Recommendation is to work with landowners to exclude cattle from within 100 ft of channel along south bank.

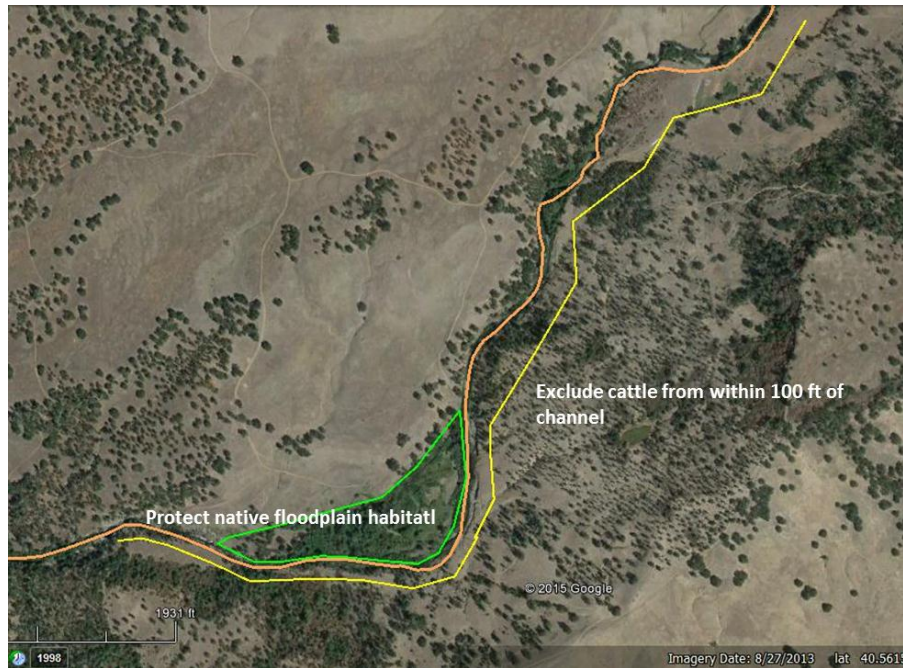
Figure 6-5. Condition reach 6a along lower Old Cow Creek. Recommendation is to exclude cattle from within 100 ft of channel on the river left (south side of channel) and to protect existing excellent floodplain habitat on a section of the river right.

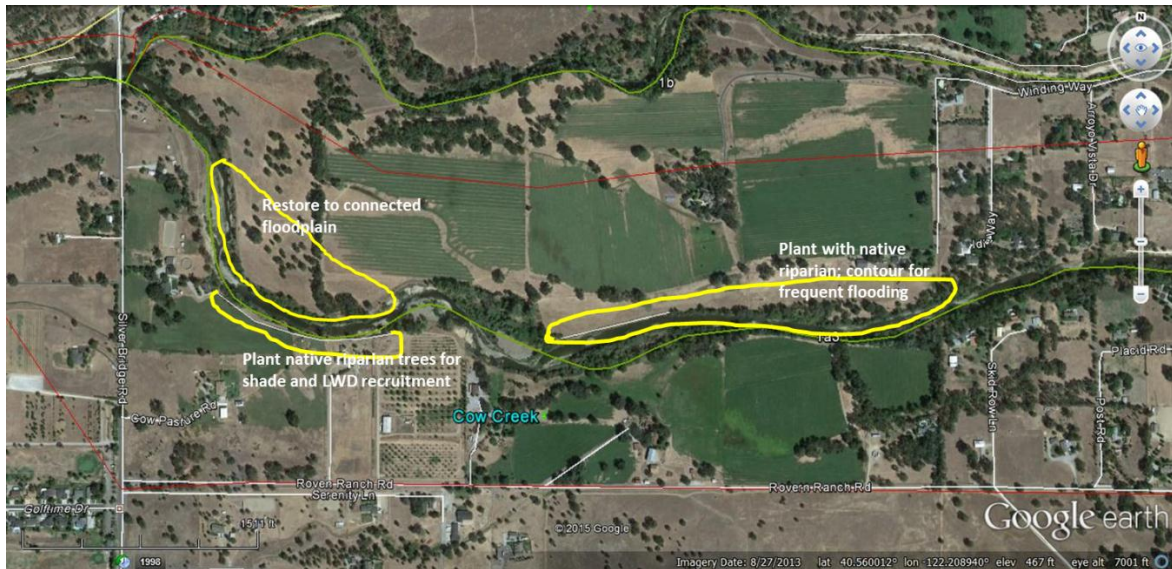
Figure 6-8. Condition reach 1a3 on South Cow Creek below Clover Creek confluence, recommended priority area sites 1, 2 and 3 (upper left, lower left, and right, respectively).

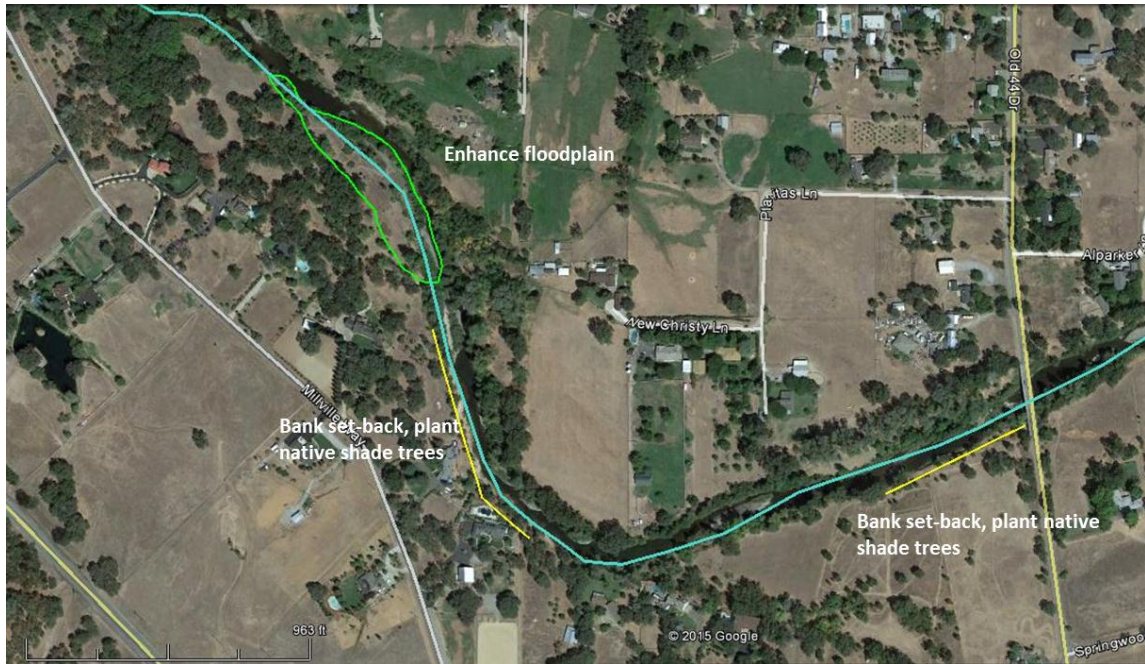
Figure 6-10. Condition reach 1a4 on South Cow Creek sites 2, 3, and 4 (left to right) recommended priority areas.

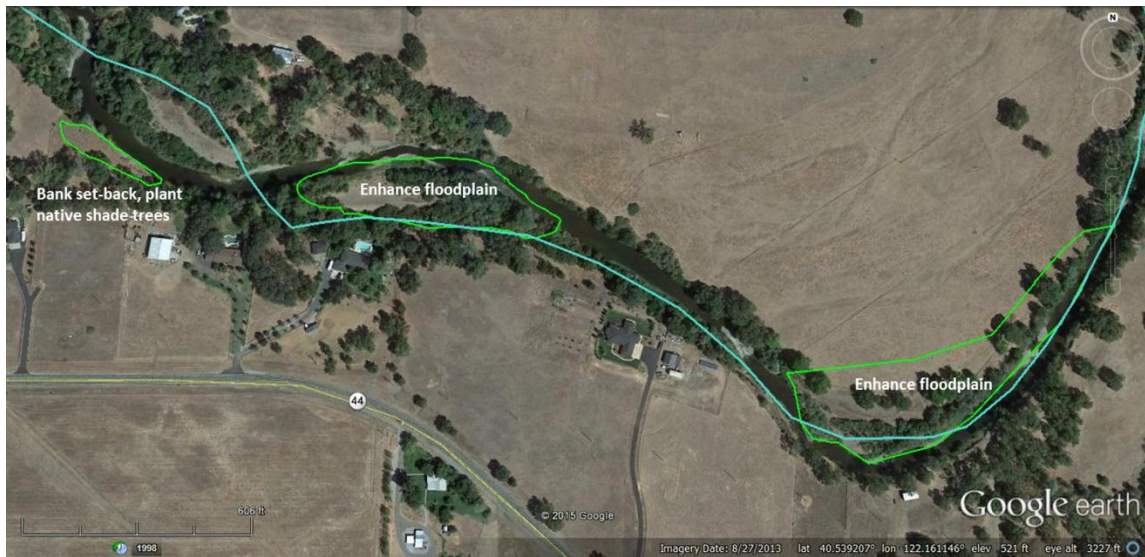
Figure 6-11. Condition reach 1a4 on South Cow Creek sites 5, 6, and 7 (left to right) recommended priority areas.

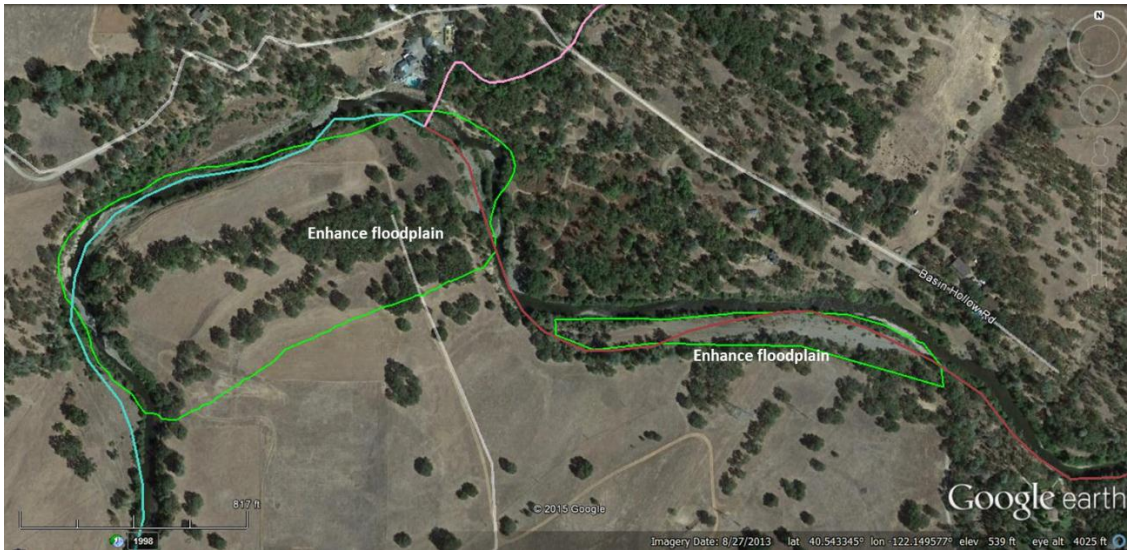
Figure 6-12. Condition reach 1a4 on South Cow Creek sites 8 and 9 (left to right) recommended priority areas.

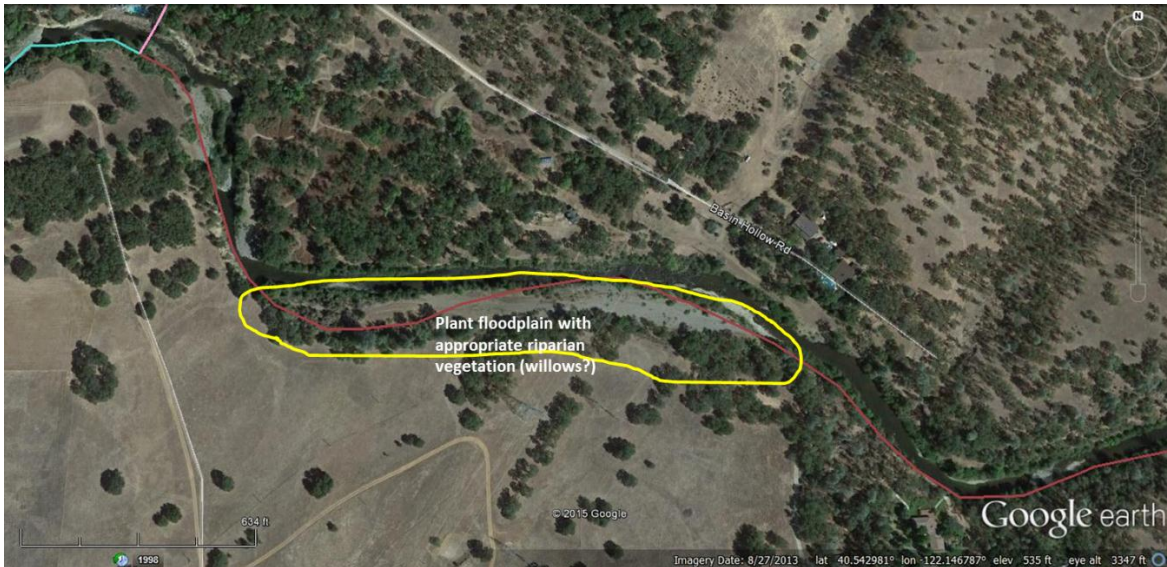
Figure 6-13. Condition reach 7a. Recommended priority management area along South Cow Creek below Old Cow Creek confluence.

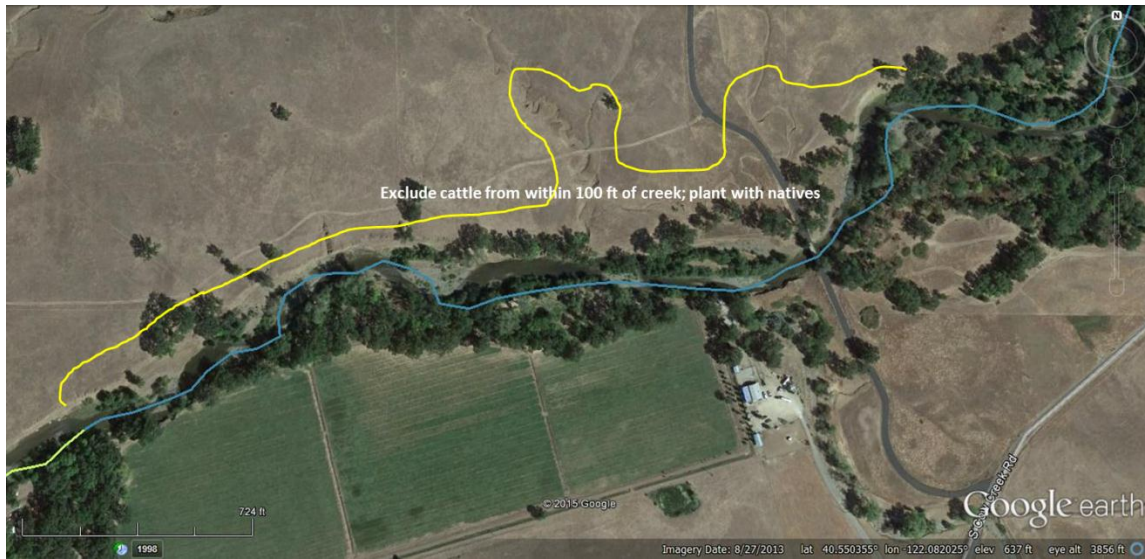
Figure 6-16. Condition reach 7c, site 1 along South Cow Creek above Old Cow Creek confluence. Recommended action is to exclude cattle from within 100 ft of channel on river right.

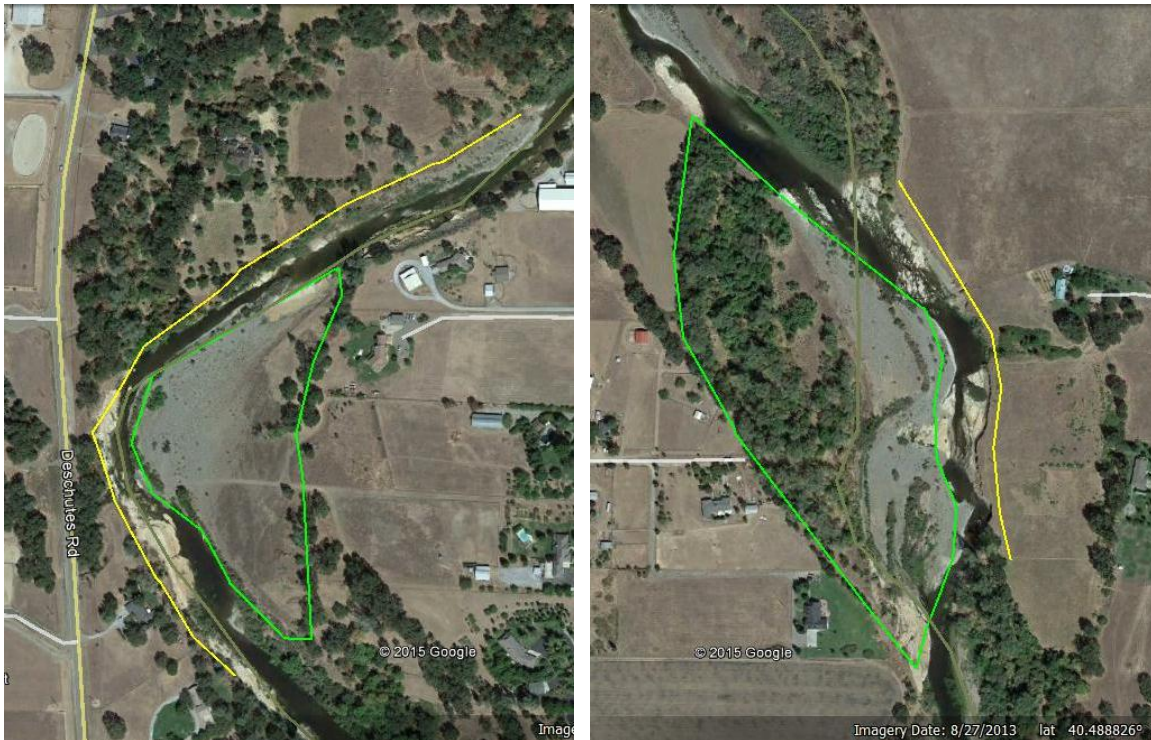
Figure 6-18. Condition reach 1a sites 3 and 4 (left), and 7 and 8 (right) along lower Mainstem Cow Creek. These are examples of areas where existing floodplains could be protected and enhanced, and eroding channel banks set back and or planted, according to findings on local processes and needs.

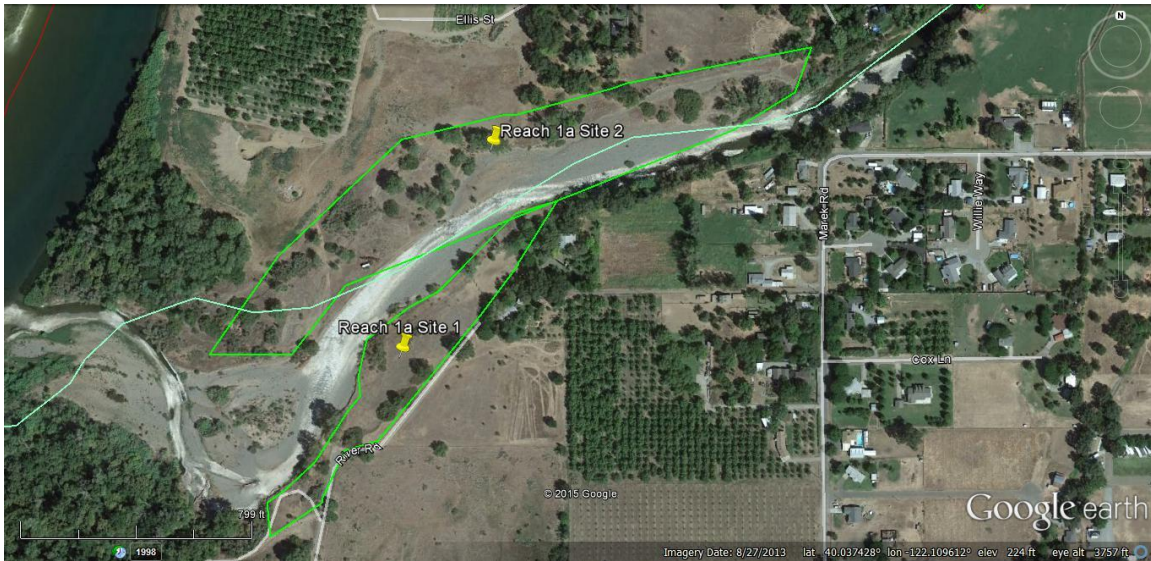
Figure 6-19. Mill Creek condition reach 1a sites 1 and 2 (lower and upper, respectively).
(Google imagery date 8/27/2013)

Recommended priority areas to protect, enhance, and /or restore along condition reach 1a, between Highway 99 and the Sacramento River are pictured in Figures 6-19 and 6-20.

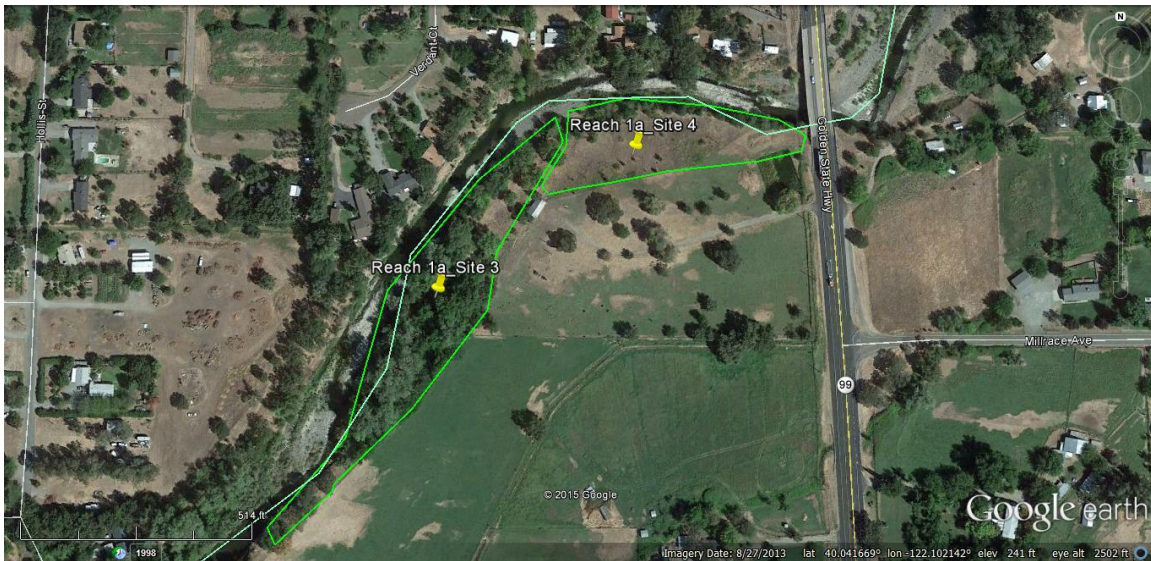
Figure 6-20. Mill Creek condition reach 1a sites 3 and 4 (lower and upper, respectively).
(Google imagery date 8/27/2013)

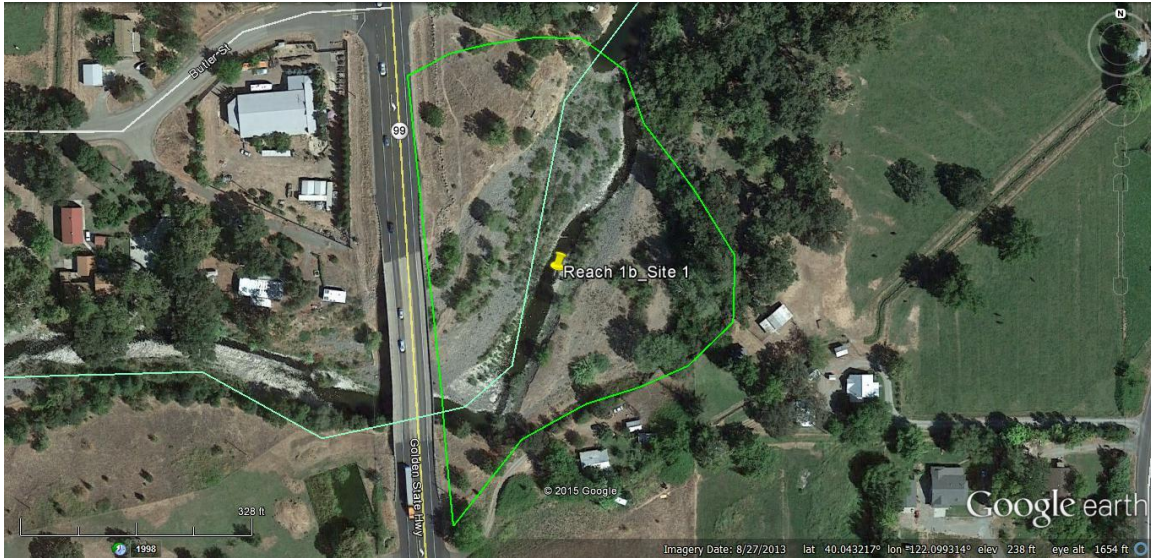
Figure 6-21. Mill Creek condition reach 1b site 1. *Arundo* eradication and enhancement of existing native riparian vegetation is recommended. (Google imagery date 8/27/2013)

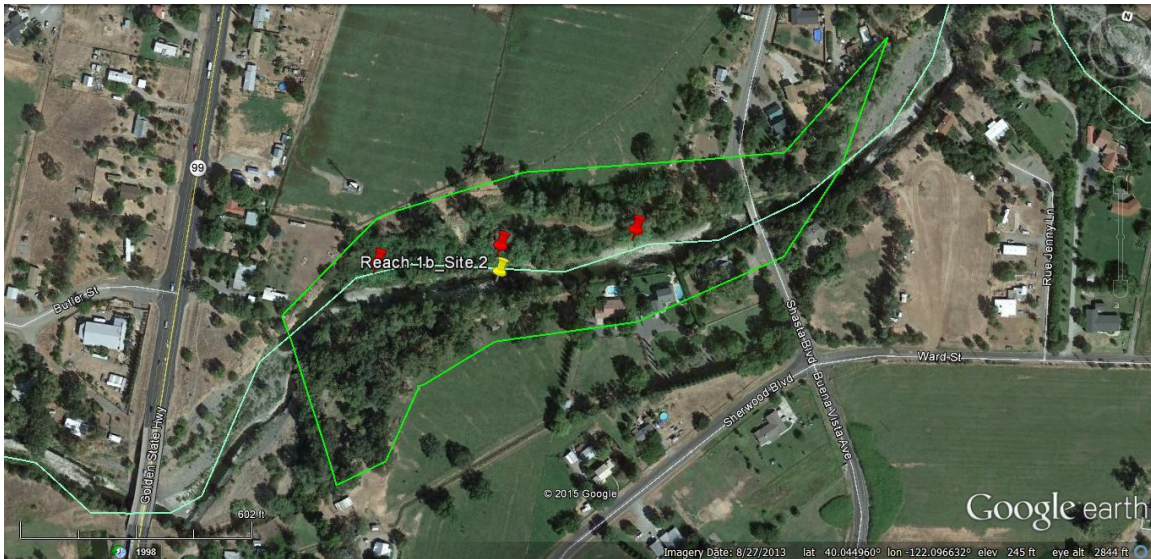
Figure 6-22. Mill Creek condition reach 1b site 2, with recommendations to enhance existing vegetation and to eradicate invasive weeds (*Arundo* locations shown with red pins). (Google imagery date 8/27/2013)

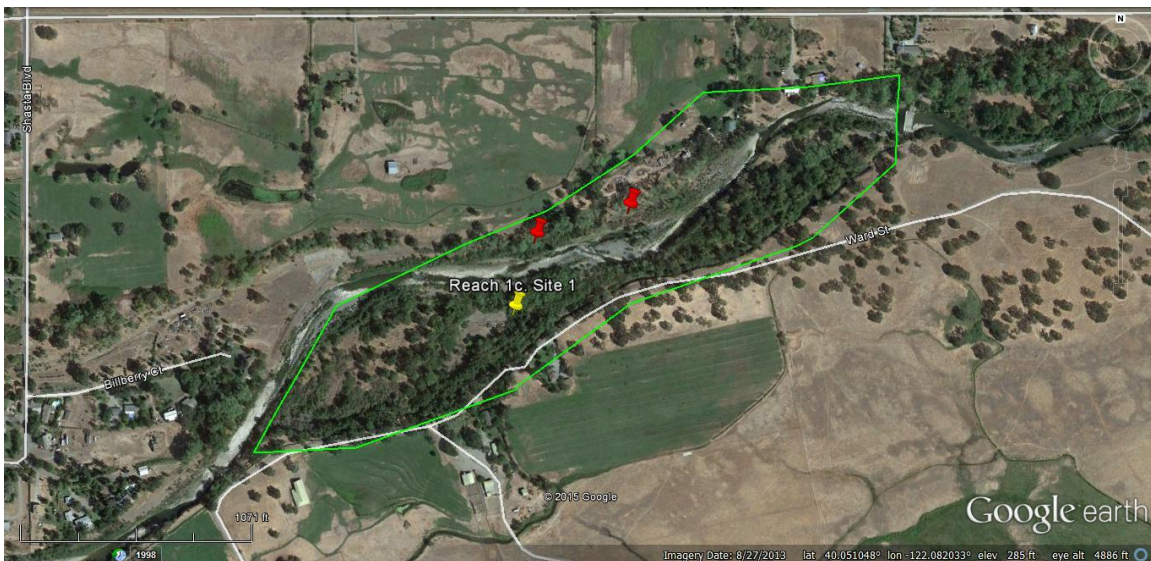
Figure 6-24. Mill Creek condition reach 1c site 1, with recommendations to enhance existing vegetation and to eradicate invasive weeds (*Arundo* locations shown with red pins). (Google imagery date 8/27/2013)

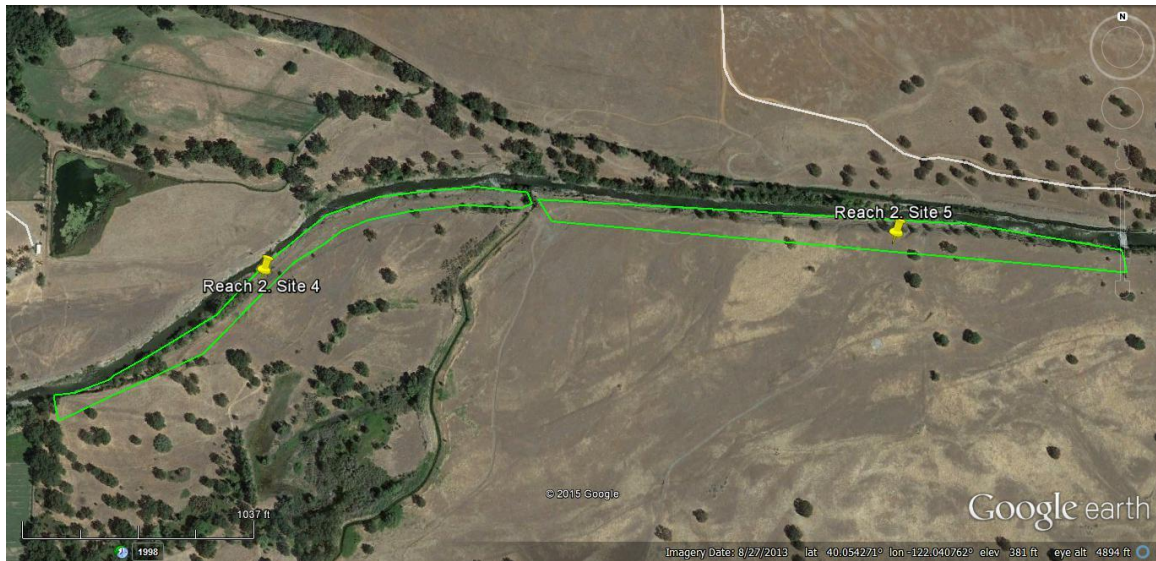
Figure 6-27. Mill Creek condition reach 2 sites 4 and 5, with recommendations to enhance existing vegetation, work with the landowner to exclude grazing from within 100 ft of the channel edge, and to consider planting shade trees along the southern channel bank. (Google imagery date 8/27/2013)

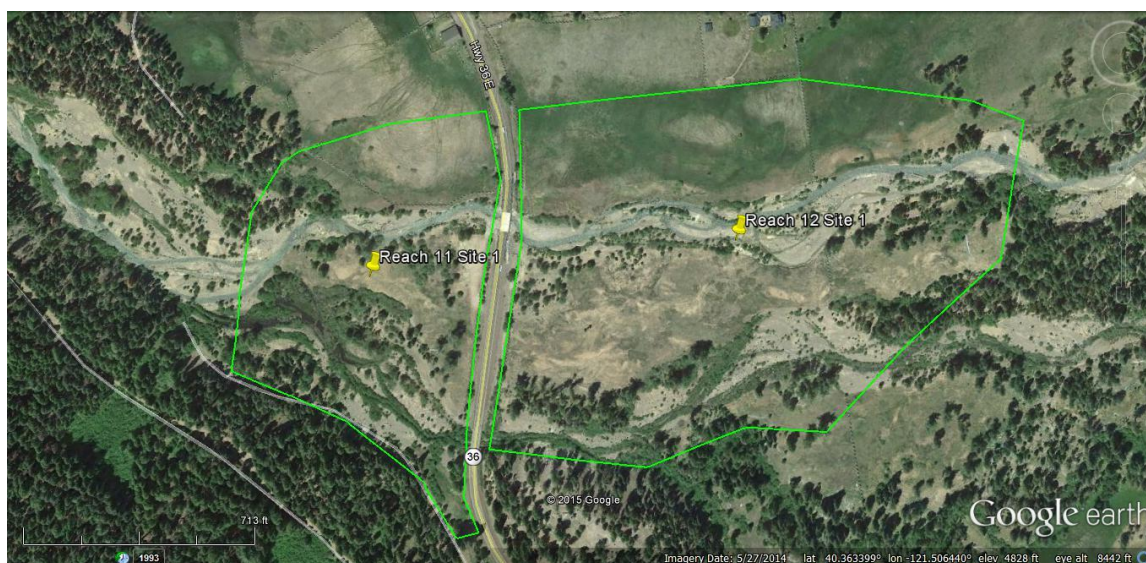
Figure 6-29. We recommend a closer review of the geomorphic, hydrologic and vegetation conditions along the stream channel and meadows above and below highway 36; part of condition reach 11 (below 36 to the left) and 12 (above 36 to the right).

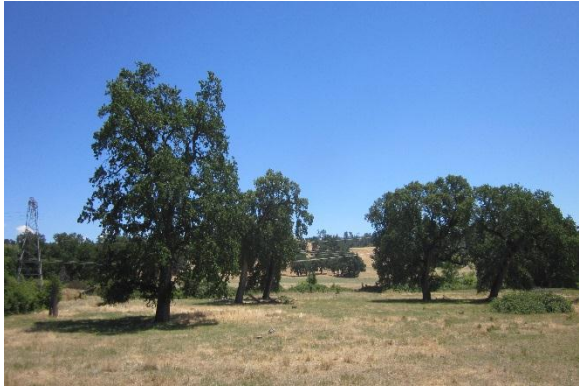
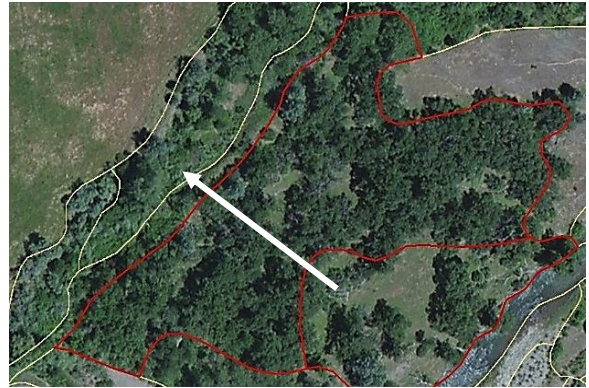
1313—*Quercus lobata* Alliance

The *Quercus lobata* Alliance occurs throughout Cow Creek Watershed and only in the lower most elevations of Mill Creek. The Alliance is mapped where *Q. lobata* dominates or co-dominates the stand, generally with *Populus fremontii* and/or *Alnus rhombifolia*. Stand cover ranges from open savannah like settings to dense woodlands where it occurs with *A. rhombifolia* in rather narrow bands. Stands occur in both riparian and upland settings.

Q. lobata tends to have a large crown with low- to mid-stem multiple branching throughout. Crowns are more open and irregularly shaped than interior live oak and are generally lighter green. Sites occur on fairly deep soils, especially where *Q. lobata* dominates.

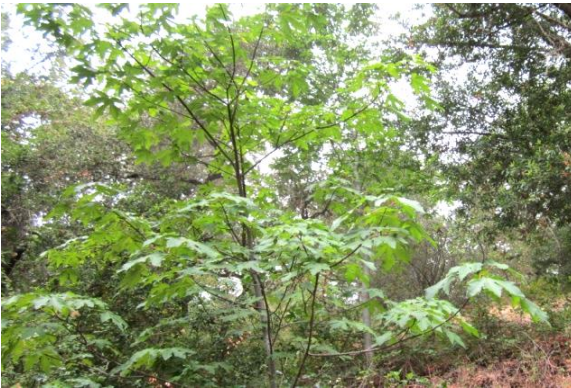
2111—*Acer macrophyllum* Alliance

This Alliance occurs on narrow steep north trending canyons adjacent to a 5-mile segment of Mill Creek from the 3200' level up to where Mill Creek bends due north around 3800'. Only 16 acres of this type were mapped in the study area. This Riparian Alliance occurs adjacent to stands of *P. ponderosa* and *P. menziesii* on both sides of the watershed.

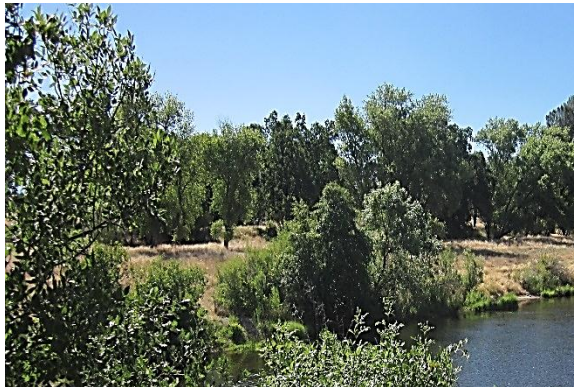
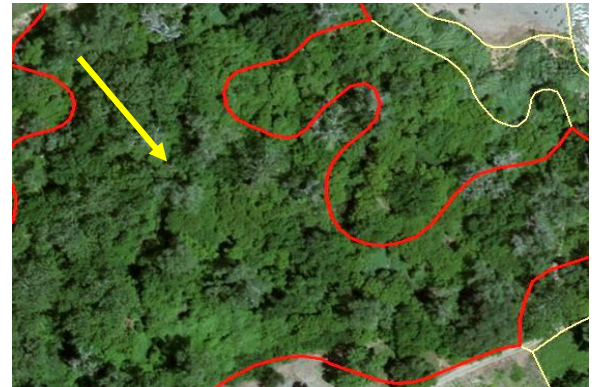
3110—*Populus fremontii* Alliance

Populus fremontii dominates or co-dominates the hardwood canopy in this Alliance in moderate to dense cover. *Salix* spp. is characteristically present as in the example above. *Q. lobata* can be present in the canopy, but only in small numbers.

Populus fremontii has a somewhat variable signature depending on the age of the stand. More mature stands have a grayish green hue and are not as brightly colored as other riparian species commonly comingling such as *Platanus racemosa* or *Acer negundo*. When *Salix* spp. are present in the stand, they can be separated out from *P. fremontii* by the individual crown density (mature willows having the denser crown).

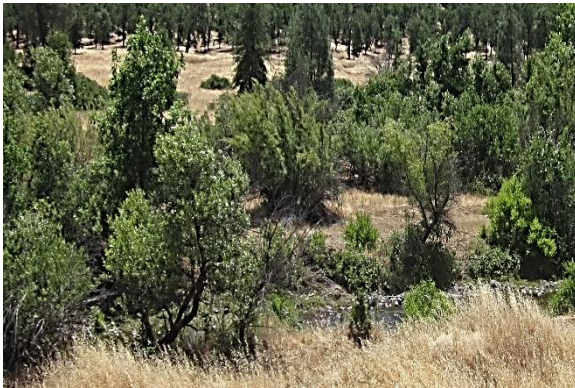
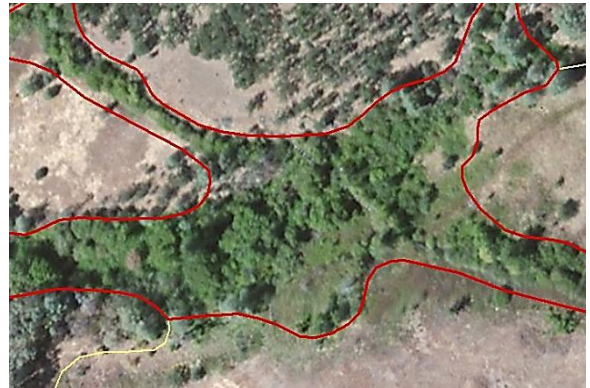
3111—*Salix laevigata* Alliance

Salix laevigata dominates the hardwood canopy in this Alliance in moderate to dense cover. *Salix lasiolepis* can co-dominate in the stand; generally in a lower stature understory. *Populus fremontii* can be present in the canopy but does not co-dominate. Stands were mapped in generally more dynamic settings than *P. fremontii*, usually in slightly more flooded moisture regimes.

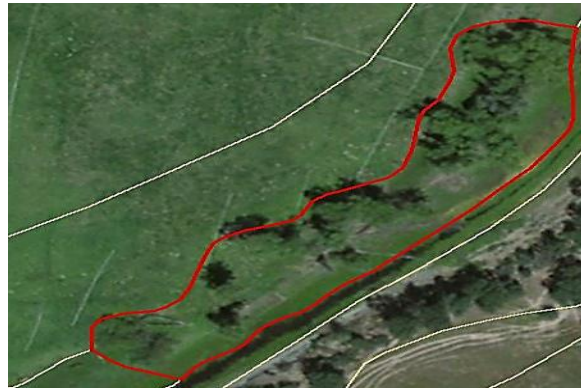
3111—*Salix gooddingii* Alliance

Salix gooddingii dominates the hardwood canopy in this Alliance in moderate to dense cover. Only 8 polygons totaling approximately 12 acres have been mapped to the Alliance level. This type could be more common in the mapping area but was observed infrequently during field reconnaissance. Noted as a component to the *Salix laevigata* and *Populus fremontii* Alliance throughout their range along the lower most reaches of both watersheds.

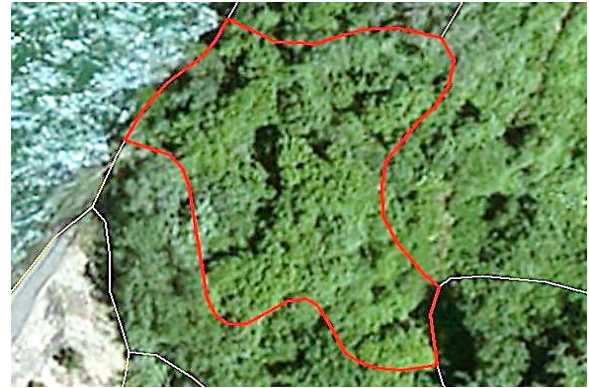
3114—*Acer Negundo* Alliance

Acer negundo rarely forms stands in the watersheds but is frequently a fairly common component to lower elevation well developed riparian forests and woodlands. Several polygons in the lower reaches of Mill Creek watershed have been pulled out from existing larger stands of *Populus fremontii*. In these small stands, *A. negundo* strongly dominates the riparian canopy.

Acer negundo generally yields one of the brighter green signatures of the Riparian Alliances but can easily be confused with other types that occasionally form stands such as *Fraxinus latifolia*. Stands in the mapping area generally occur at lower elevations than stands defined to the *Fraxinus latifolia* alliance.

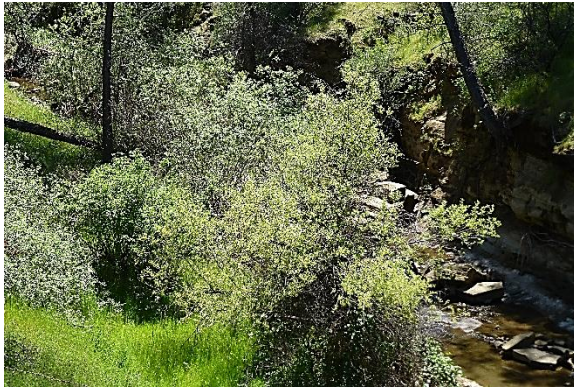
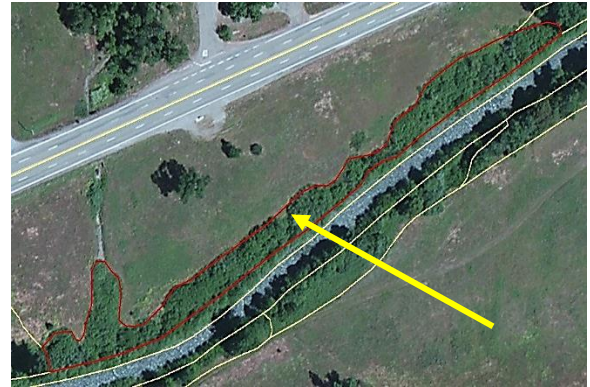
3115—*Salix lasiolepis* Alliance

Salix lasiolepis occurs in dense cover as a tall shrub mainly in all but the lowest reaches of Cow Creek watershed. *Salix lasiolepis* strongly dominates the canopy; emergent tree willows can be present as an inconsistent cover. *Salix exigua* occasionally co-dominates the stand. This Alliance tends to form along the outer margins of forested riparian types.

Signature generally remains fairly even across the stand in dense settings; color and texture tends to vary more in open disturbed settings. The sample picture above depicts a dense even-age stand almost entirely populated with *Salix lasiolepis*.

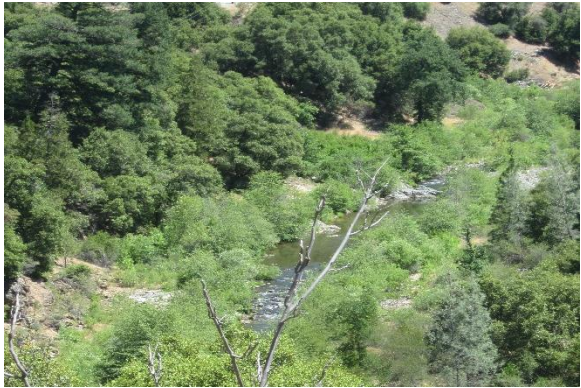
3210—*Alnus rhombifolia* Alliance

The *Alnus rhombifolia* Alliance is frequently mapped along the margins of the perennial stream channels where it occurs in very narrow bands, often as the sole riparian tree in the stand. Cover is characteristically dense, but can be lower in disturbance settings. Distribution of this Alliance is widespread, occurring in all regions except the lower most reaches of Cow Creek watershed and the upper third of Mill Creek watershed. It is uncharacteristically absent from most of the Oak run, possibly due to the low gradient along the waterway and/or the high amount of disturbance along this tributary.

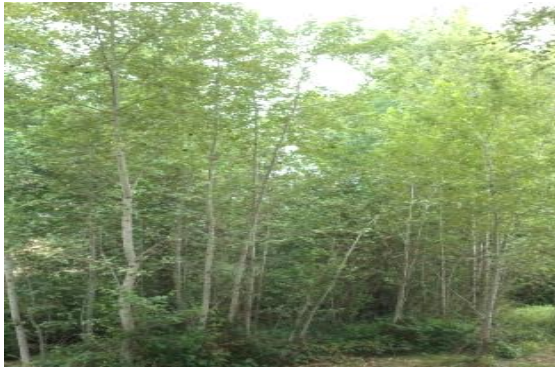
3312—*Populus trichocarpa* Alliance

Populus trichocarpa is found in the upper Mill Creek watershed in the vicinity of Childs Meadows to the south of Lassen National Park. Stands are dominated by *Populus trichocarpa* in open to moderately dense cover and at times have a minor component of *Pinus jeffreyi* in the canopy as depicted in the above image. Stands often are adjacent to mesic low gradient riparian meadows and may form boundaries along the drier margins of *Alnus incana* thickets. Polygons appear to be mapped in well drained settings. About 45 acres of this uncommon type were mapped in the study.

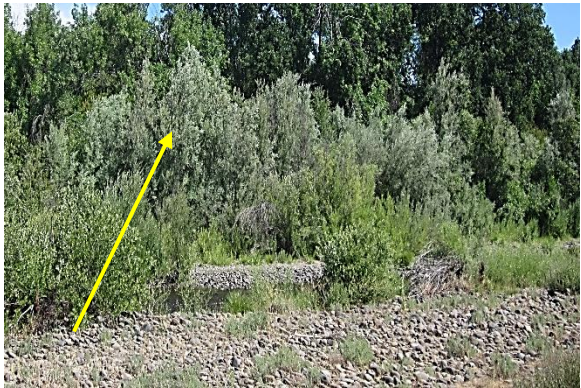
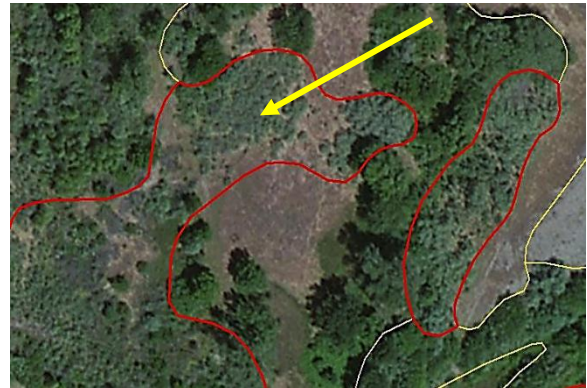
6211—*Salix exigua* Alliance

Salix exigua ranges extensively along all tributaries and the main stem of Cow Creek at the mid and lower elevations; within Mill Creek watershed, it is found only in the lowest reaches of that region. This Alliance is mapped where *S. exigua* dominates the shrub layer, generally in dense cover. Young sapling willows other than *S. exigua* may be a component and at times can co-dominate the thicket. Generally found close to the active channel.

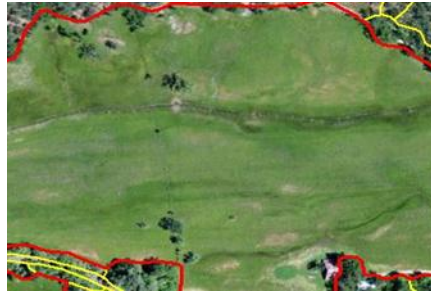
7102—Irrigated pasture—green during the dry season without consistent rows

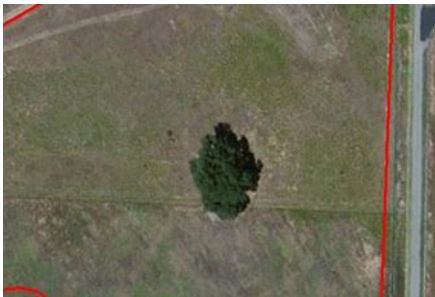
7101—Weedy—note late season greening and mottling to the signature

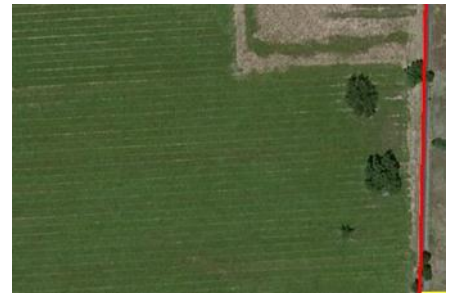
9200 – Agriculture – note consistent “rows” across the picture

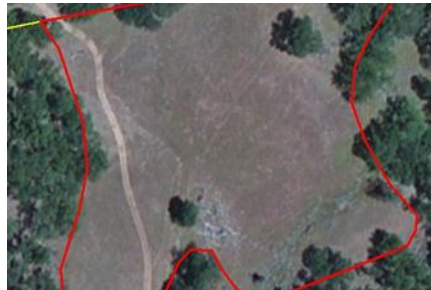
7100—California Annual Grasses—less mottling across the stand

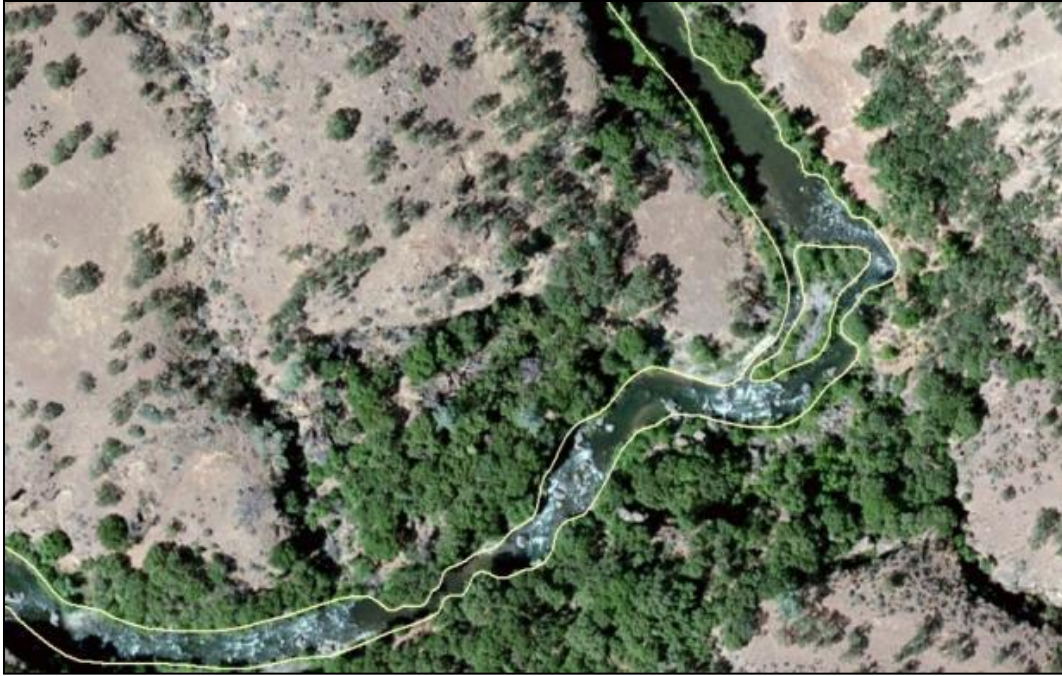
Figure F-1. Example showing a portion of Mill Creek delineated to the tree canopy edge. Although the lines depict canopy overhang, it is not quantifiable.

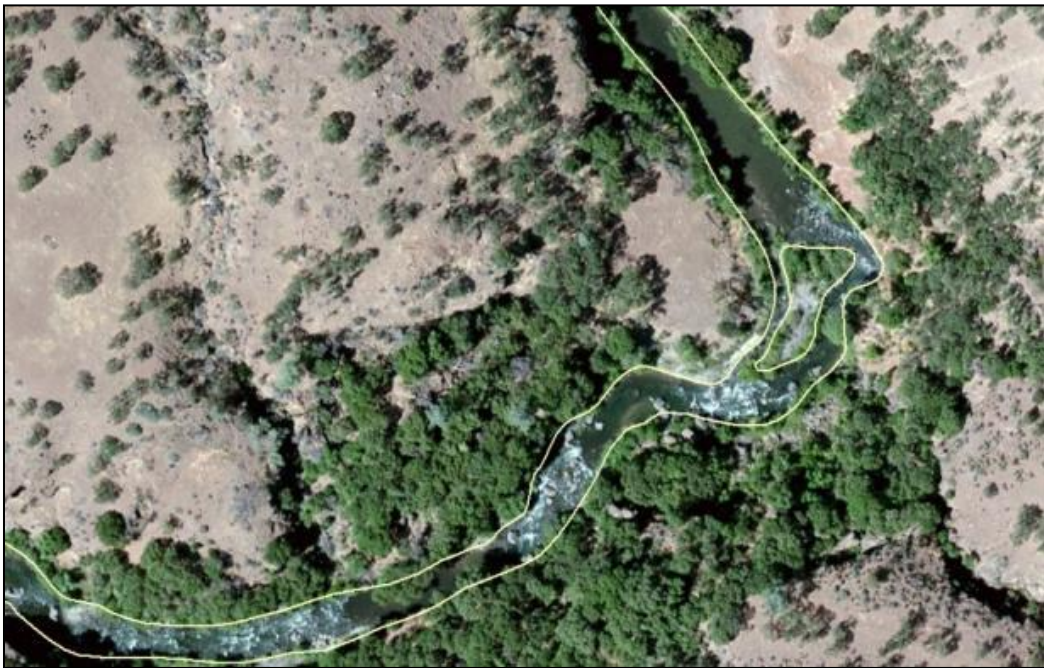
Figure F-2. Same area with delineations to the perceived channel boundary—depicts accurate delineation of the stream course but there is no visual representation of canopy overhang

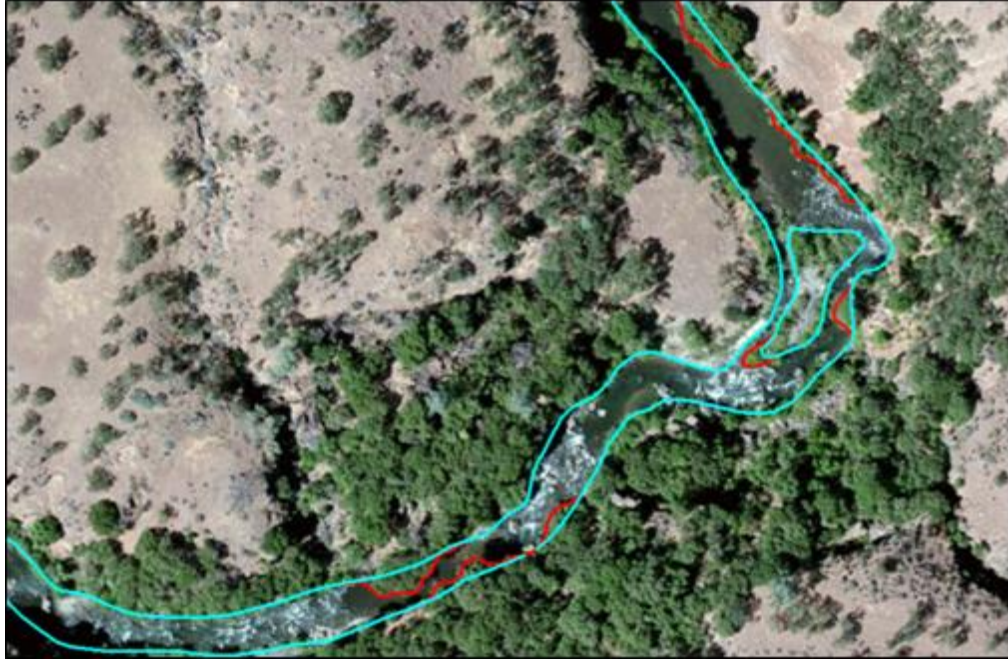
Figure F-3. Side by side comparison showing canopy delineations (in red) and channel edges delineated (in blue). *Note—actual delineations on the map are to the channel edge
