Site Name: Grade Control Structure at Ranger Office

Stream Name: Upper Penitencia Creek

Structure Owner: City of San Jose

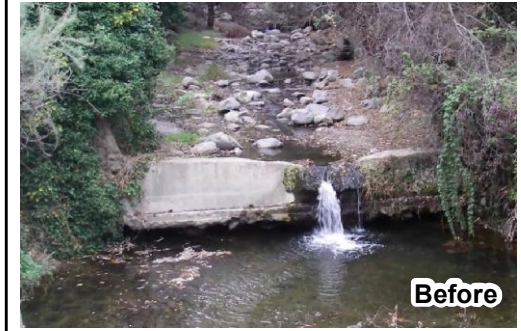
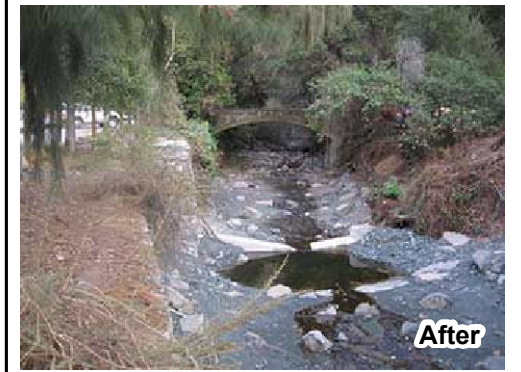
Notes: In January 2013, a pool and rock weir fishway was constructed below the grade control structure. The project included the addition of a floodplain to add refuge during high flows for steelhead, and the construction of an abutment to preserve the 1930's historic bridge upstream. This project was a partnership between VTA and the City of San Jose. This project has helped fish swim upstream during a period of low flows. This was a VTA mitigation project. Before: Temporal barrier per professional judgement by CDFW in 2001. 5 foot tall grade control structure adjacent to ranger office and nature center, partial barrier at low flow.
