Site Name: Abandoned check dam (removed)

Stream Name: Arroyo Sequit

Year Remediated: 2014

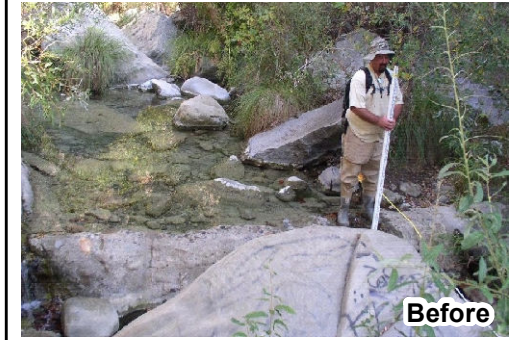
Photo Credit: California Conservation Corps

Notes: The California Conservation Corps worked with the California State Parks and the Bay Foundation to remove the check dam structure and protruding metal pipe from Arroyo Sequit Creek. Two barriers (arizona xings: one partial (705777) and one total (705778)) downstream of the check dam are slated for removal by State Parks in 2015. They will be replaced with free span bridges. Before: Partial barrier assessed using the DFG restoration manual, and severity/passage determined by Caltrout in a 2006 assessment. Rating: GRAY, concrete dam, jump height 0 m, pool depth 0.92 m, slope 4.6%.

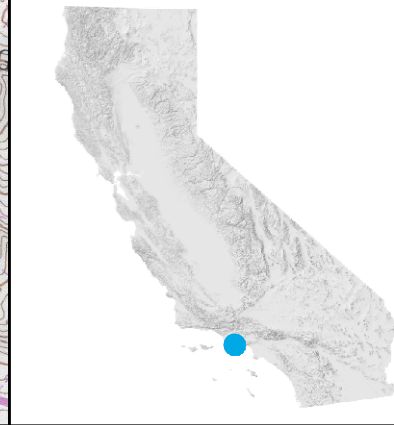
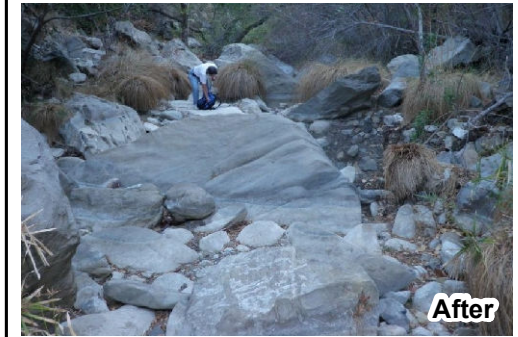
Photo Credit: CalTrout

Barrier Description Prior to Remediation: Partial
