**Site Name:** Rock and mortar dam (removed)

**Stream Name:** Holy Jim Creek

**Structure Owner:** U.S. Forest Service

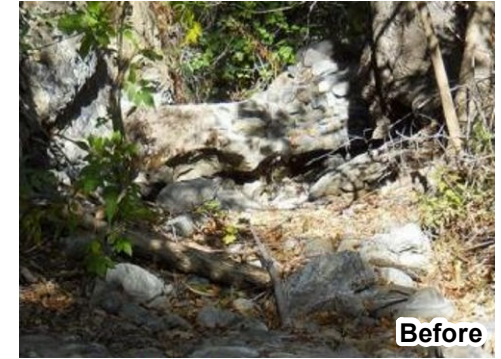
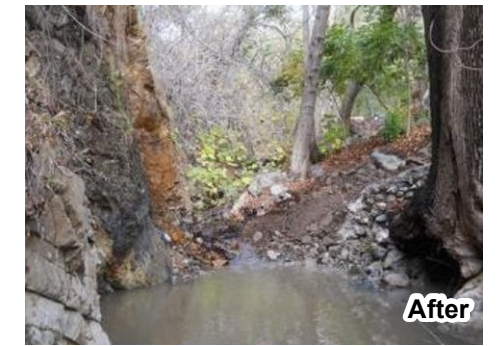
**Notes:** In December 2014, the Cleveland National Forest in conjunction with the Tahoe Mine Reclamation Crew removed this dam. Before: Total barrier per field survey conducted by U.S. Forest Service. 2013 USFS survey comments: Rock and mortar dam (2.5' h x 3' w x 21' l), condition: Good. Barrier to juveniles Intact, scouring at base Dams are planned for removal. Removal of dams will likely be completed between 2017- 2019.
