Site Name: Rock and mortar dam (removed)

Stream Name: Holy Jim Creek

PAD ID: 758709

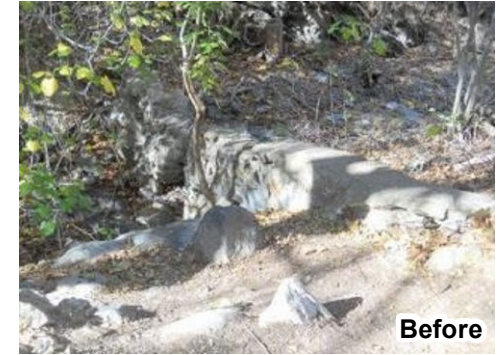
Notes: In December 2014, the Cleveland National Forest in conjunction with the Tahoe Mine Reclamation Crew removed this dam. Before: Total barrier per field survey conducted by U.S. Forest Service. 2013 USFS survey comments: Rock and mortar dam (5' h x 2.5' w), condition: Good. Barrier to juveniles Solid and intact, spillway is degraded and plugged with bedload Dams are planned for removal. Removal of dams will likely be completed between 2017- 2019.
