Site Name: Rock and mortar dam (removed)
Stream Name: Holy Jim Creek
Structure Owner: U.S. Forest Service
Year Remediated: 2014
Site Type: Dam
Site Status After Remediation: Remediated, fish response unconfirmed
Species Benefited After Remediation: Steelhead
Immediate Downstream barrier PAD ID:

PAD ID: 758710
Tributary To: Arroyo Trabuco
Barrier Remediation By: U.S. Forest Service
Barrier Description Prior to Remediation: Unknown
Count of Barriers Downstream:
Count of Barriers Upstream:
Distance Upstream to Next Barrier or Limit of Anadromy : Miles

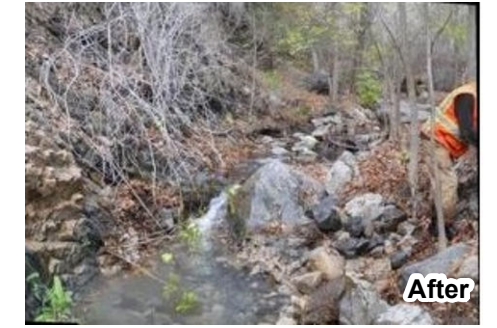
Notes: In December 2014, the Cleveland National Forest in conjunction with the Tahoe Mine Reclamation Crew removed this dam. Before: Unknown passage status per field survey conducted by U.S. Forest Service. 2013 USFS survey comments: Rock and mortar dam (2.3' h x 3.6' w x 14' l), condition: Fair. Sheet flow over structure, possible velocity barrier to juveniles Intact but worn on left bank
