*North Coast Watershed Assessment Program*

**Mattole River  
Watershed  
Assessment Report**

March, 2003

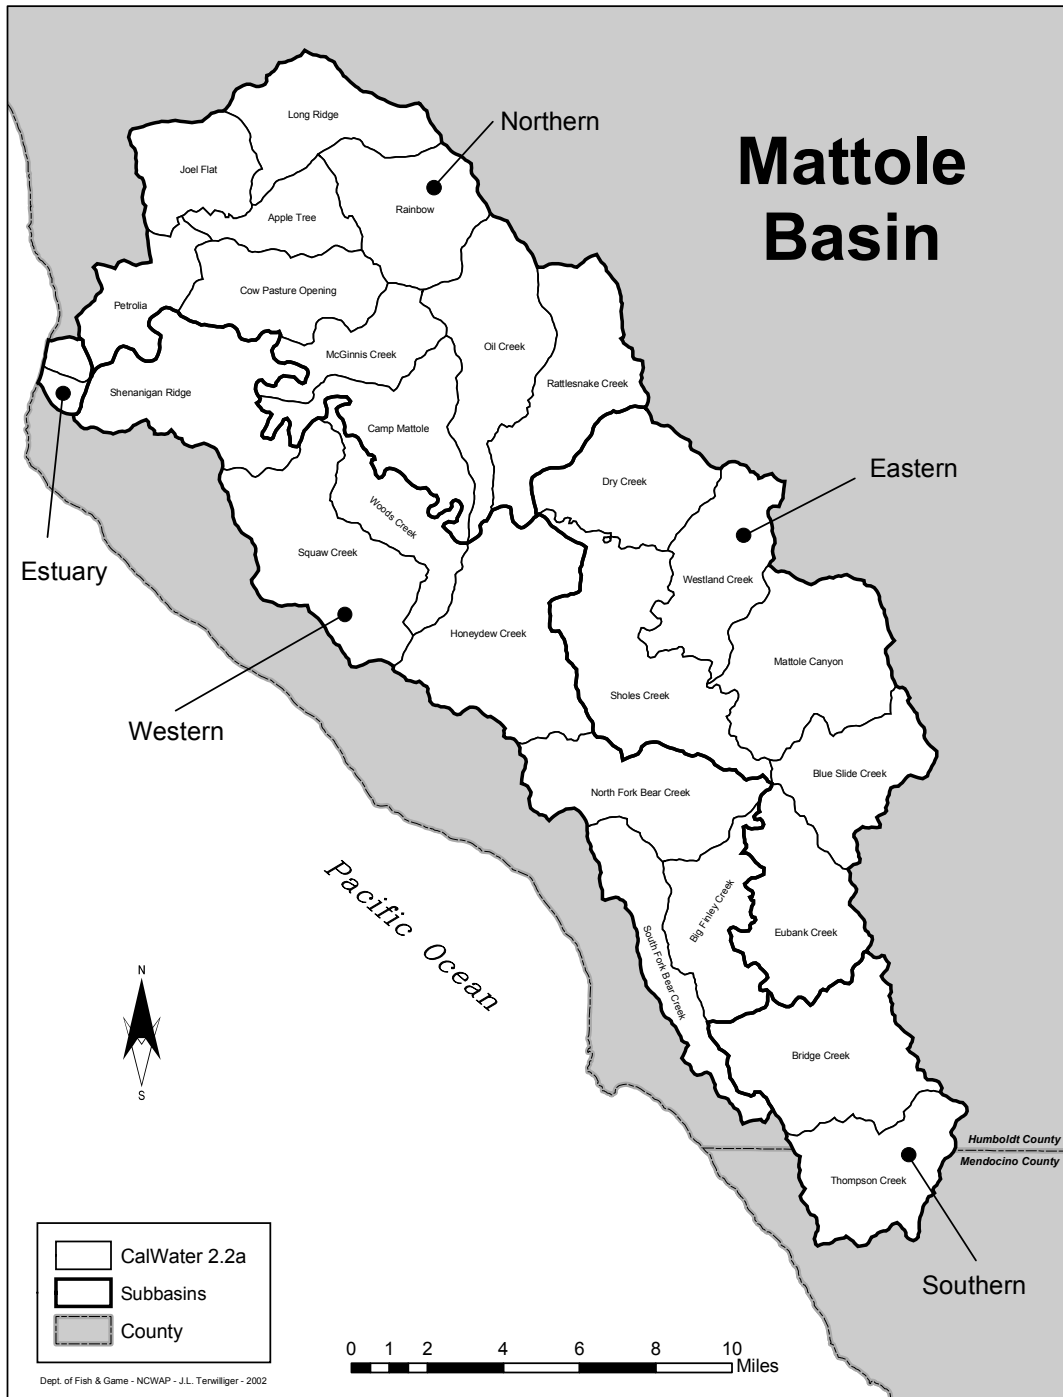
Figure 2. NCWAP Mattole subbasins and CalWater 2.2a Planning Watersheds.

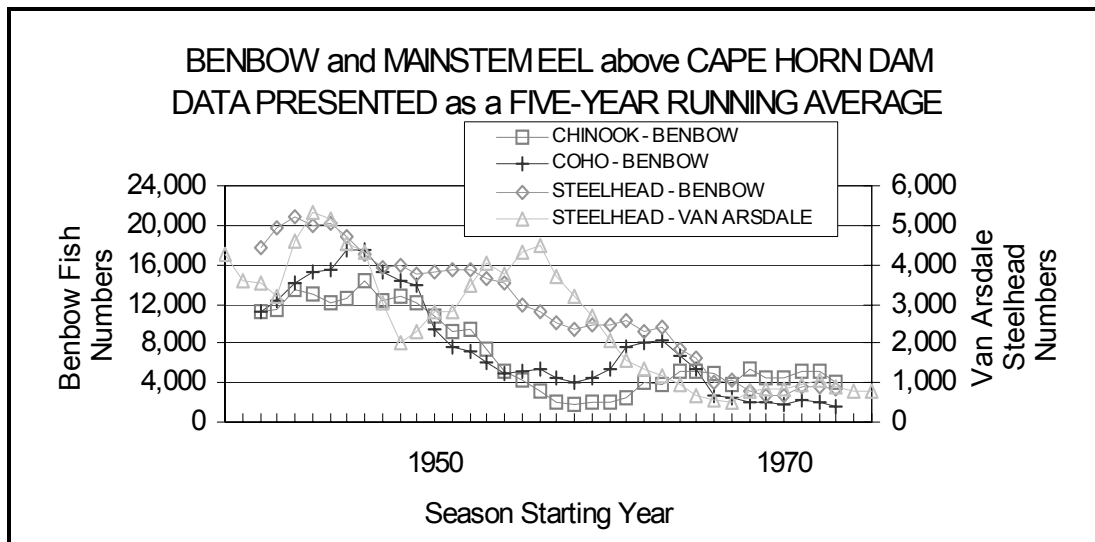
Figure 4. Five-year running average of salmonids at Benbow Dam, South Fork Eel River, and Mainstem Eel River above Cape Horn Dam

Although no long-term fish counts exist for the Mattole River, Department of Fish and Game fish ladder counts at Benbow Dam and Cape Horn Dam, in the neighboring Eel River system, reflect an over 80% decline in coho salmon, Chinook salmon, and steelhead trout populations over the span of the last century (Figure 4, Figure 5). The Eel River, especially the nearby South Fork Eel River, which is the location of Benbow Dam, has similar watershed conditions and land use history to the Mattole River. Anecdotal evidence from anglers and longtime local residents supports the likelihood of a similar decline in Mattole fisheries (see Mattole Basin Profile). Since 1980, collaborative work between the Department of Fish and Game and the Mattole Salmon Group to collect field data and observations shows there is a record of very low coho and Chinook salmon populations, and depressed steelhead trout populations.

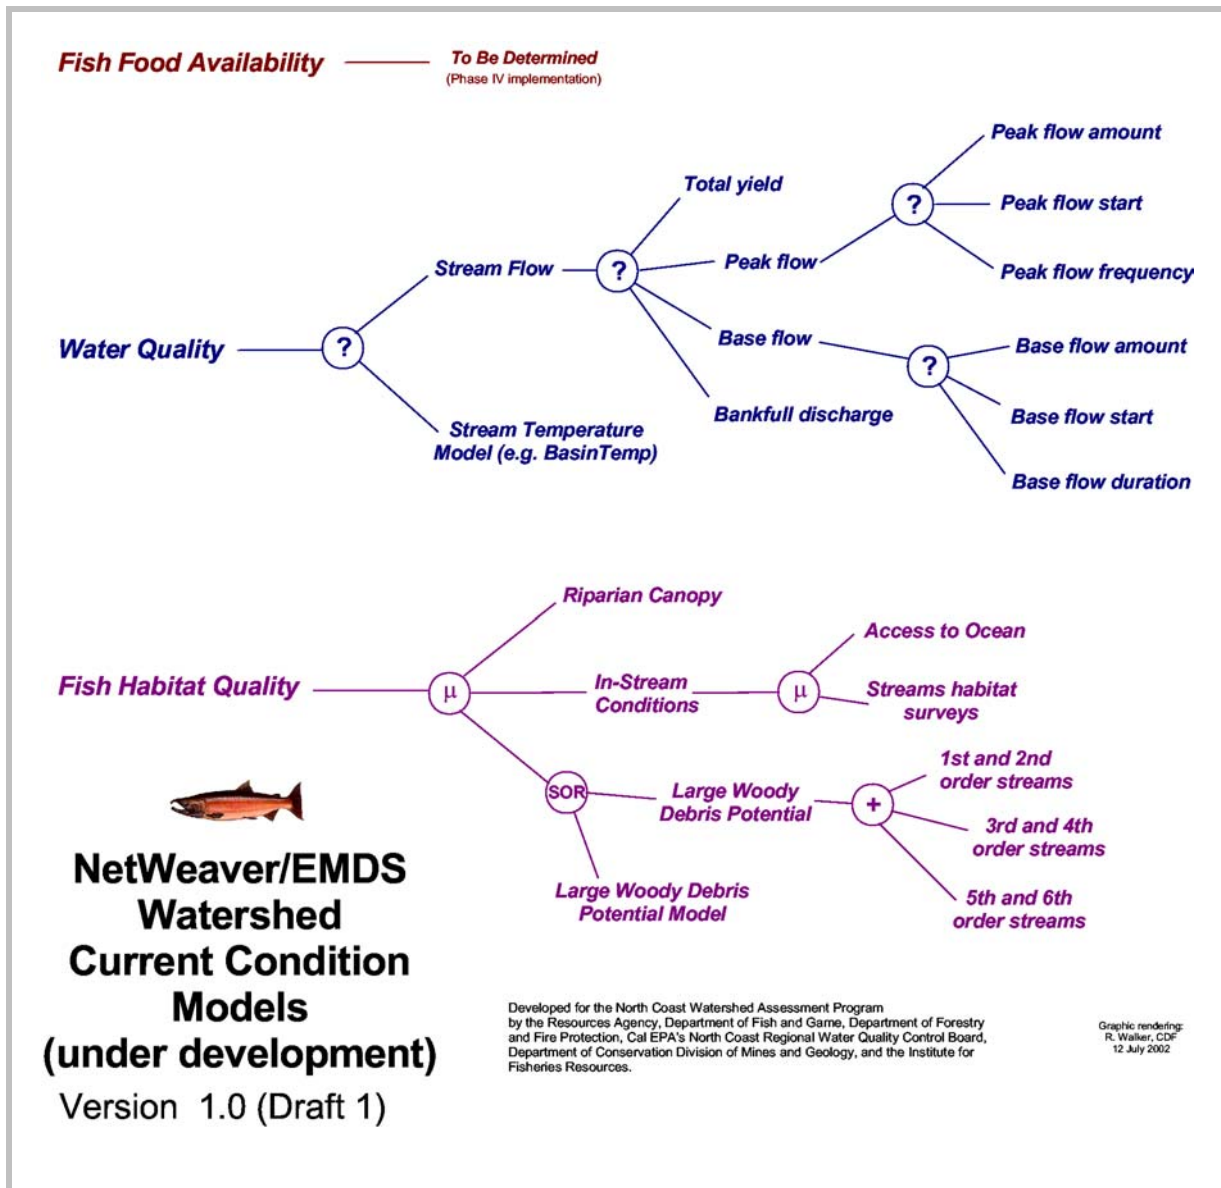
Figure 13. NCWAP EMDS fish food availability, water quality, and fish habitat quality models

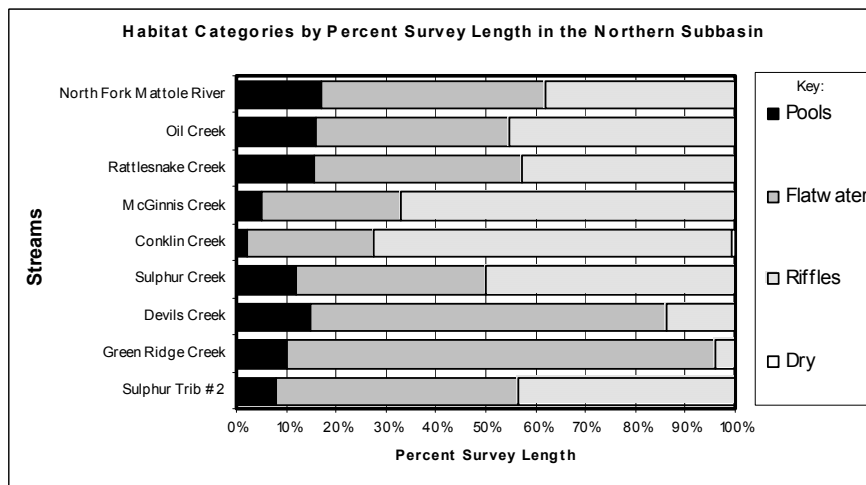
Figure 70. Percentage of pool habitat, flatwater habitat, riffle habitat, and dewatered channel by surveyed length, Northern Subbasin.

Pool, flatwater, and riffle habitat units observed were measured, described, and recorded during CDFG stream surveys. During their freshwater life history, salmonids require access to all of these types of habitat. EMDS does not evaluate the ratio of these habitat types, but a balanced proportion is desirable. All of the surveyed Northern Subbasin streams have less than 20% pool habitat by length (Figure 70). This is well below the range considered fully suitable as described below. Dry units were also measured, and obviously indicate poor conditions for fish.

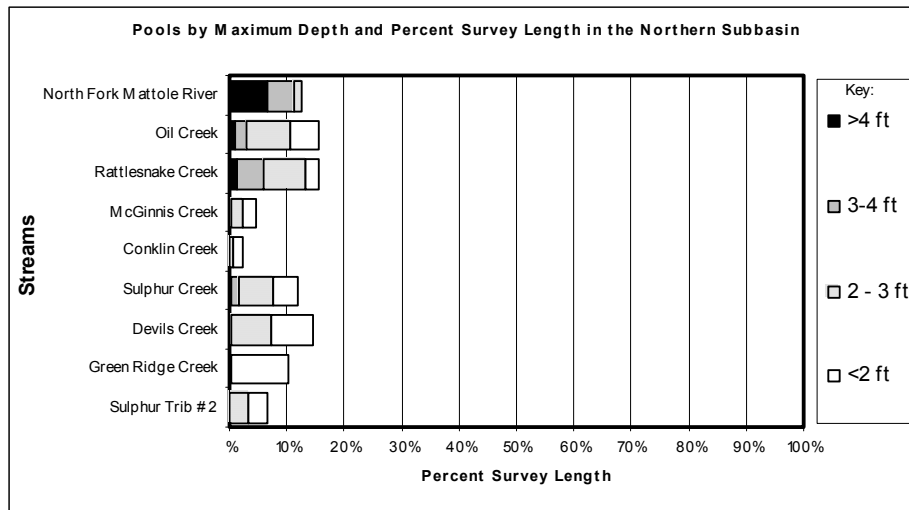
Figure 71. Percent length of a survey composed of deeper, high quality pools.

indicate streams with more suitable or unsuitable pool depth conditions relative to other streams of that subbasin. North Fork Mattole River has the most pool habitat with maximum depth greater than 3 feet, but this measures less than 10% of total pool length (Figure 71). The EMDS rates pool quality in all Northern Subbasin streams as moderately unsuitable or unsuitable for supporting anadromous fish populations.

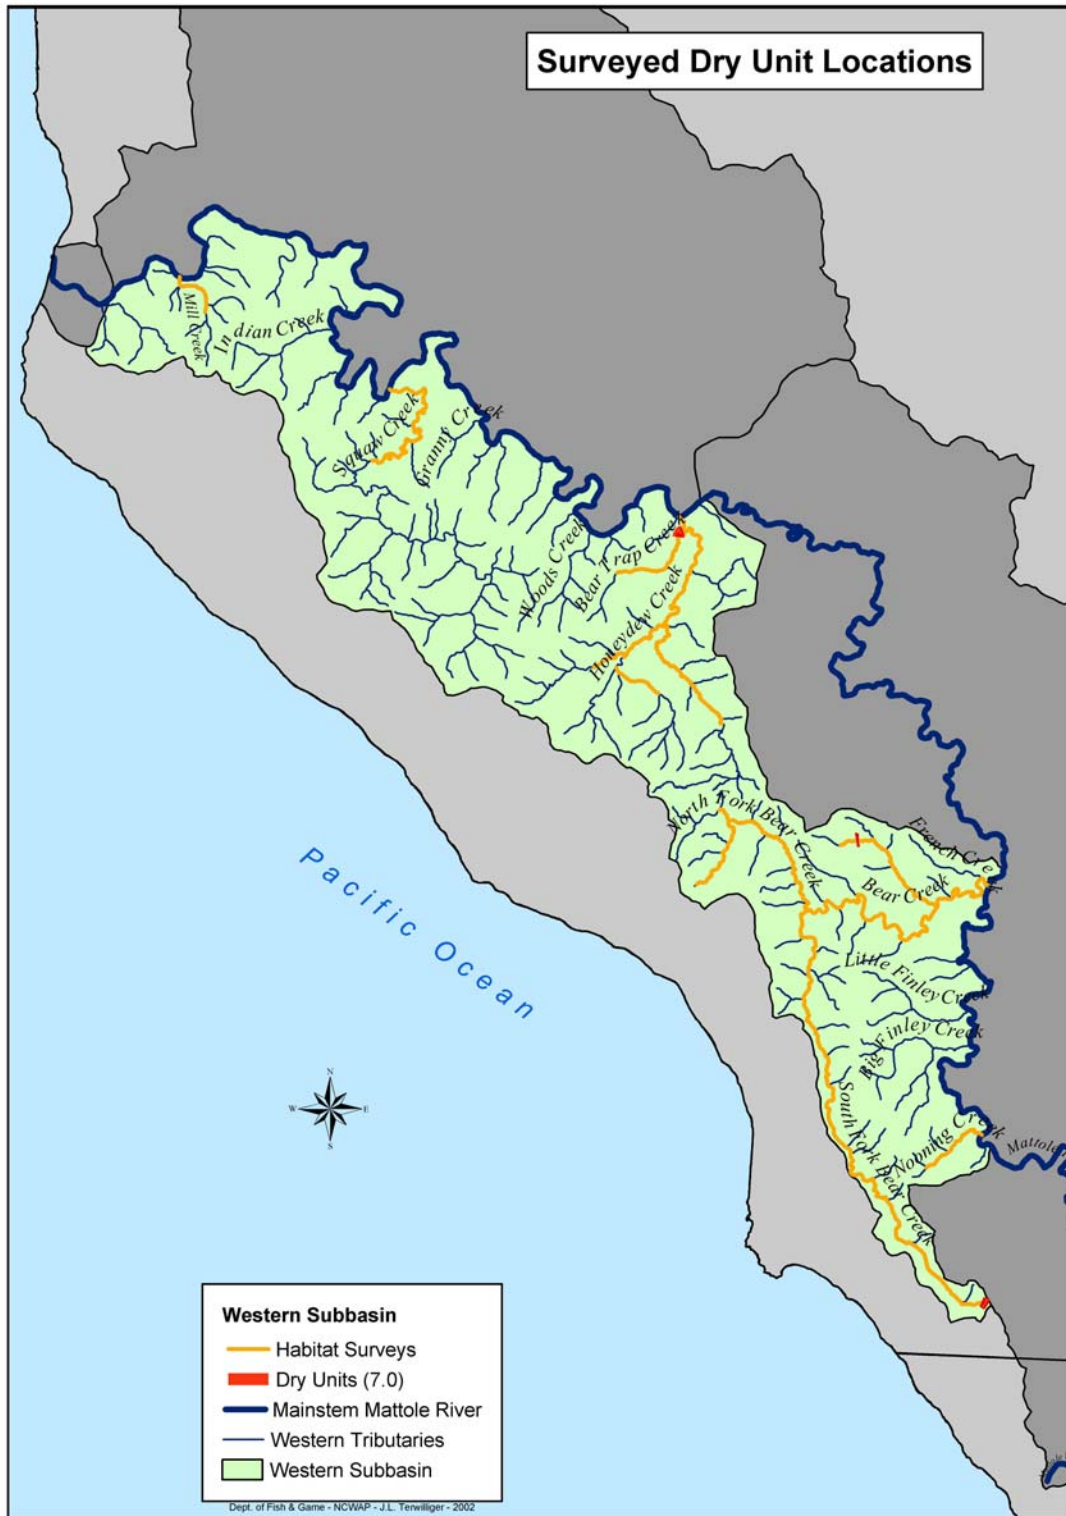
Figure 132. Mapped dry channels of the Western Subbasin.
