Assessment of Future Surface Water Conditions in the Dry Gap of the Santa Clara River

Prepared for
Newhall Land and Farming Company

April 2008

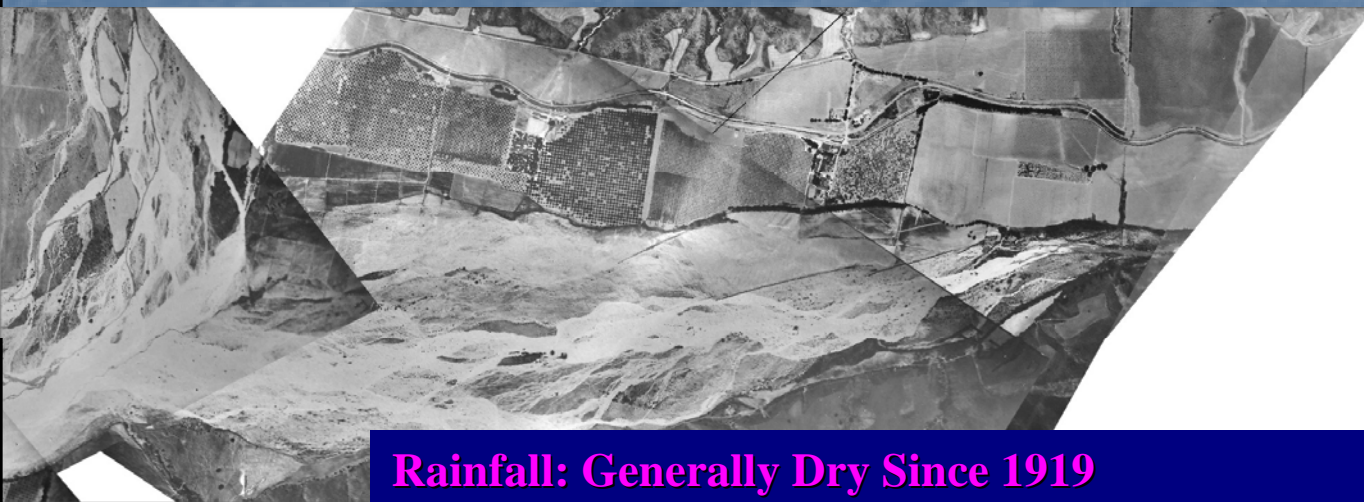
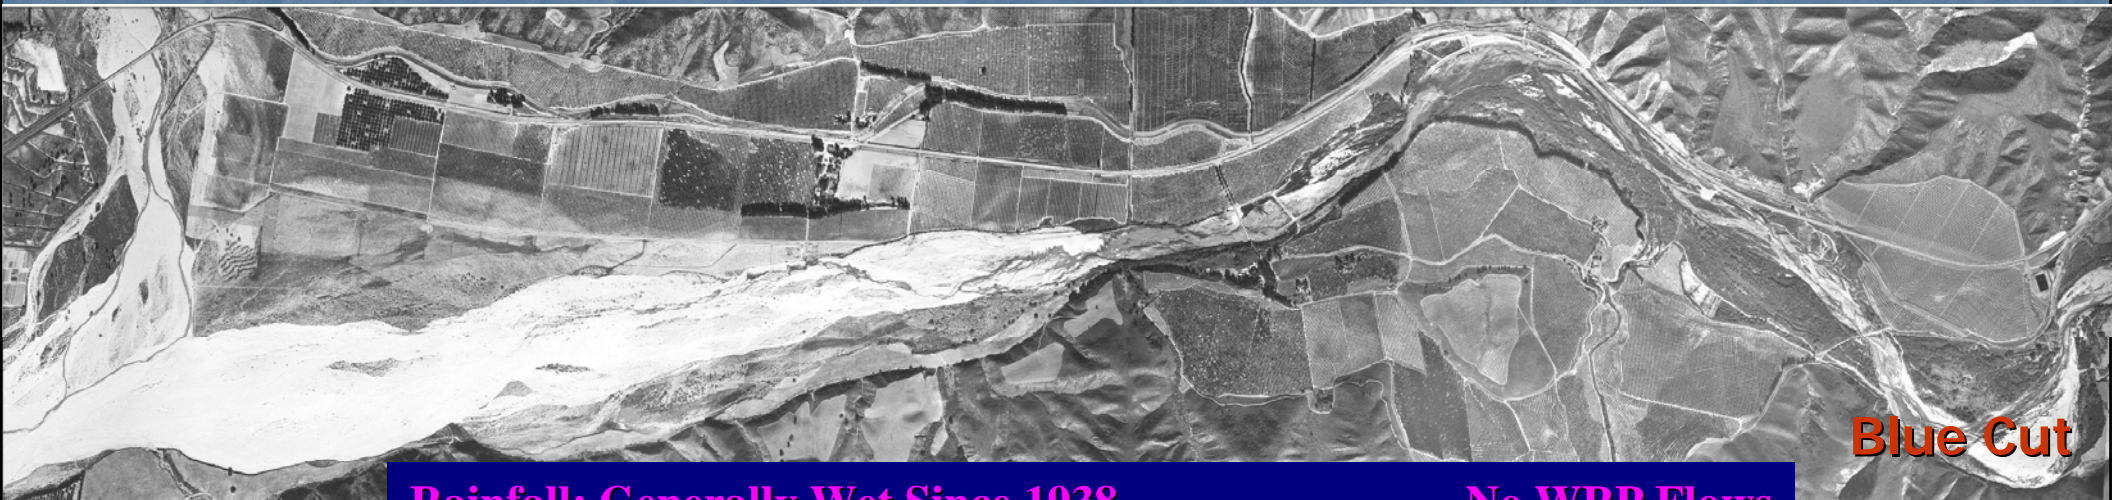
Figure 4

- **Figure 4 (1927 and 1945).** The 1927 photo shows that the dry riverbed begins where the alluvial valley widens and the vegetation disappears. The 1945 photo shows similar conditions, though the river’s flow continues about halfway down to Piru Creek from the point where the alluvial valley widens. Farther downstream, Piru Creek contributes notable flow in 1945, and minor flow in 1927.
- **Figure 5 (1945 and 1966).** Compared with 1945, the river’s flow in 1966 does not occur as far downstream, likely because of an extended period of generally below-average rainfall. Additionally, Piru Creek is dry. Minimal WRP flows began from the Saugus plant in 1966 (550 AF/yr).

Pre-Development Photos At and Above Piru Creek (1927 to 1945)

Rainfall: Generally Dry Since 1919

No WRP Flows

Rainfall: Generally Wet Since 1938

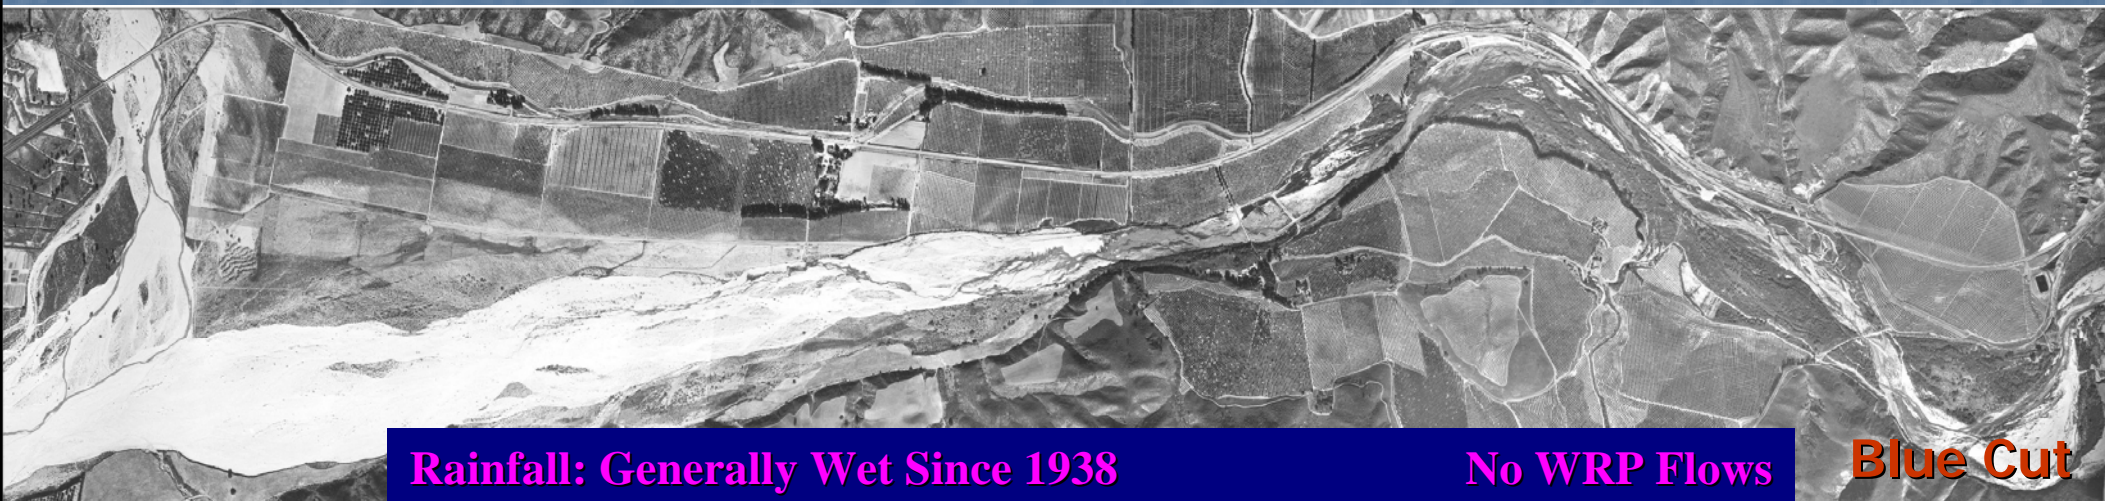
Figure 5

Pre-Development Photos At and Above Piru Creek (1945 to 1966)

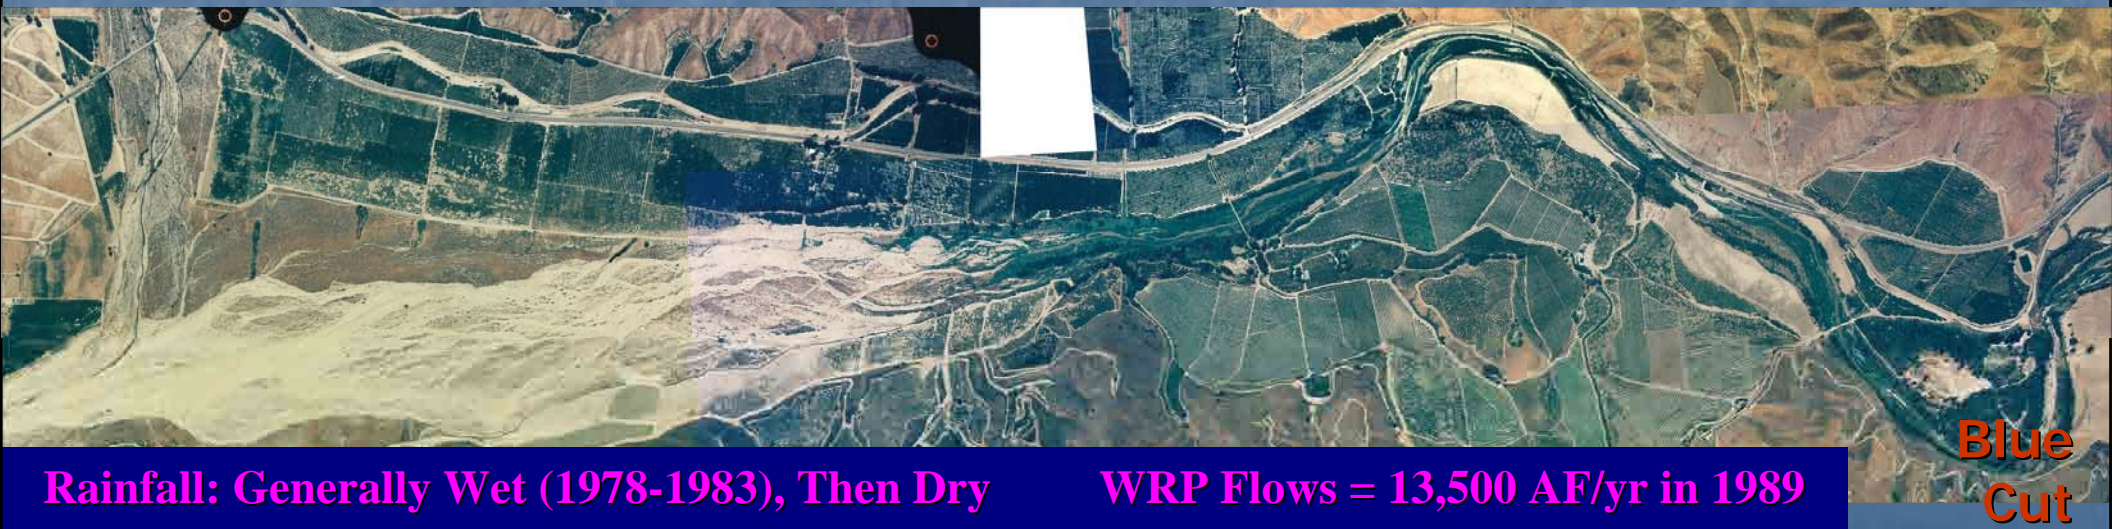
Figure 6

- **Figure 6 (1966 and 1989).** Compared with 1966, the vegetated zone near the river is more prominent and extends farther downstream in 1989, likely because of a period of generally above-average rainfall from 1978 through 1983. However, in 1989, the river does not show visible flow beyond the western limit of the vegetated corridor. WRP flows had risen to 13,500 AF/yr by 1989. Minor inflow is visible from Piru Creek in 1989.

Rainfall: Generally Dry Since 1945

WRP Flows = 550 AF/yr in 1966

Rainfall: Generally Wet (1978-1983), Then Dry

WRP Flows = 13,500 AF/yr in 1989

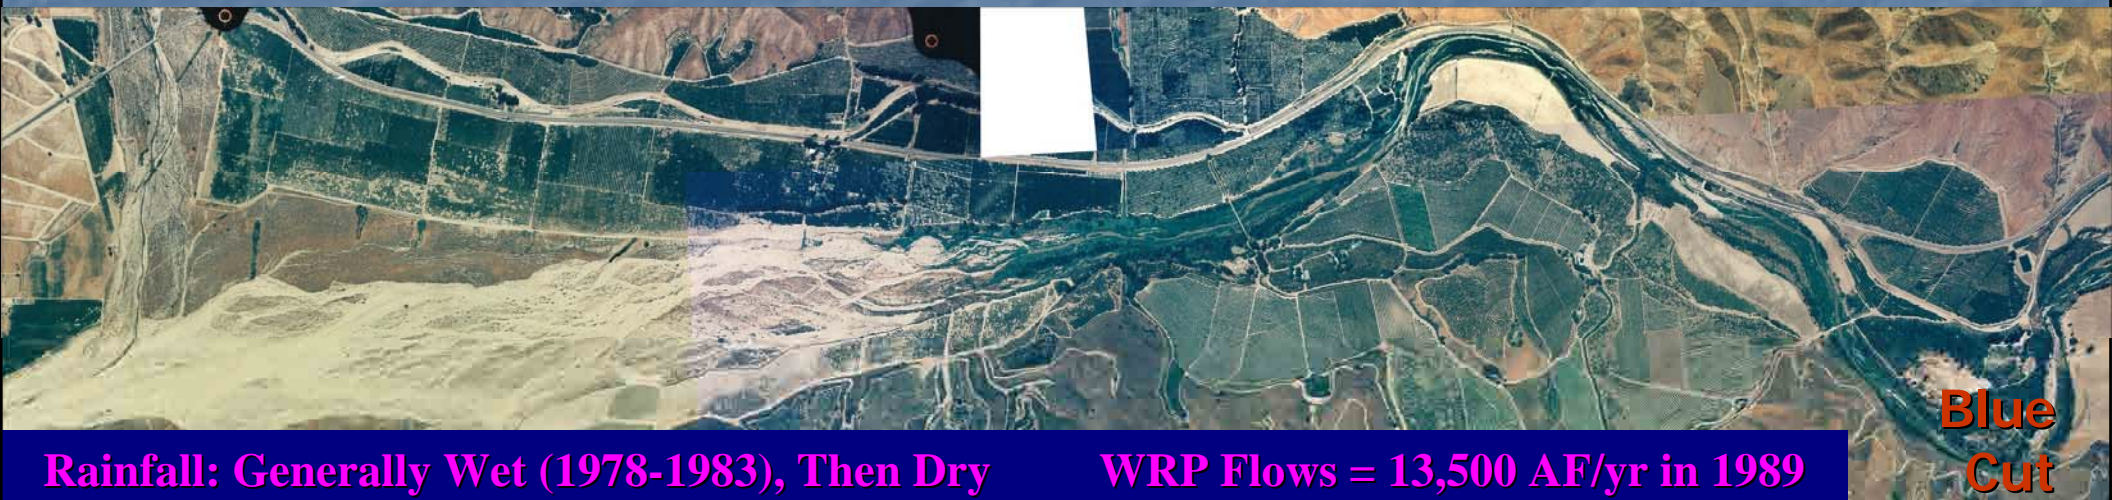
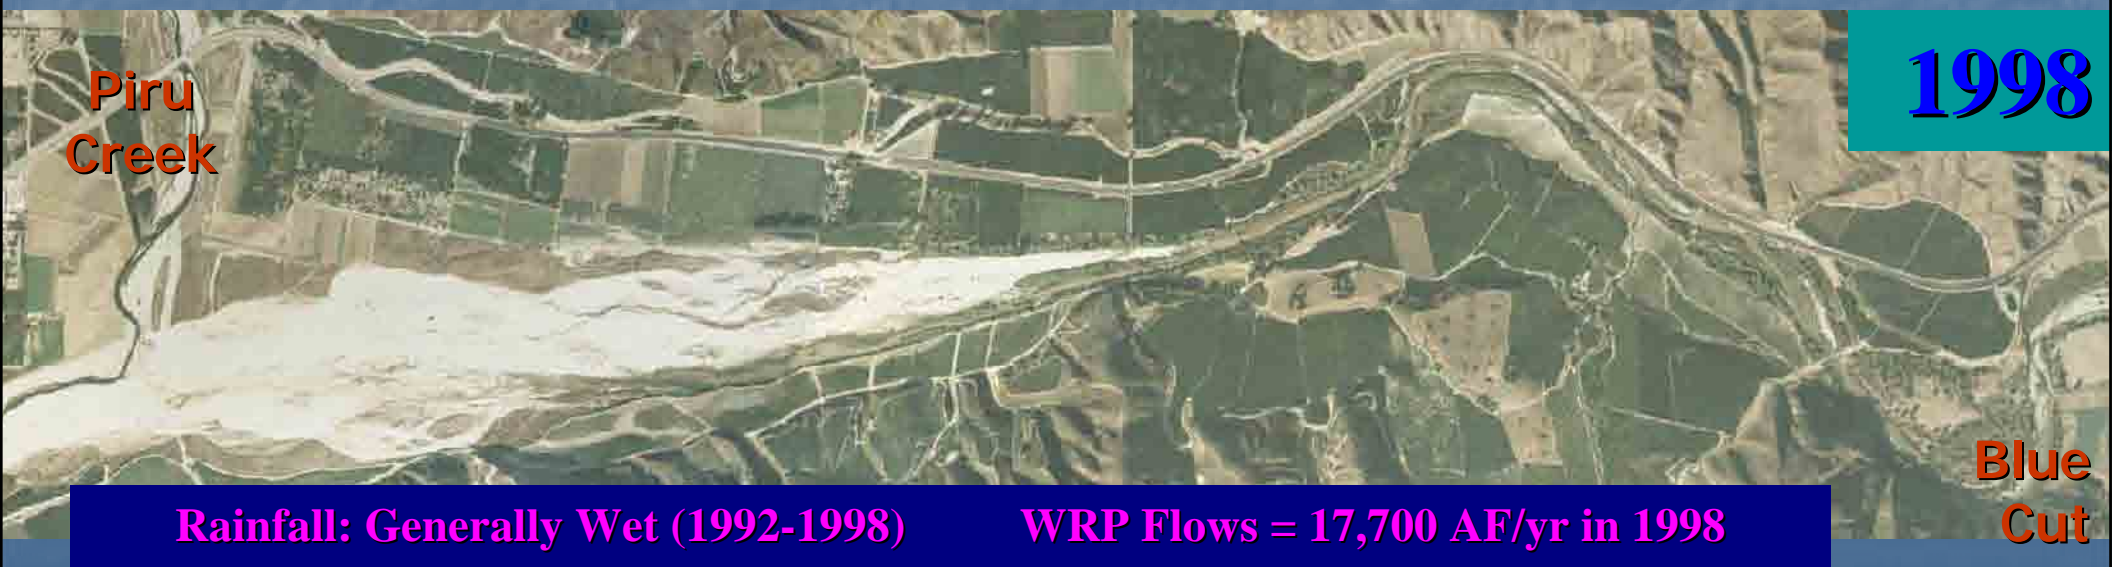
Figure 7

- **Figure 7 (1989 and 1998).** The 1998 photo was taken at the end of a 7-year period of generally above-average rainfall. Vegetated conditions are similar to 1989. The only difference in 1998 is a small reach of flow that is visible above Piru Creek, and notably more flow in Piru Creek itself. WRP flows had risen to 17,700 AF/yr by 1998.

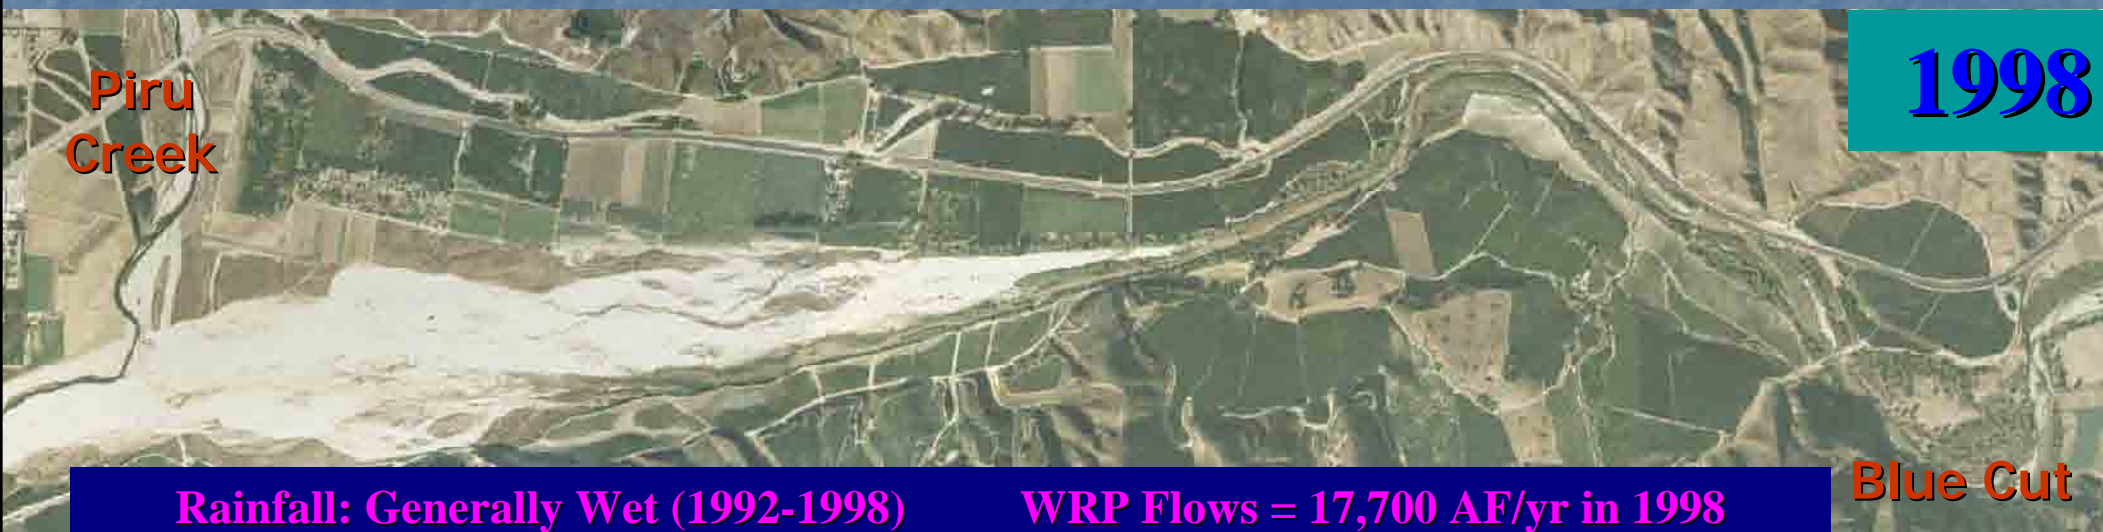
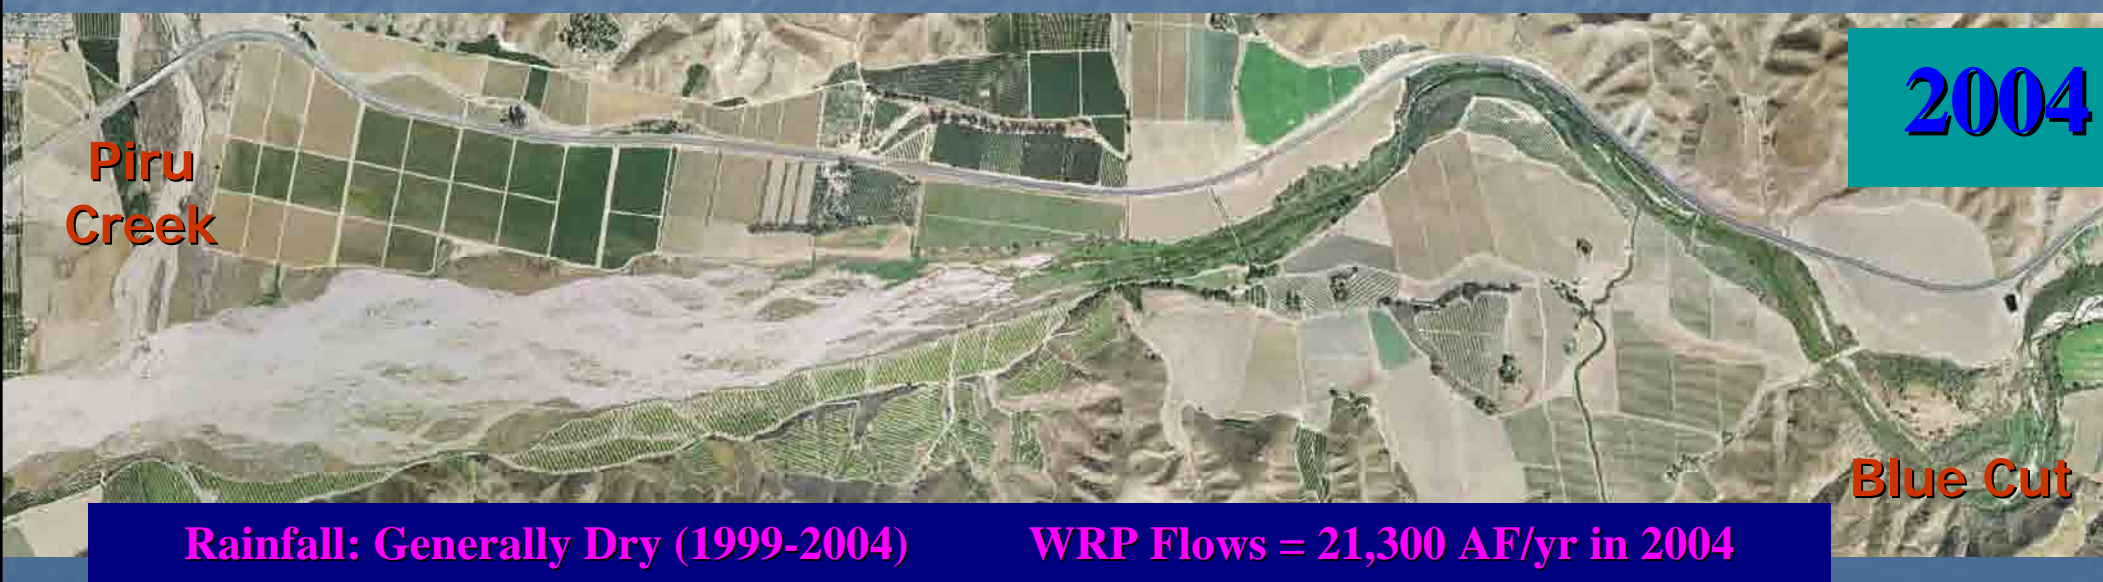
Figure 8

- **Figure 8 (1998 and 2004).** These two photos show generally similar conditions, though the short reach of flow that is visible in the Santa Clara River just above Piru Creek is not present in 2004 likely because of the generally below-average rainfall that occurred from 1999 through 2004. Additionally, Piru Creek was dry at the time of the 2004 photo. WRP flows had risen to 21,300 AF/yr by 2004.

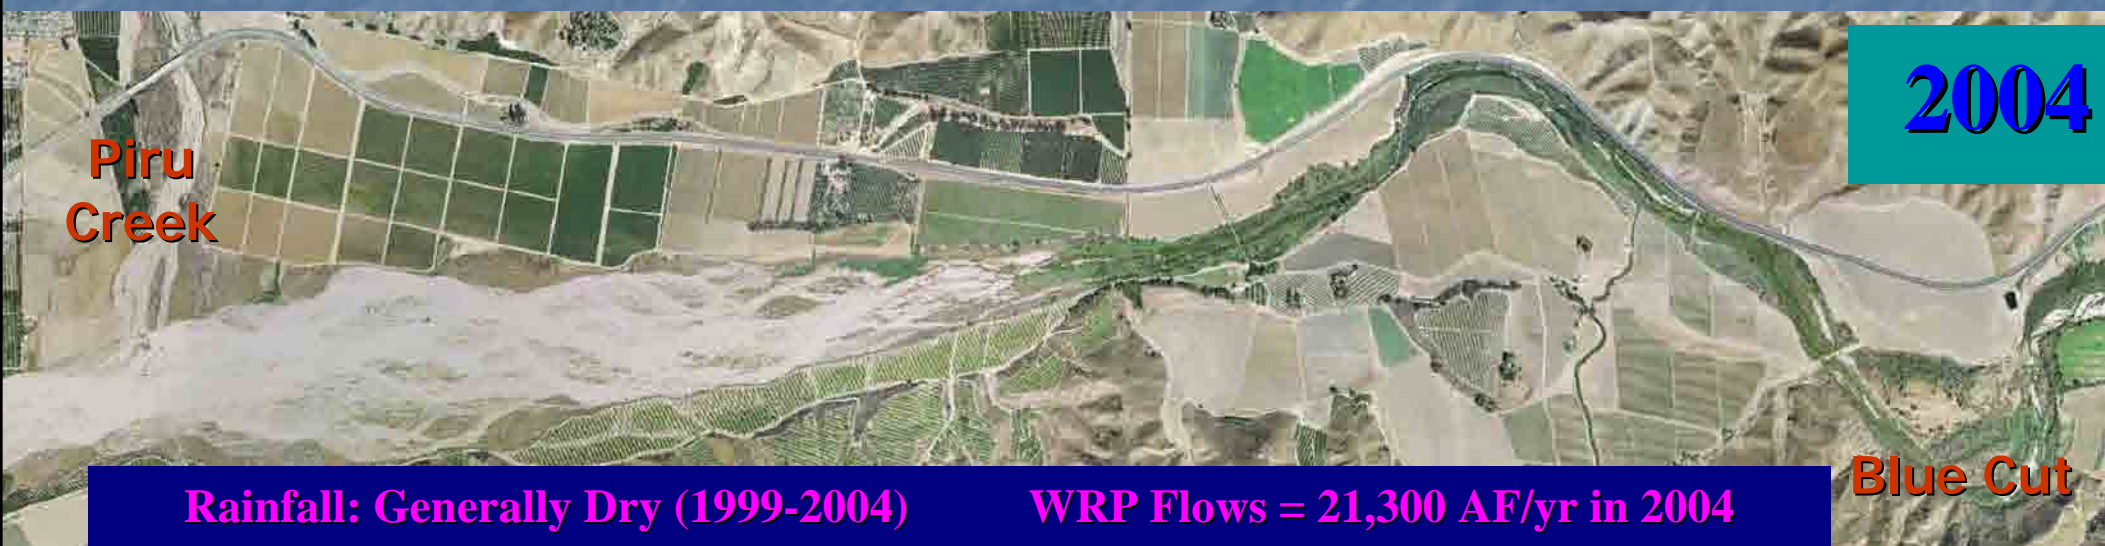
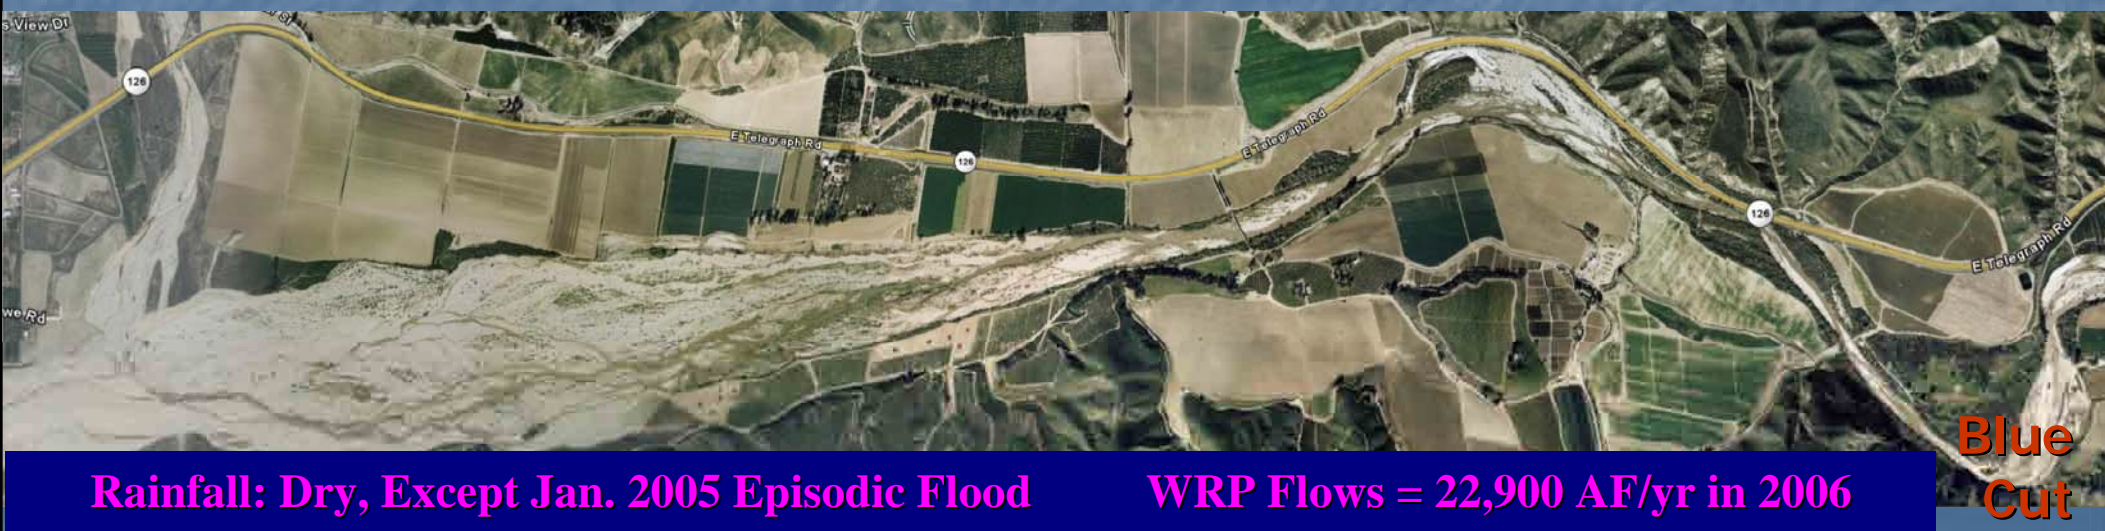
Figure 9

- **Figure 9 (2004 and Post-2004).** These two photos show notable differences in vegetation. The vegetation that was present in the 2004 photo is gone in the post-2004 photo, having been removed by the episodic flood of January 2005. The river is flowing farther downstream in the post-2004 photo than in 2004, most likely reflecting drainage of shallow groundwater following this episodic flood. Specifically, the excessive rainfall and flooding increased groundwater levels in the Santa Clarita Valley, at and upstream of Blue Cut, which in turn increased the amount of groundwater discharging to the river upstream of Blue Cut. The greater river flow is not attributable to WRP flows because the reach containing the dry gap has been completely dry since that time (except during infrequent rainfall events) because of below-normal rainfall.

The only significant change that is visible over time in this group of aerial photos occurred recently. The aerial photos through 2004 show significant vegetation at and below Blue Cut. After 2004, this vegetation is absent. The vegetation was scoured out by large episodic flood flows that occurred because of unusually heavy rainfall from December 2004 through February 2005.

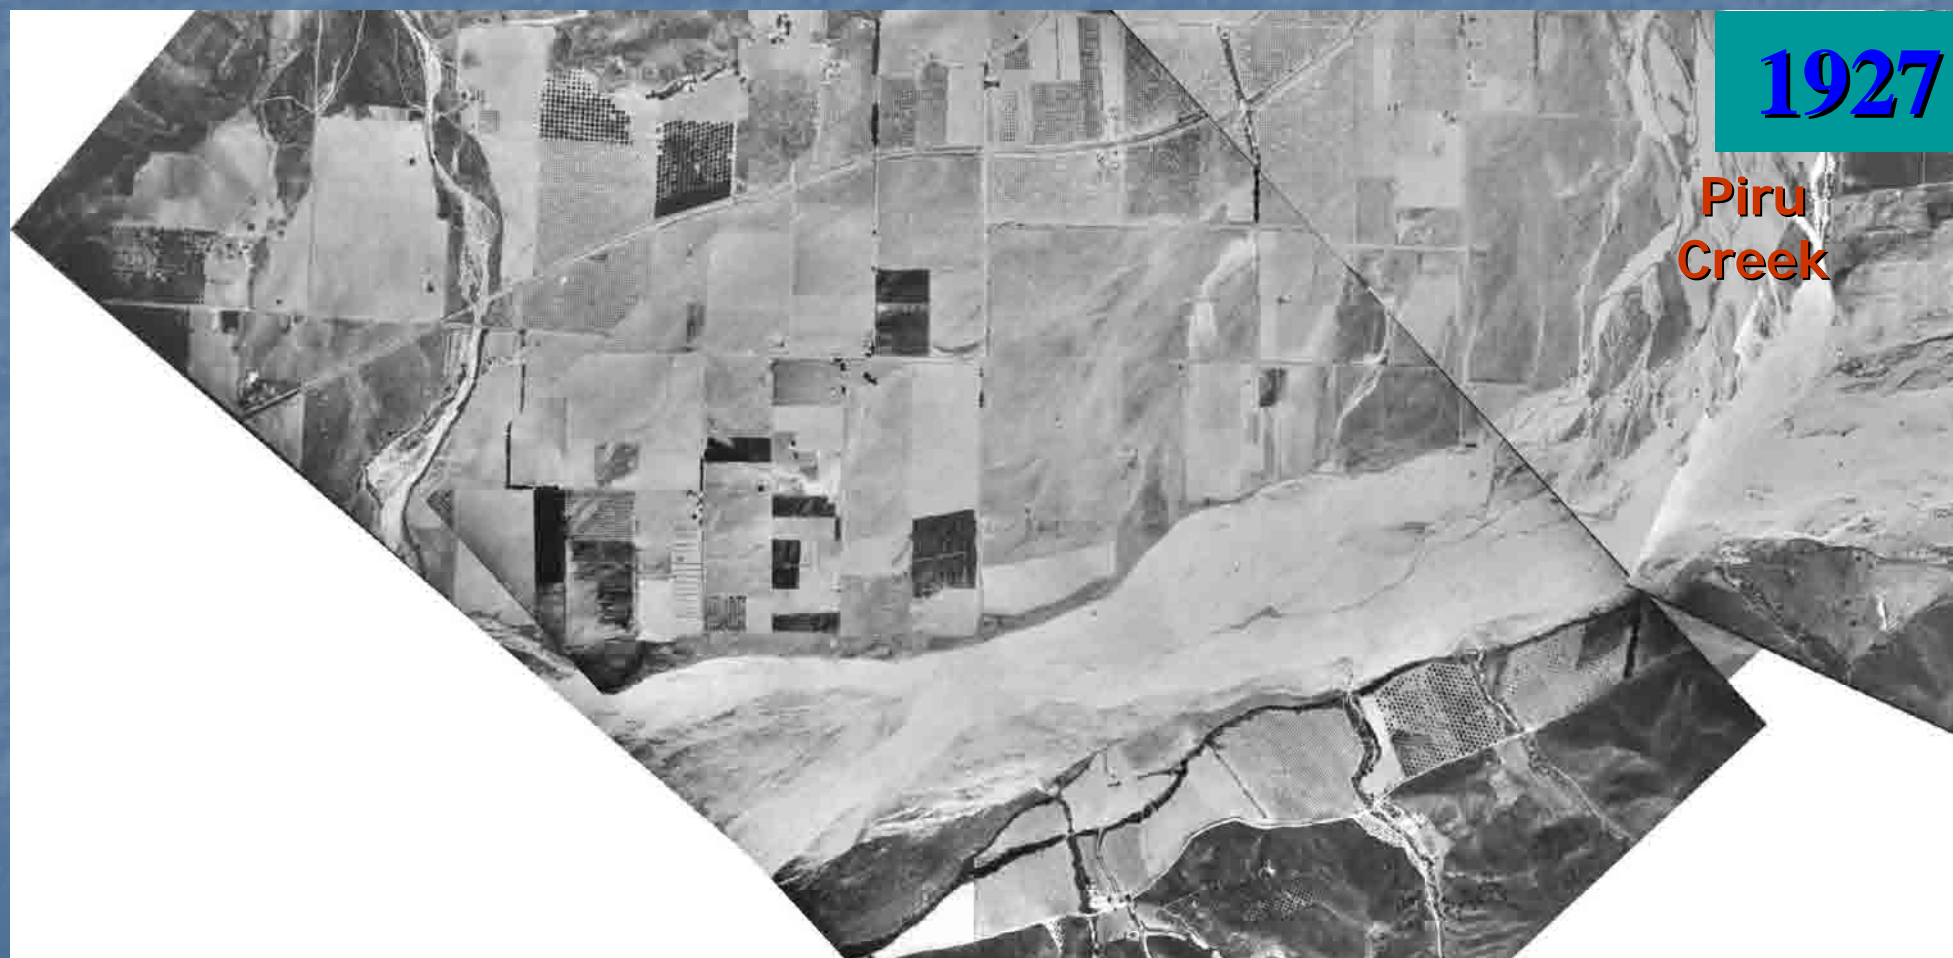
Figure 10

- **Figure 10 (1927).** The 1927 photo shows that the small flow volume entering the river from Piru Creek disappears into the riverbed shortly downstream, resulting in a dry riverbed in the dry gap portion of the Santa Clara River.
- **Figure 11 (1945).** The 1945 photo shows greater flow from Piru Creek and a decrease in flow below the mouth of Piru Creek. However, not all of the Piru Creek flow infiltrates within the view frame.

Rainfall: Generally Dry Since 1919

No WRP Flows

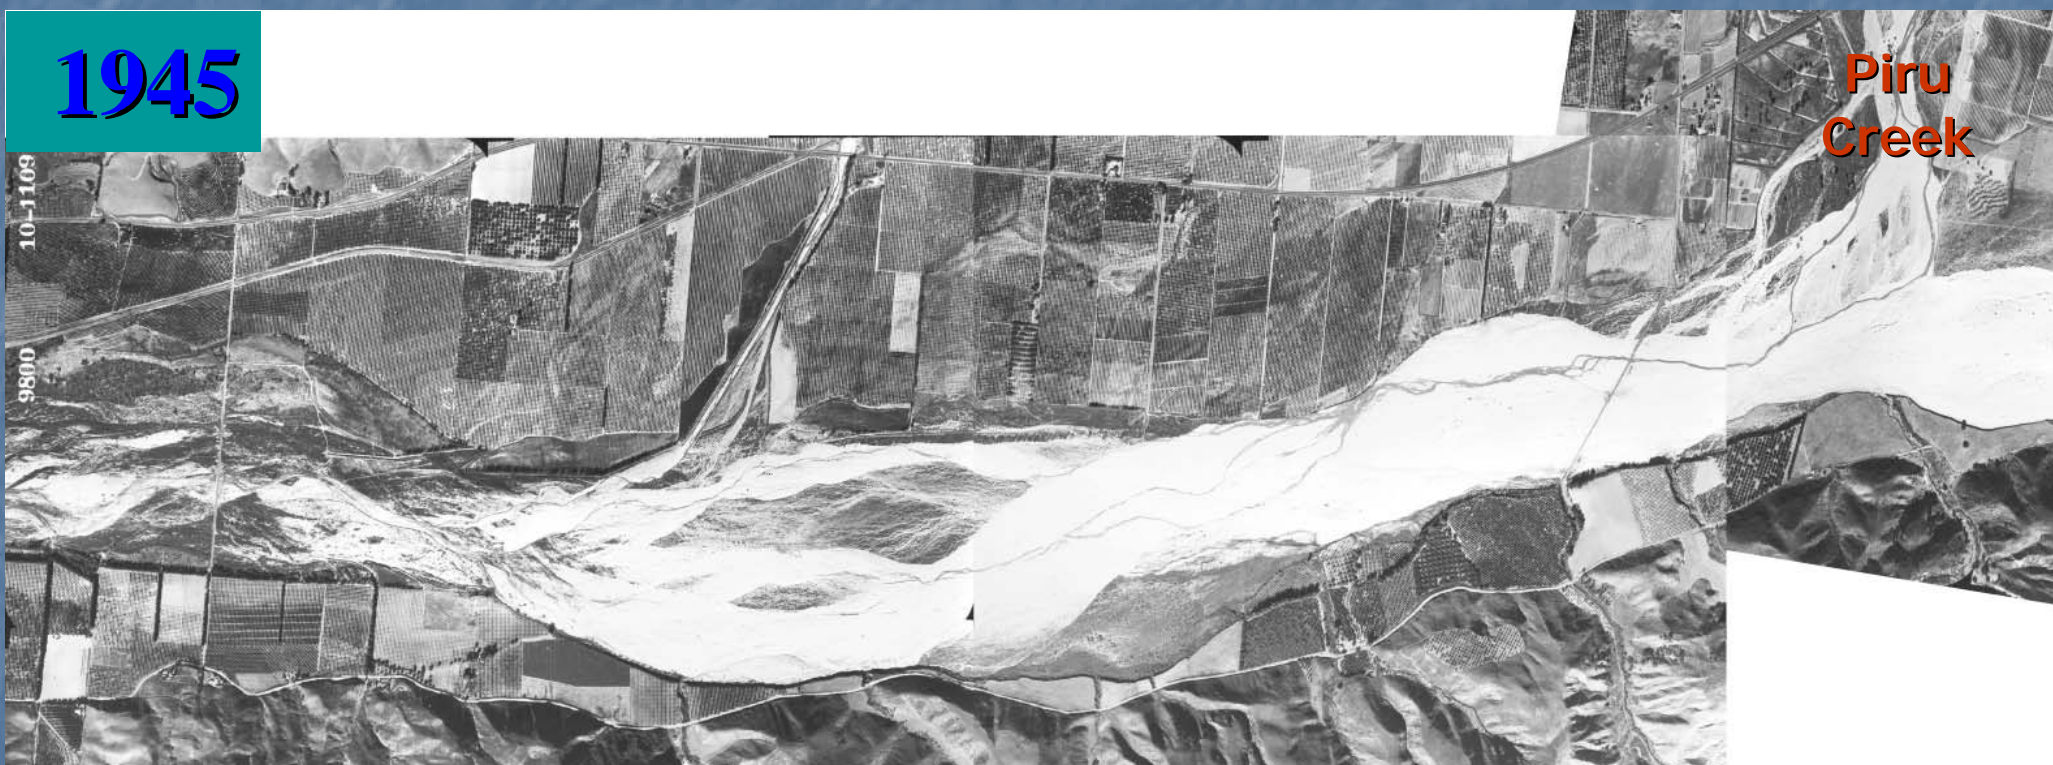
Figure 11

Rainfall: Generally Wet Since 1938

No WRP Flows

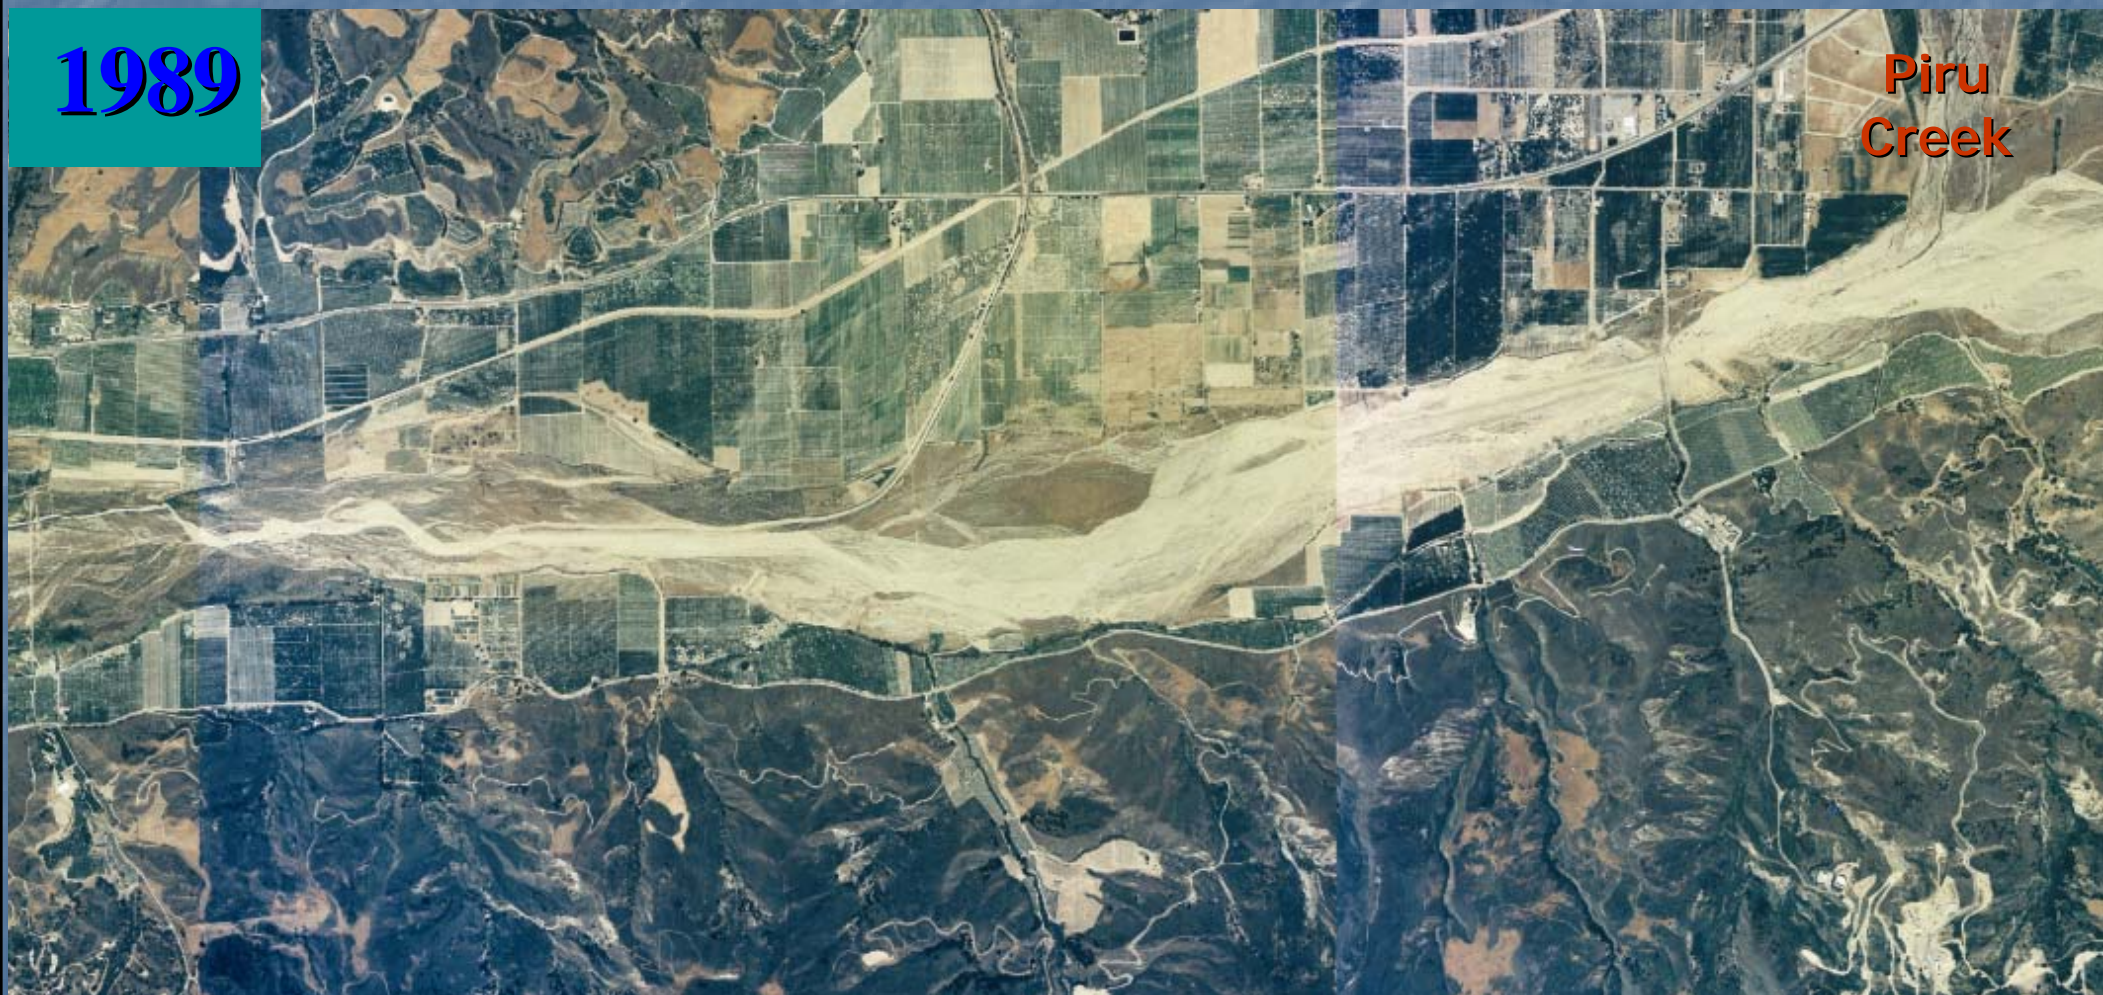
Figure 13

- **Figure 13 (1989).** Only minor flow enters the river from Piru Creek, and this flow disappears shortly downstream, resulting in a dry riverbed in the Santa Clara River.

Rainfall: Generally Wet (1978-1983), Then Dry

WRP Flows = 13,500 AF/yr in 1989

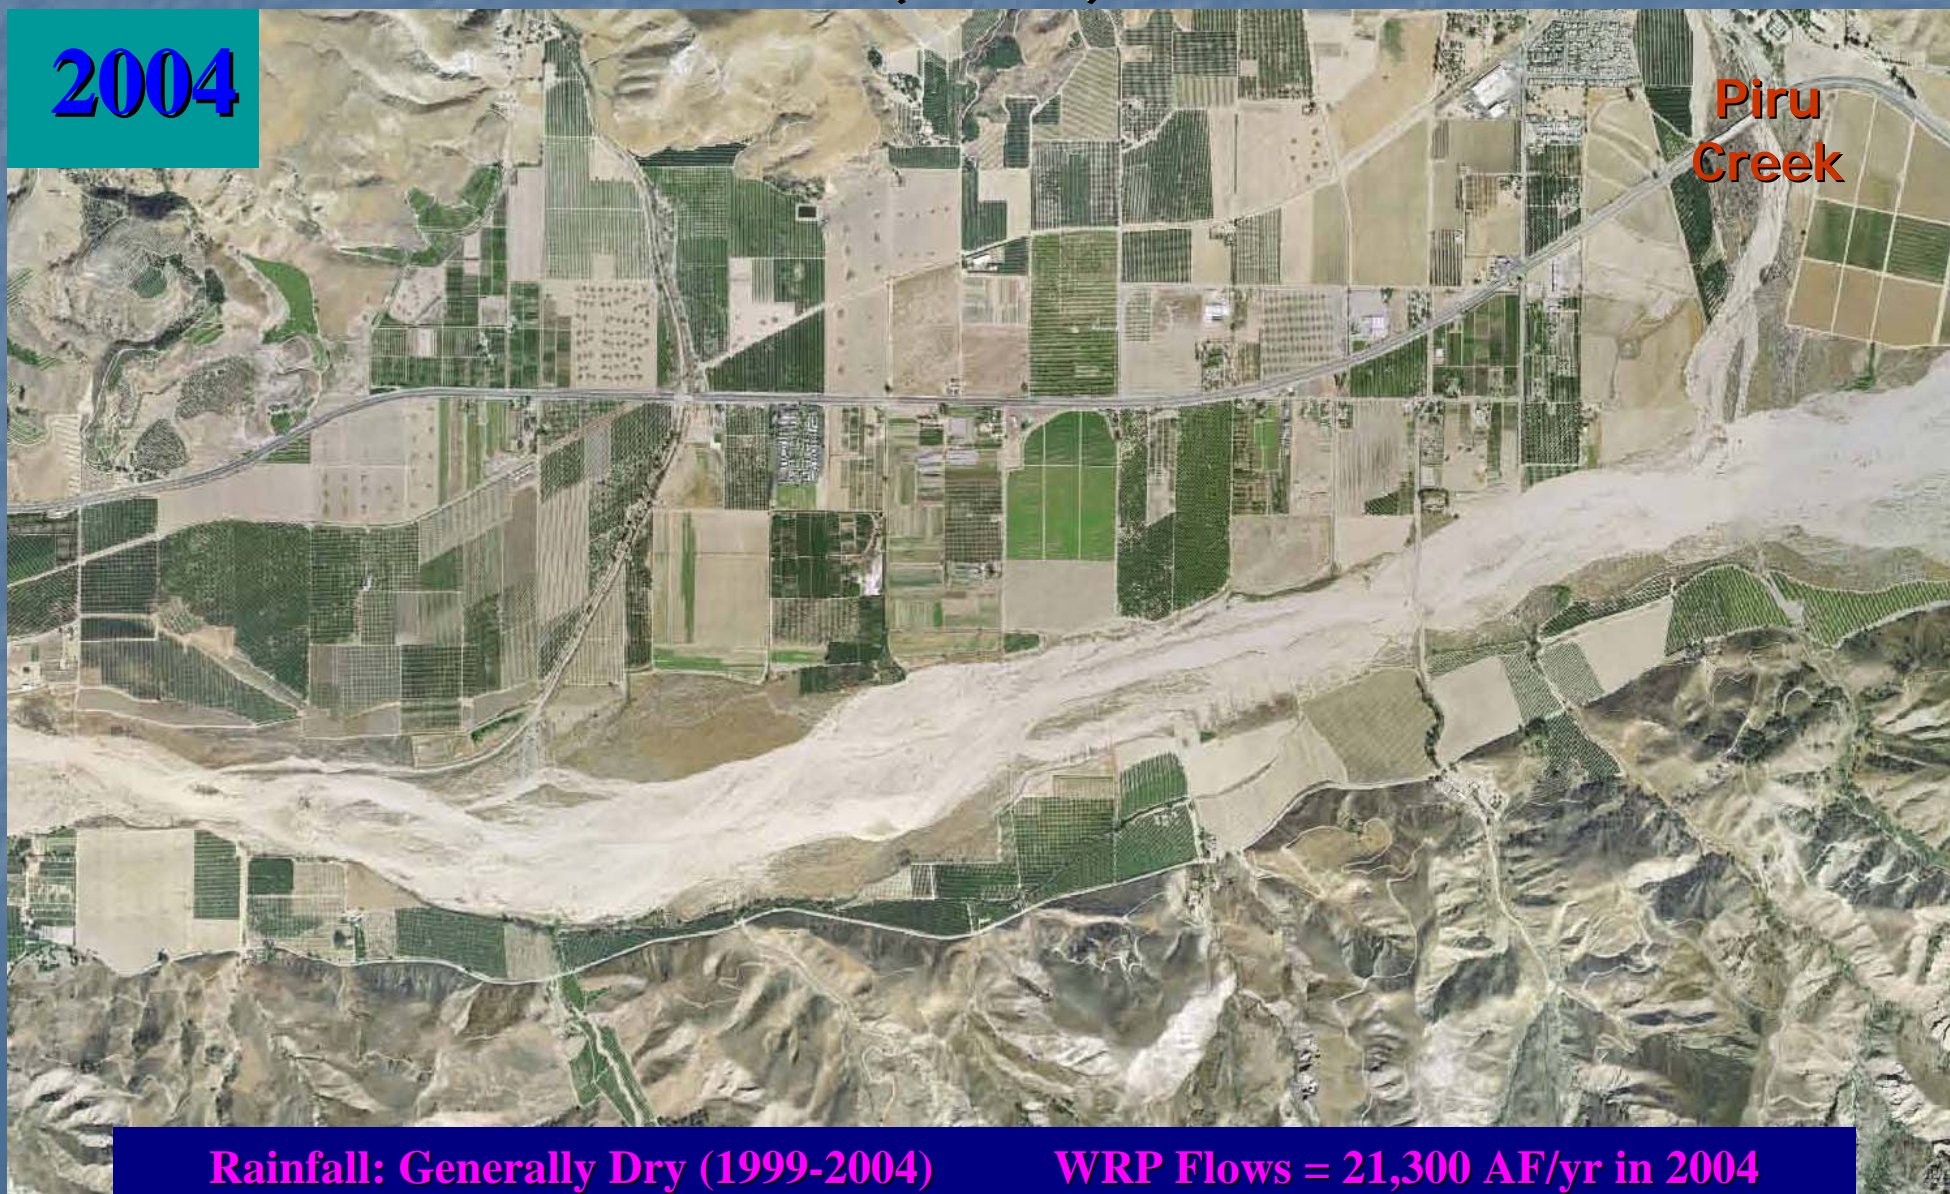
Figure 15

- **Figure 15 (2004).** Piru Creek and the Santa Clara River are both dry.
- **Figure 16 (Post-2004).** Flow is visible in the Santa Clara River at the time of the photo because of the episodic flood in January 2005. Little if any flow is visible in a short reach downstream of Piru Creek, indicating that most of the river flow has infiltrated to groundwater. As discussed earlier in this report, the dry gap has since completely reappeared in the river.

Rainfall: Generally Dry (1999-2004)

WRP Flows = 21,300 AF/yr in 2004
