MEMORANDUM

PWA Project Name: Newhall Ranch

Channel geomorphic assessment of Grande Canyon

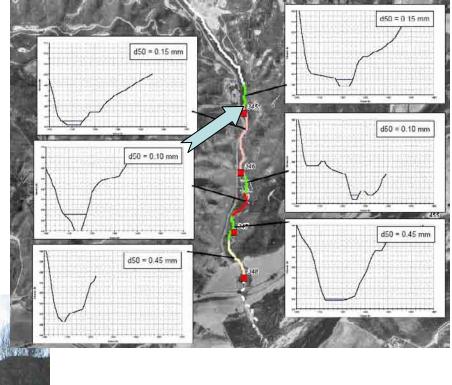
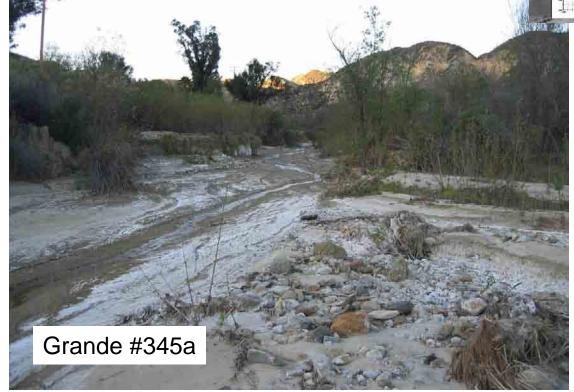
Stable - stable bankfull channel with inset floodplain – some overwidening d50 = 0.10 mm d50 = 0.45 mm Grande #345b

Stable – stable bankfull channel with inset floodplain

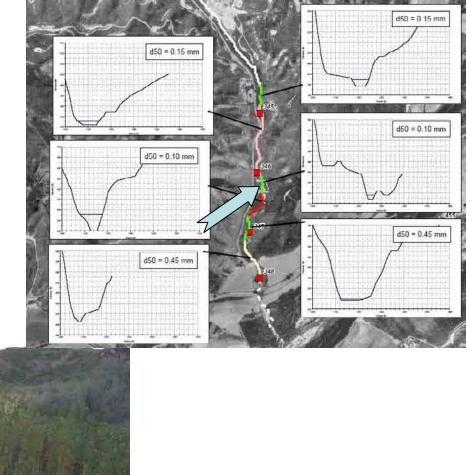
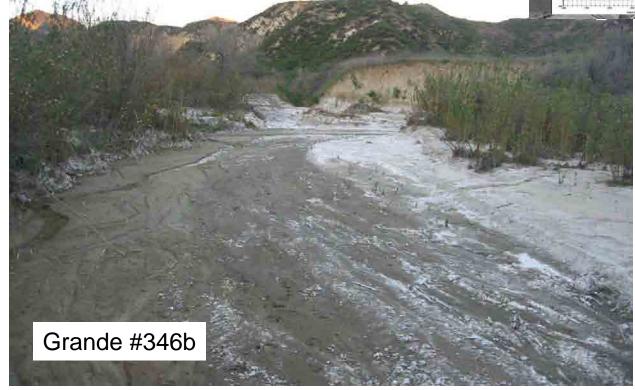
Widening with active bank erosion on abandoned floodplain terraces d50 = 0.10 mm Grande #345c

Widening with active bank erosion on abandoned floodplain terraces but new floodplain forming on inside bend

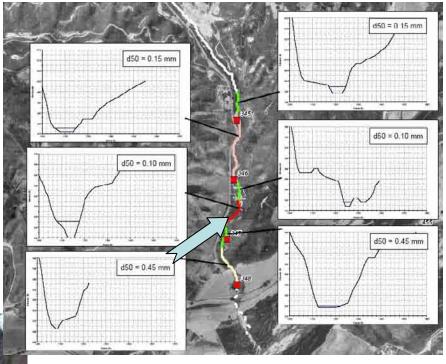
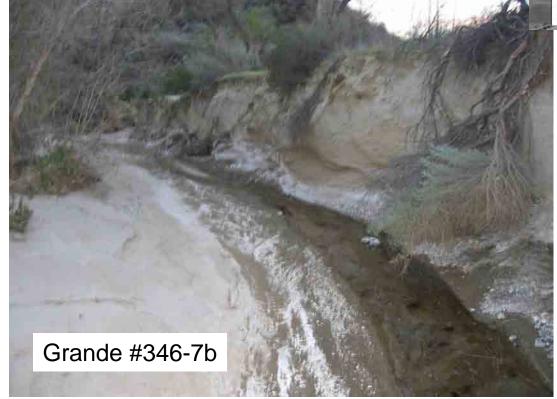
Unstable – eroding outside bend condition

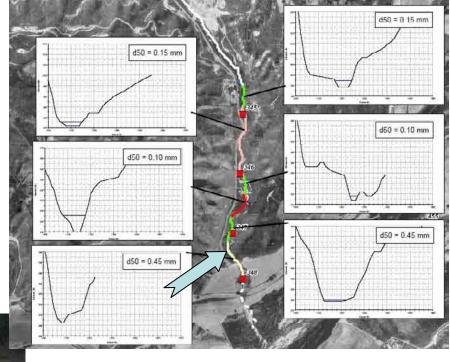
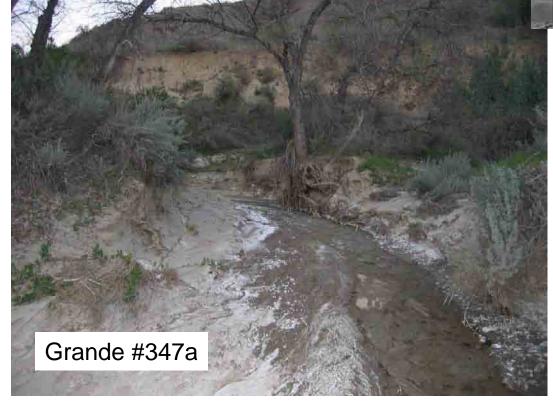
Moderately stable condition with eroding upper terraces and stable new inset terraces d50 = 0.10 mm d50 = 0.45 mm Grande #347b

Moderately stable condition with eroding upper terraces and stable new inset terraces

Grande Canyon combines a series of reaches alternating between unconfined stable reaches with small inset floodplains and confined, slightly incised and unstable conditions with actively eroding outside bends. The upper reach has a well defined and relatively stable bankfull channel that contains the 5-year flow adjacent to a small inset floodplain (Images 345a-b). Downstream the channel is more confined and many outside bends are actively eroding into relict raised floodplain terraces, creating steep and failing banks (Images 354c, 346a, 346b, 346-7a, 3467b). Downstream of this reach the valley opens up and we again encounter more stable conditions (Images 347a, 347b) with small floodplains that persist towards the downstream end of the channel (Images 348b, 348c).

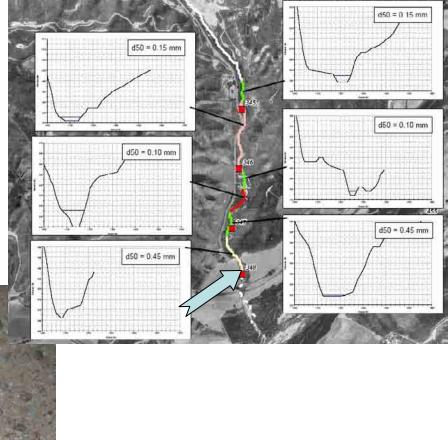
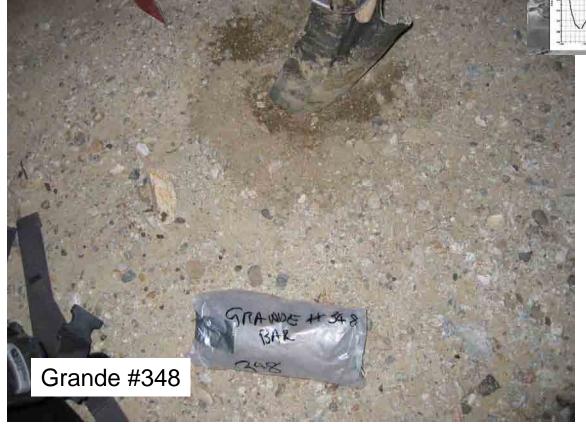
Moderately stable condition

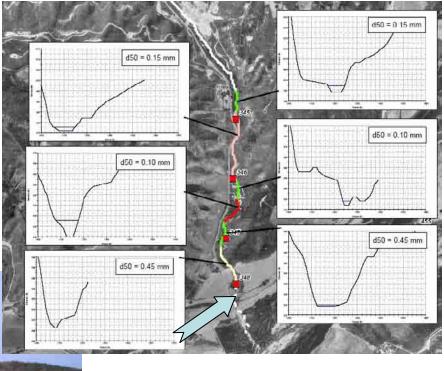
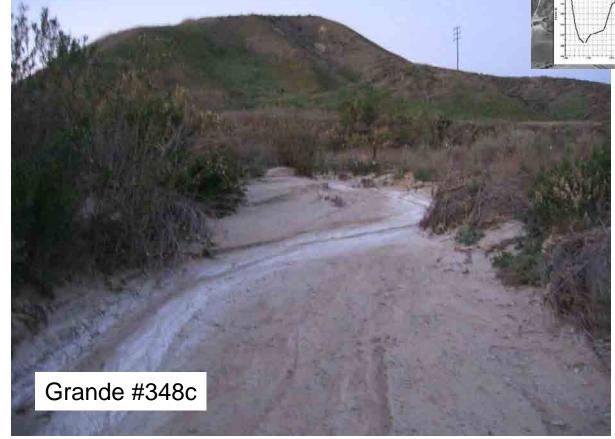
Moderately stable condition
