LOS ANGELES COUNTY SOFT BOTTOM CHANNELS
2003 FOCUSED SURVEY RESULTS

2003
Lanier
Spec

County of Los Angeles
Department of Public Works
900 S. Fremont Avenue, 11th Floor
Alhambra, CA 91803

BonTerra Consulting
151 Kalmus Drive, Suite E-200
Costa Mesa, CA 92626
(714) 444-9199

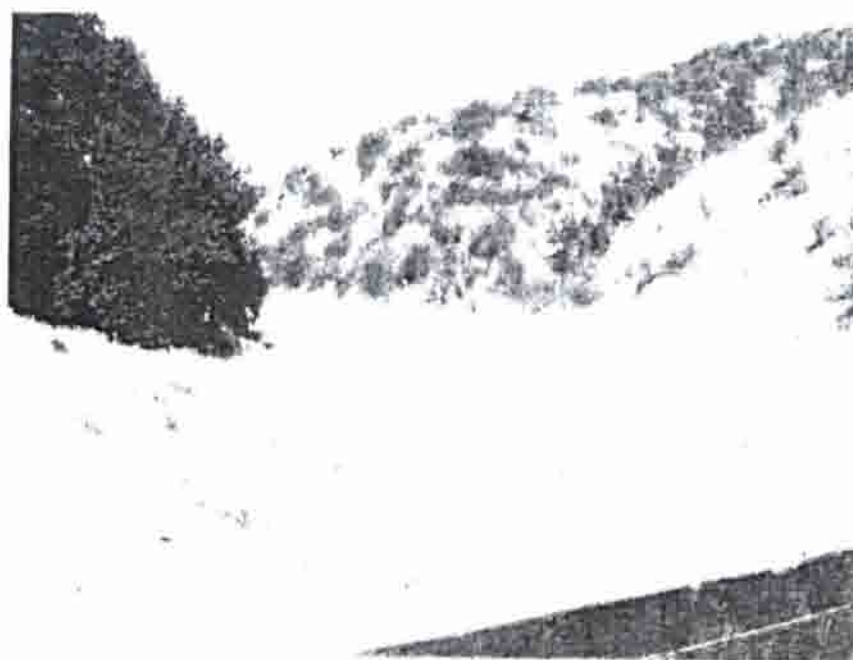
Exhibit 3.4.1-2

No surveys were required at this reach in 2003. Survey results for 2002 are provided in the 2002 focused survey results report (BonTerra Consulting 2002).

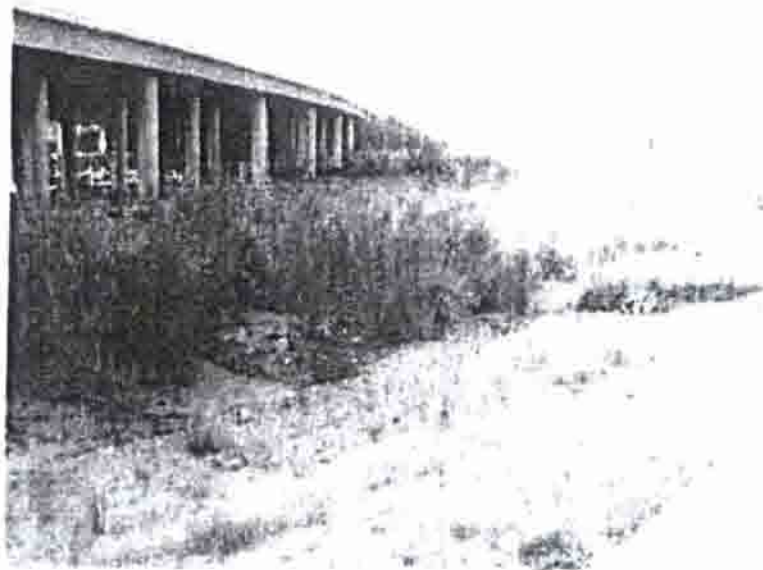
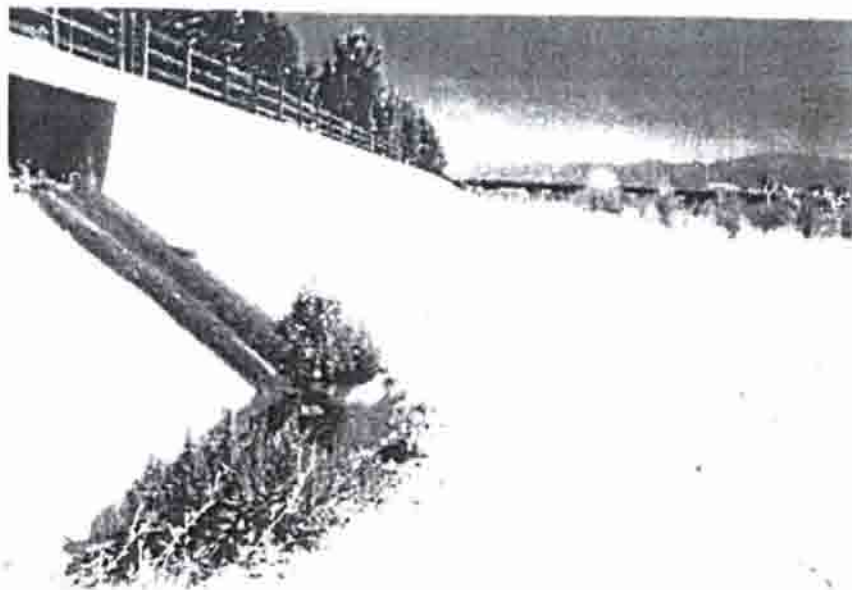
Exhibit 3.4.3-2

This reach consists primarily of open sandy wash with areas of early-successional alluvial scrub. In general, the areas where previous maintenance has occurred adjacent to flood control structures provide no suitable habitat for the slender-horned spineflower. However, suitable habitat for the slender-horned spineflower is present in the alluvial fan sage scrub vegetation along the flood control structures that have not been disturbed by previous vegetation maintenance. Suitable

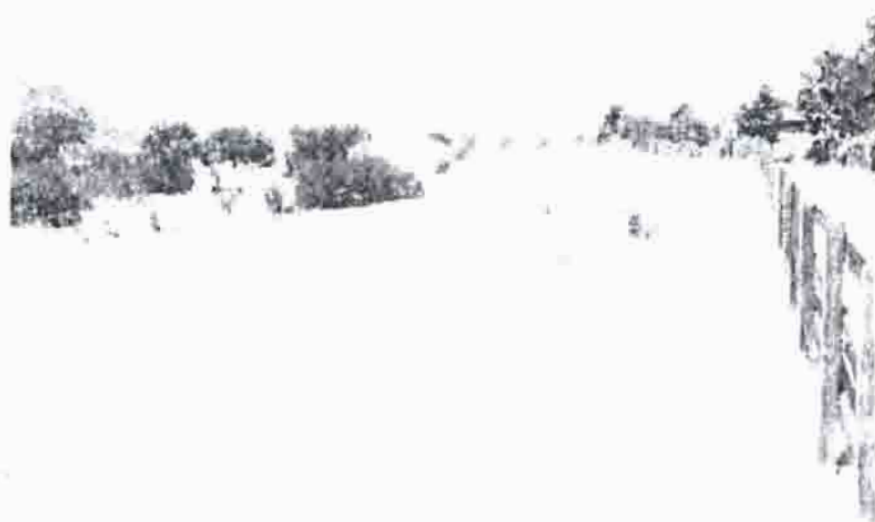
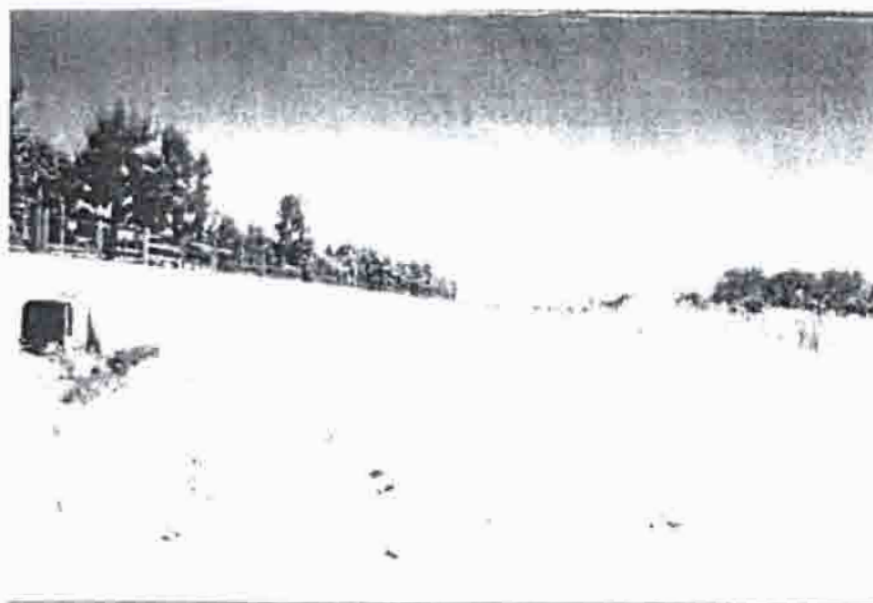
Exhibit 3.4.5-2

This reach consists primarily of open sandy wash with areas of early-successional alluvial scrub. In general, the areas where previous maintenance has occurred adjacent to flood control structures provides no suitable habitat for the slender-horned spineflower. However, suitable habitat for the slender-horned spineflower is present in the undisturbed alluvial fan sage scrub vegetation along the flood control structures where vegetation maintenance has not occurred. Suitable habitat for the slender-horned spineflower is therefore present in Reach #56, and focused surveys were recommended following the 2002 habitat assessment.

No slender-horned spineflower was observed during the 2003 surveys.

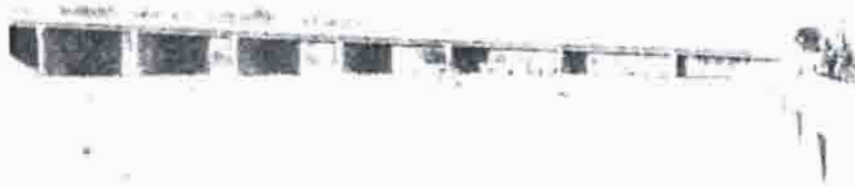
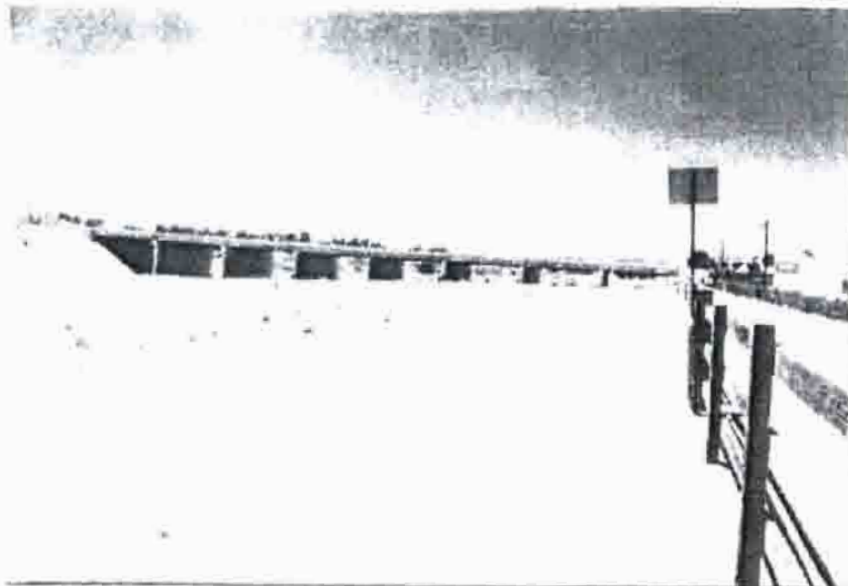
Exhibit 3.4.6-2

The Santa Clara River Channel in this reach contained very little vegetation in some areas but there were patches of vegetation including a few cottonwoods; there was no well-developed riparian corridor. The river channel in this reach is braided, and the primary low flow channel is poorly defined. The low flow channel has little substrate heterogeneity and is dominated by sand-sized particles. Although this reach was dry in 2003, it does have a low potential to hold fish in normal rainfall years if surface water is present. Fish are undoubtedly washed into or through this reach during periods of high rainfall. There is an upstream population of sticklebacks that would allow colonization of this reach when surface water is present. In years where appropriate rainfall conditions occur, it is recommended that this reach be monitored prior to any channel maintenance. However, in most years this reach will be dry.

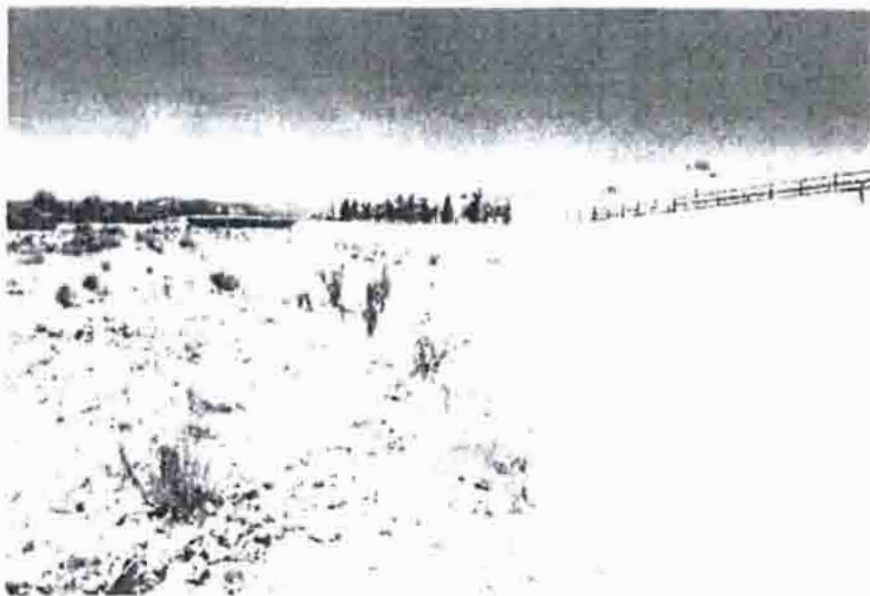
Exhibit 3.4.7-2

No slender-horned spineflower was observed during the 2003 surveys.

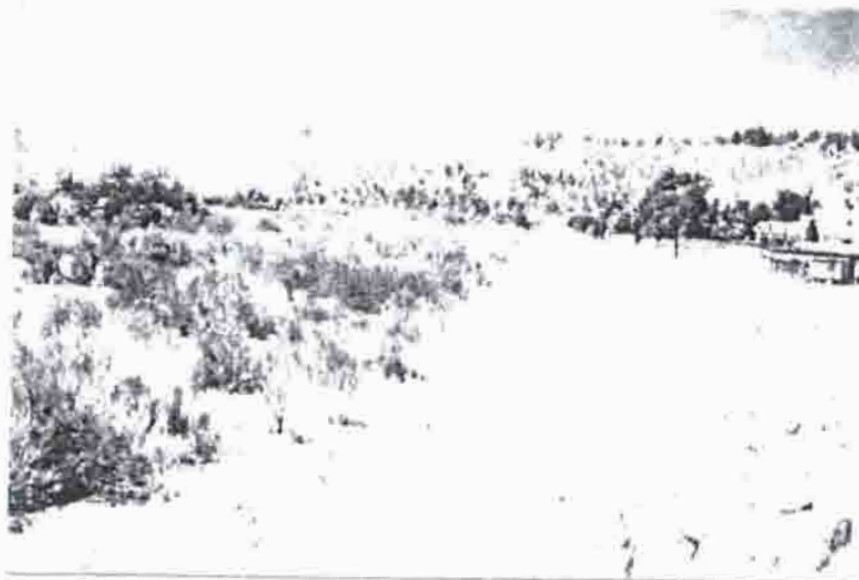
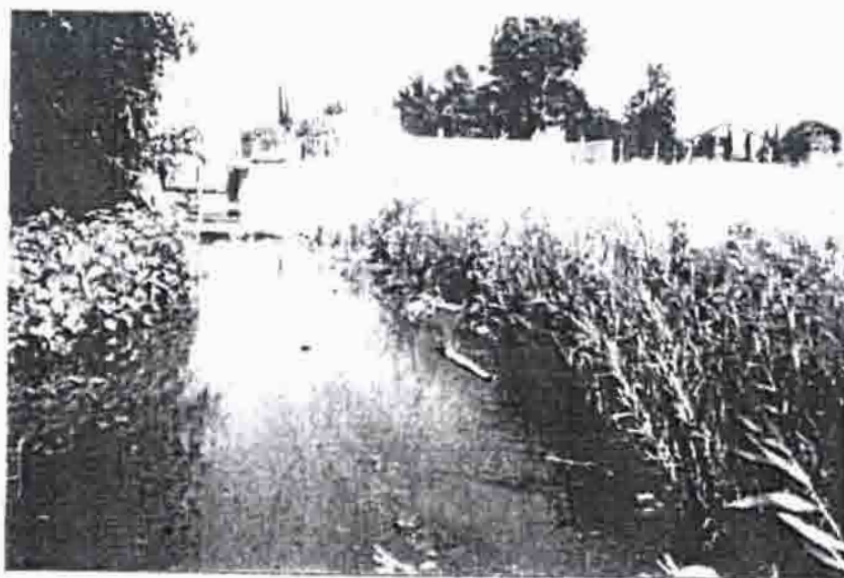
Exhibit 3.4.8-2

The Santa Clara River channel in this reach contained some scrub vegetation, although there was no well-developed riparian corridor. The river channel in this reach is braided, and the primary low flow channel is poorly defined. The low flow channel has little substrate heterogeneity and is dominated by sand-sized particles. Although this reach was dry in 2003 (except as discussed above), it does have a low potential to hold fish in normal rainfall years if surface water is present. Fish are undoubtedly washed into or through this reach during periods of high rainfall. If the flow from the side channel reaches the Santa Clara River during high flows, fish could colonize the side channel and due to the large amount of water present, this could serve as a refugium during the

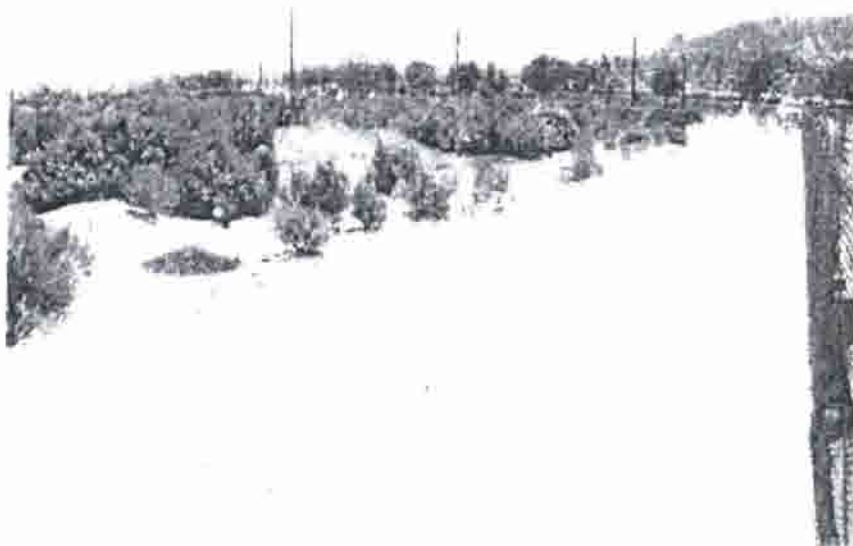
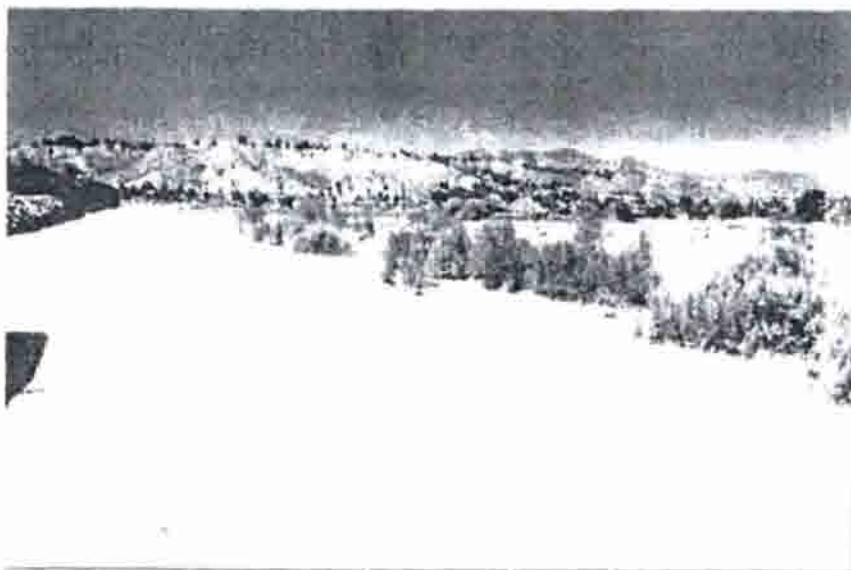
Exhibit 3.4.9-2

The Santa Clara River Channel in this reach contained a moderate amount of scrub vegetation which becomes thicker downstream, but there was no well-developed riparian corridor. The river channel in this reach is braided, and the primary low flow channel is poorly defined. The low flow channel has little substrate heterogeneity and is dominated by sand-sized particles. Although this reach was dry in 2003, it does have a low potential to hold fish in normal rainfall years if surface water is present. Fish are undoubtedly washed into or through this reach during periods of high

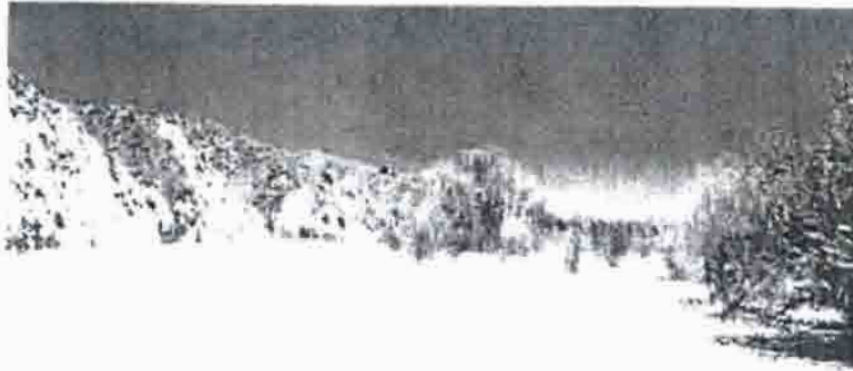
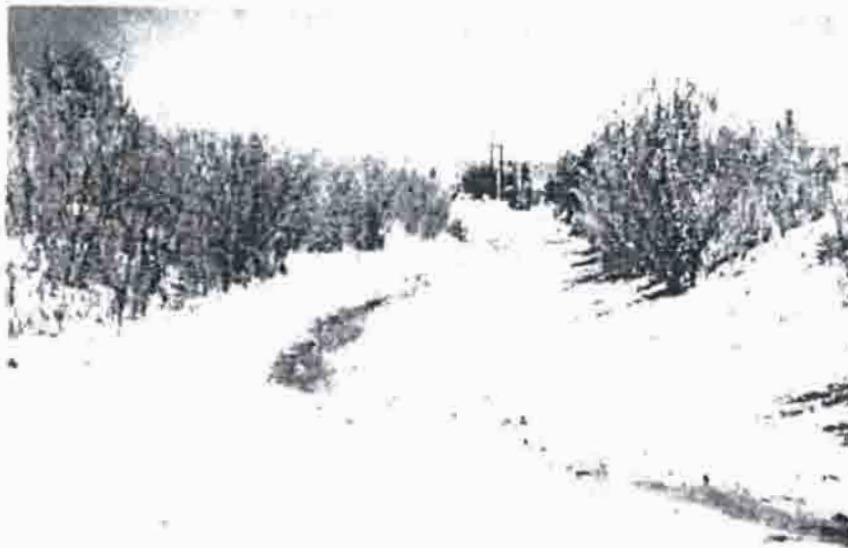
Exhibit 3.4.10-2

The Santa Clara River Channel in this reach contained thick scrub vegetation with scattered cottonwoods, but there was no well-developed riparian corridor. The river channel in this reach is braided, and the primary low flow channel is poorly defined. The low flow channel has little substrate heterogeneity and is dominated by sand-sized particles. Although this reach was dry in 2003 (except as noted above), it does have a low potential to hold fish in normal rainfall years if

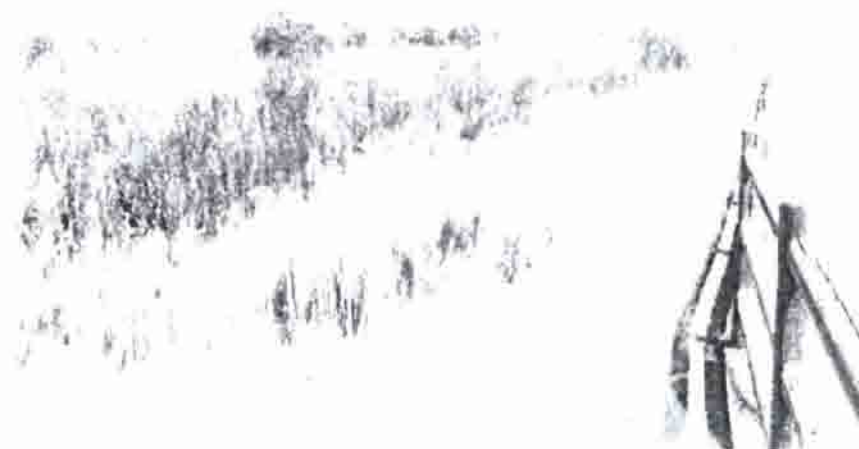
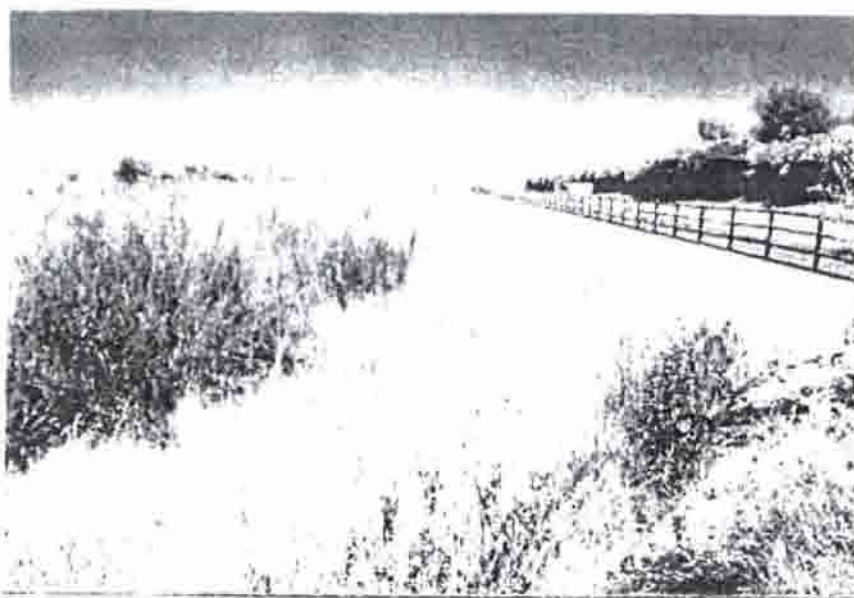
Exhibit 3.4.11-2

The Santa Clara River Channel in this reach contained thick scrub vegetation, but there was no well-developed riparian corridor. The river channel in this reach is braided, and the primary low flow channel is poorly defined. The low flow channel has little substrate heterogeneity, and is dominated by sand-sized particles. Although this reach was dry in 2003, it does have a low potential to hold fish in normal rainfall years if surface water is present. Fish are undoubtedly

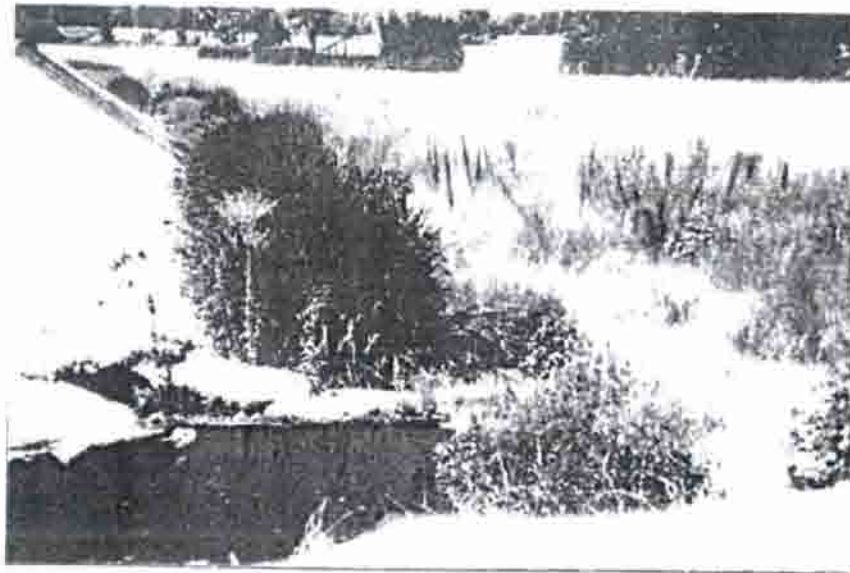
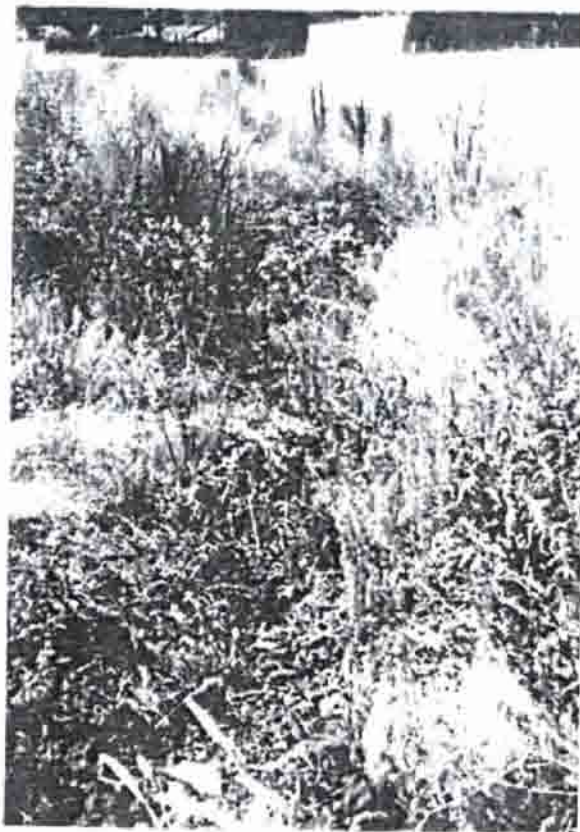
Exhibit 3.4.12-2

There is considerable emergent and aquatic vegetation. The substrate is dominated by sand-sized particles, and the primary flow channel is poorly defined. This reach is essentially contiguous with the unchannelized portion of Bouquet Canyon Creek, which contains a stickleback population. Therefore, there is a potential for sticklebacks to be washed into this reach during high flows. During wetter years, this lower portion of Bouquet Canyon Creek contains a population of the unarmored three-spine stickleback (Baskin and Haglund, personal observation). During dry years,

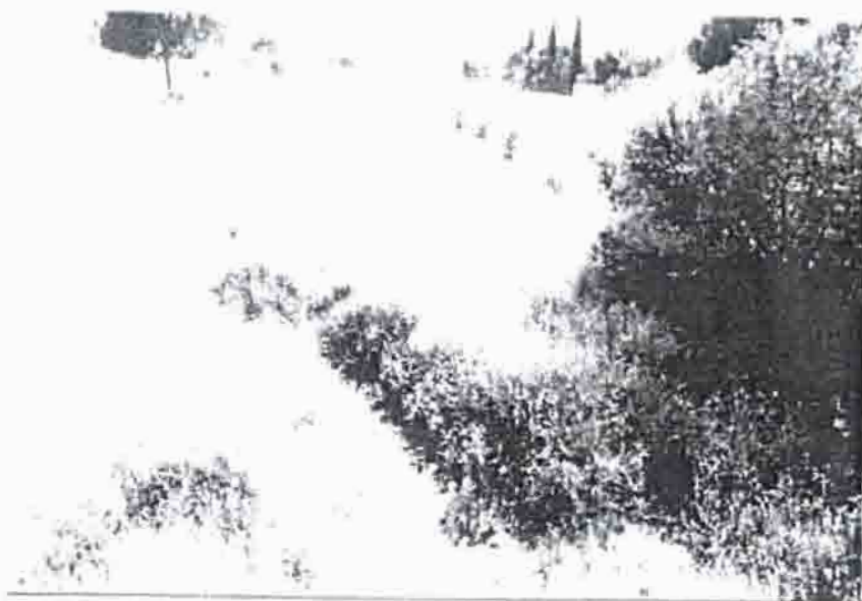
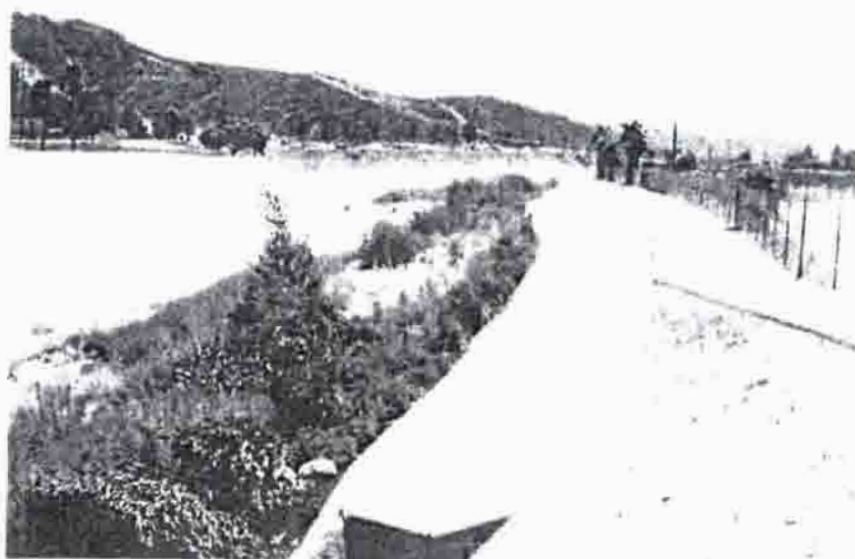
Exhibit 3.4.13-2

There is patchy vegetation in this reach. The substrate is dominated by sand-sized particles, and the primary flow channel is poorly defined. This reach is contiguous with Reach #67, Bouquet Canyon Upper. Reach #67 is essentially contiguous with the unchannelized portion of Bouquet Canyon Creek, which contains a stickleback population. Therefore, there is a potential for sticklebacks to be washed into this reach during high flows. During wetter years, this lower portion of Bouquet Canyon Creek contains a population of the unarmored three-spine stickleback (Baskin and Haglund, personal observation). During dry years, the more upstream portions of the canyon with perennial water maintain the stickleback population, which expands downstream when there is surface flow in the lower portion of the creek. It is likely that any stickleback population occupying the channelized reach requires the downstream movement of individuals from the unchannelized portion of the creek in order to maintain the population. However, this means that at least in some years this reach will be expected to support fish. In years where appropriate rainfall conditions occur, it is recommended that this reach be monitored prior to any channel maintenance.

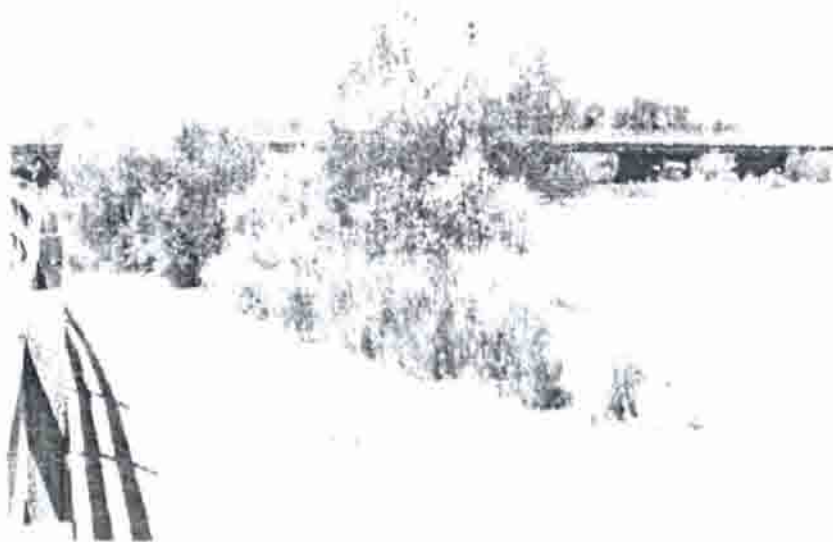
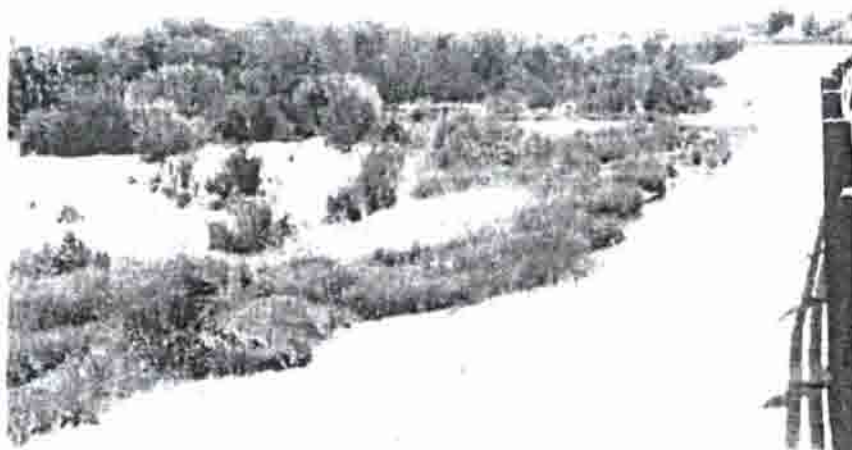
Exhibit 3.4.15-2

Reach #71, Santa Clara River Main Channel (PD 1946), is located within the Santa Clara River-South Fork Watershed in the City of Santa Clarita (Exhibit 3.4.15-1). The limits of Reach #71 are approximately 276 feet upstream of McBean Parkway (at the confluence with the South Fork of the Santa Clara River) to the downstream edge of McBean. Reach #71 is 346 feet in total length. The

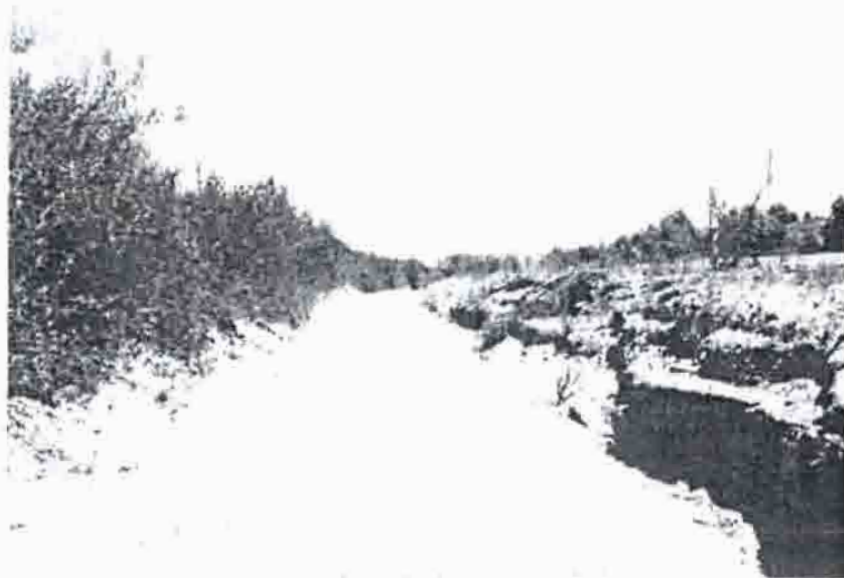
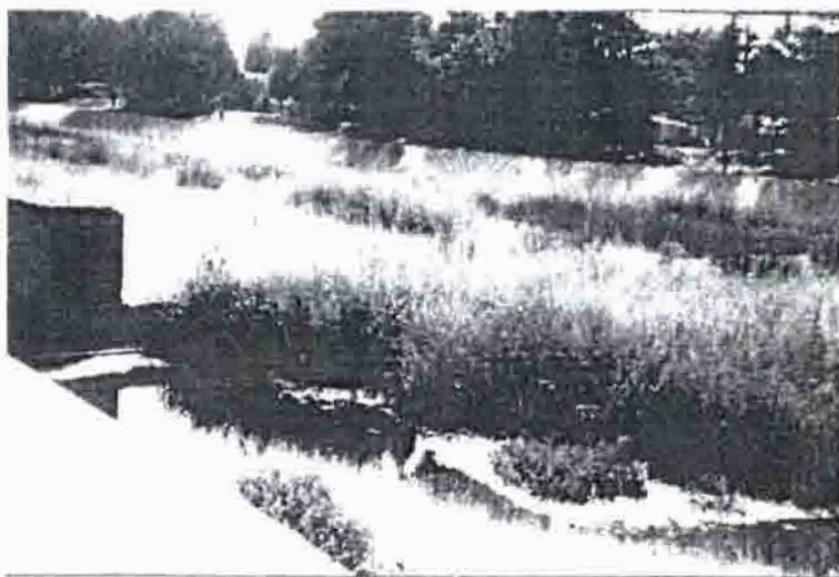
Exhibit 3.4.16-2

The portion of the reach upstream of Orchard Village Boulevard to Lyons Avenue has more surface water, and there are areas that have sufficient flow and depth to support fish. This reach lacks the riparian vegetation of the more downstream portion of the reach, but it does have well-developed emergent and aquatic vegetation. Therefore, this portion of the reach was seined. No fish were found.

Despite the fact that the upper portion of the reach has sufficient water to provide habitat and the lower portion of the reach has the potential to develop habitat in a wetter year, future occupation of this reach by the unarmored three-spine stickleback is not expected. Although fish habitat may be present, this reach cannot be colonized from downstream due to the presence of the Valencia

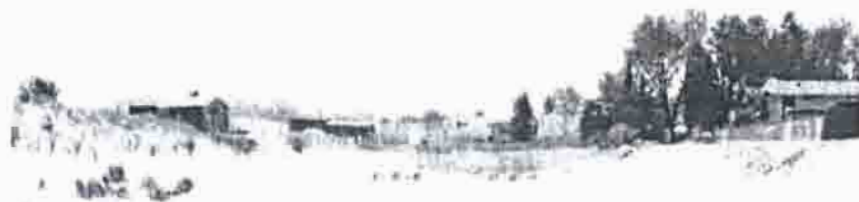
Exhibit 3.4.17-2

The table below summarizes the type of surveys completed, survey dates, and surveying biologist for each survey within this reach. Photographs of this reach are shown in Exhibit 3.4.17-2.

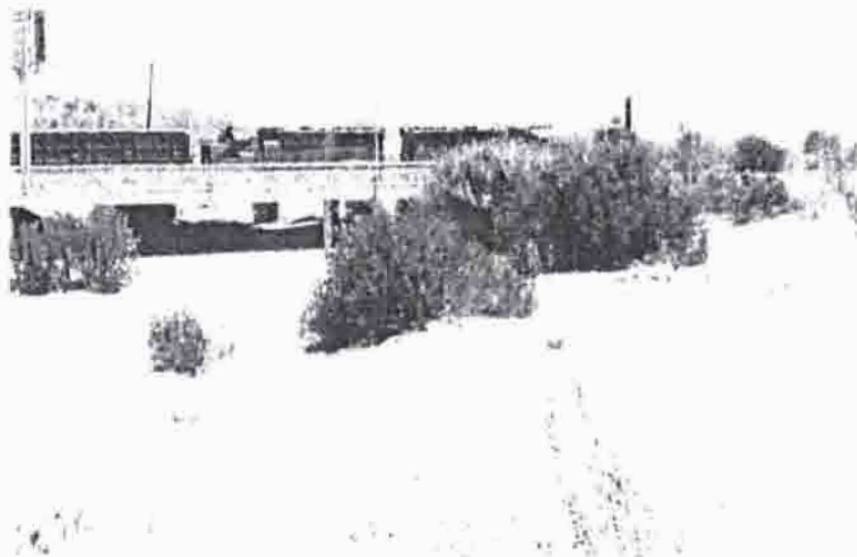
Reach #78 - Placerita Creek

This reach consists primarily of an unvegetated channel where previous maintenance has occurred along Newhall Creek and adjacent to the groin at the confluence with the Santa Clara River. In general, this area provides no habitat for the slender-horned spineflower. However, early successional alluvial scrub is present on the banks above the central part of the maintained channel and adjacent to the maintained corridor adjacent to the groin. Therefore, suitable habitat for the slender-horned spineflower is present in Reach #78 and focused surveys were recommended following the 2002 habitat assessment.

No slender-horned spineflower was observed during the 2003 surveys.

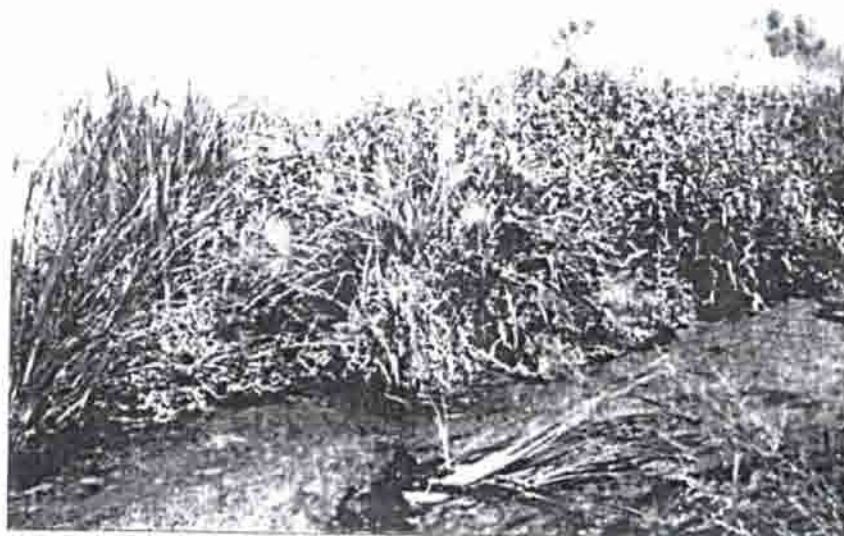
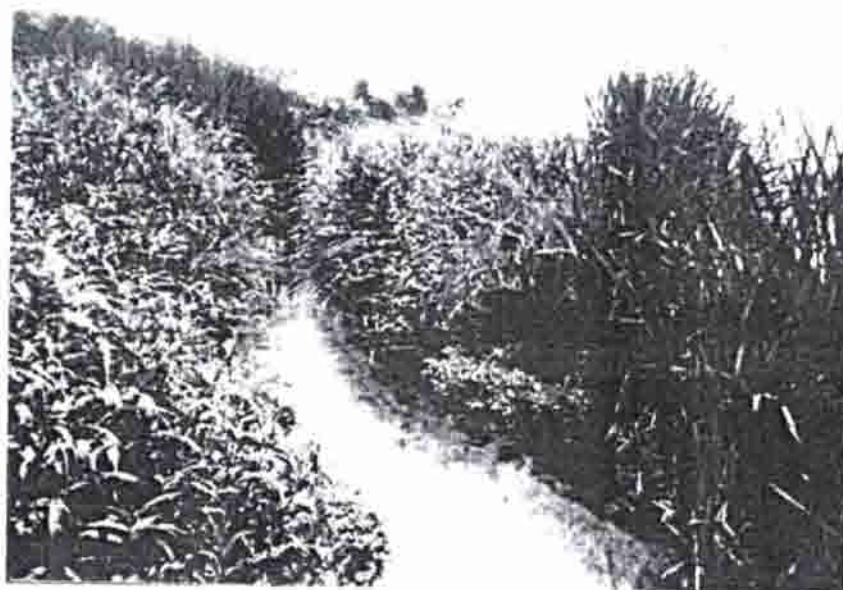
Exhibit 3.4.20-2

There is well-developed emergent and aquatic vegetation throughout the reach, and some young, relatively thick riparian vegetation exists in a portion of the reach. The structure of the stream is appropriate to support all three native fishes typically found in this area of the Santa Clara River: the unarmored three-spine stickleback, Santa Ana sucker, and arroyo chub. The stream within this reach provides appropriate habitat for the fishes, and this reach was continuously occupied by the three native fish species during the 1990s (Baskin and Haglund, personal observation). In years where appropriate rainfall conditions occur, this reach should be monitored prior to any channel maintenance.

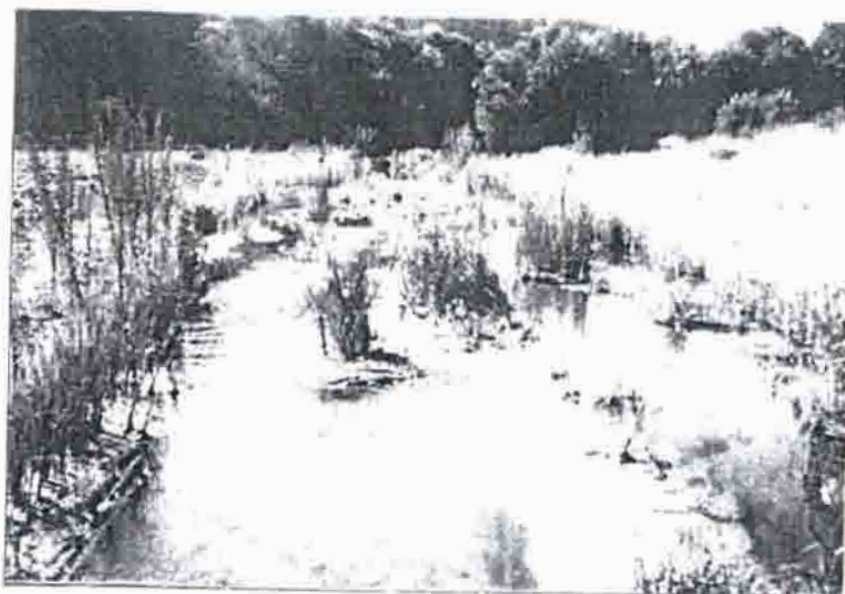
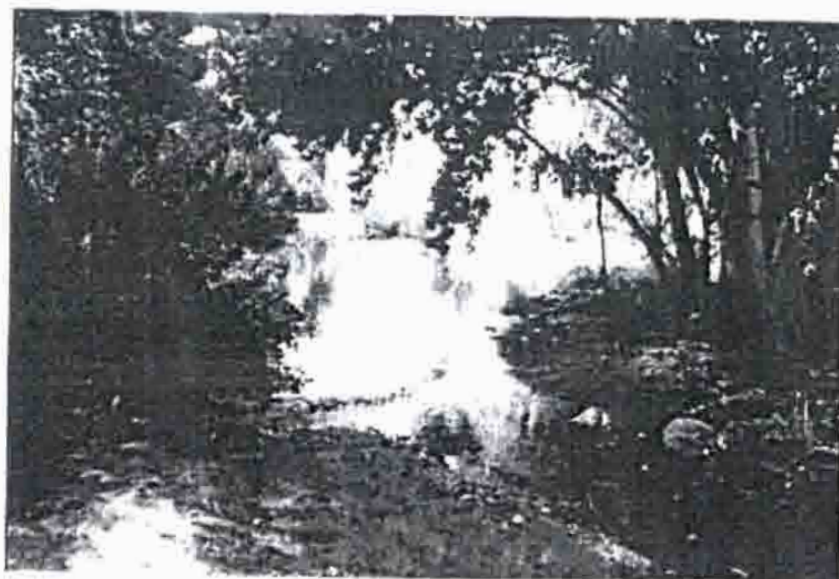
Exhibit 3.4.22-2

The table below summarizes the type of surveys completed, survey dates, and surveying biologist for each survey within this reach. Photographs of this reach are shown in Exhibit 3.4.22-2.

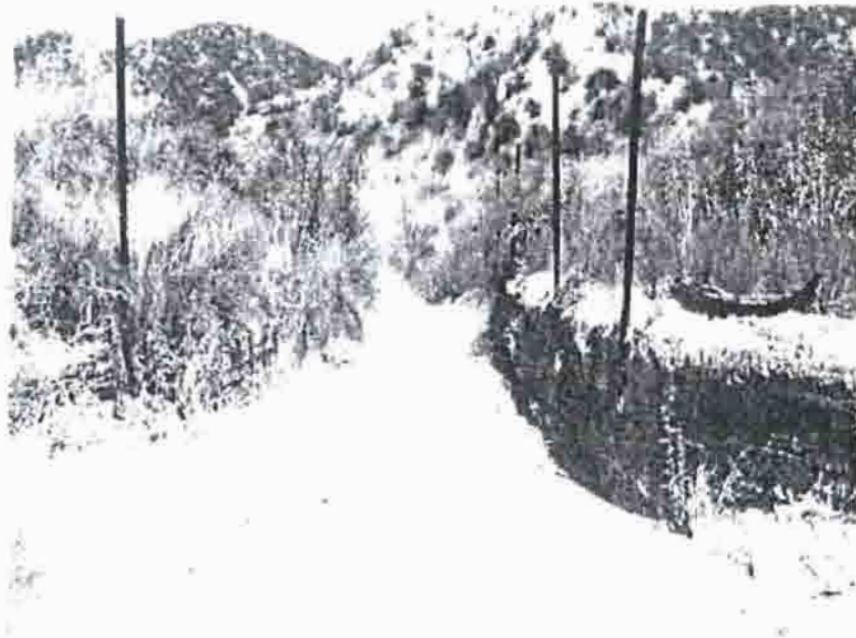
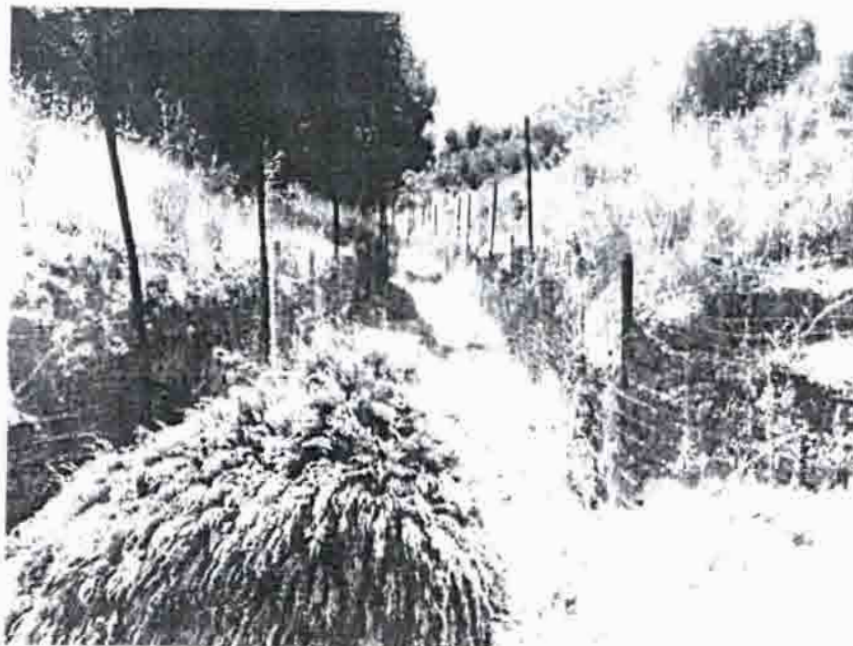
Exhibit 3.4.28-2

Reach #92 consists of an incised channel protected by wire revetment structures. Some alluvial scrub is present within the channel and good quality alluvial scrub with scalebroom and Great Basin sagebrush is present on the adjacent benches. Suitable habitat for the slender-horned spineflower is therefore present in Reach #92, and focused surveys were recommended following the 2002 habitat assessment.

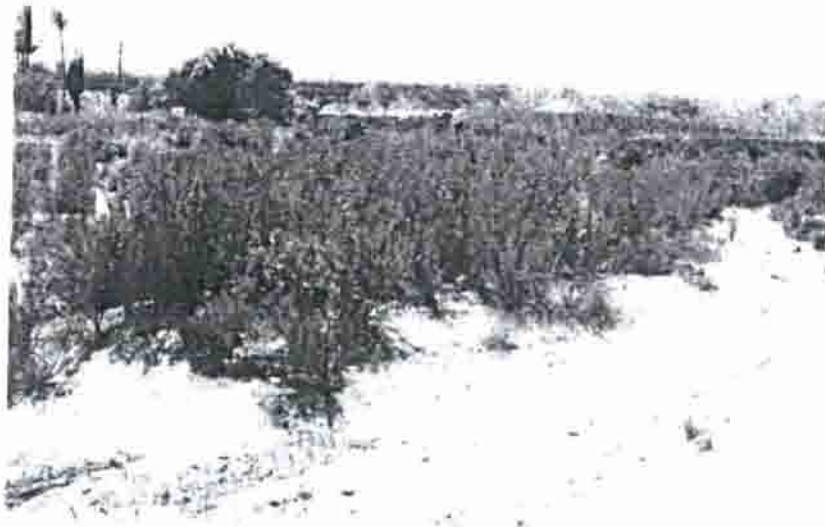
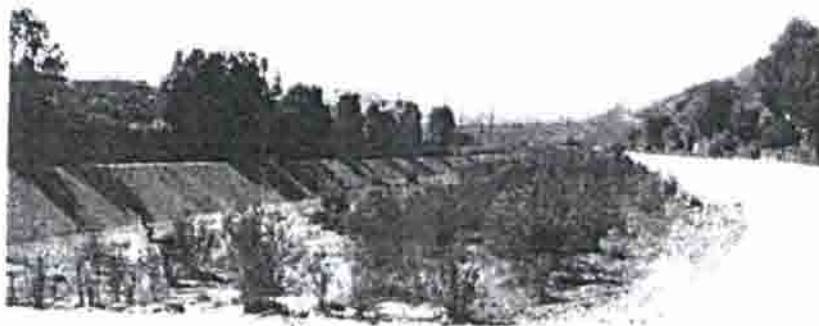
New Reach - Violin Canyon

The New Reach Violin Canyon consists of open alluvial scrub at the upper end of a flood wall area in the broad channel between flood walls. In some areas this alluvial scrub extends to the base of these flood walls. This habitat is good quality with a low percentage of weedy species. Suitable habitat for the slender-horned spineflower is therefore present in the New Reach, and focused surveys were recommended following the 2002 habitat assessment.

No slender-horned spineflower was observed during the 2003 surveys.
