COMPOSITE WETLAND DELINEATION

**NEWHALL RANCH RESOURCE MANAGEMENT
AND DEVELOPMENT PLAN SITE AND ENTRADA
PLANNING AREA**

URS Project Number 28907071

April 2, 2009

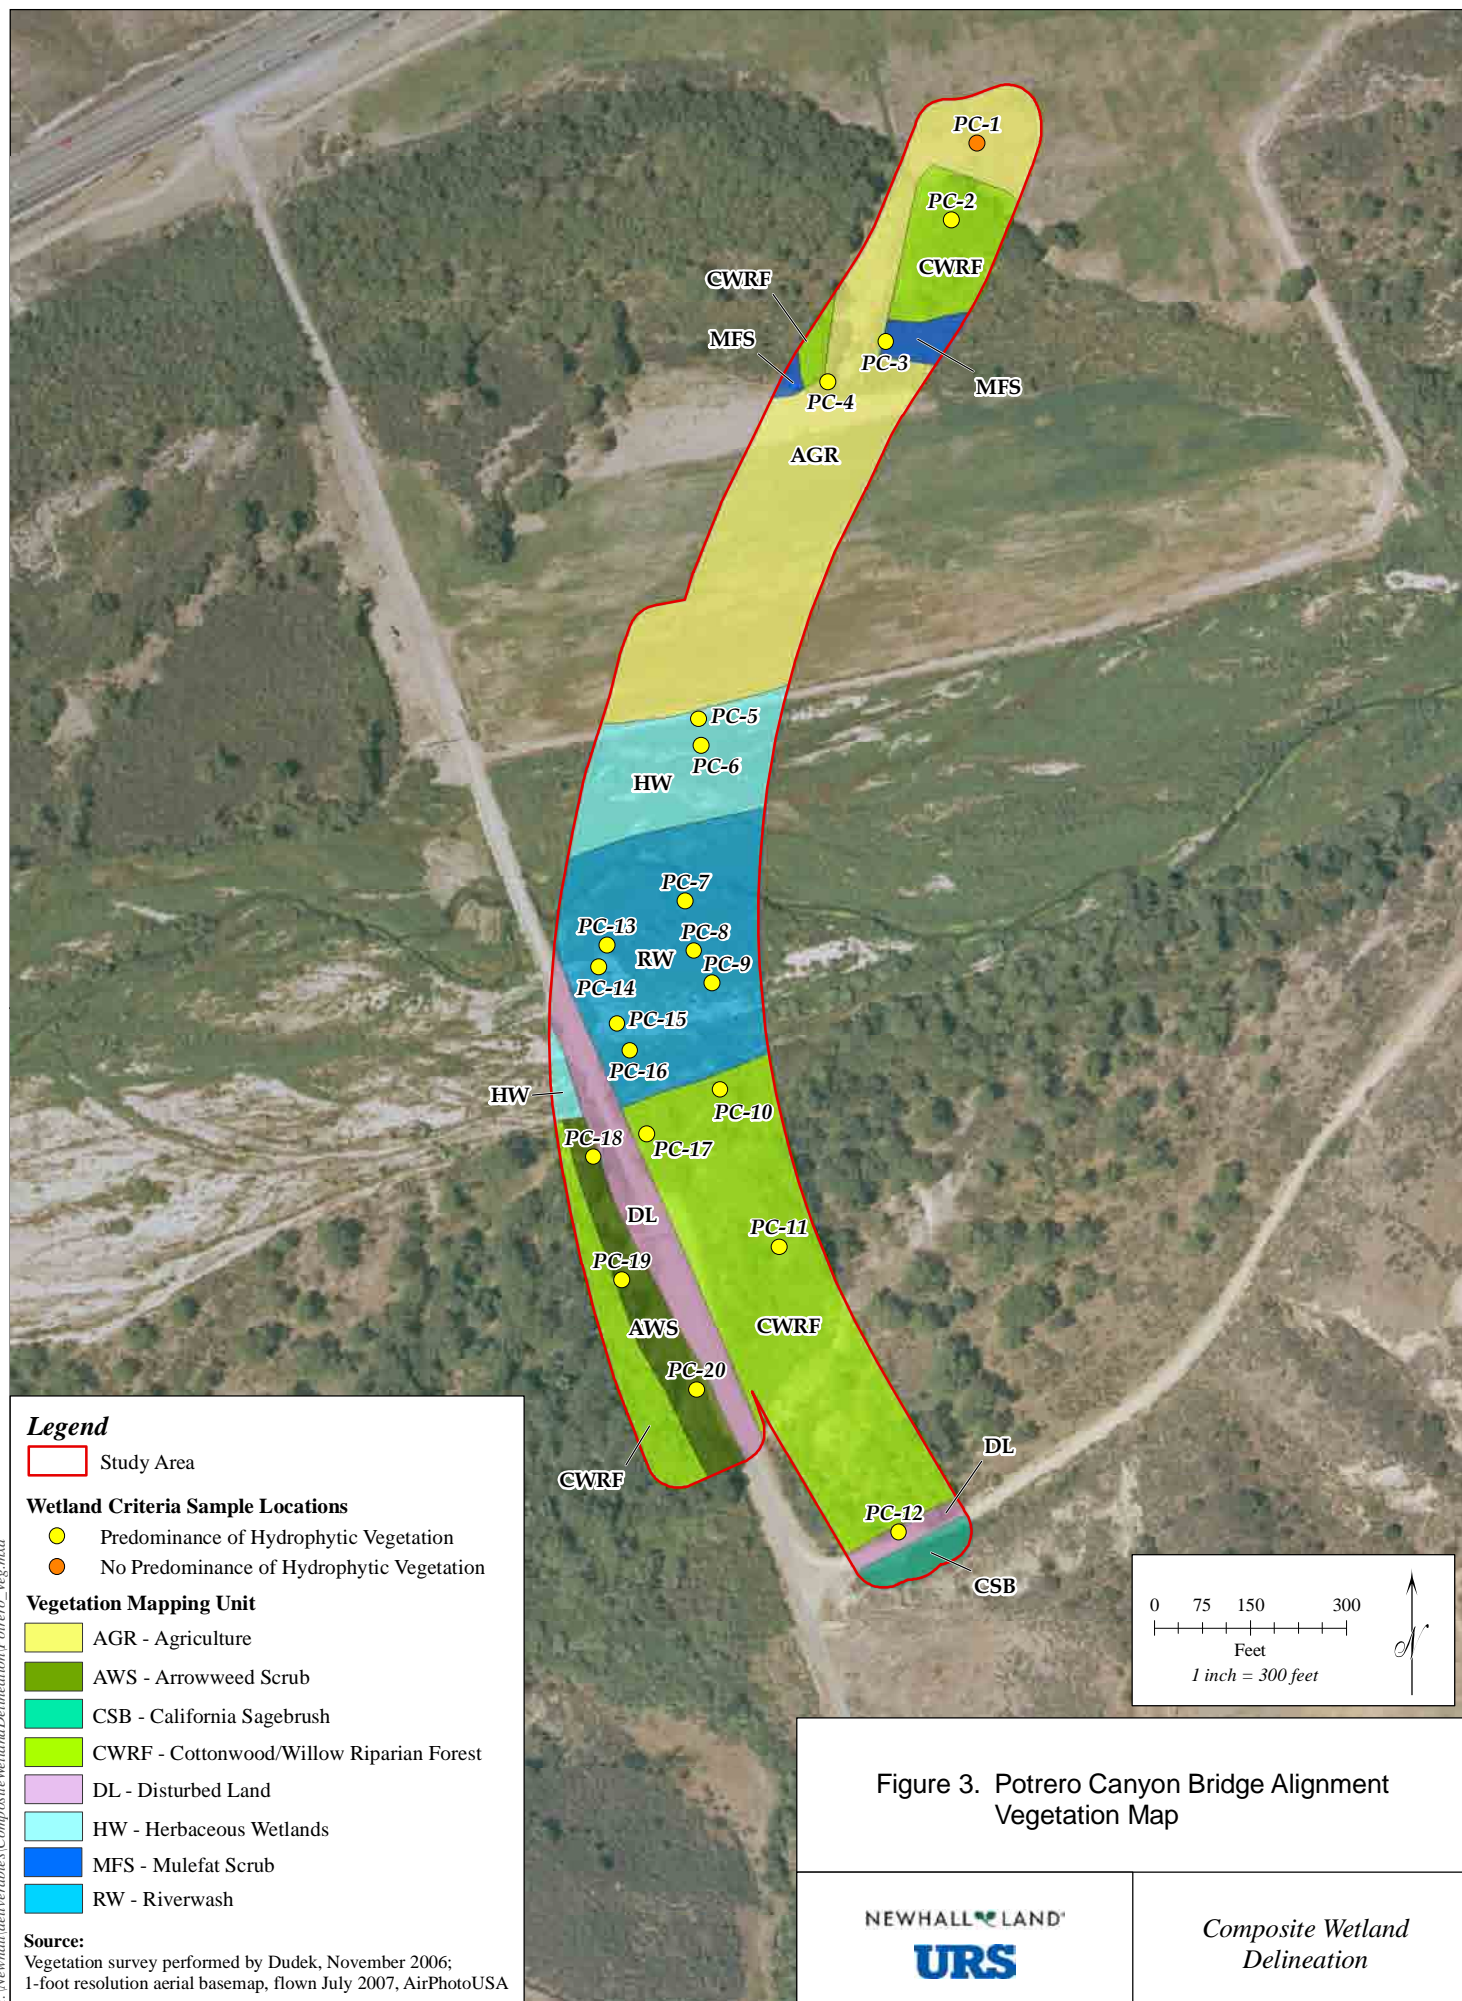
All but one of these data points (data point PC-1, located in an agricultural field) showed a dominance of hydrophytic vegetation. Dominant hydrophytic plant species observed within this study location included red willow, narrow-leaved willow, Fremont cottonwood, mulefat, cattail, and white sweetclover. Although most of the hydrophytic vegetation within the study location was associated with the current channel of the Santa Clara River, hydrophytic vegetation was also observed in a strip of agricultural land in the northern portion of the study location. In this area, the historic floodplain of Santa Clara River was evident as riparian scrub and forest bordered the narrow swath of agriculture. The area to the south of this hydrophytic vegetation is occupied by a fallow agriculture field. Vegetation in the field consists of Bermuda grass (*Cynodon dactylon*), Mexican sprangletop (*Leptochloa uninervia*), white sweetclover, and mulefat. The locations of sampling points and presence/absence of hydrophytic vegetation are depicted graphically on Figure 3.

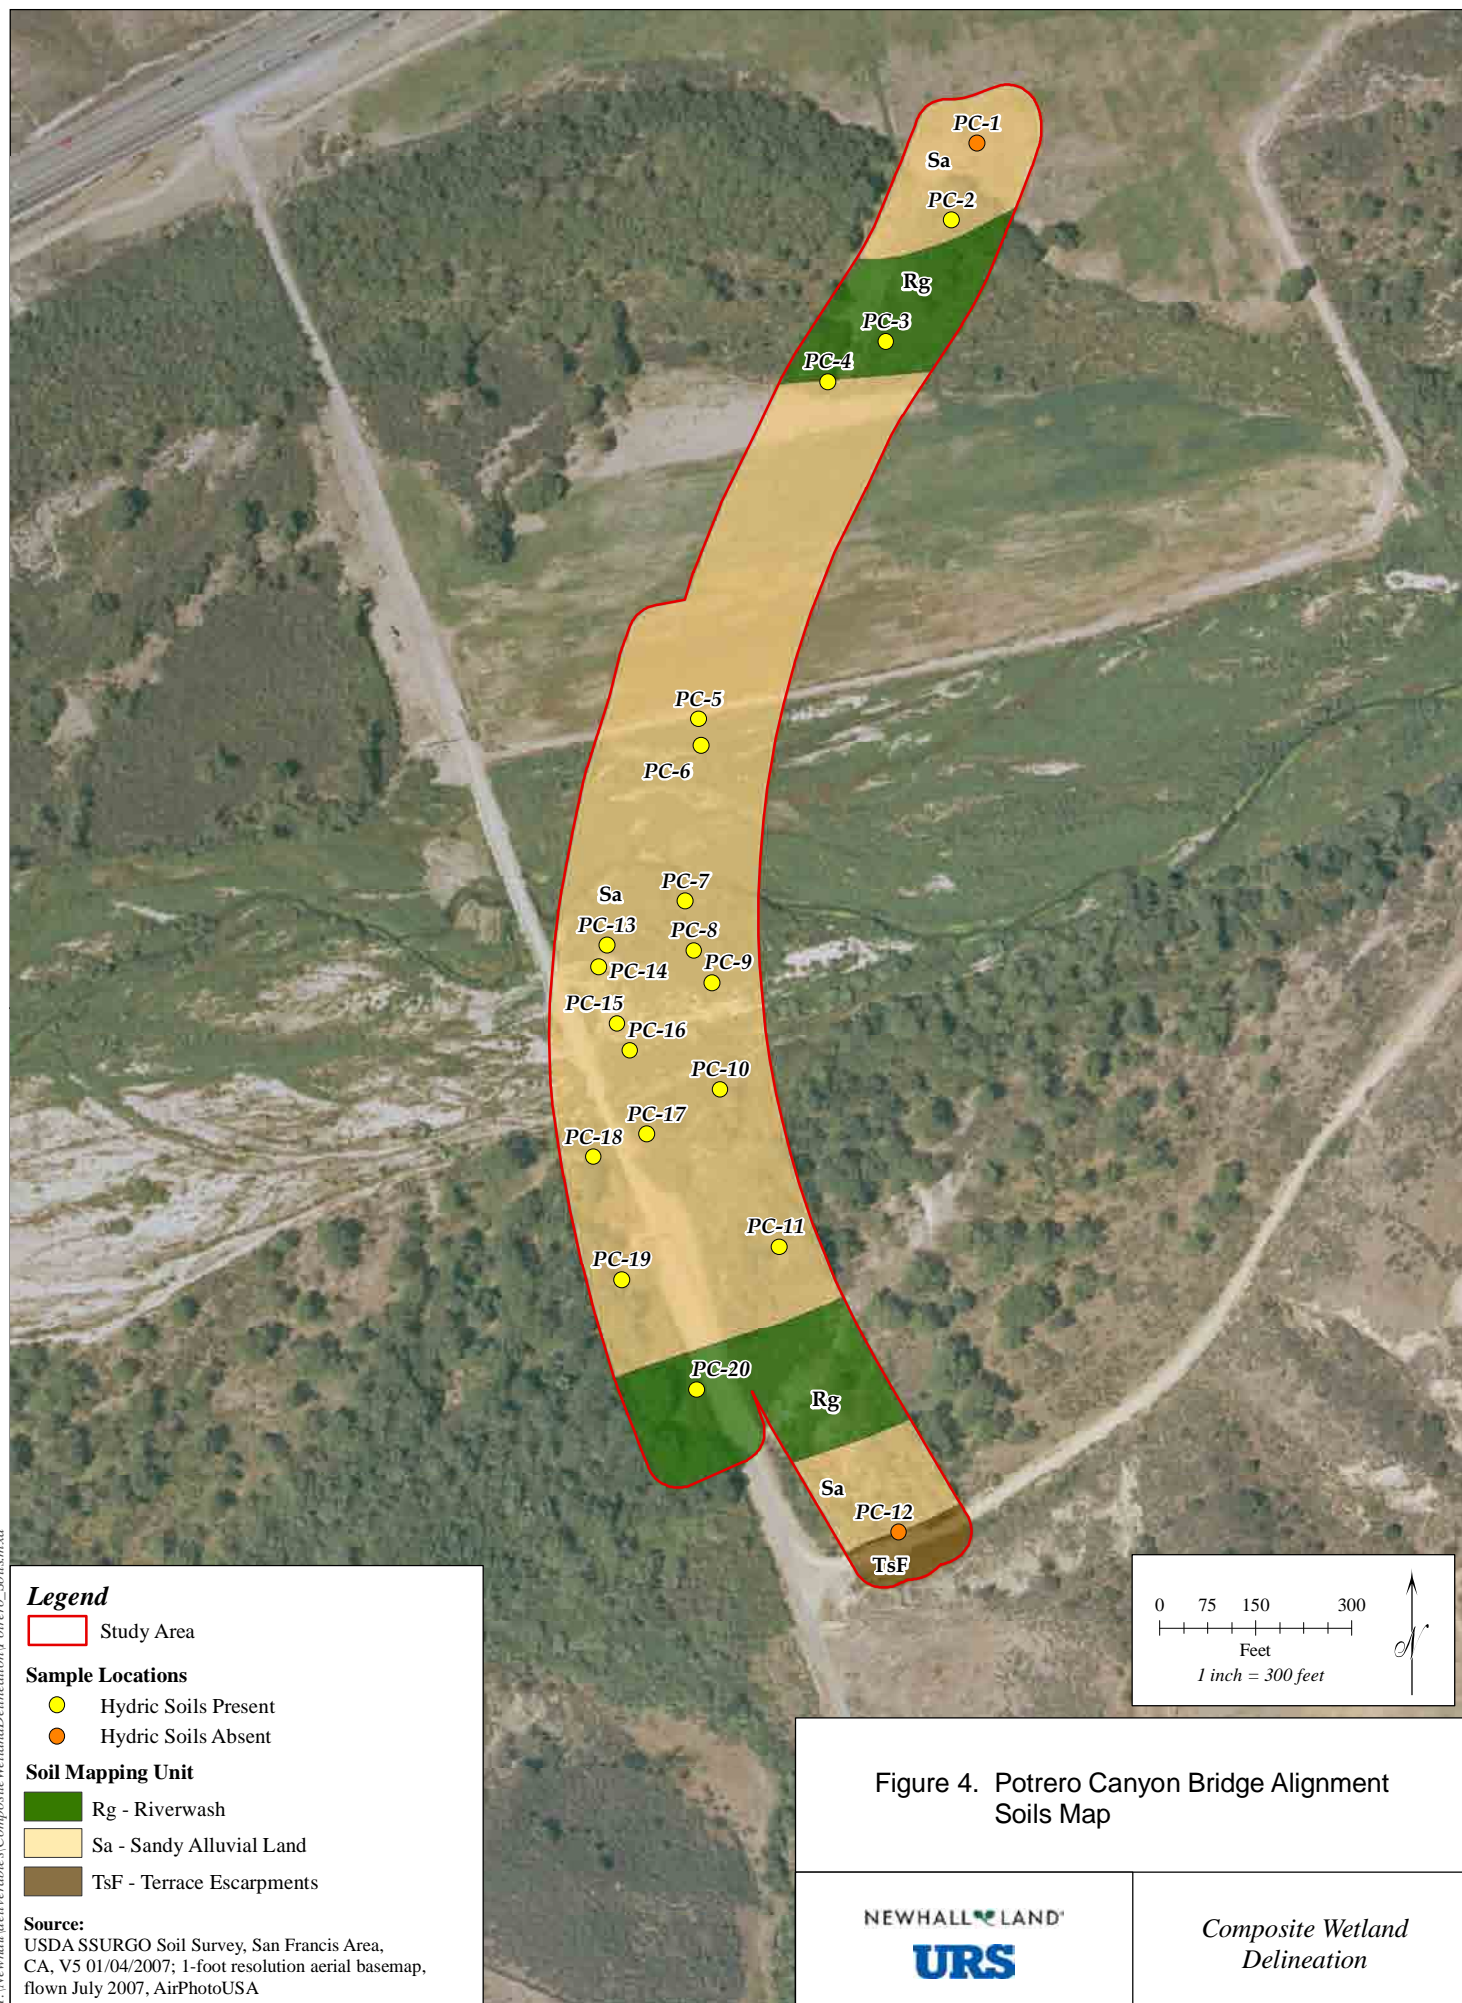
Escarpments, respectively). The mapped soil types, along with locations of sampling points and presence/absence of hydric soil indicators, are depicted graphically on Figure 4.

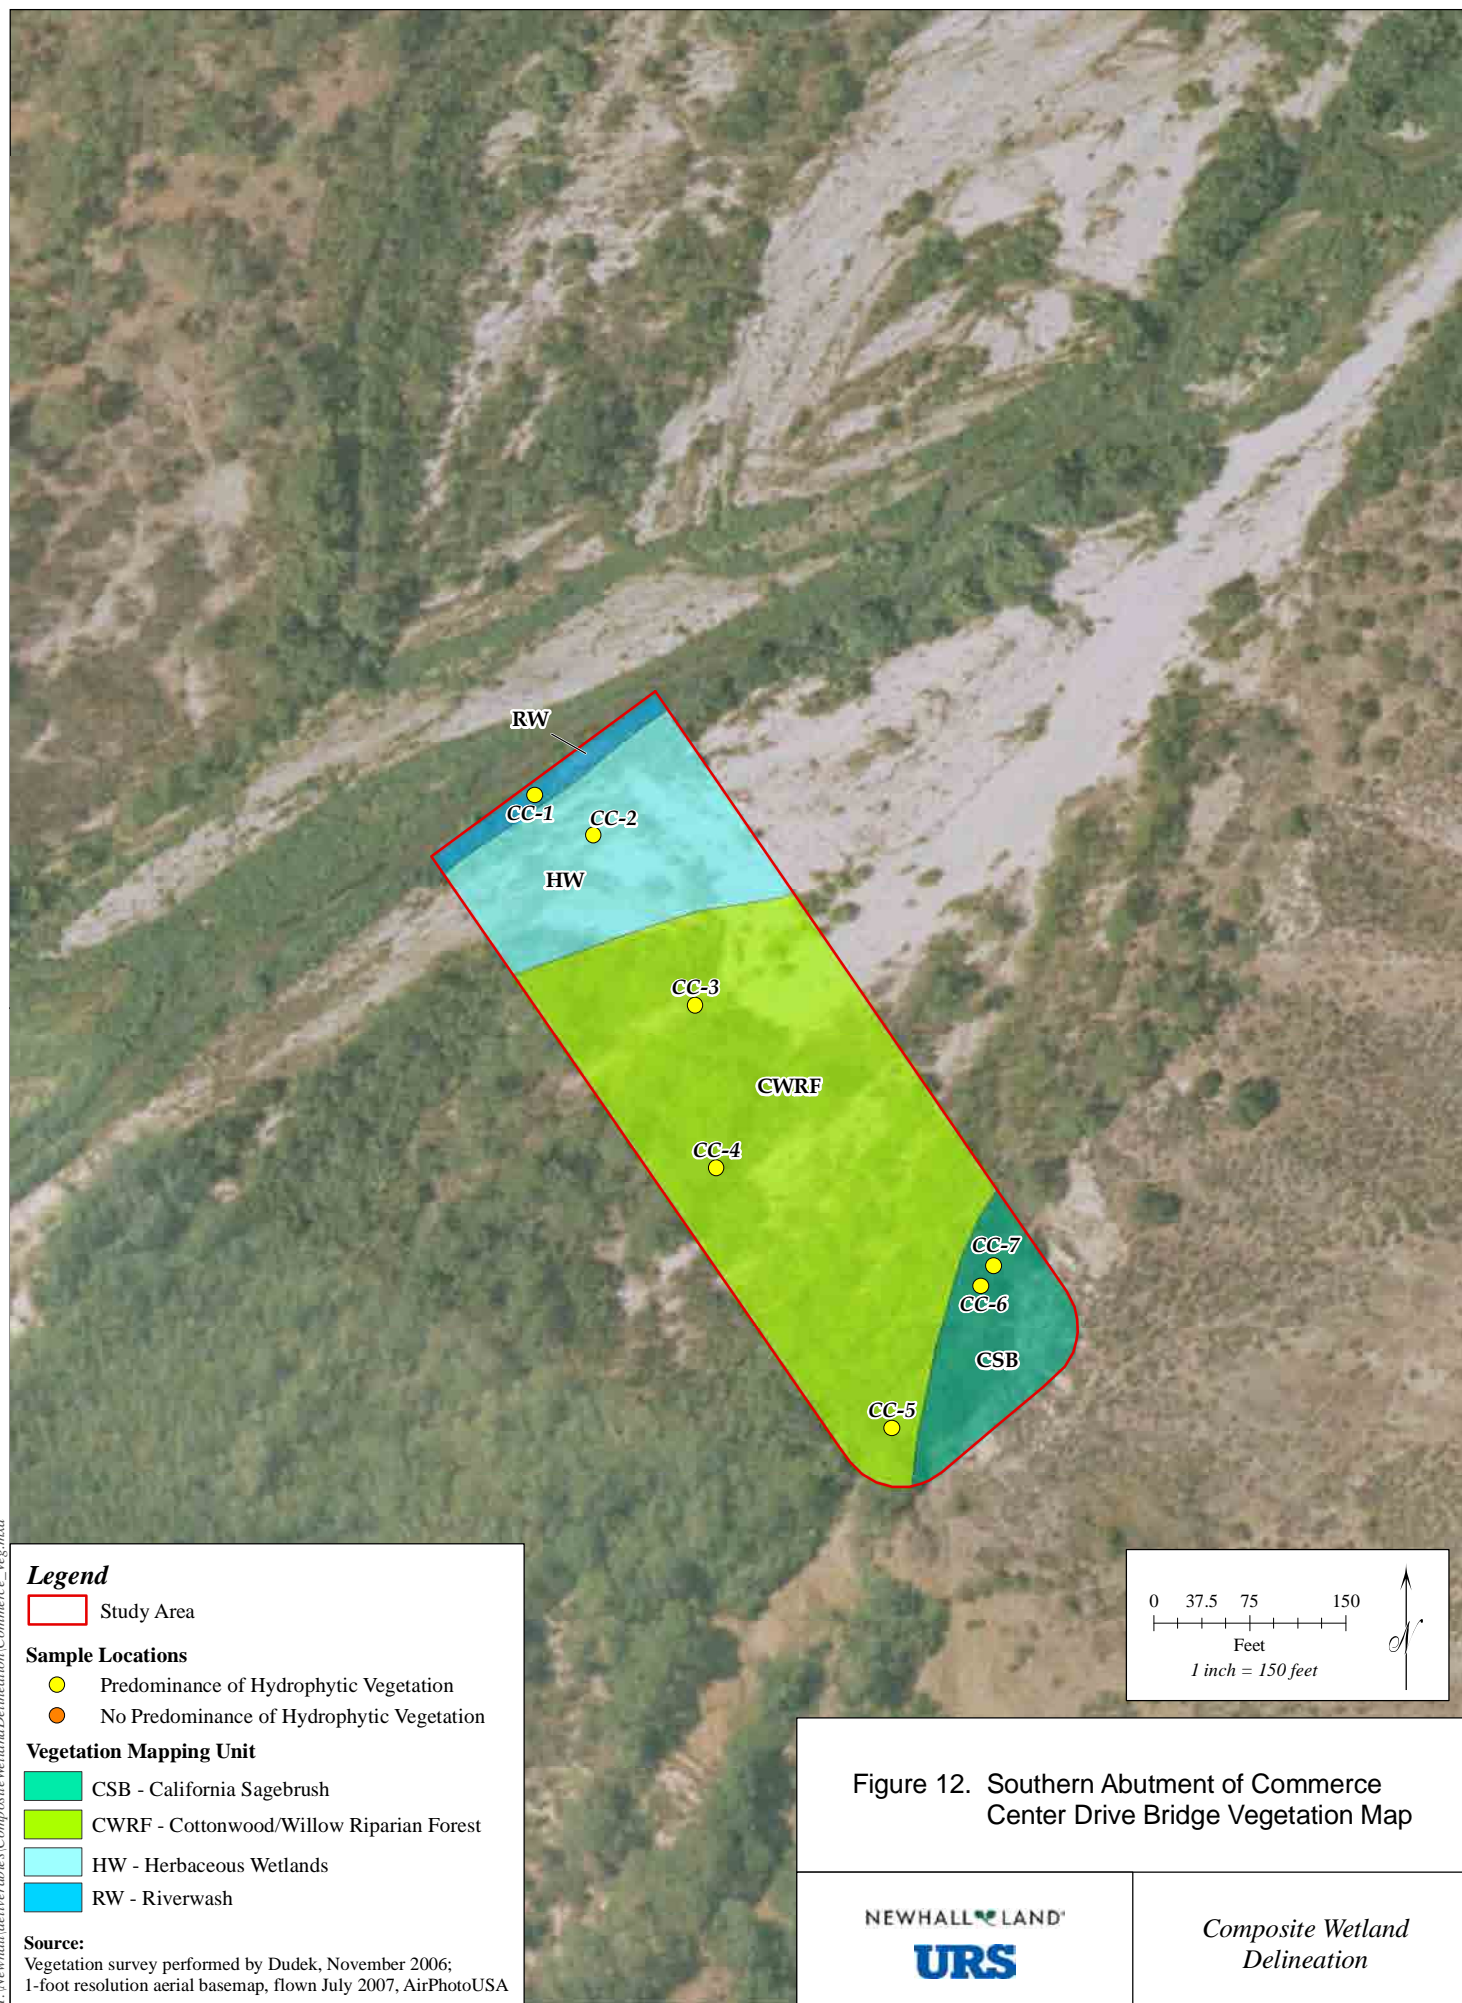
Figure 12. Southern Abutment of Commerce Center Drive Bridge Vegetation Map

The vegetation map for the RMDP site (Dudek 2006) shows four vegetation types within the Commerce Center Drive study location, including riverwash, herbaceous wetlands, cottonwood/willow riparian forest, and California sagebrush scrub. For a description of these communities, please refer to Section 4.2, above. Of the eight sampling points assessed within this study location, one was located within an area mapped as riverwash, one was in herbaceous wetlands, three were within cottonwood/willow riparian forest, and the remaining two were mapped as California sagebrush scrub (Figure 12). All of the sampling points assessed exhibited a dominance of hydrophytic vegetation. Dominant hydrophytic plant species within the Commerce Center Drive study location included red willow, sandbar willow, Fremont cottonwood, mulefat, cattails (*Typha* spp.), and giant reed. All of the

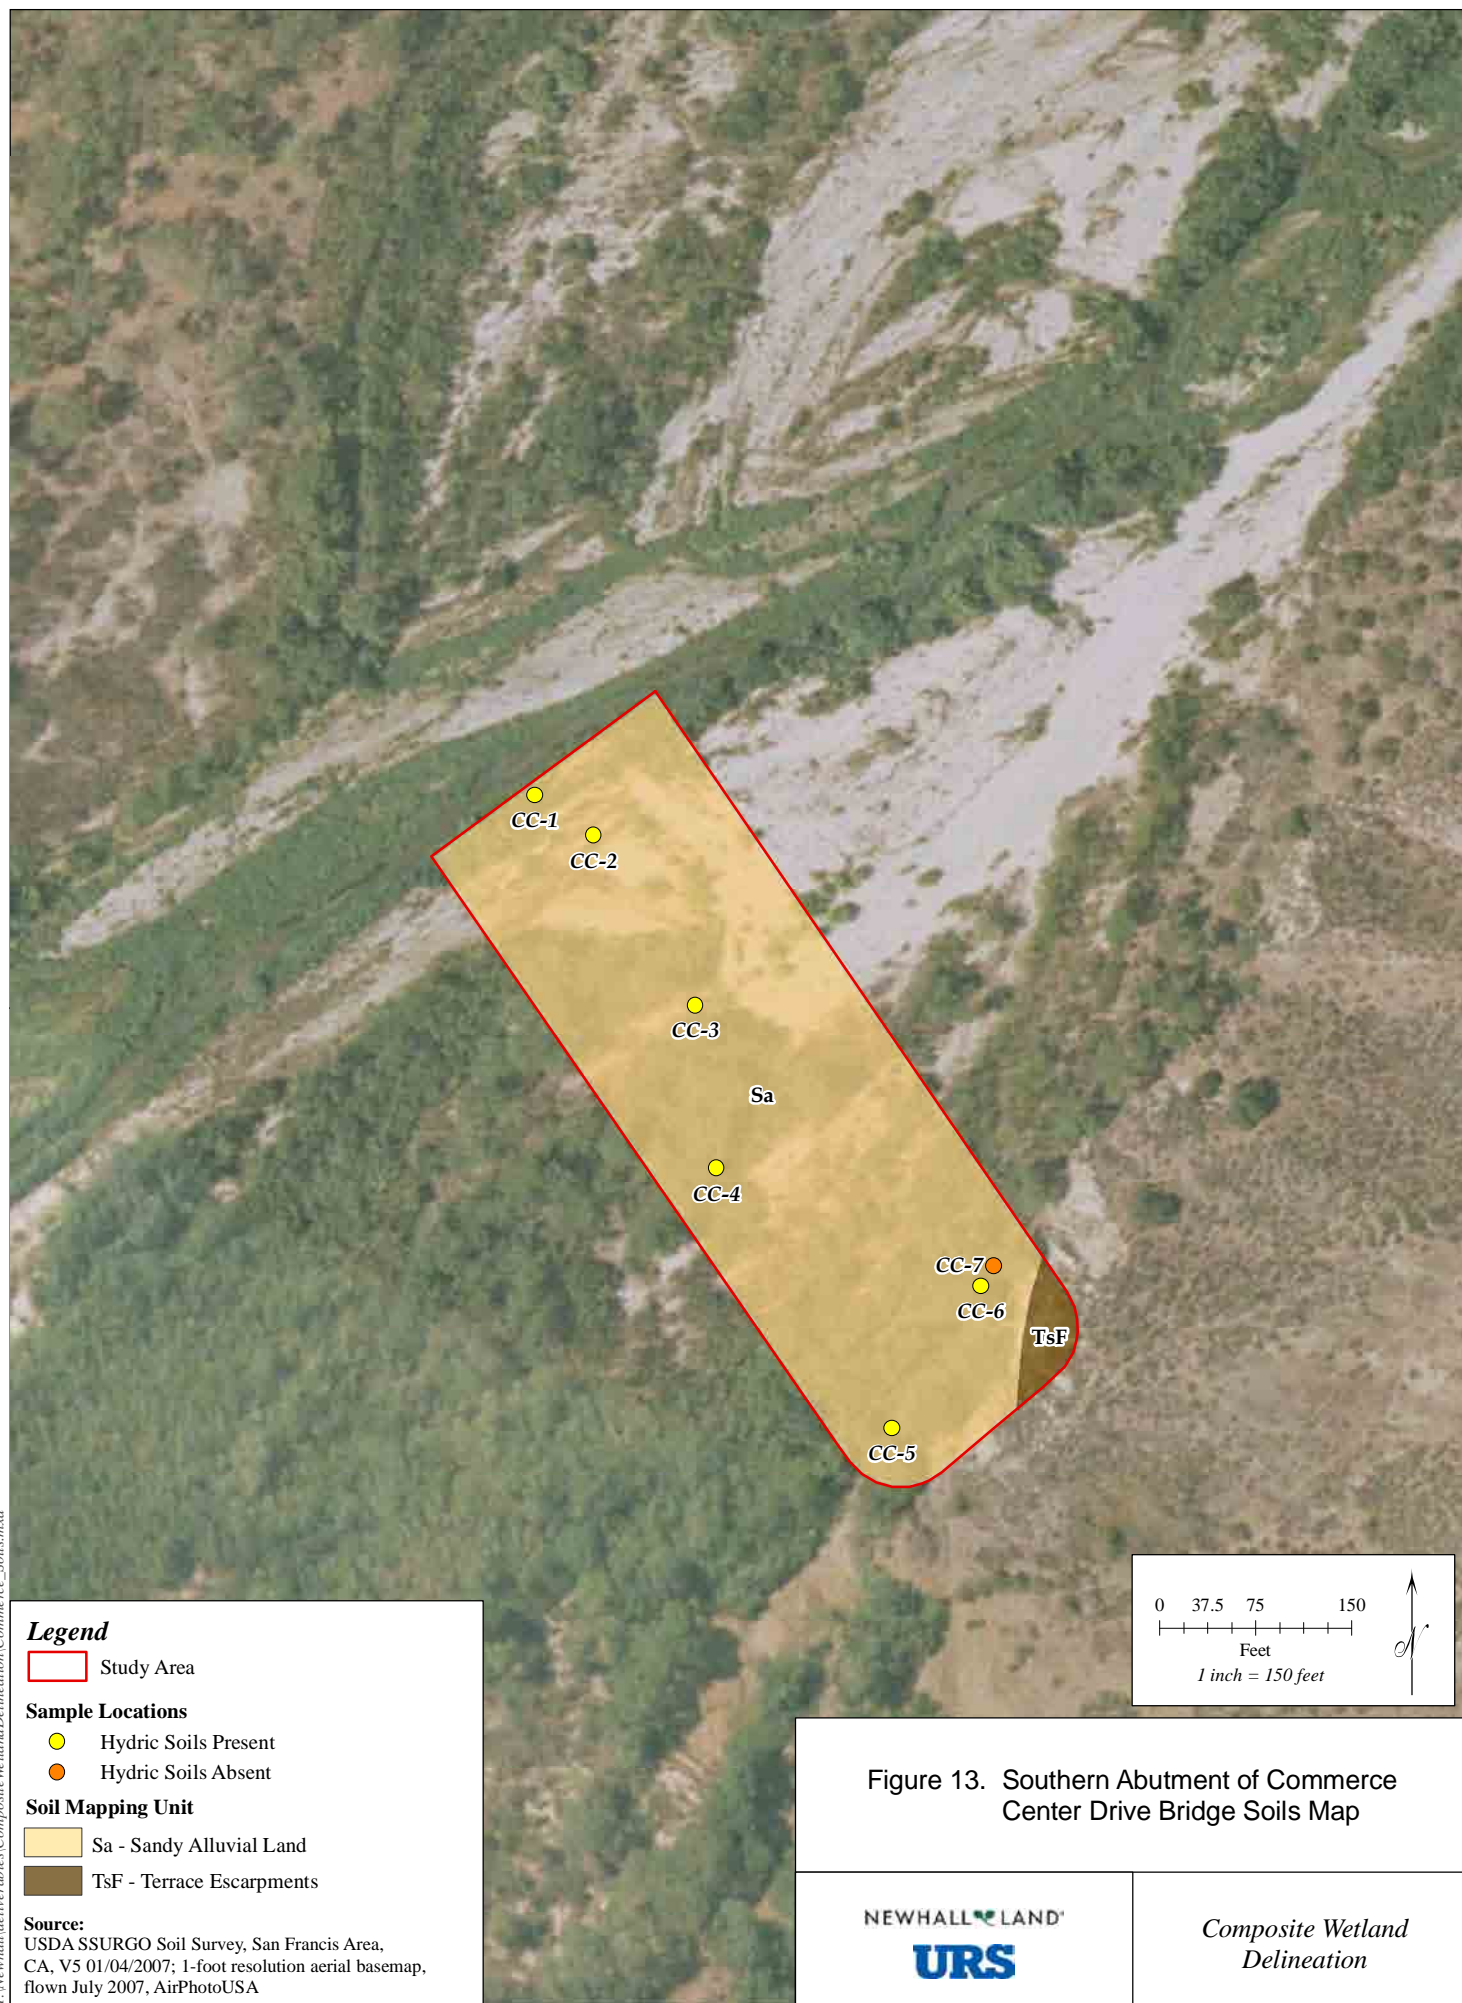
Figure 14. Southern Abutment of Commerce Center Drive Bridge Wetland Delineation Map

A total of 2.84 acres of wetlands were delineated within the Commerce Center Drive study location (Figure 14 and Table 1). The determination of wetlands was difficult given the presence of sandy and eroding soil types, and the mapped soil types and observed inundation/saturation were used as evidence of hydric soils in some areas. Wetlands were

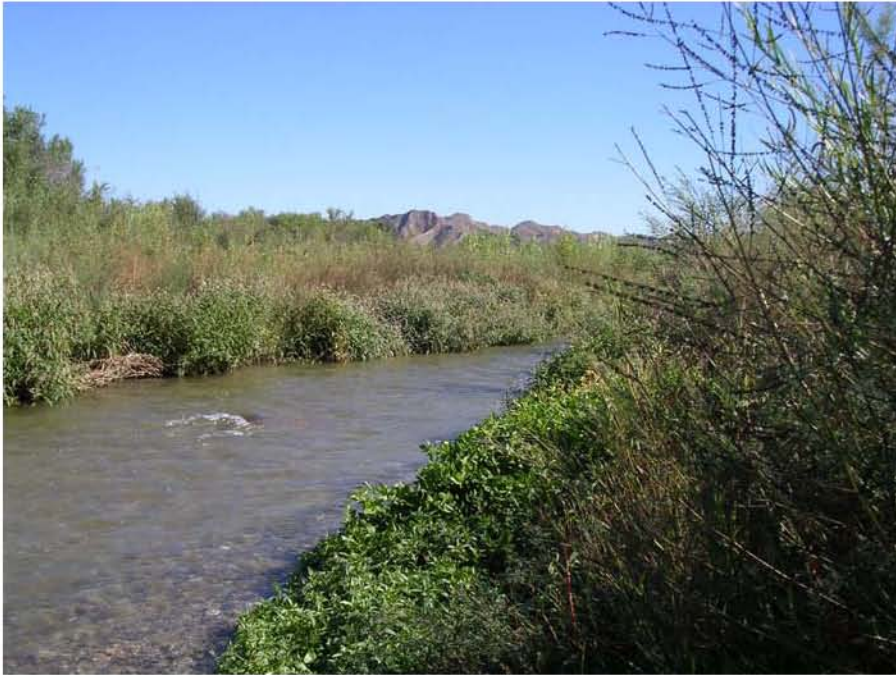
Photo 1. Viewing west along the Santa Clara River, featuring the main channel and riparian scrub vegetation. Wetlands occur adjacent to the river and riparian scrub vegetation is visible in the background. This photo was taken on September 26, 2007 (CC-1).

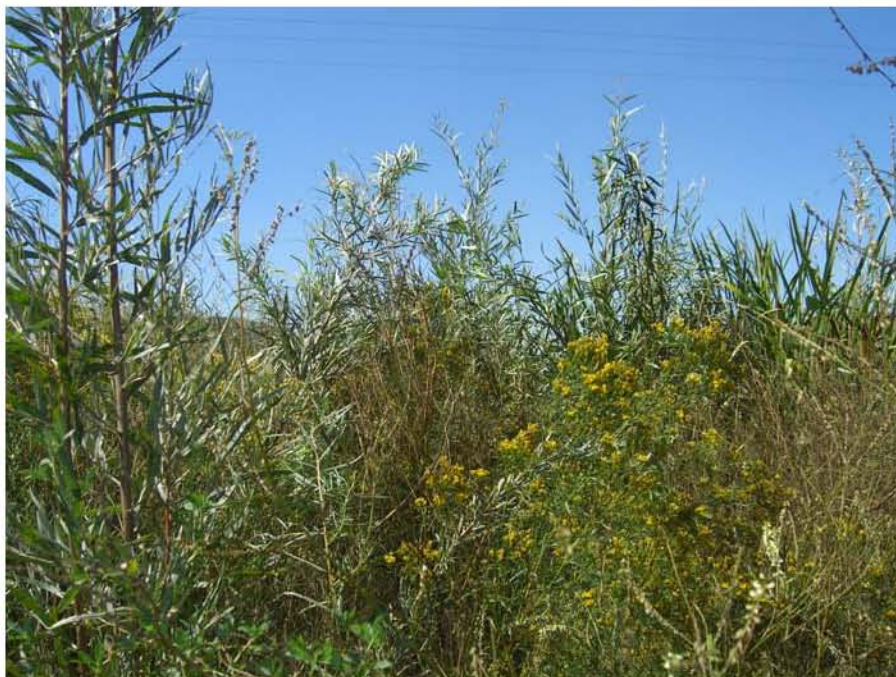
Photo 2. A mix of hydrophytic vegetation is displayed consisting of narrowleaf willow, red willow, western goldenrod, and cattail. This vegetation arrangement is representative of the on-site riparian scrub wetlands. This photo was taken on September 25, 2007 (PC-13).

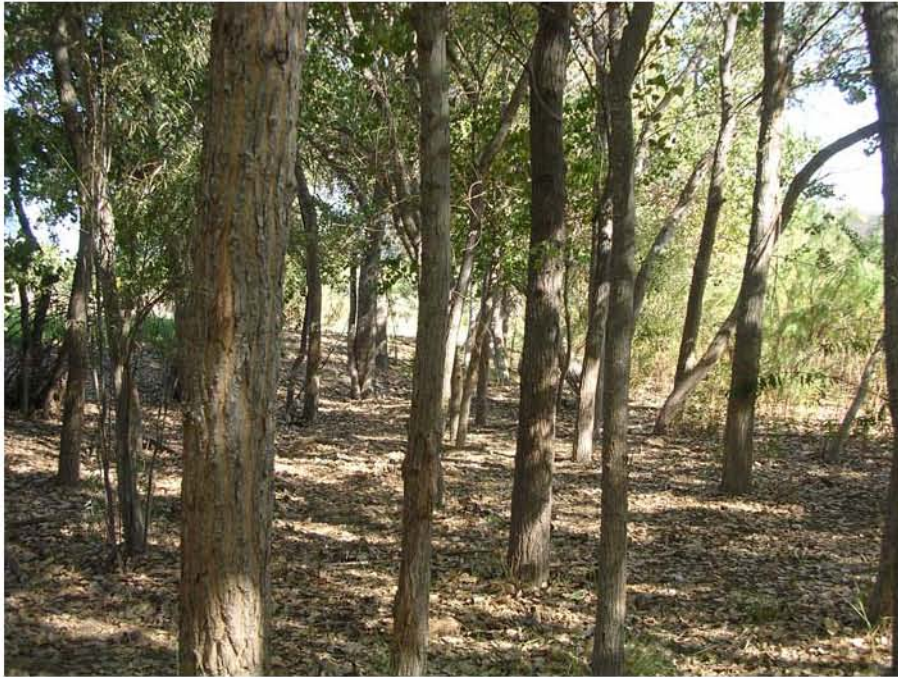
Photo 3. A view of a representative on-site mature riparian forest. This photo was taken on September 26, 2007 (PC-2).

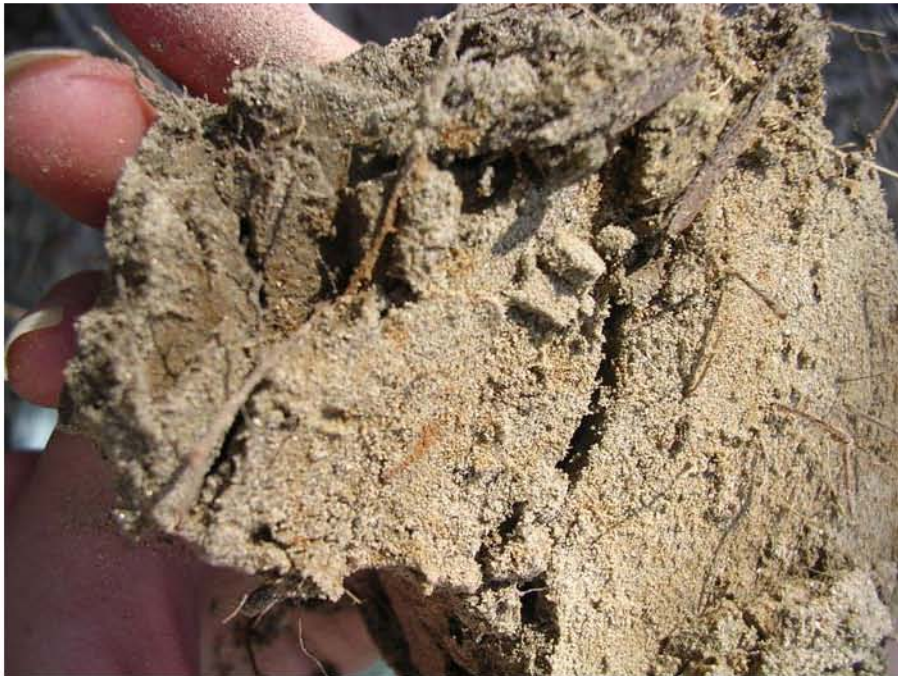
Photo 4. A view of redox features that occurred in sandy soils in a riverwash land form adjacent to the Santa Clara River. This photo was taken on September 26, 2007 (CC-3).

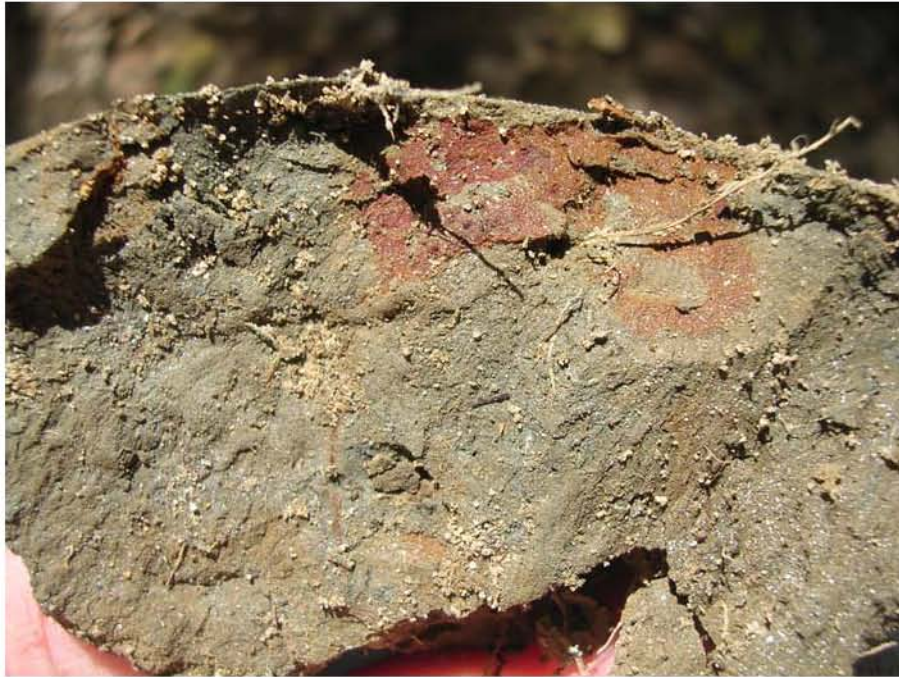
Photo 5. A view of a depleted matrix that occurred in a sandy alluvial land form within a mature riparian forest wetland. This photo was taken on September 26, 2007 (PC-2).

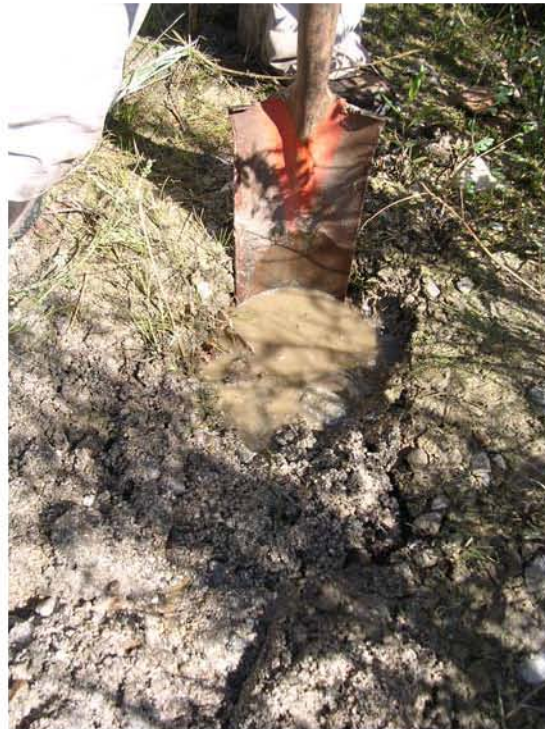
Photo 6. A view of a high water table present within sandy soils. This photo was taken on September 26, 2007 (PC-6).

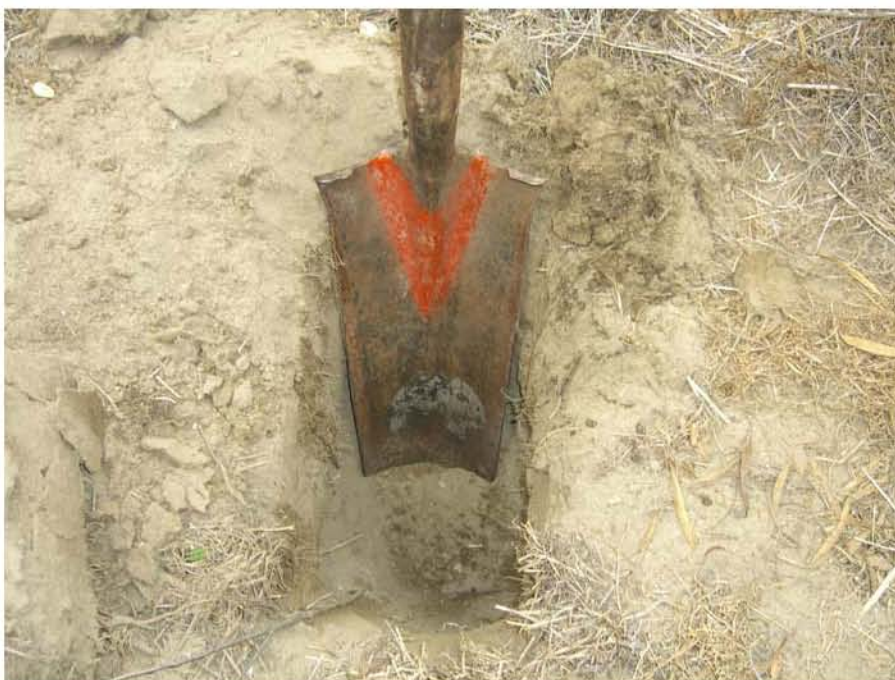
Photo 7. A view of a soil pit in a typical upland habitat. Hydric soils and hydrology indicators were absent. This photo was taken on September 28, 2007 (LC-7).

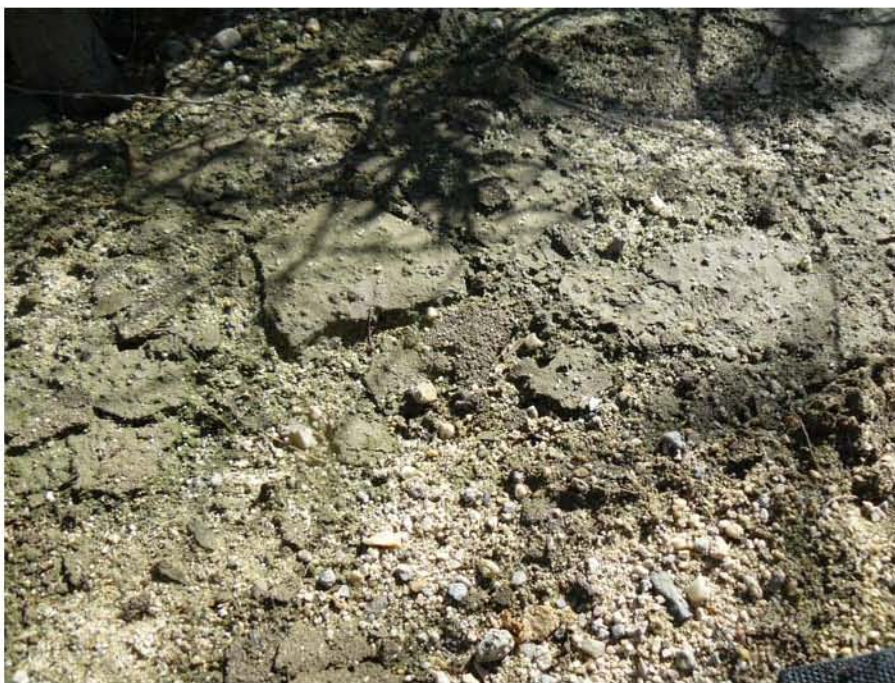
Photo 8. A view of wetland hydrology indicators including soil cracking, crust, and sediment deposits. This photo was taken on September 25, 2007 (PC-15).
