Development Plan

SAN LUIS REY MITIGATION BANK DEVELOPMENT PLAN

July 2014

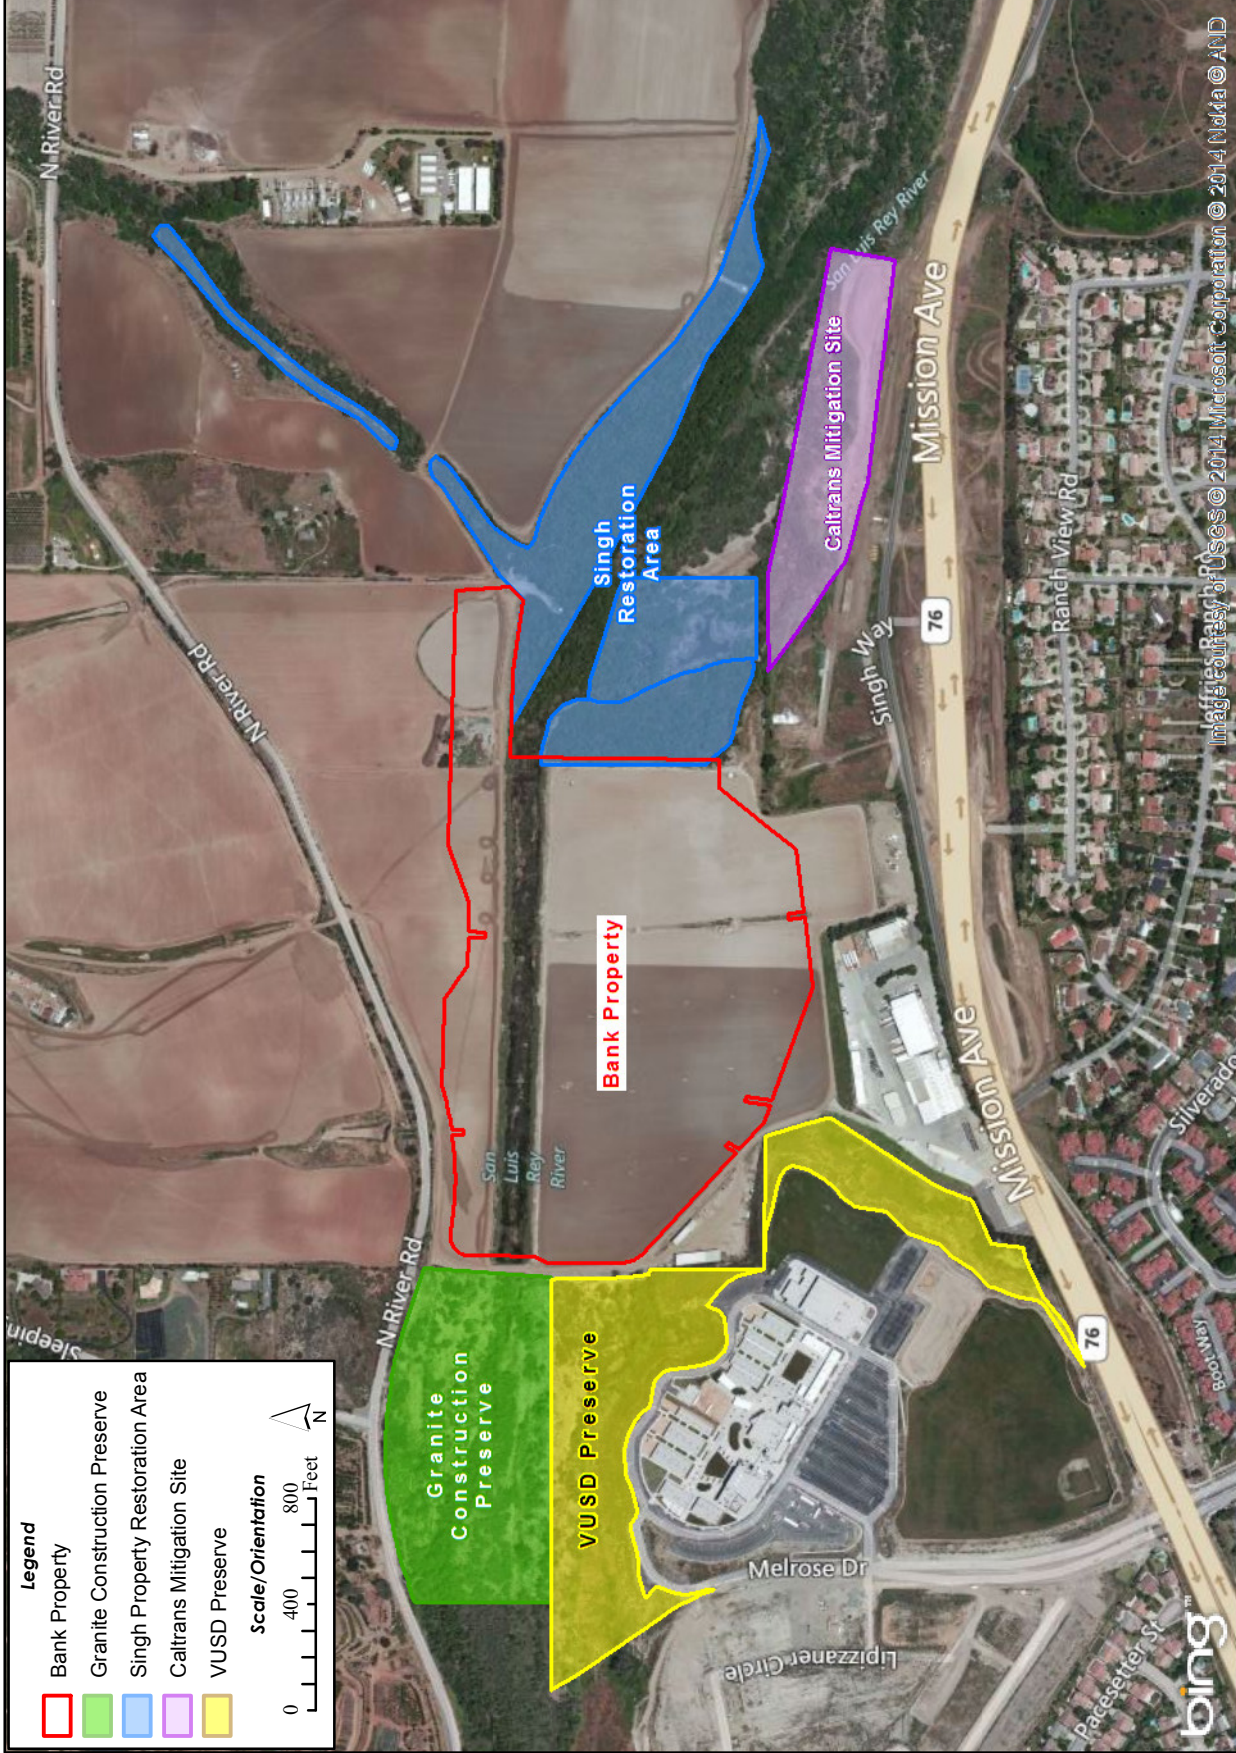
Figure 3
Assessor Parcel Map

For the purpose of this Development Plan, the “Property” is defined as 56.54 acres designated as all or portions of San Diego County Assessor Parcel Numbers (APNs) 122-130-33; 122-130-35; 122-130-37; 122-130-39; and 122-130-41 (Figure 3). There is no known address associated with the Property.

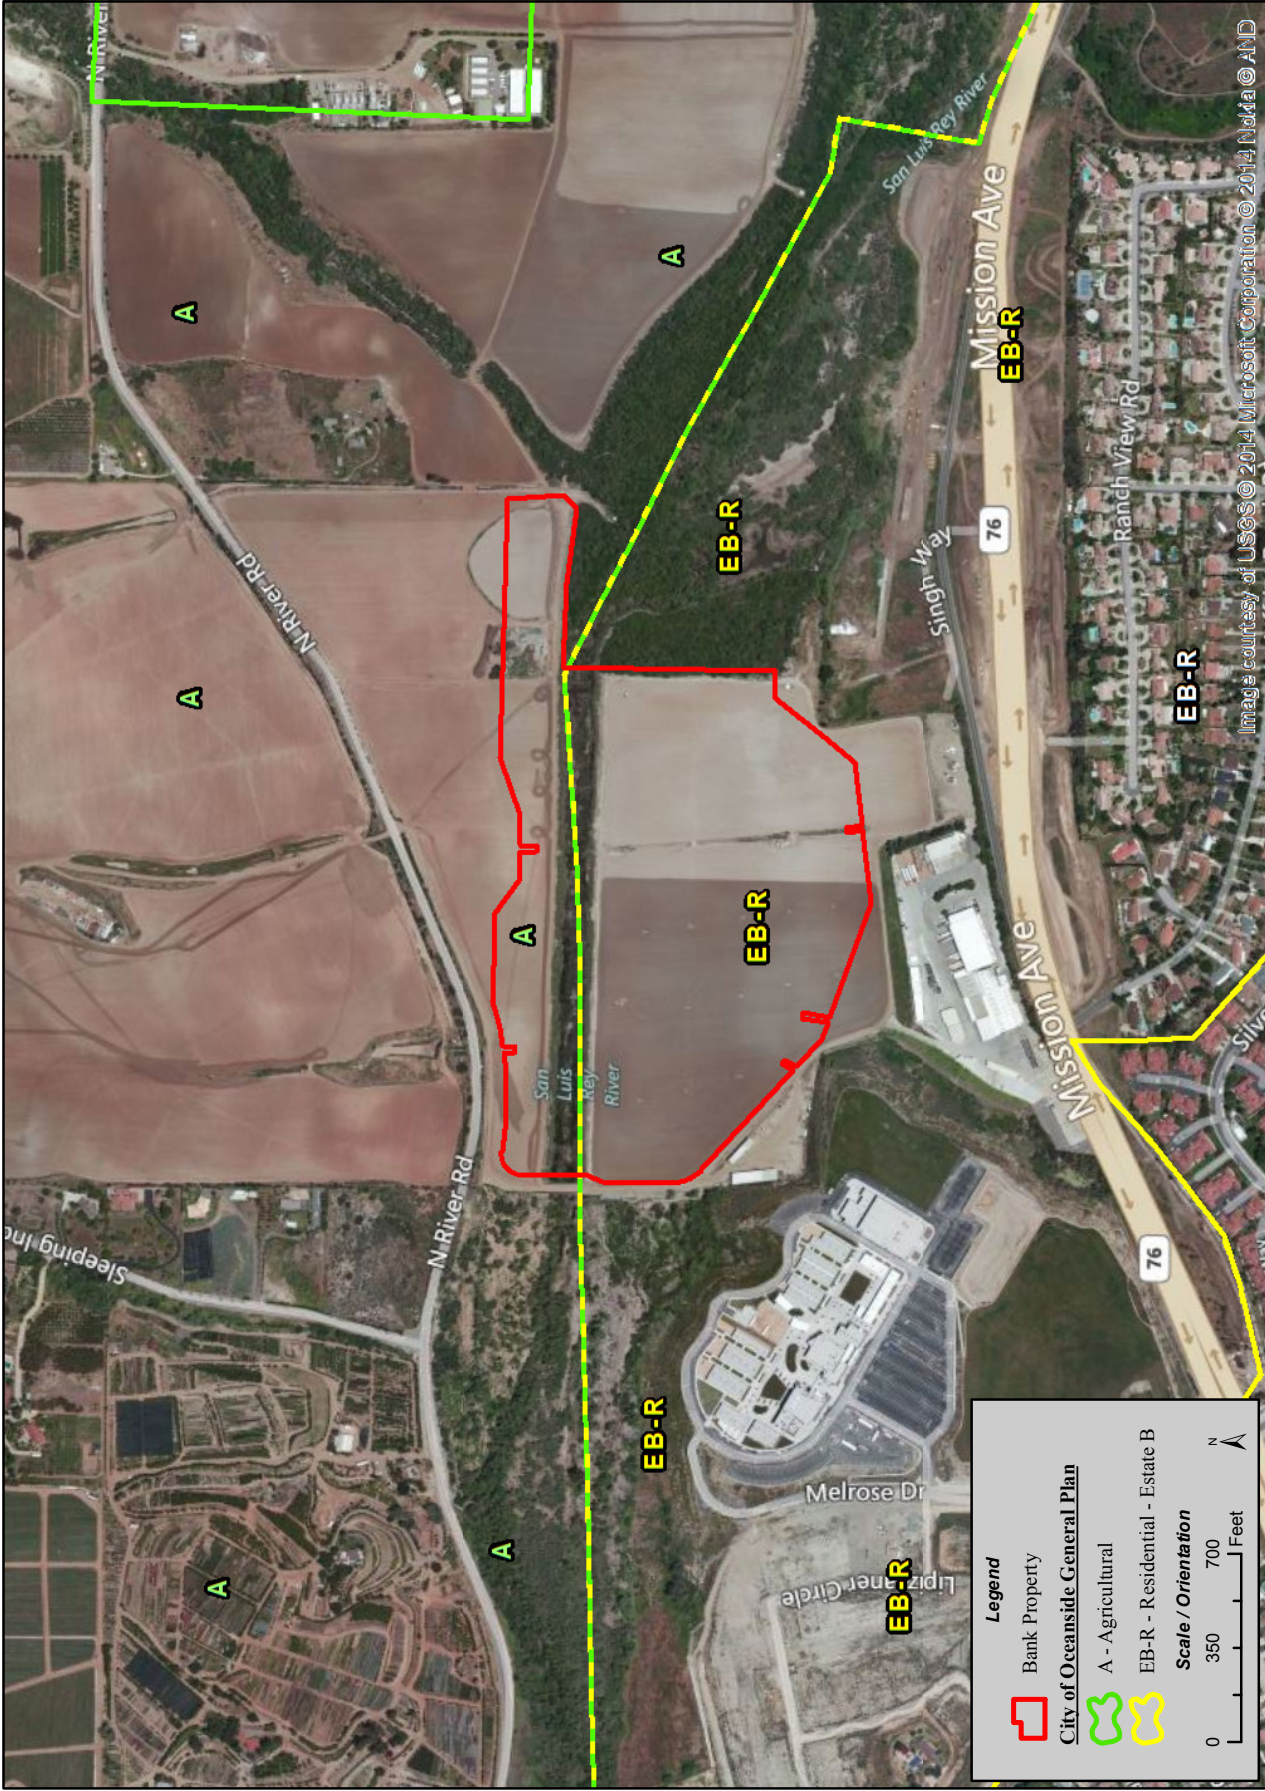
Figure 4
Nearby Restoration Projects

Several completed restoration projects are located along San Luis Rey River floodplain immediately upstream and downstream of the site and another restoration project is located southeast of the site (Figure 4). The site immediately upstream to the east involved restoration and enhancement of 21± acres of riparian habitat and the removal of 11± acres of giant reed along with other invasive, non-native plant species and revegetation with native riparian species.. A second upstream restoration area is associated with the Caltrans widening of State Route 76.

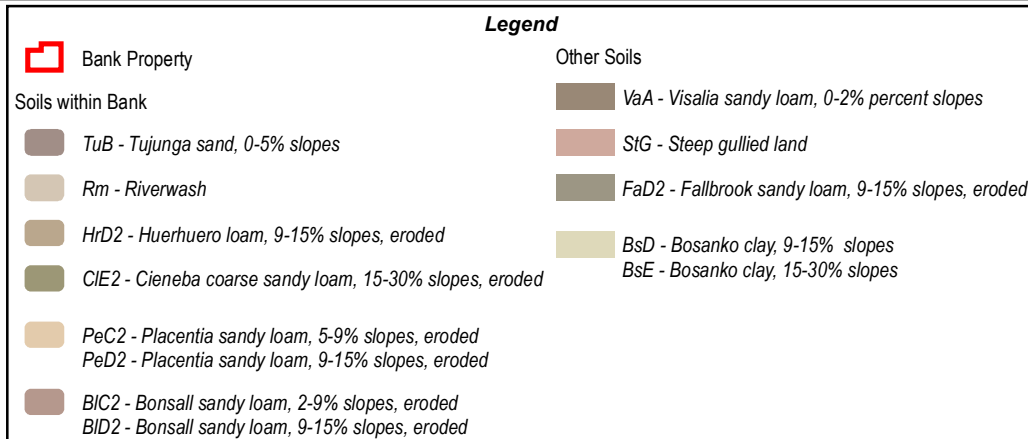
Figure 7
Soils

The Soil Survey of San Diego Area, California (Soil Conservation Service and Forest Service) was accessed via <http://websoilsurvey.nrcs.usda.gov/app/HomePage.htm> to determine the soils on the Property. As shown in Figure 7, there are six soil series and eight soil types found in the Property; however, the site soil is predominantly characterized by three soil units: Bonsall sandy loam, 2 to 9 percent slopes; Riverwash; and Tujunga sand, 0 to 5 percent slopes.

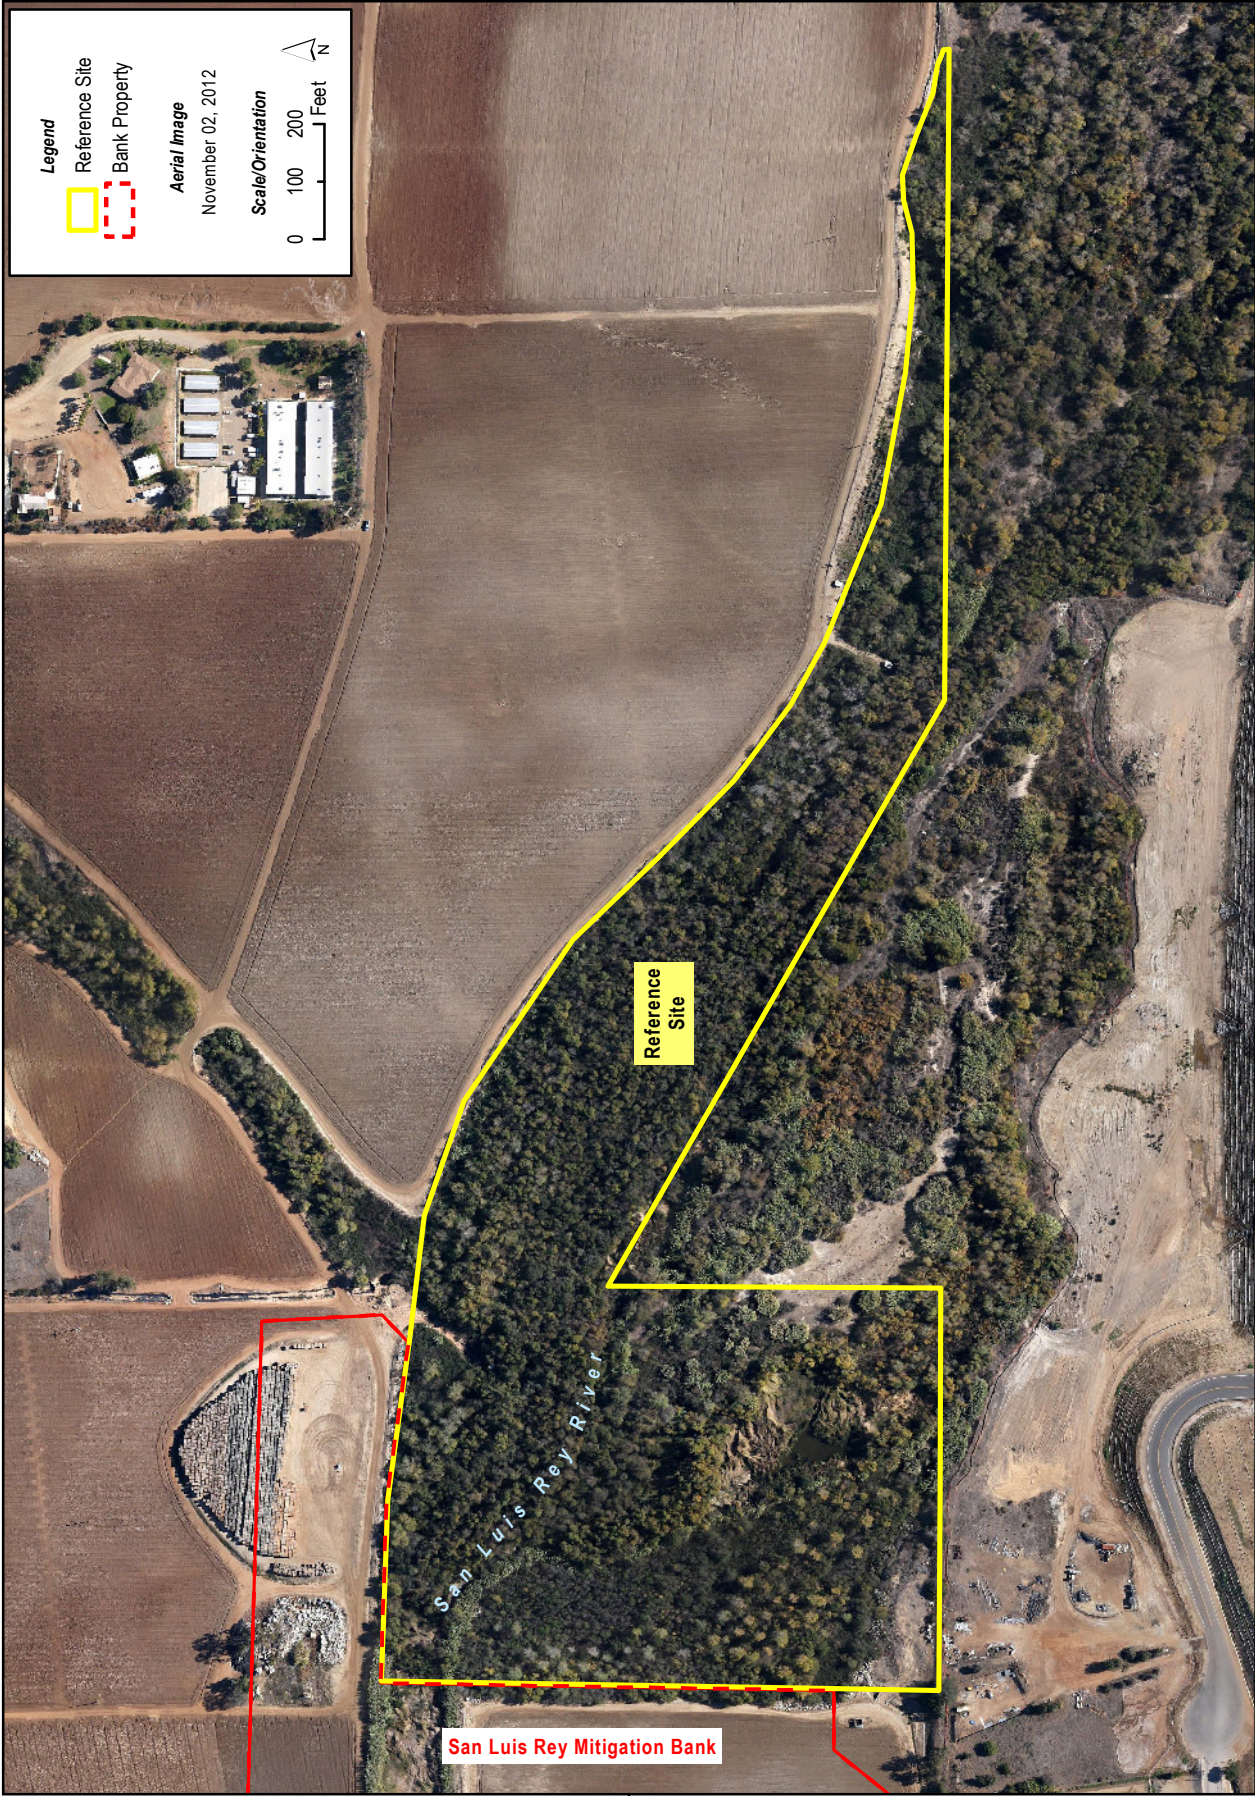
Figure 19
Schematic Cross-Section

The Conceptual Restoration Plan, Figure 18 and Figure 19, proposes the rehabilitation¹ of the San Luis Rey River and the re-establishment² of the floodplain via the removal of fill material from the agricultural fields. Revegetation of the site will result in a broad riparian corridor and improved wildlife habitat.
