SAN LUIS REY MITIGATION BANK

SAN DIEGO COUNTY, CALIFORNIA

BIOLOGICAL RESOURCES REPORT

August 2011

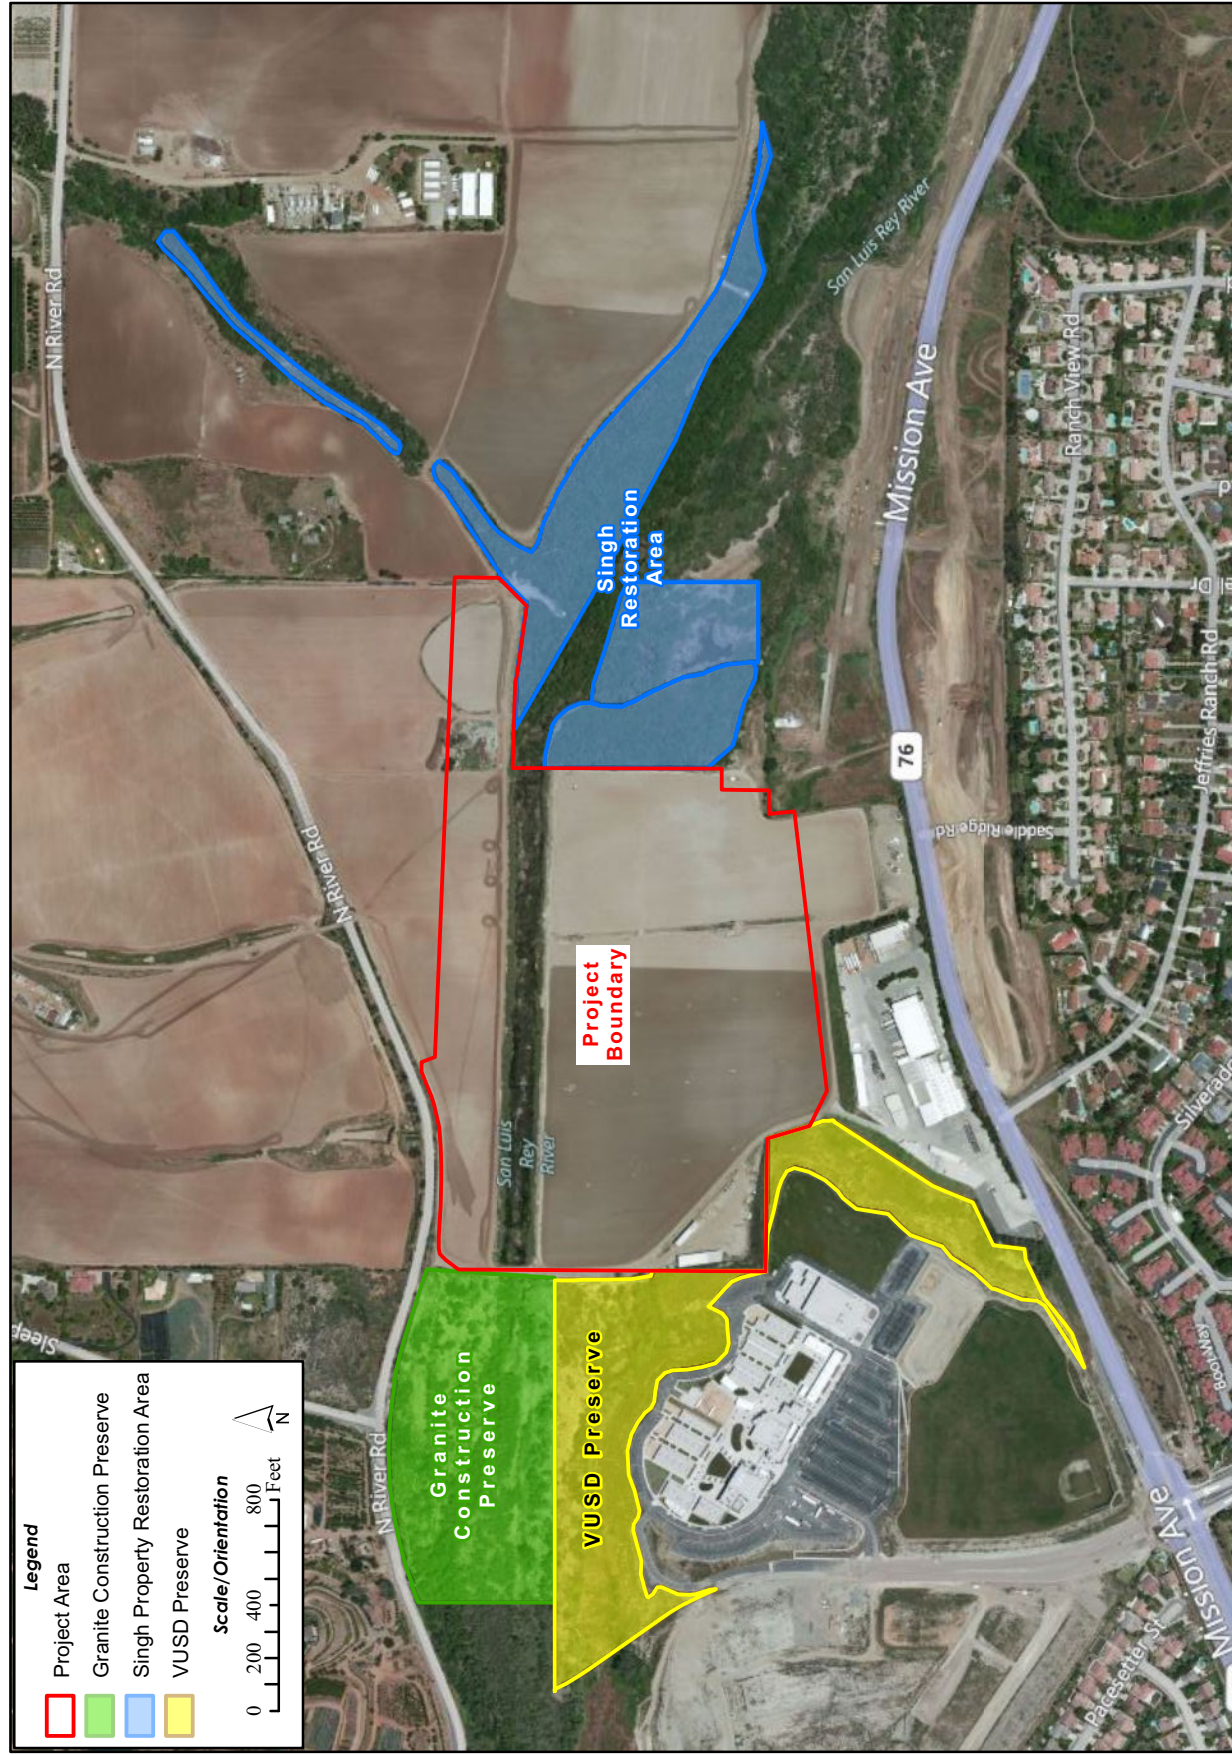
Soils within Property

The Soil Survey of San Diego Area, California (Soil Conservation Service and Forest Service) was accessed via <http://websoilsurvey.nrcs.usda.gov/app/HomePage.htm> to determine the soils on the Study Area. As shown in Figure 3, there are nine soil series and 12 soil mapping units found in the Study Area; however, the site soil is predominantly characterized by three soil units: Bonsall sandy loam, 2 to 9 percent slopes; Riverwash, and Tujunga sand, 0 to 5 percent slopes. Each of the soil series and soil types is described below.

Table 1. Soil Types		
Soil Type	Acres	Percentage
BIC2 - Bonsall sandy loam, 2 to 9 percent slopes, eroded	11.66	18.6%
BID2 - Bonsall sandy loam, 9 to 15 percent slopes, eroded	2.03	3.2%
BsD - Bosanko clay, 9 to 15 percent slopes	0.09	0.1%
BsE - Bosanko clay, 15 to 30 percent slopes	0.35	0.6%
CIE2 - Cienega coarse sandy loam, 15 to 30 percent slopes, eroded	3.02	4.8%
FaD2 - Fallbrook sandy loam, 9 to 15 percent slopes, eroded	0.11	0.2%
HrD2 - Huerhuero loam, 9 to 15 percent slopes, eroded	0.36	0.6%
PeC2 - Placentia sandy loam, 5 to 9 percent slopes, eroded	0.85	1.3%
PeD2 - Placentia sandy loam, 9 to 15 percent slopes, eroded	1.14	1.8%
Rm - Riverwash	11.42	18.2%
StG - Steep gullied land	0.2	0.3%
TuB - Tujunga sand, 0 to 5 percent slopes	<u>31.56</u>	<u>50.3%</u>
Total:	62.79	100.0%

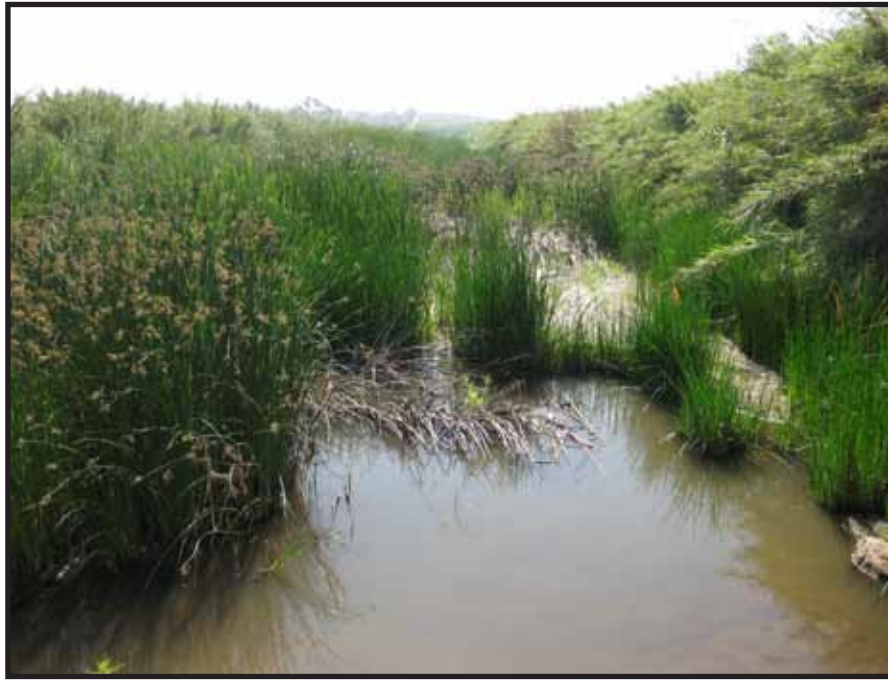
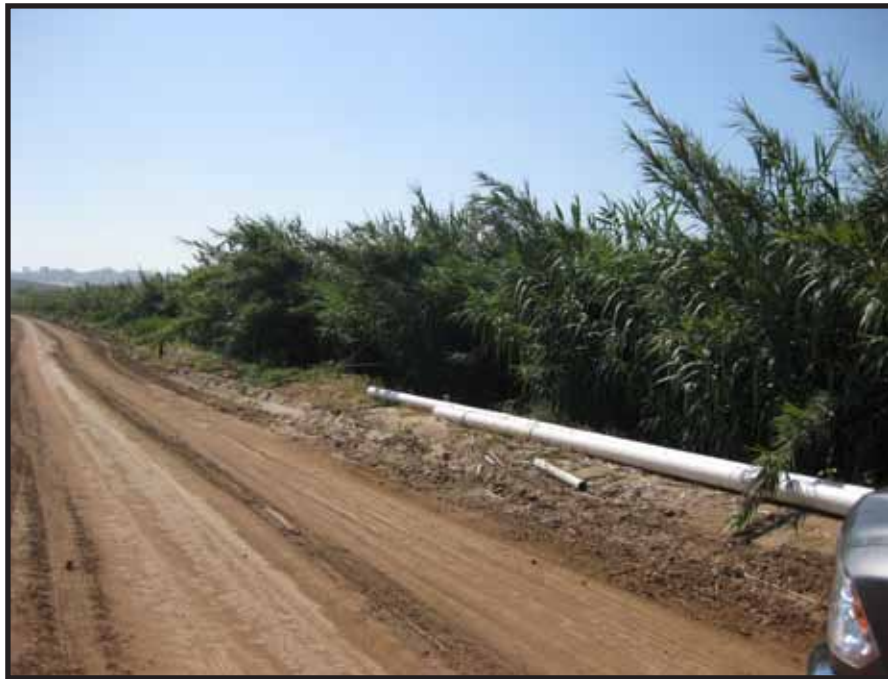
Top: Eastward view of Study Area from western boundary. The entire reach of the San Luis Rey River bisecting the Study Area is channelized and characterized as freshwater marsh bordered by *Arundo donax*.

Bottom: Eastward view of Study Area with *Arundo donax* bordering the channelized reach of the San Luis Rey River. The balance of the Study Area is cultivated agricultural fields.

No suitable arroyo toad breeding habitat is present within the Study Area. The existing freshwater marsh habitat located within the Study Area does not represent suitable breeding conditions for the species. The extensive emergent vegetation, deep pools (>1ft) and unsuitable substrates are not characteristic of where arroyo toads breed. Suitable arroyo toad breeding habitat was documented immediately up and downstream of the Study Area where the San Luis Rey River is not channelized.

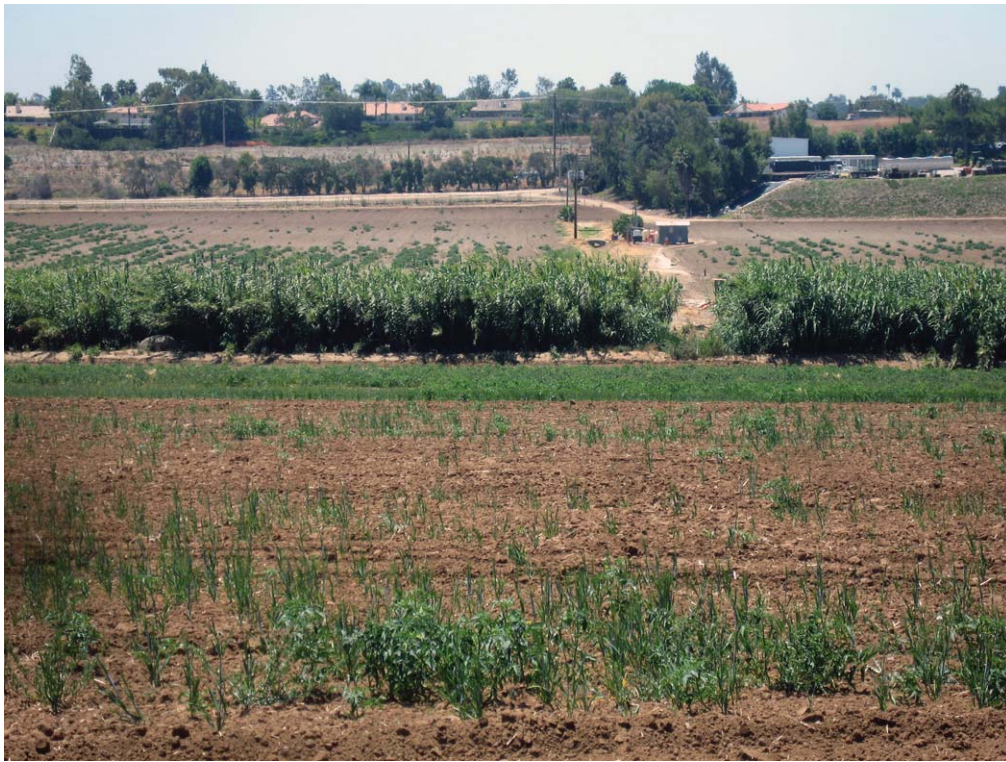
Photo 1: Looking south across the site. Note *Arundo*-lined channel and adjacent agricultural fields.

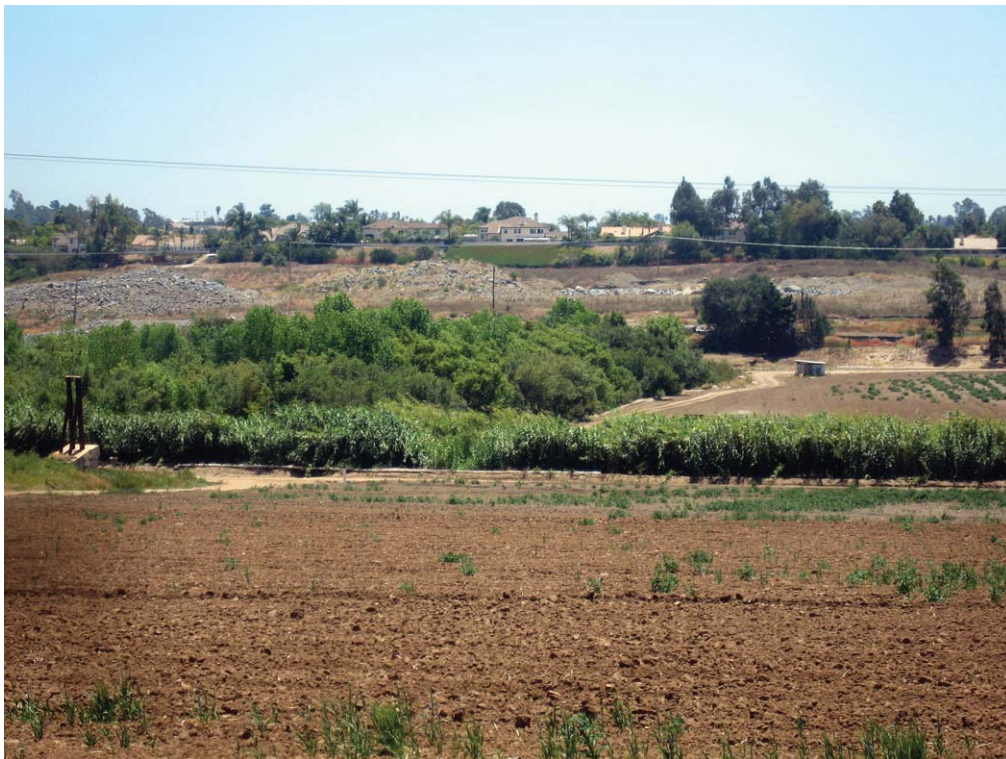
Photo 2: Suitable LBVI and SWWF habitat is present upstream of the site and to the south of the northeastern portion of the study area. No suitable LBVI or SWWF habitat exists on site due to lack of suitable structure and composition.

Based on the conditions observed onsite, the Study Area does not contain suitable breeding habitat for LBVI or SWWF. The lack of tree and shrub elements would preclude the use of the site for nesting by either species. The existing freshwater marsh habitat located within the Study Area does not represent suitable breeding conditions for either species especially in the absence of key structural elements like trees and shrubs adjacent to the river. Potentially suitable breeding habitat was observed immediately up and downstream of the Study Area where the San Luis Rey River where riparian vegetation with the necessary structural and compositional elements occurs. The current site conditions are documented in Figure 3. The proposed mitigation site is an ideal location for the creation of riparian habitat that could support LBVI and/or SWWF and connect native riparian upstream and downstream of the site.

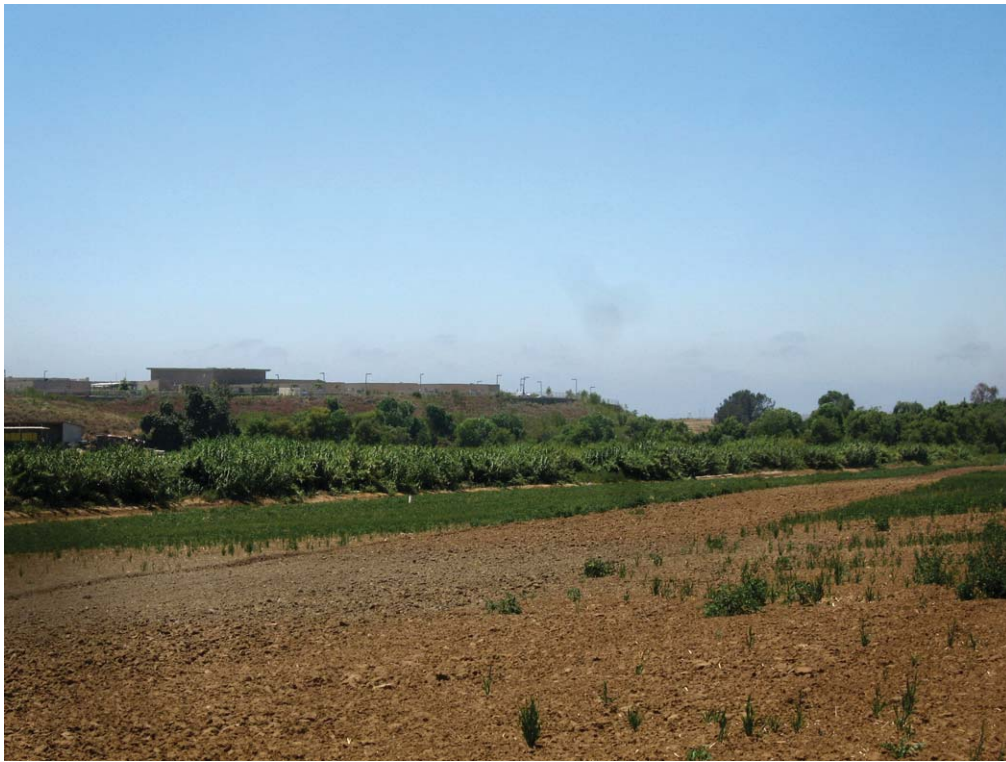
Photo 3: Suitable LBVI and SWWF habitat is present downstream of the site, but no suitable habitat exists on site due to lack of suitable structure and composition.

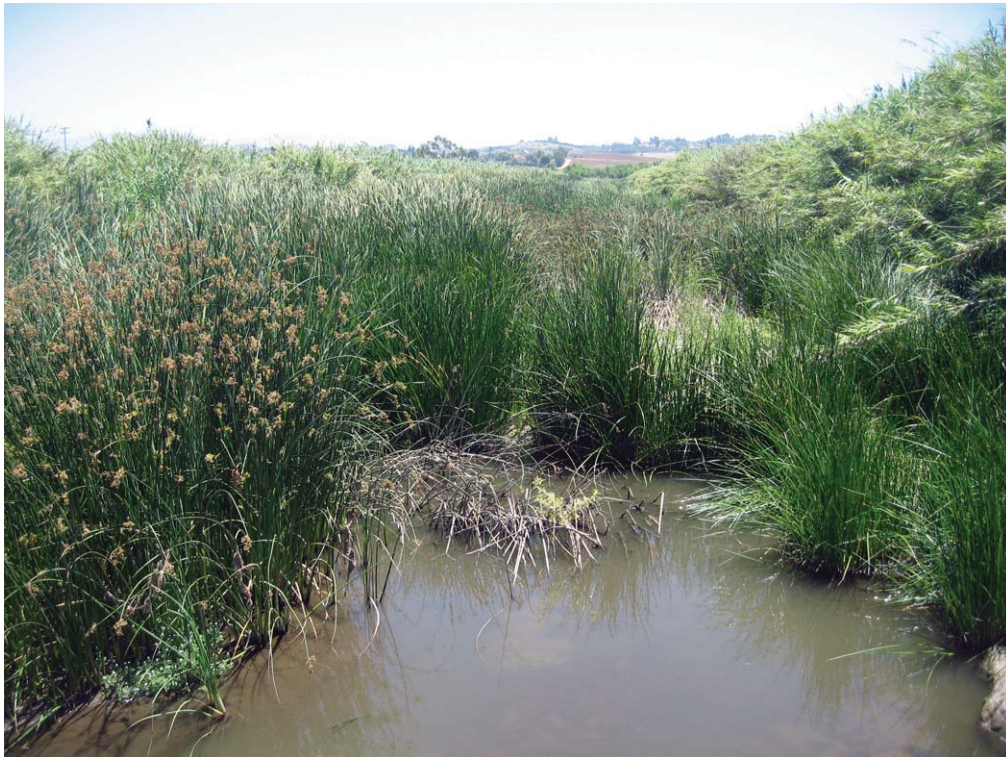
Photo 4: Habitat within the channel consists solely of dense stands of *Arundo* along the banks and *Scirpus*-dominated freshwater marsh in the channel. Stream flow was present at the time of the assessment.

Freshwater marsh within the project site is found entirely within the channelized reach of the San Luis Rey River. The freshwater marsh habitat is dominated by three-square bulrush (*Scirpus americanus*) and broadleaf cattail (*Typha latifolia*) with isolated regions of surface water expression. Other common plant species observed within the fresh water marsh where California bulrush (*Scirpus californicus*), river bulrush (*Scirpus fluvialis*) and watercress (*Rorippa nasturtium-aquaticum*). The edges of the emergent marsh (abutting the levees) were lined with giant reed. Giant reed extends up the levees along the north and south banks of the river.
