McNears Beach County Park Fishing Pier Restoration: Final Programmatic Report (Amended)

Recipient Organization/Agency: County of Marin

COUNTY OF MARIN
MARIN COUNTY PARKS
PLANS FOR CONSTRUCTION OF
MCNEARS BEACH PARK
PIER REPAIR

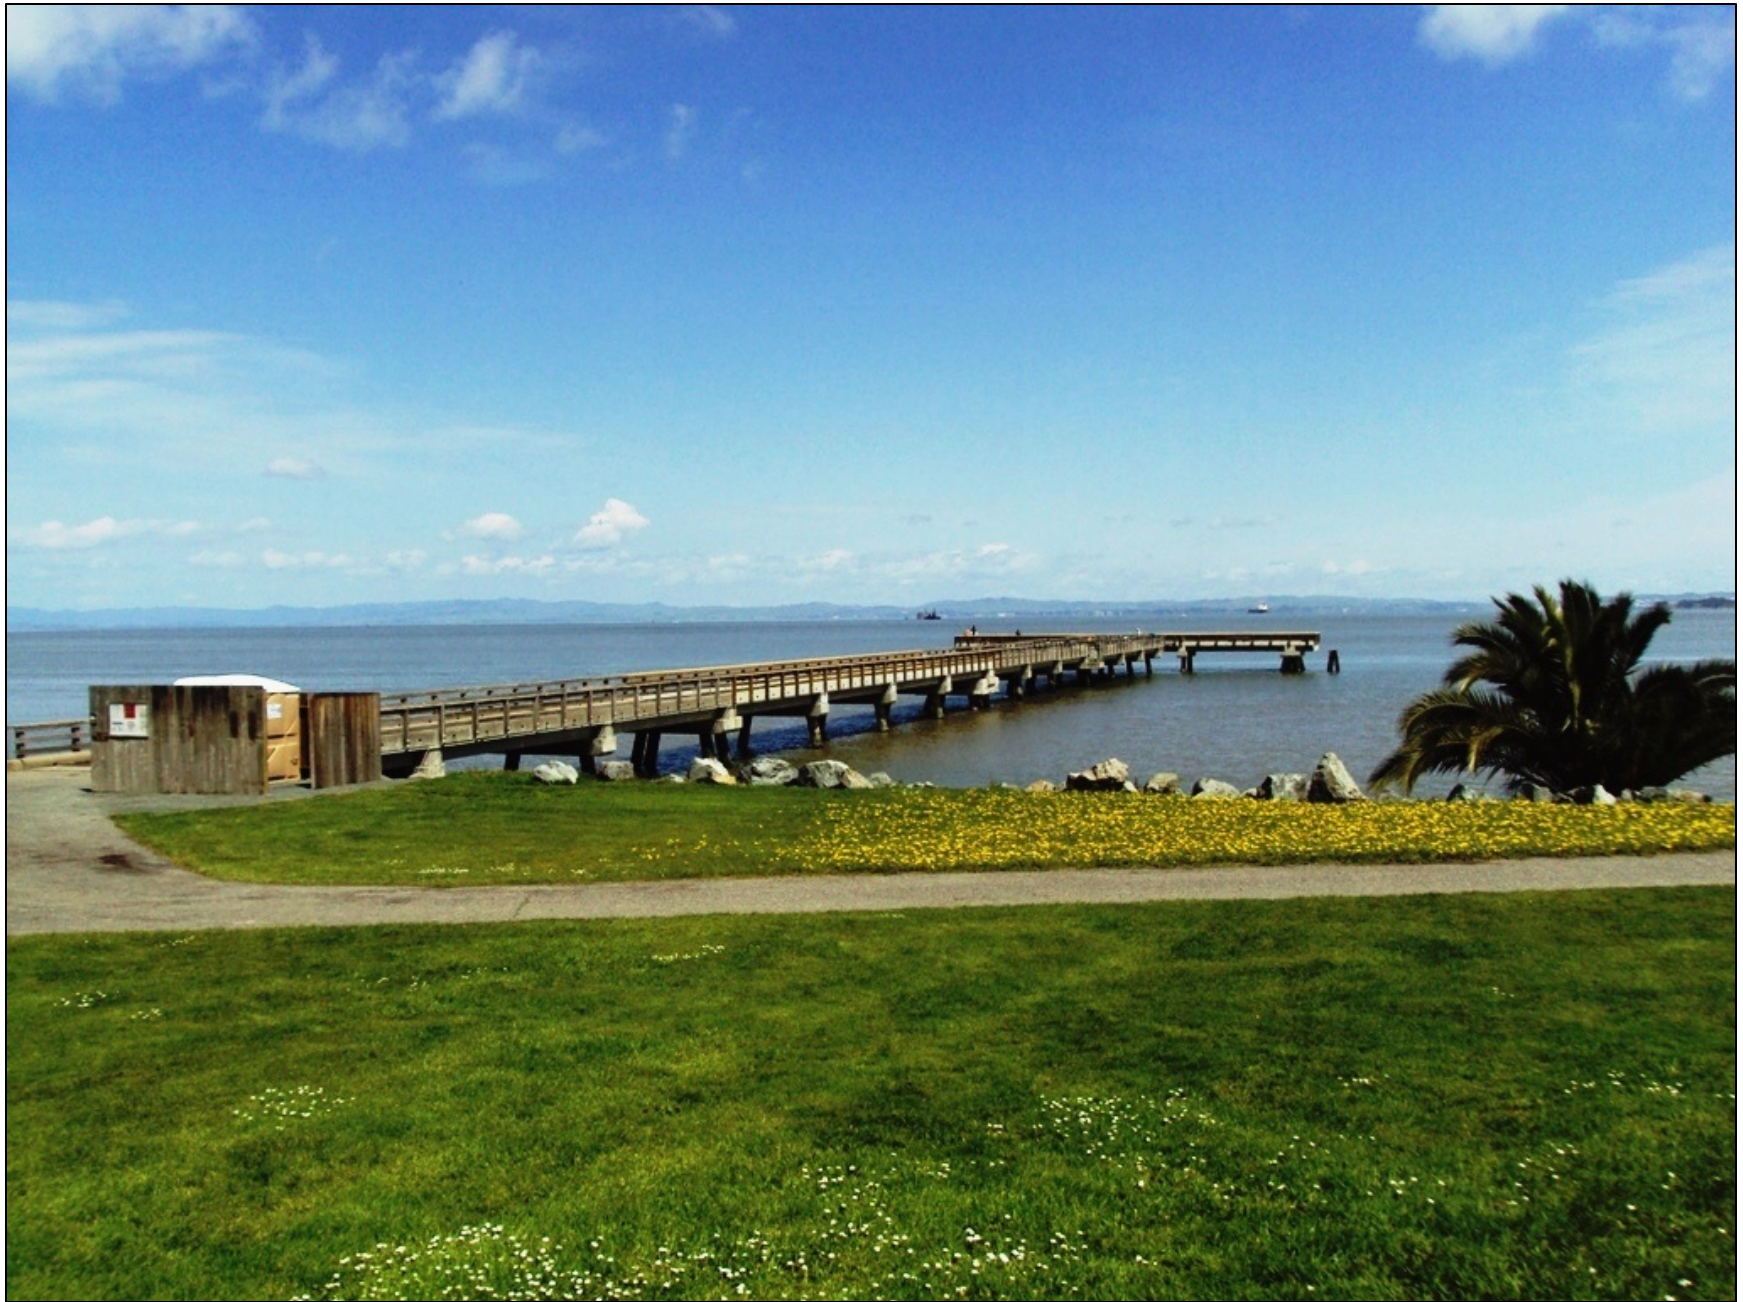
Image 1: View of existing pier

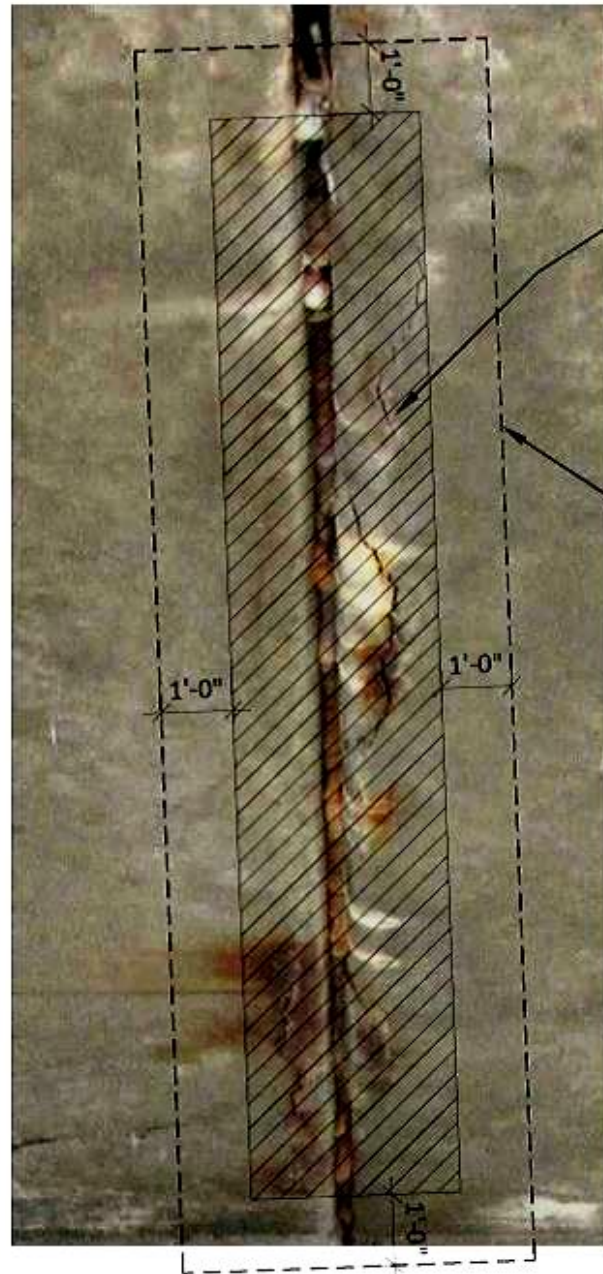
DECK JOINT REPAIR

SURFACE DAMAGED
CONCRETE AREA W/ HAIR
LINE CRACKS

12" MIN BEYOND VISIBLE
SIGNS OF CORROSION.
REFER TO CLEAN AND
COAT ON SHEET G3.

TEE CRACKING AT DECK JOINT

NOTE:
THIS REPAIR ASSUMES THAT THE
CONCRETE IS SOUND, IF NOT
NOTIFY ENGINEER.

Image 3: Example specification in plans for repair of pier decking joint

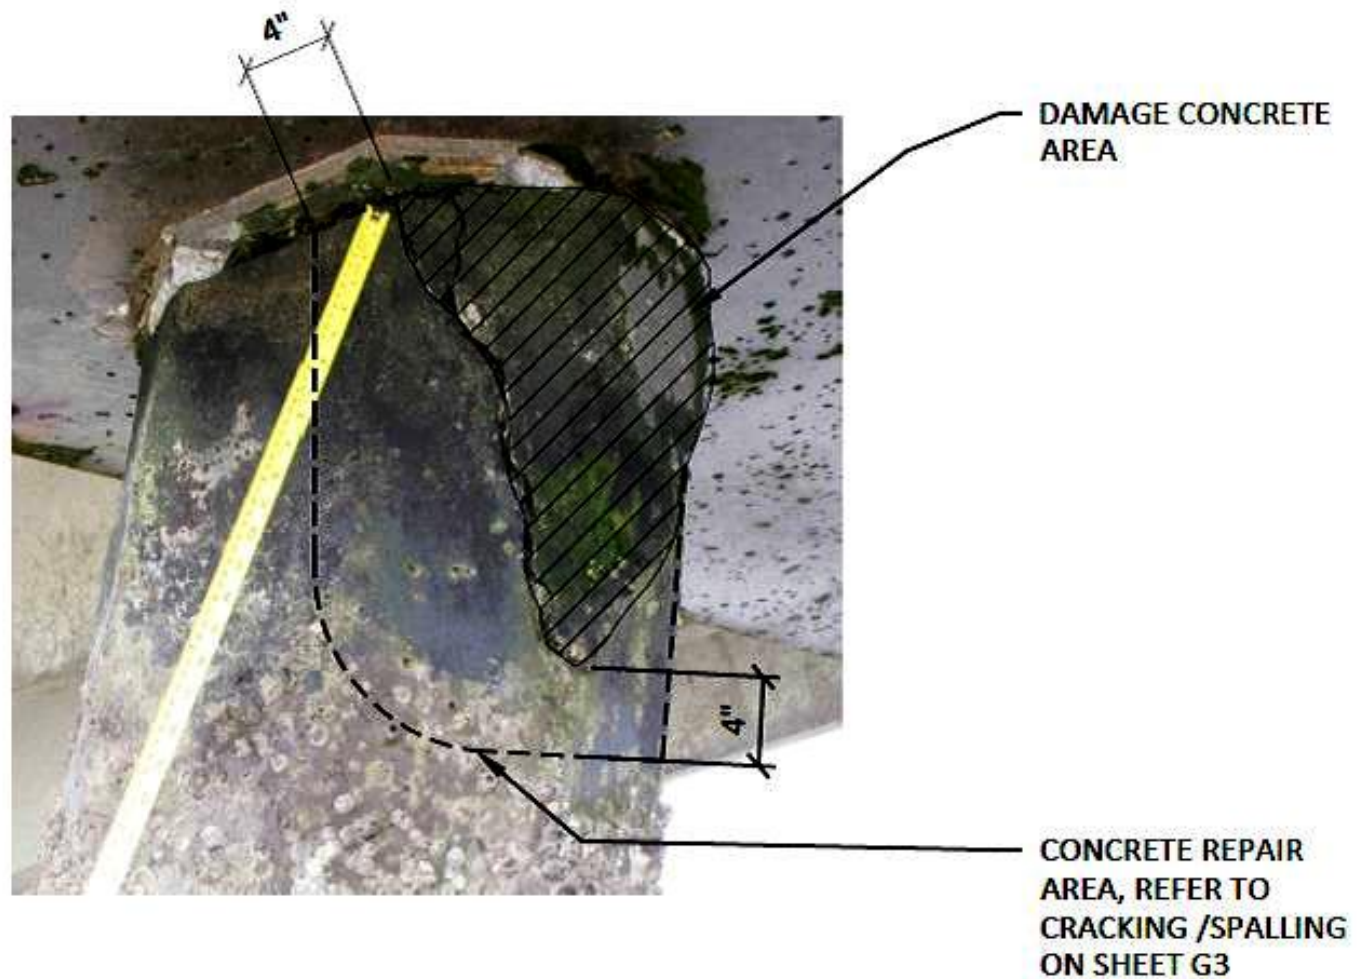
PILE REPAIR

SPALLING AT TOP OF PILE

Image 4: Example repair specification of pier pile spalling

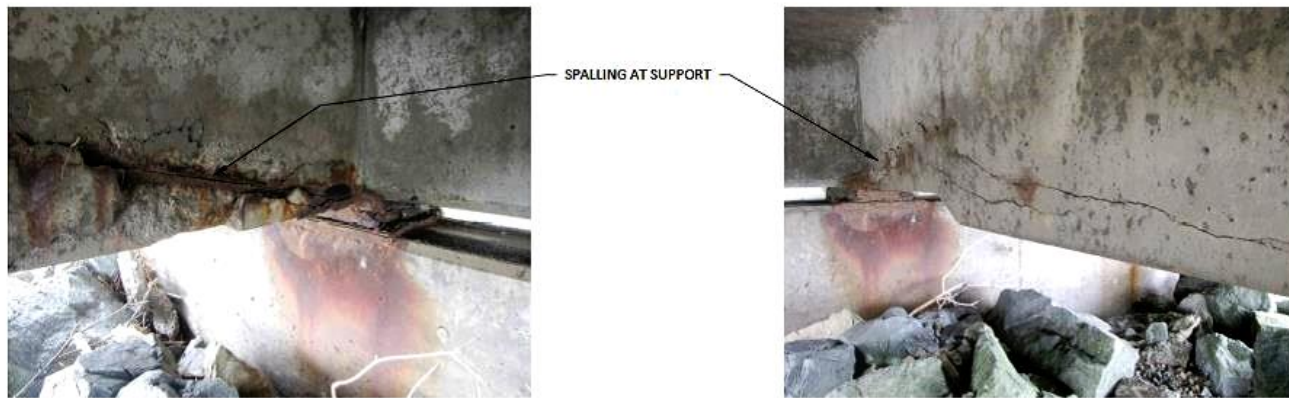
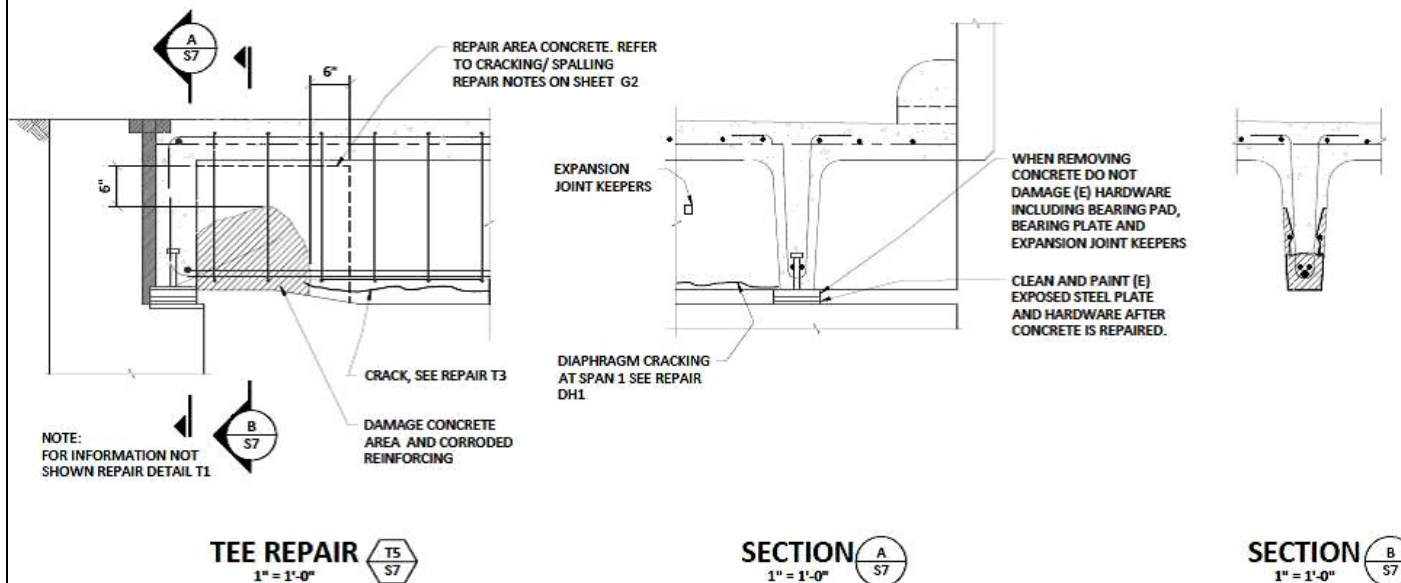
TEE SPALLING AT SPAN 1

Image 5: Example repairs to span length and connection to tee

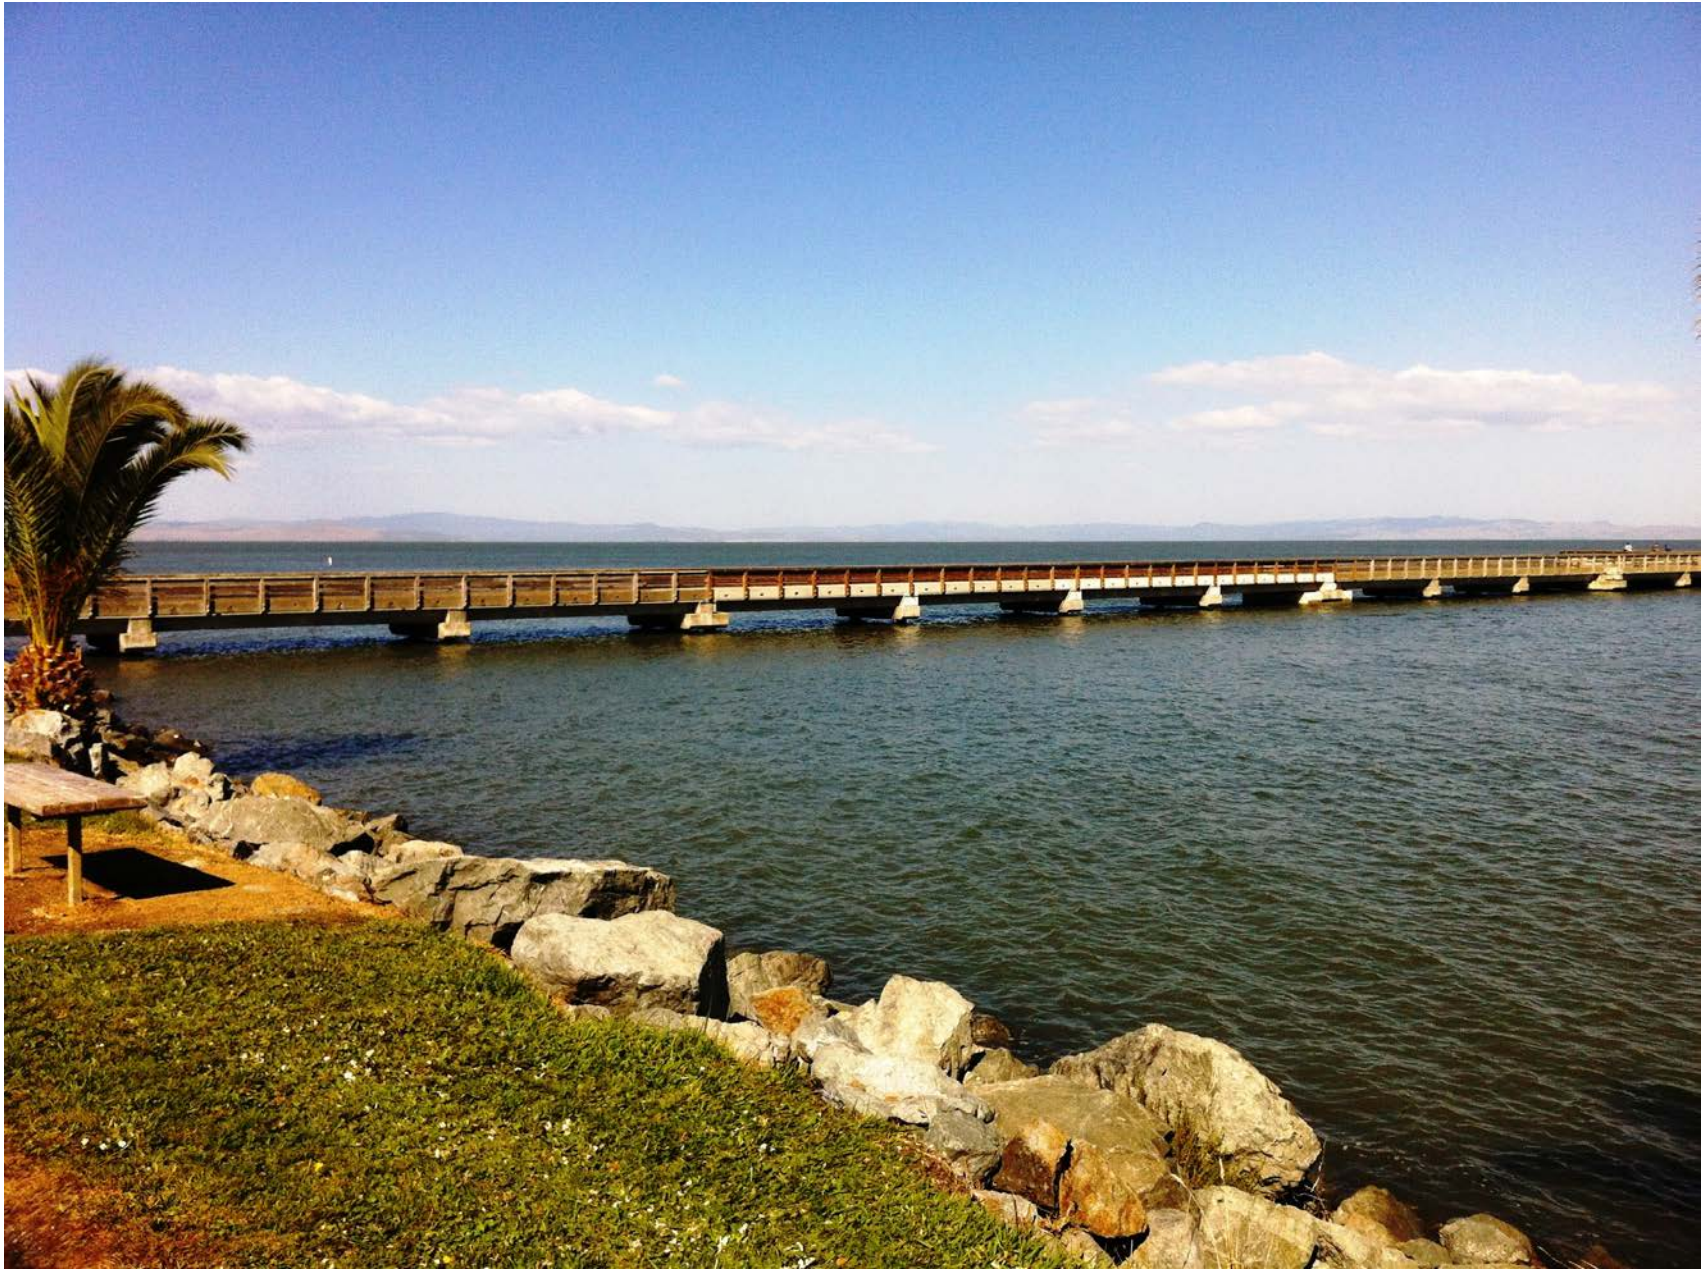
Image 7: Pier conditions during high water. Shows limited access for repair construction.

Plans and specifications for construction were straightforward, excepting a few detail options. More challenging was cost estimating that includes possible techniques of construction at a restricted marine site. Imagining

access methods under a pier during varying tides without restricting creativity for the future bidding contractors proved to be complex.

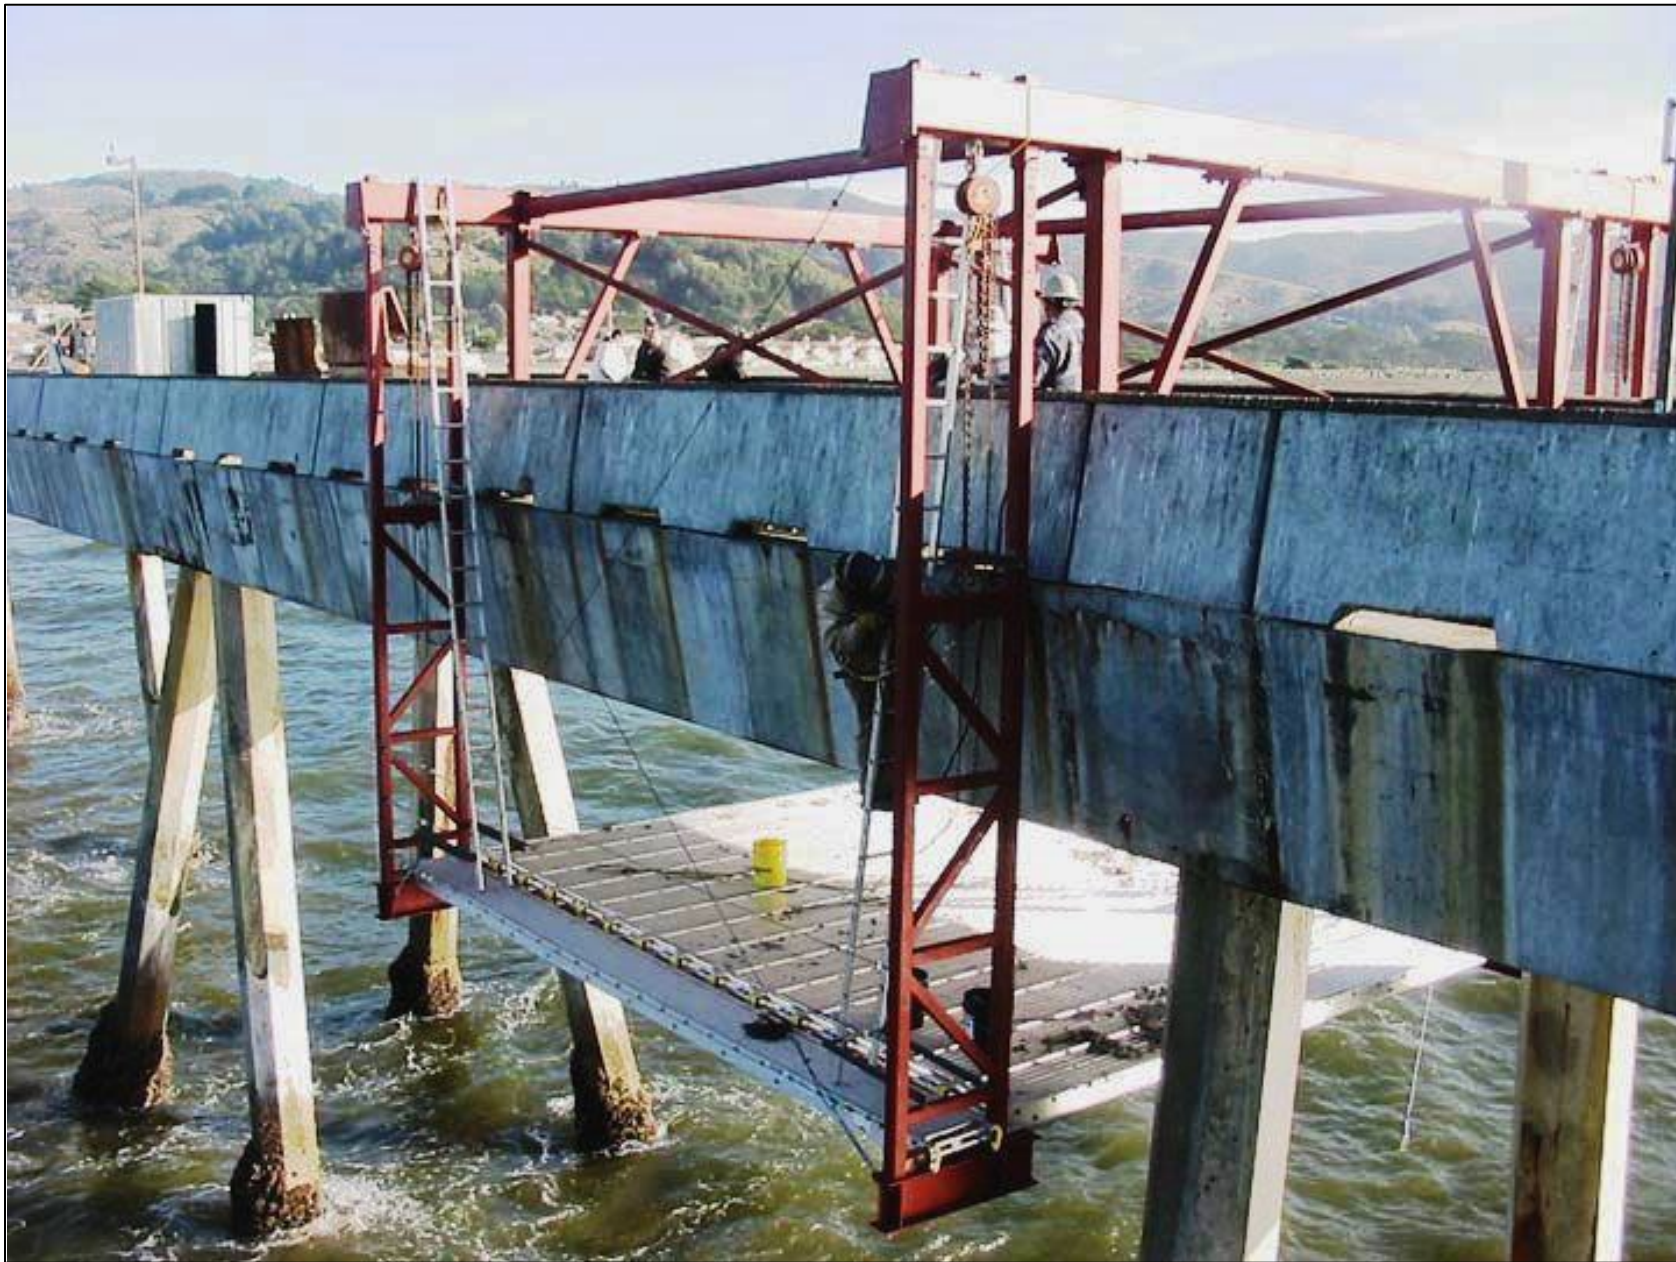
Image 8: Example of repair techniques on other piers (1 of 3). Presented to assist with cost estimating discussions.

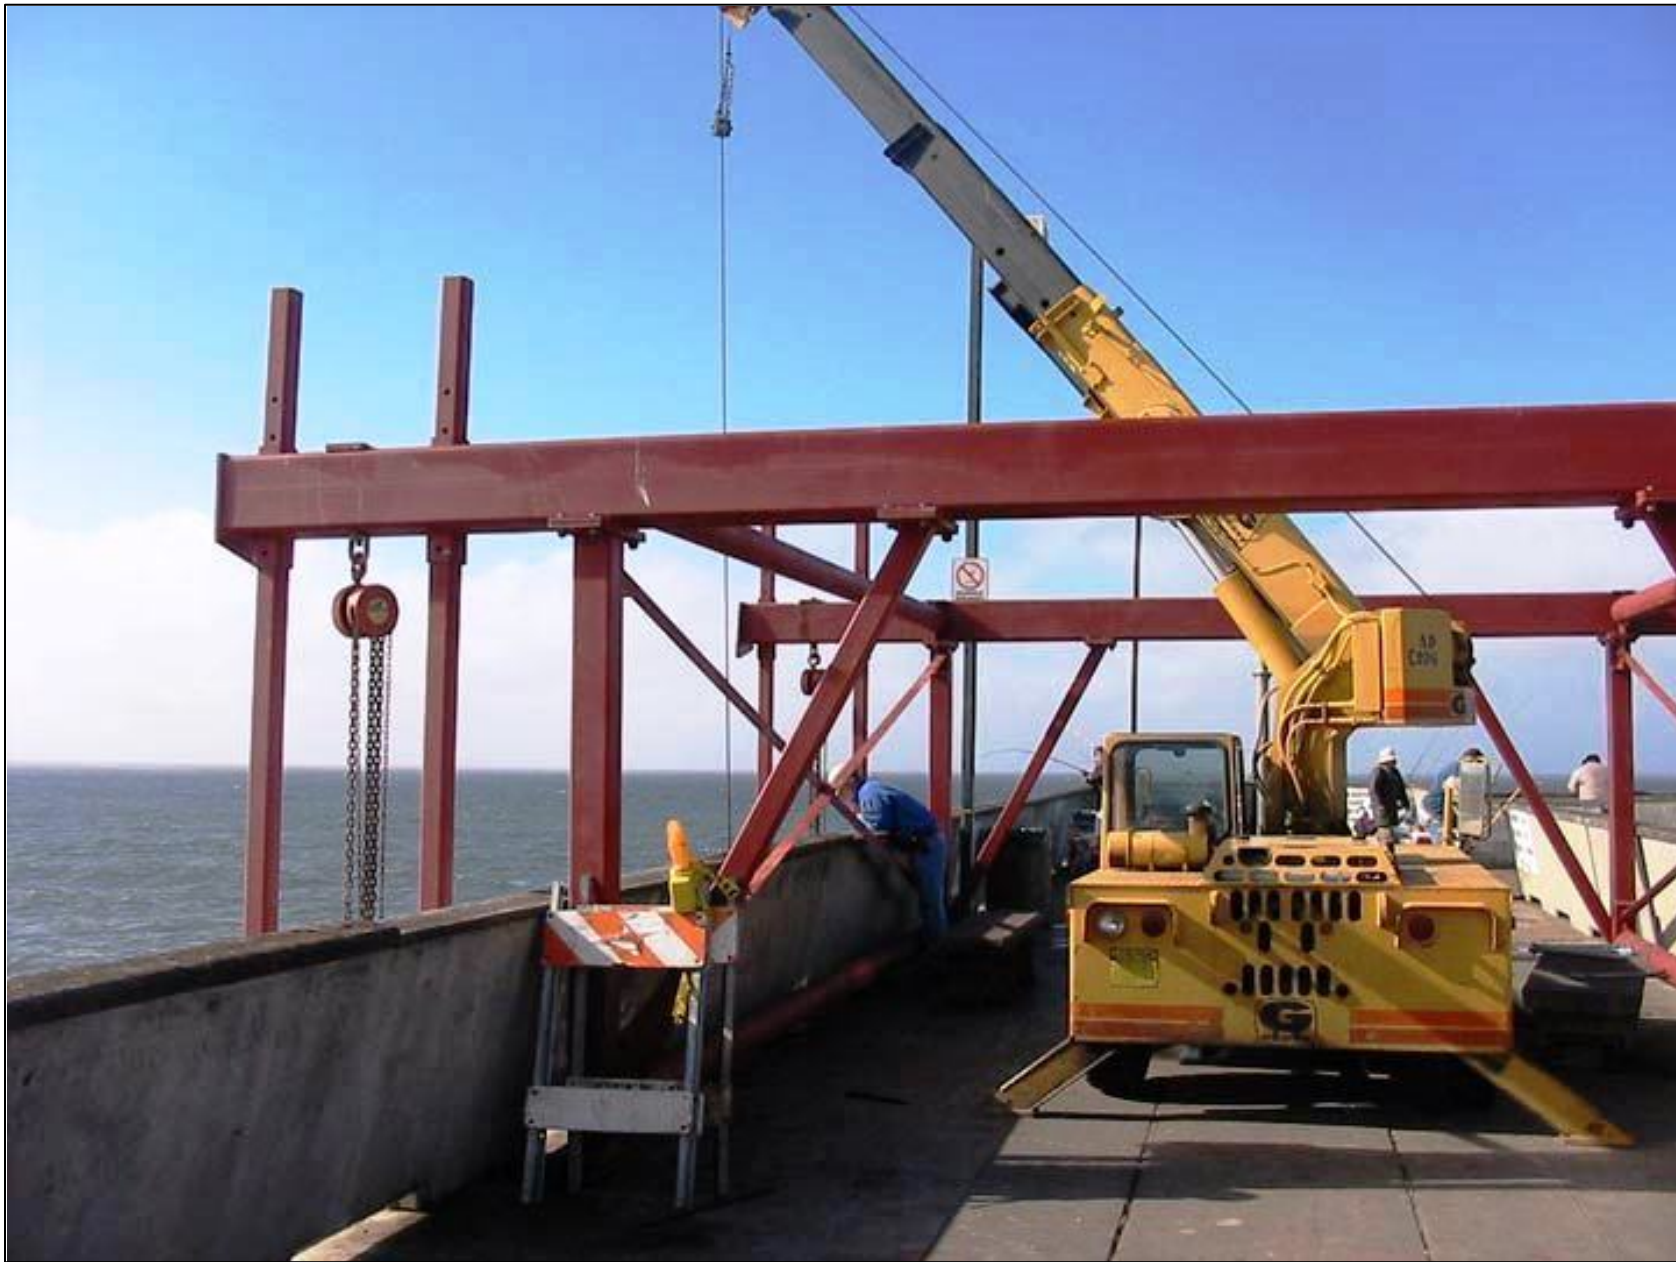
Image 9: Example of repair techniques on other piers (2 of 3). Presented to assist with cost estimating discussions.

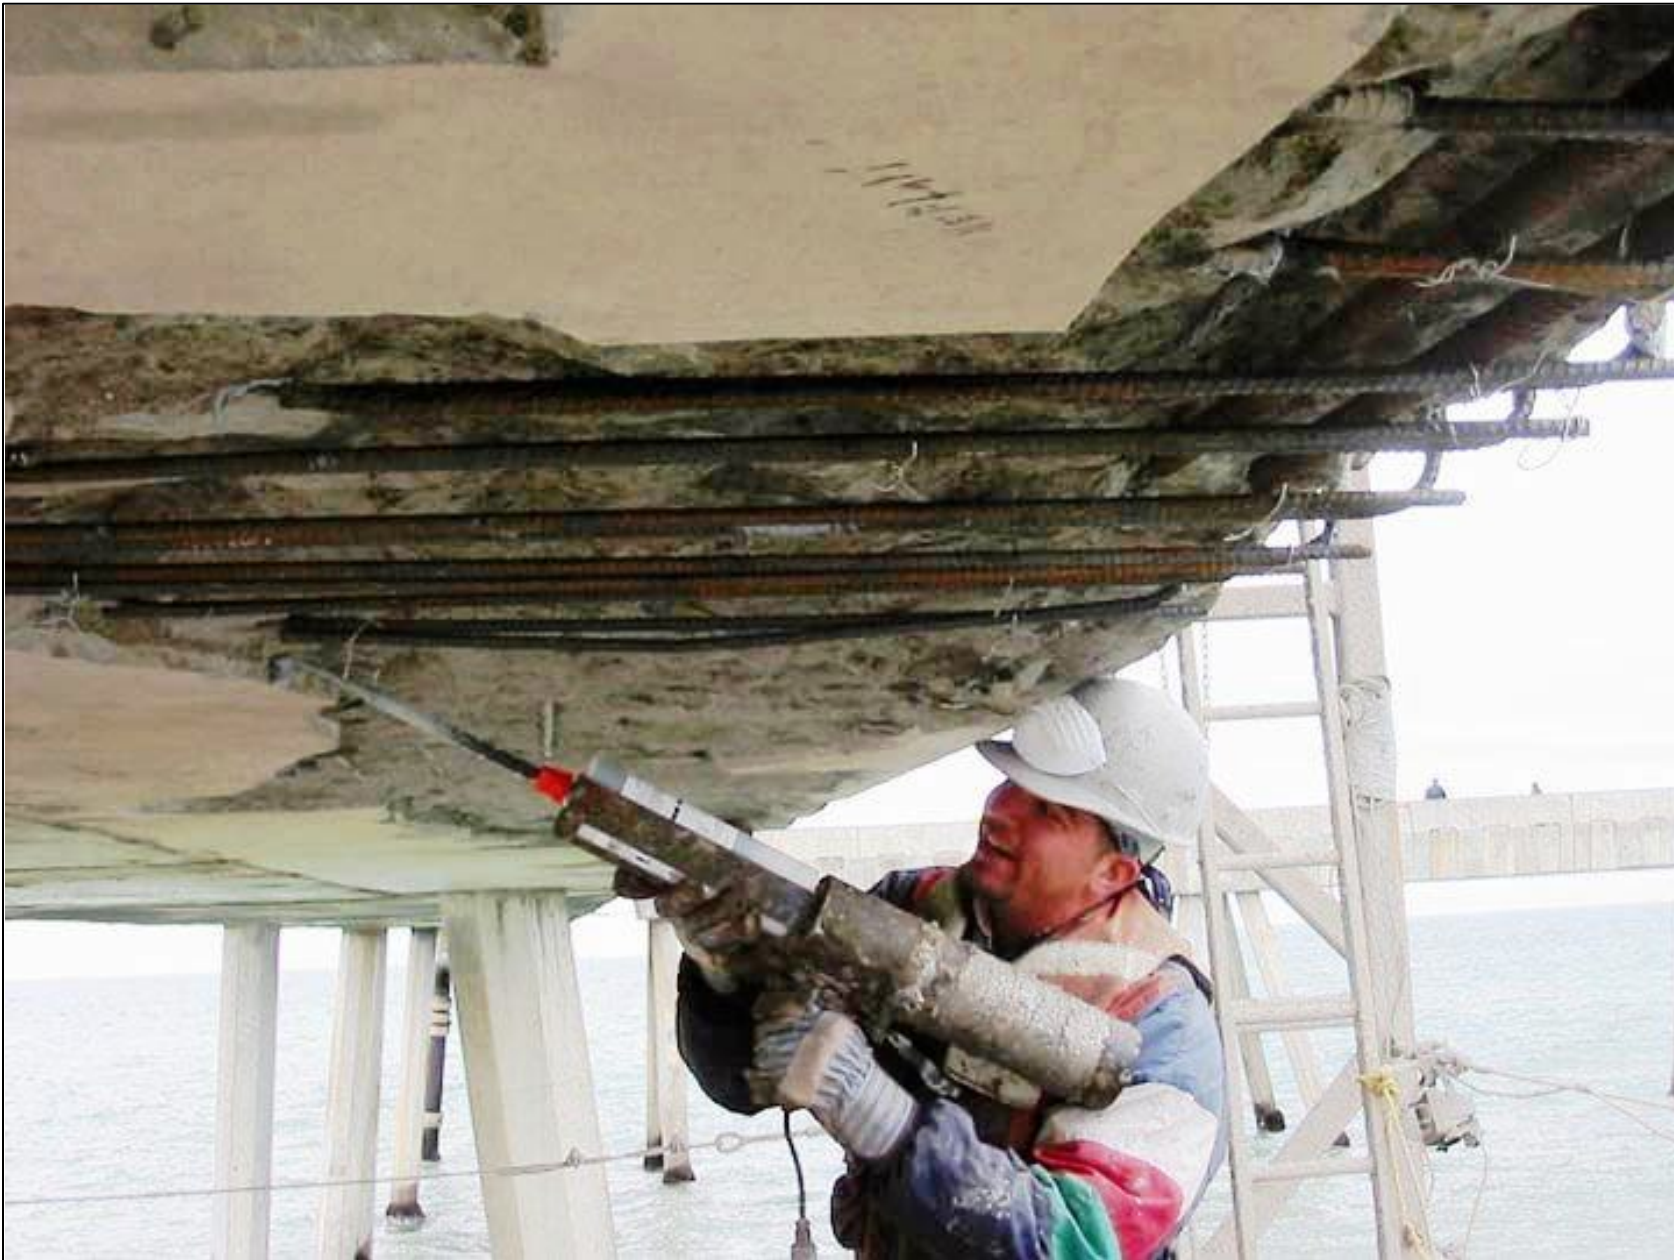
Image 10: Example of repair techniques on other piers (3 of 3). Presented to assist with cost estimating discussions.
