Coyote Valley Linkage Assessment Study Final Report

PATHWAYS FOR WILDLIFE, TANYA DIAMOND AND
AHIGA ROGER SNYDER

CALIFORNIA DEPARTMENT OF FISH
AND WILDLIFE

MARCH 1, 2016

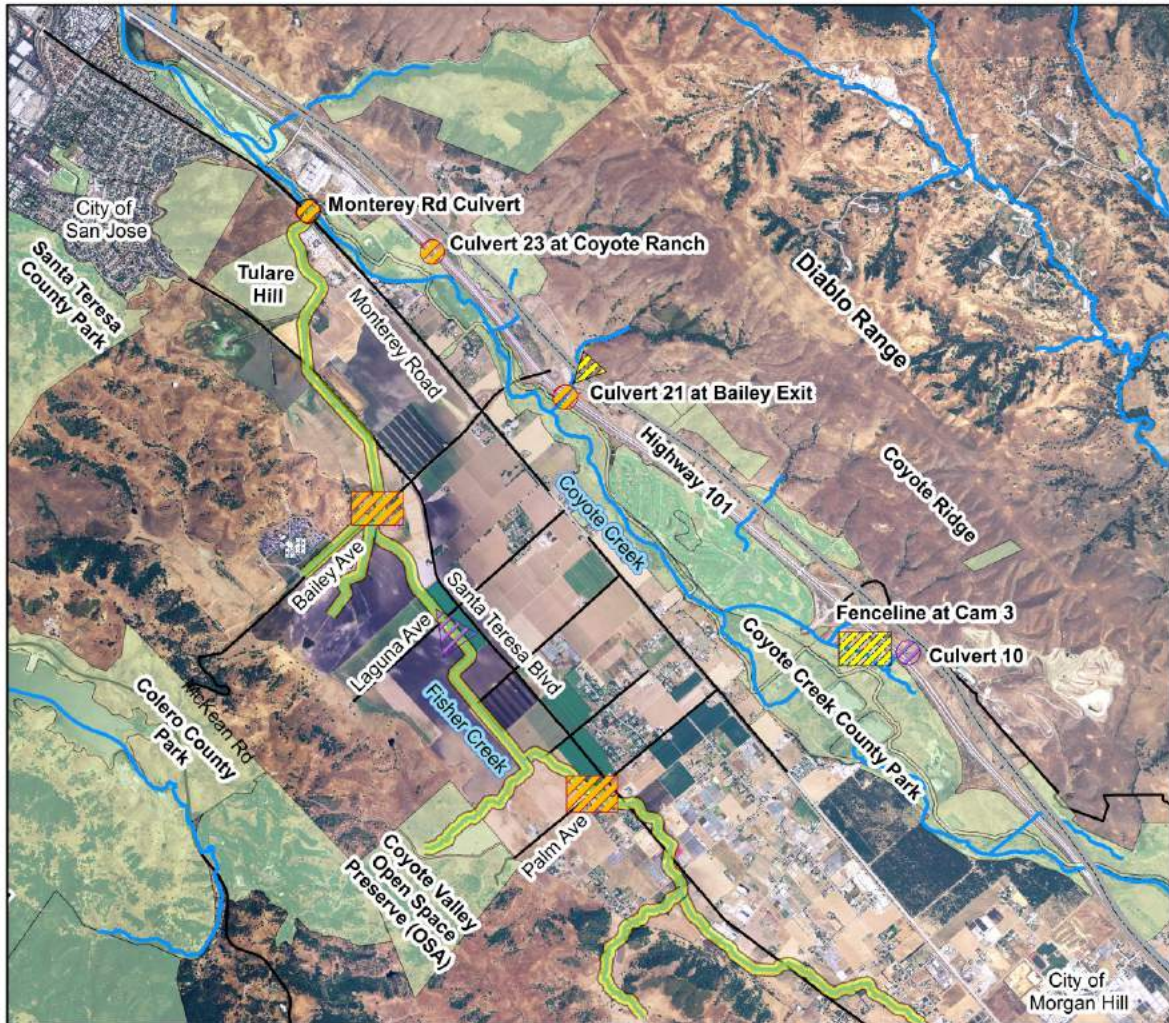
Wildlife Connectivity Design with Permeability Improvements

through the landscape (Figure 22). This map also prioritizes barrier removal based on the impacts they are causing such as roadkill rates correlated at sites with blocked or inhibited crossing structures, in which animals have no choice but to cross over the road. Rankings were also based on high use areas by wildlife to lower use. High & Secondary Priority Recommendations, colored coded as orange (high priority) and yellow (secondary priority) in Figure 21:

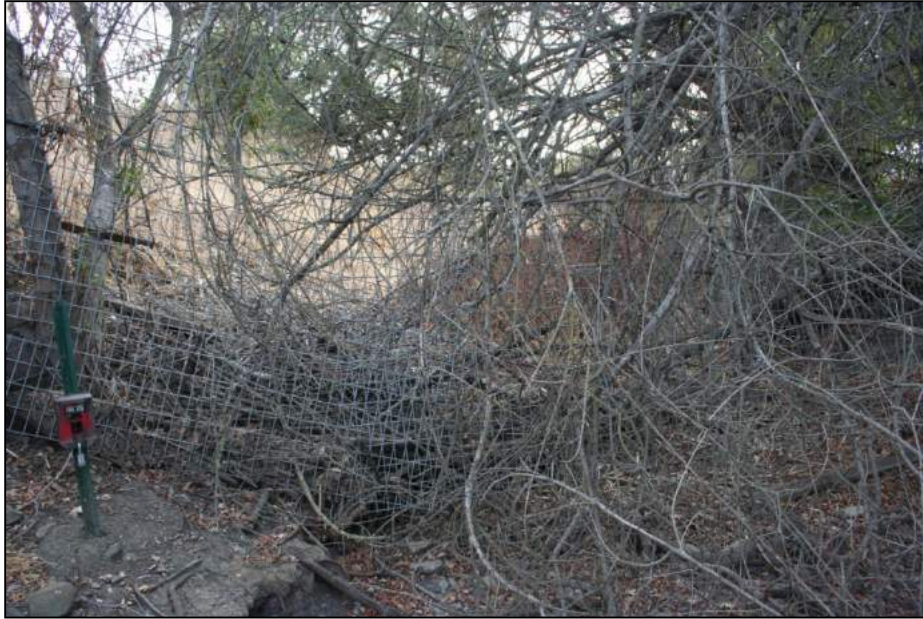
Figure 33: Exclusionary Fencing on south side of the Bailey bridge in Fisher Creek.

The highest number of detections was bobcat (6) (Table 8, Chart 8, & Figure 30). Overall, the total number of detections, 11, is low compared to the other camera stations along Fisher Creek. This is most likely due to an exclusionary fence that has been put up on the south end of the culvert, see Figure 33.

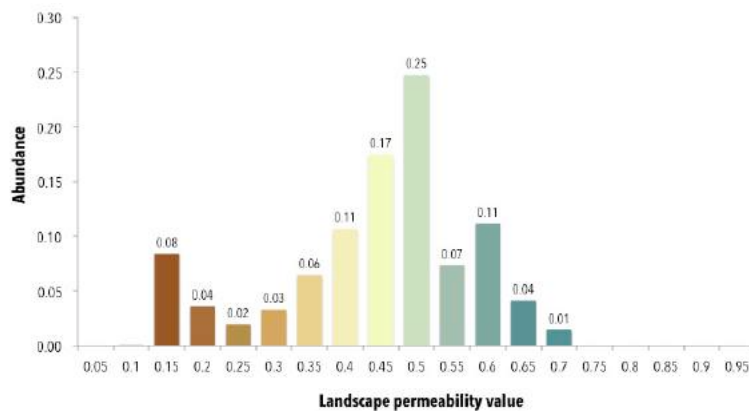
Figure 3. Distribution of landscape permeability values for Coyote Valley, grouped into 0.05 unit increments.

Our results showed Coyote Valley has a broad range of permeability values, with much of the region with relatively high permeability. Specifically, 66% of land in Coyote Valley has a permeability value between 0.45-0.75 (Figure 3), a habitat permeability range that is preferentially used by wildlife, as demonstrated for pumas (*Puma concolor*) by Gray et al. (2016). This distribution indicated that there is land of relatively high permeability within Coyote Valley, and such habitat is not rare.

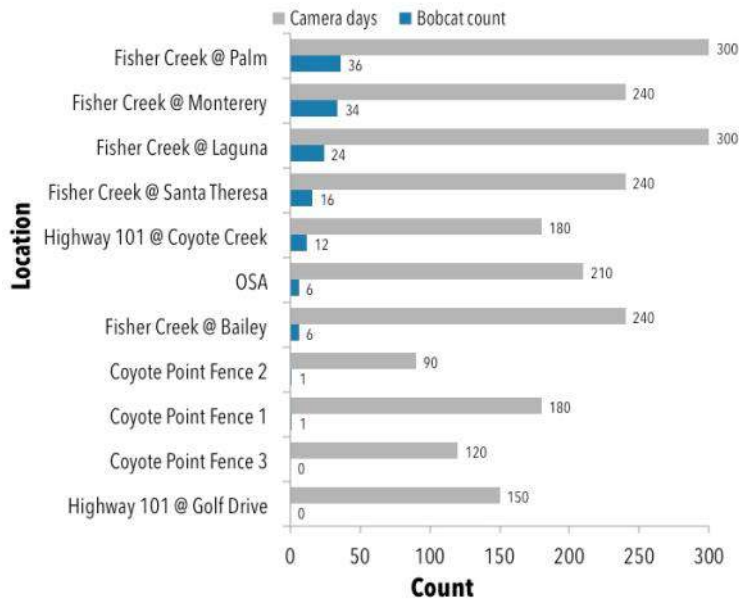
Figure 7. Bobcat detections by camera location.

Given this preliminary data, we can begin building an occupancy model for bobcats that includes variables related to camera location, like crossing structure type, distance to road, and landscape permeability value. To better understand how the surrounding habitat matrix influences bobcat movement, we will set up additional cameras across a land use gradient (Figure 8).
