**Upland Account Grant Proposal**  
Proposal for Wildlife Guzzler Rehabilitation  
Prepared by SCVQUWF on May 15, 2014

**Title of Project:** Maintenance for DFW Guzzler Nos. 3,15,24,25,27,29,31,30,36 & 37  
Angeles National Forrest, Los Angeles County, CA  
DFW - Region 5 South Coast Region

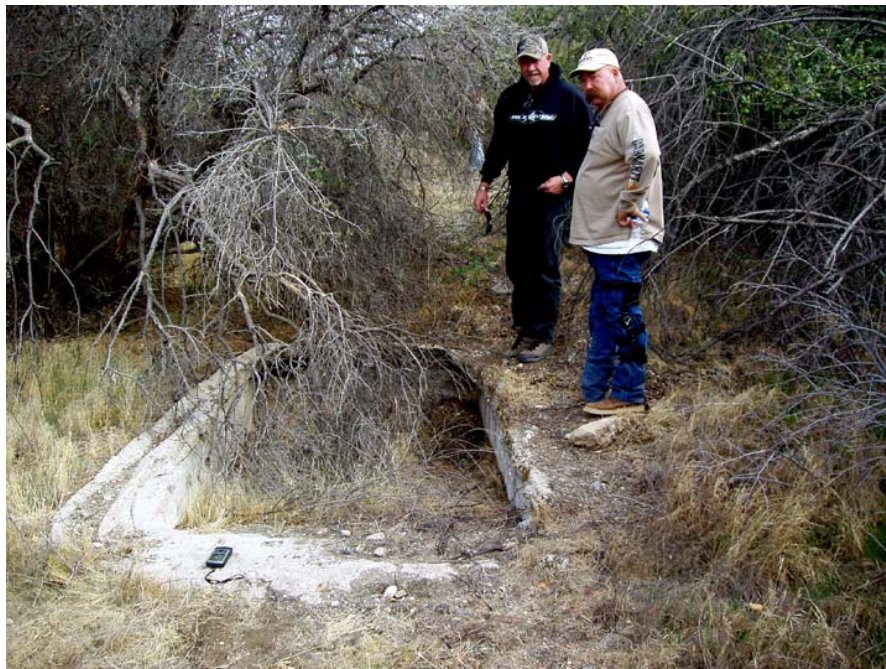
**Condition as of 1/26/2014:** Top collapsed, apron missing and/or removed. Tall brush has encroached onto site. Open tank is partly filled with sediment and debris

**Photo DFW No. 27.** Taken on 1-26-2014 by J. Cota, Tank missing tank lid, filled with debris, no apron, overgrown with brush

**Recommended maintenance:** Remove & Replace: Propose to remove old tank, excavate old material and frame and pour new 5 x 4 x 12 concrete tank, 5 x 12 concrete lid and 4" x 14' x 14' apron. Concrete should be reinforced with 6 X 6/10-10 welded wire mesh. Lid should have access manhole cover. Clear brush around new apron, Install stainless steel Big Game Drinker approximately 20 yards from site.

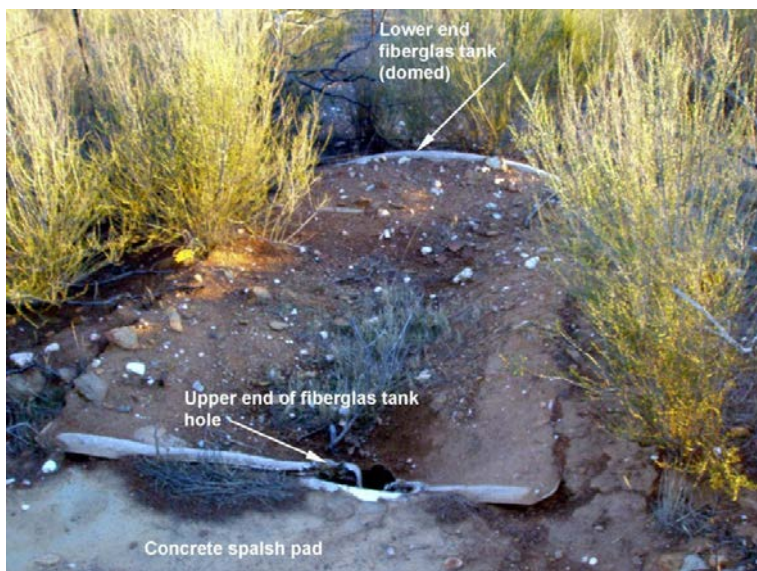
**Condition as of 1/23/2014:** 40 ft south of loop in motorcycle trail, double fenced, outer fence is driven steel post, 4 ft high 4X6 inch twisted wire mesh inner fence 4 strands 8 gauge wire ties to driven steel posts unit has a 10ft X 15 ft concrete splash pad above a partially buried 6 ft X 8 ft fiberglass storage tank. Fiberglass exposed & cracked at north and south end. Apron is concrete and has cracks in need of repair. Collapsed tank top appears to have completely closed off game bird access to the tank.

**Recommended maintenance:** Remove old material and frame and pour new 6 x 8 x 4 concrete tank, 6 x 8 concrete lid and 4" x 10' x 15' apron. Concrete should be reinforced with 6 X 6/10-10 welded wire mesh. Lid should have access manhole cover. Clear brush around new apron, Install stainless steel Big Game Drinker approximately 20 yards from site.

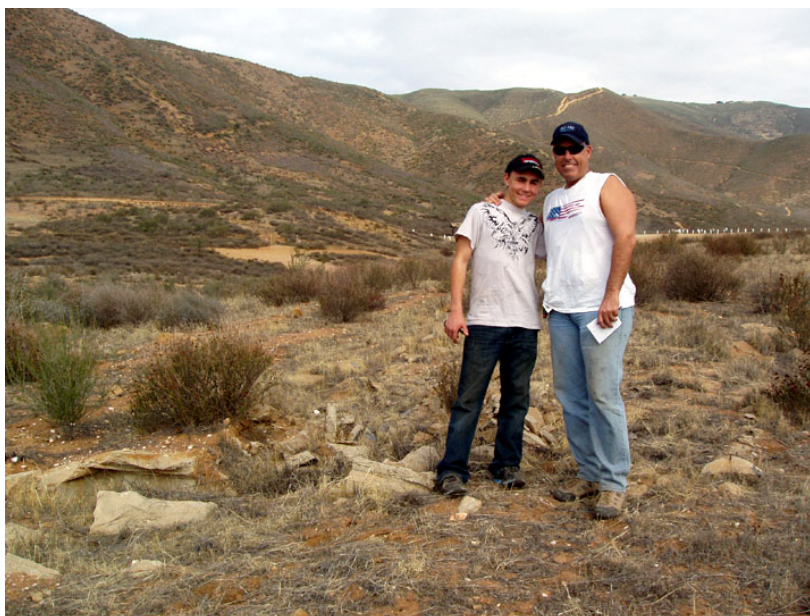
**Condition as of 1/26/2014:** Top collapsed, apron entirely broken up. Open tank is partly filled with sediment and debris. All construction appears to have been concrete

**Photo DFW No. 31.** Taken on 1-26-2014 by J. Cota, Tank lid and apron completely broken up. CJ & Justin Gross, SCVQUWF volunteers and locators of the guzzler standing for scale.

**Recommended maintenance:** Complete replacement, Remove old material and frame and pour new 5 x 4 x 12 concrete tank, 5 x 12 concrete lid and 4" x 14' x 14' apron. Concrete should be reinforced with 6 X 6/10-10 welded

wire mesh. Lid should have access manhole cover. Clear brush around new apron, Install stainless steel Big Game Drinker approximately 20 yards from site.

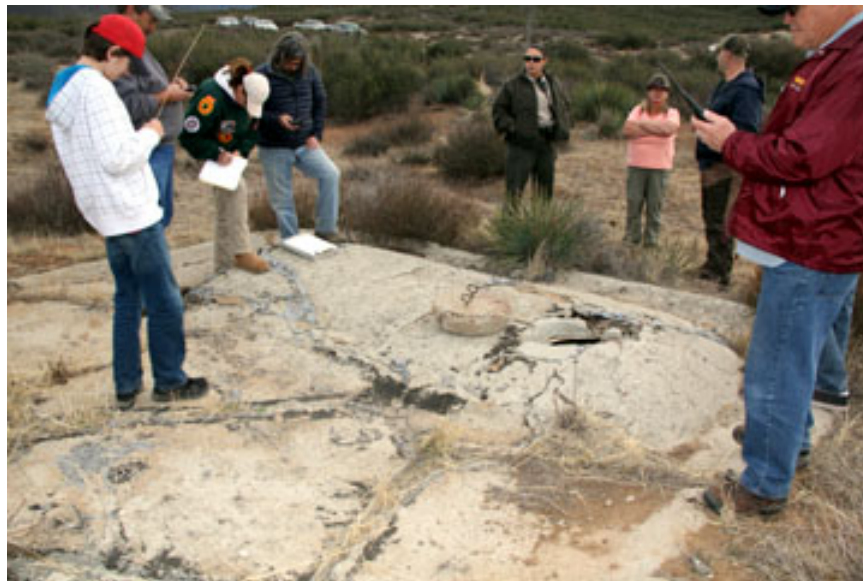
**Condition as of 1/26/2014:** 6' X 10', 500 gal tank, large 18' X 22' X 15' apron (including tank), top not reinforced with steel, roof cracked and partially collapsed. Apron has many cracks with weed infestation and is not sealed. Siphon hole of unknown origin in bottom/feeding PVC pipe broken/no other visible cracks in tank

**Photo DFW No. 37.** Taken on 1-26-2014 by D. Fong, Volunteers and DFW Staff inspecting apron

**Recommended maintenance:** Clean debris from tank and inspect bottom for additional cracks. Repair cracks and plug up siphon hole and repair as necessary with epoxy or concrete. Reconstruct new lid and place new 12 ft. X 12 ft. reinforced concrete. Concrete should be reinforced with 6 X 6/10-10 welded wire mesh. Lid should have access manhole cover. Repair Apron, repair broken concrete, fill, patch cracks and seal surface with epoxy sealant. Clear brush around new apron and install mesh wire fence around the perimeter. Install a new Big Game Drinker 25 yards from main tank.

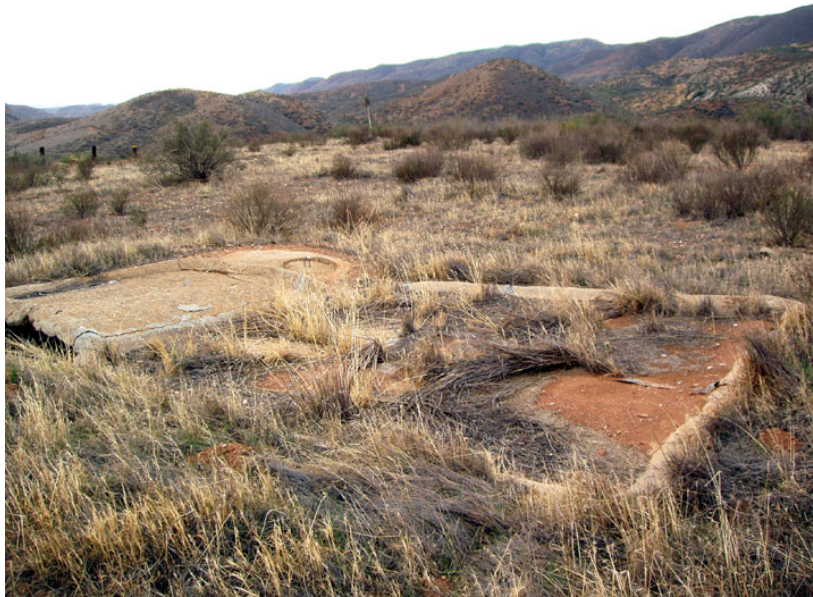
**Condition as of 1/12/2014:** Tank dry, partially filled with sediment, top and clean-out lid intact with some small cracks, apron cracked and filled with sediment and weeds, some broken restriction bars, behind fence keeping site secure from off-road vehicles

**Photo DFW No. 30.** Taken on 1-12-2014 by J. Cota, note sediment and weeds covering apron

**Recommended maintenance:** Clean debris from tank and inspect bottom for cracks. Repair cracks as necessary with epoxy or concrete. Clean apron of debris, inspect and patch cracks as necessary. Install stainless steel Big Game Drinker approximately 20 yards from site.

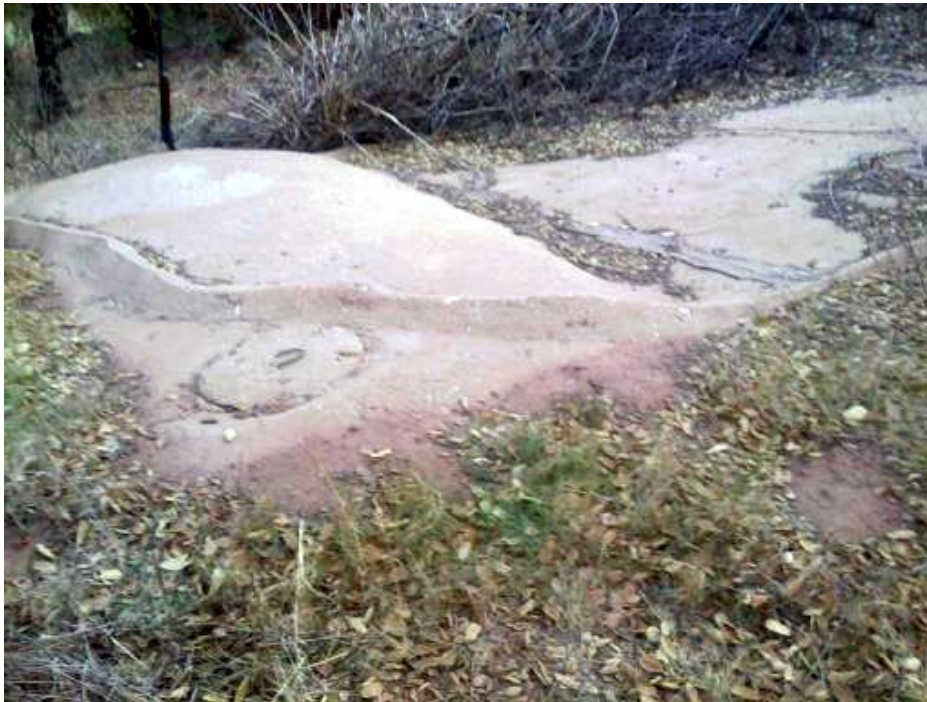
**Photo DFW No. 29.** Taken on 1-19-2014 by J. Cota,

**Condition as of 1/26/2014:** Tank dry, partially filled with sediment, top and clean-out lid intact with some small cracks, apron cracked and filled with sediment and weeds, some broken restriction bars, behind fence keeping site secure from off-road vehicles

**Recommended maintenance:** Clean debris from tank and inspect bottom for cracks. Repair cracks as necessary with epoxy or concrete. Clean apron of debris, inspect and patch cracks as necessary. Install stainless steel Big Game Drinker approximately 20 yards from site.

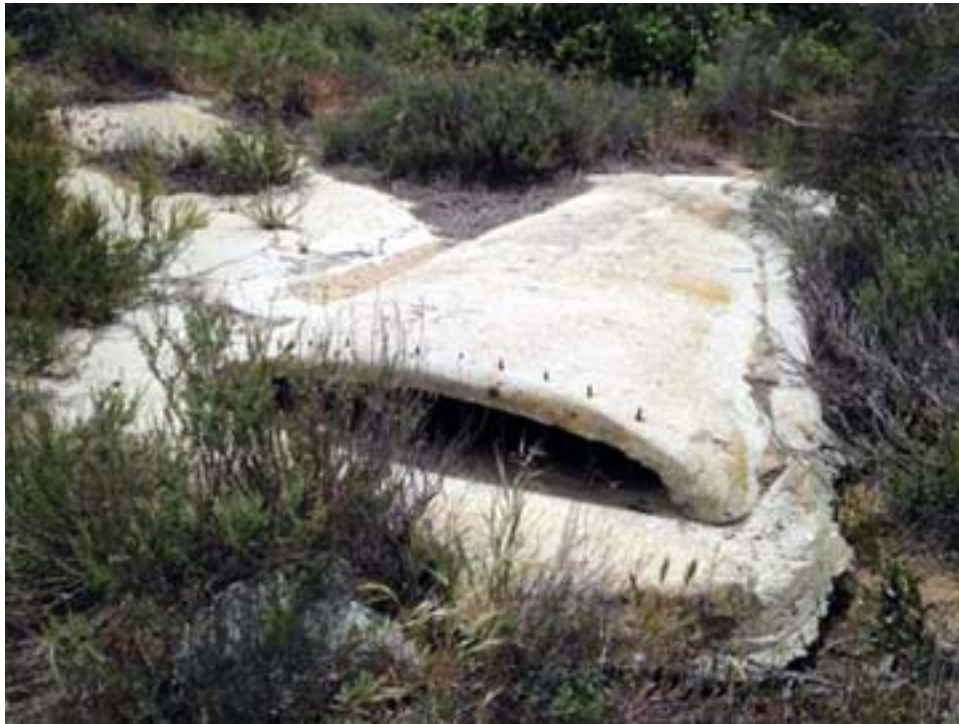
**Condition as of 5/9/2014:** Contains water, top intact, vertical large animal/predator restriction bars intact, apron present but has cracks and buckwheat growing through, brush encroaching onto the apron, quail observed in vicinity on previous visits.

**Photo DFW No. 36.** Taken on 5-9-2014 by M. Wall, note buckwheat growing up through apron

**Recommended maintenance:** Remove maintenance lid for inspection, clean interior as required, trim back weed growth, patch all apron cracks with epoxy, quickset concrete, or pitch (to be determined). Install stainless steel Big Game Drinker approximately 20 yards from site.
