### Final Report for Guzzler Rehabilitation Operations - DFW #32 / USFS 2-25 Grant Agreement Number #P1480018

**Guzzler:** DFW #32 - USFS #2-25

**Location:** Rowher Flats above Whiskey Springs Canyon  
NE ¼ of the NW ¼ Section 17, T.5N, R 14 W (SBB&M)  
Long. 118°22'16.49"W / Lat. 34°31'27.27"N

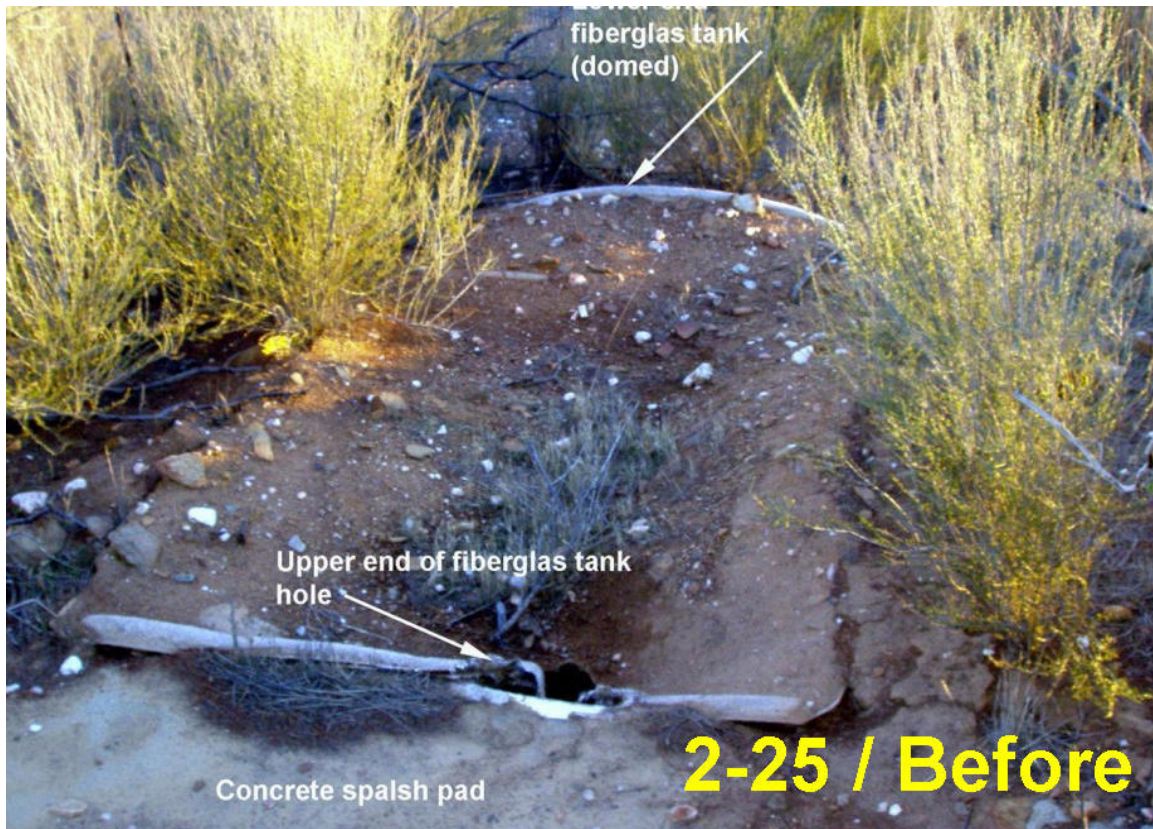
This guzzler was originally installed in the 1960's by the Issac Walton League. The last report written about this guzzler was in April 1968, in which they state this guzzler was destroyed. Now restored, this wildlife water guzzler is the only source of water for Small & Large animals and a variety of birds for one square mile.

Due to USFS restrictions on excavating and expanding area footprint, it was decided to Remove, Repair and Replace the original Fiberglass Tank, Rebuild & Reinforce Tank Lid, Repair the existing concrete apron, Contract Water carrier to fill tank, install Game Cameras and conduct wildlife surveys.

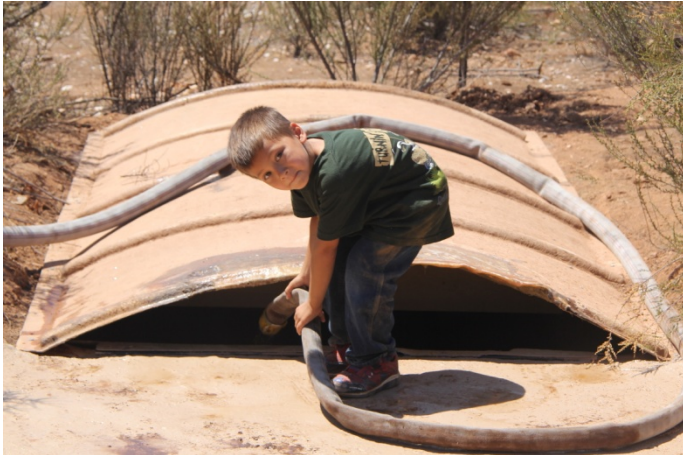
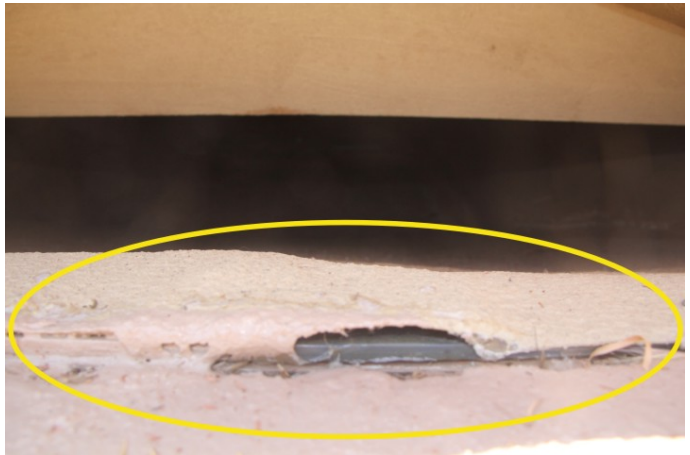
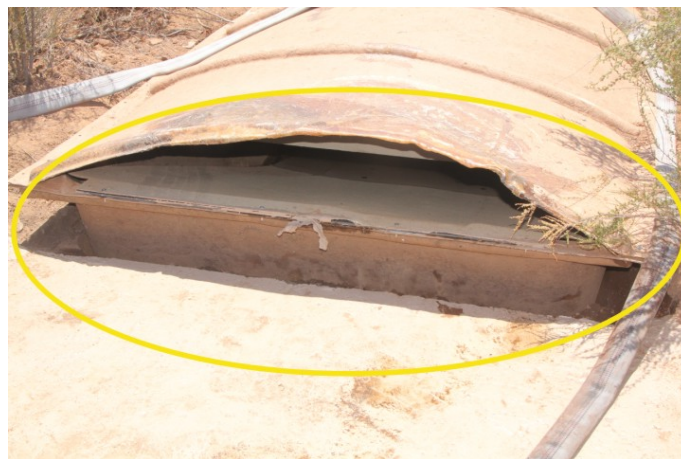
2) When filling the completed project with water, we encountered a problem where the concrete apron meets the fiberglass tank. The water began to erode the 50 year old concrete and began to flow under the fiberglass tank. The tank began to float and broke away from its original footing. The tank rose 6" above the apron and was unserviceable in its present condition.

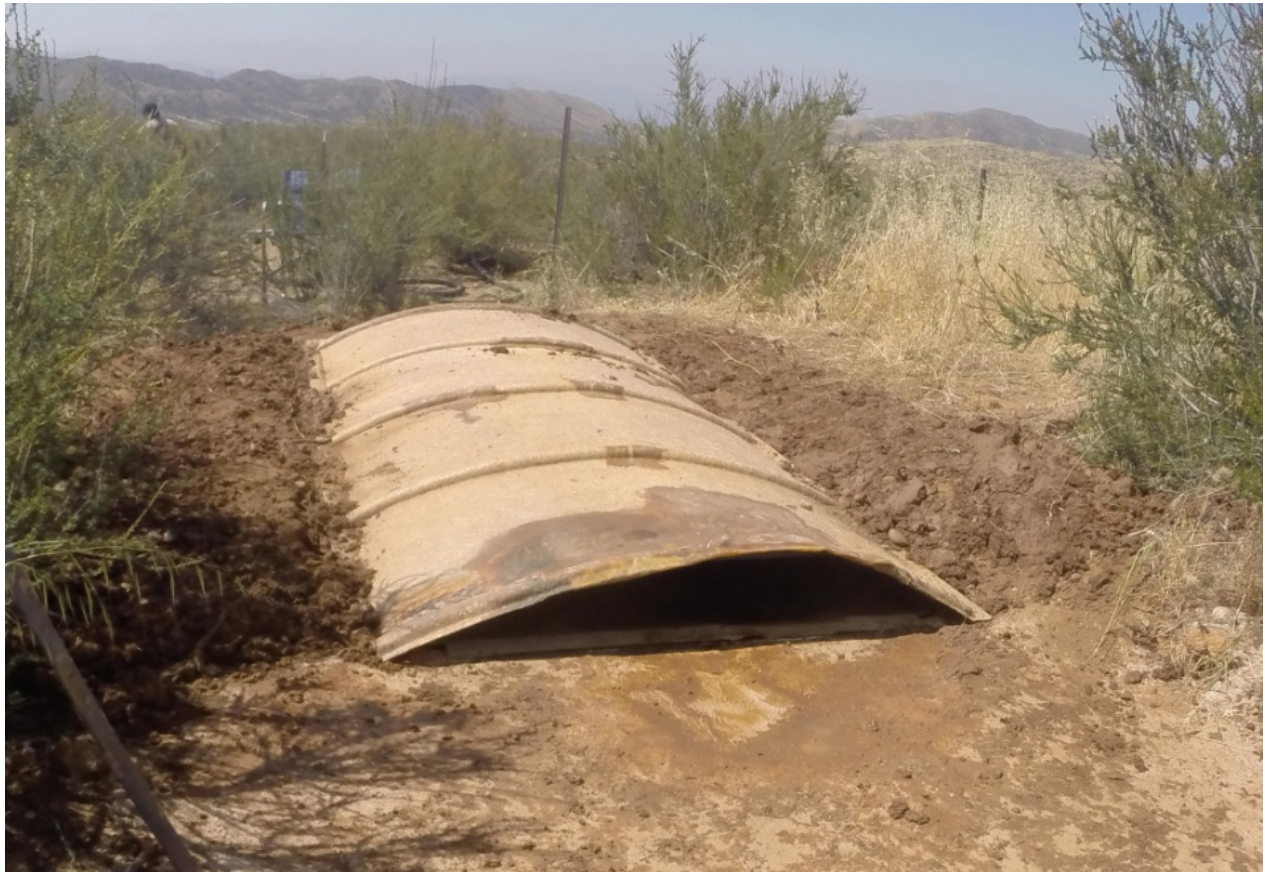
SCVQUWF's success to date for this Project is the physical restoration of guzzler unit DFW#32 / USFS 2-25. Guzzler unit DFW#32 / USFS 2-25 was rehabilitated on 7/16/2015 and once again holds water available for immediate use by a wide variety of native wildlife species, both game and non-game. DFW#32 / USFS 2-25 is situated in a very arid region of ANF public lands which continues to experience extended drought conditions. Although It is too soon to evaluate the specific impact this watering unit has had on local wildlife and which species it may benefit, SCVQUWF's Habitat Restoration volunteer members are committed to long term monitoring of all of the guzzler units we have restored to date, including this one. One of our members, Joe Cota, is a local professional geologist who has assisted in locating many of the old guzzlers and has assisted in determining which of these units are most important to rehabilitate based on location of the unit, proximity to known natural water sources, and habitat. He has conducted groundwater reconnaissance surveys in the vicinity of most of the units we have restored. It is Mr. Cota's opinion that these man-made water resources will become increasingly important over time for the survival of many game and non-game animals. As climate change continues, the average precipitation in the region will decrease. Many of the natural springs and streams in the area which have historically been relied upon by wildlife will continue to diminish over the next several decades and could possibly dry up entirely. Therefore, restoration of each of these units is a success in itself. In the coming year, SCVQUWF's volunteers will be installing game cams and monitoring of certain guzzler units. This wildlife monitoring work is in progress. At present we are trying to locate a Brood Count instructional video that had been prepared by the now defunct Quail Unlimited in the 1970's or 1980's so that our members can be properly trained. We also understand that USGS wildlife biologists are developing a systematic methodology for wildlife monitoring which we will be researching. In summary, the measurable environmental success of this project to date is the re-establishment of a former man-made water resource that we believe will become increasingly important over time. SCVQUWF will continue to monitor DFW#32 / USFS 2-25 to ensure it is still holding clear, fresh water. We will continue to research effective methodology for brood count and wildlife monitoring in an effort to quantitatively evaluate the positive impacts restoration of the guzzler has had on native species.

At a later date volunteers returned to remove the fiberglass lid, drain the tank, remove the tank, excavate the debris from below the tank, reset tank into hole and refill with water.

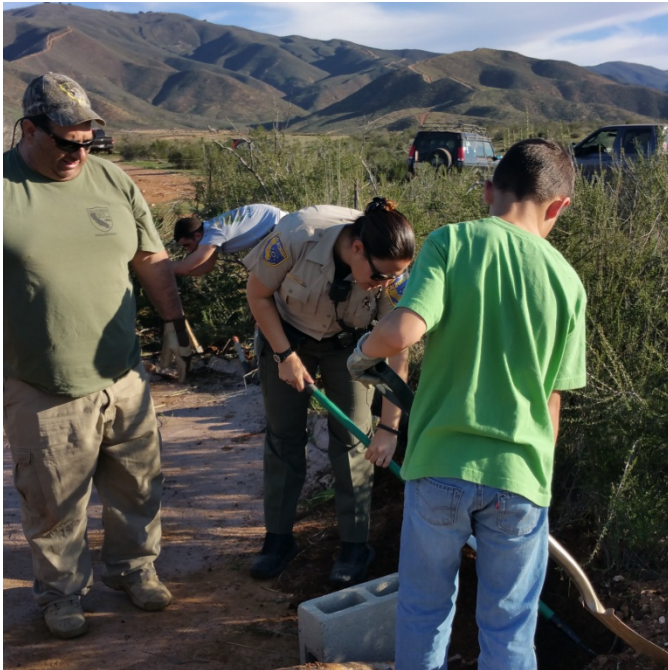
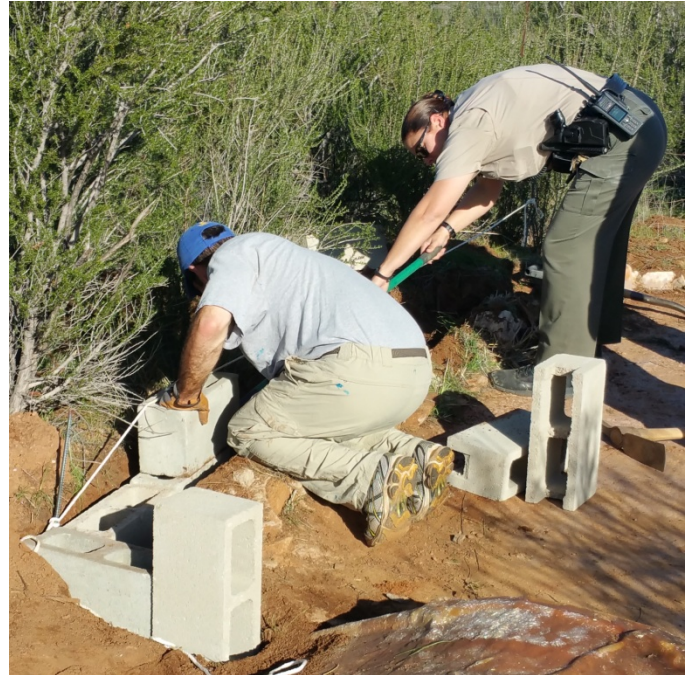
1) After some needed El Nino rainfall this Guzzler had collected an appreciable amount of water. The water quality was only deemed adequate, due to the muddy clarity. The muddy condition was due to the high volume of rainfall, the inadequate size of the apron and height of retaining berm.
