Notice of Determination

Project Title: Hart Ranch Flow Enhancement Project

Project Applicant: Hart Cattle LLC

Project Location (include county): Little Shasta Valley, Siskiyou County, CA (41° 41' 25.85"N latitude, 122° 22' 51.1'

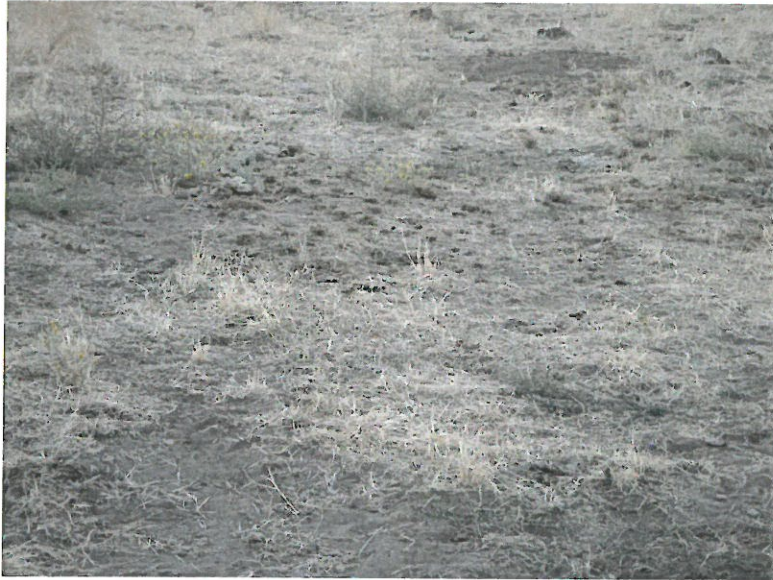
Photo 1 Plot 22 facing east

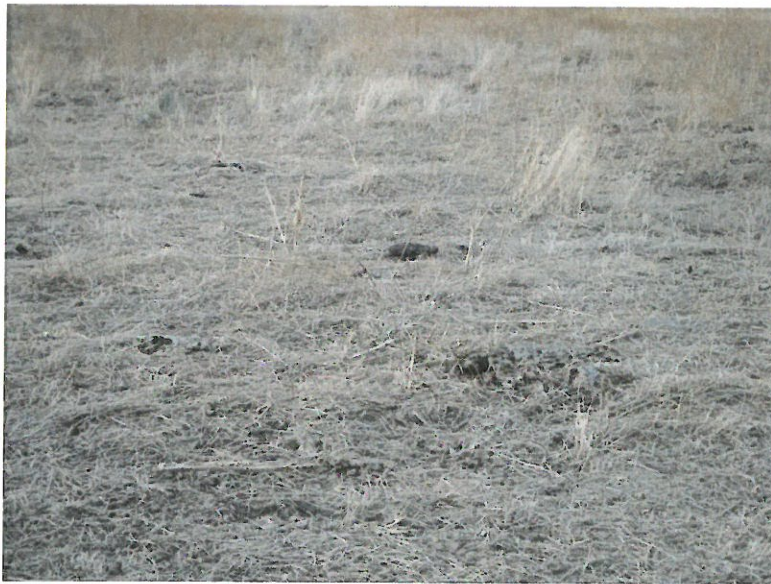
Photo 2 Plot 26 facing north

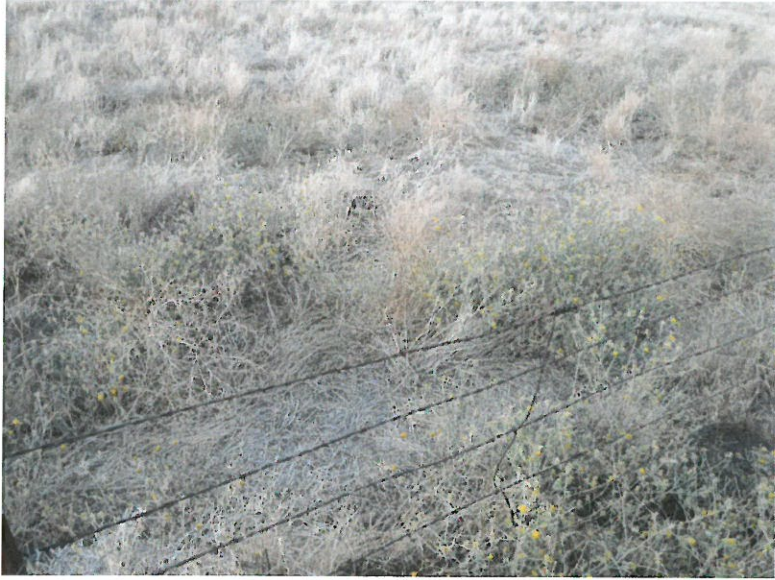
Photo 3 Plot 21a facing north

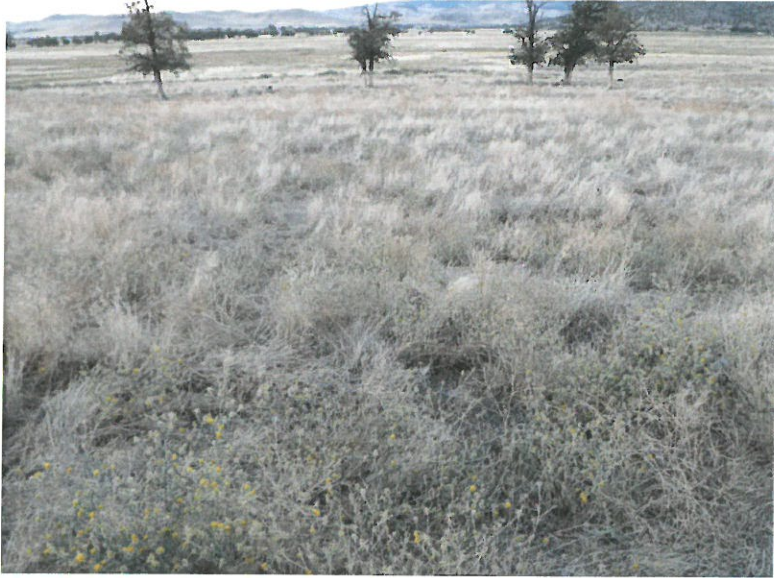
Photo 5 Plot 32 facing north

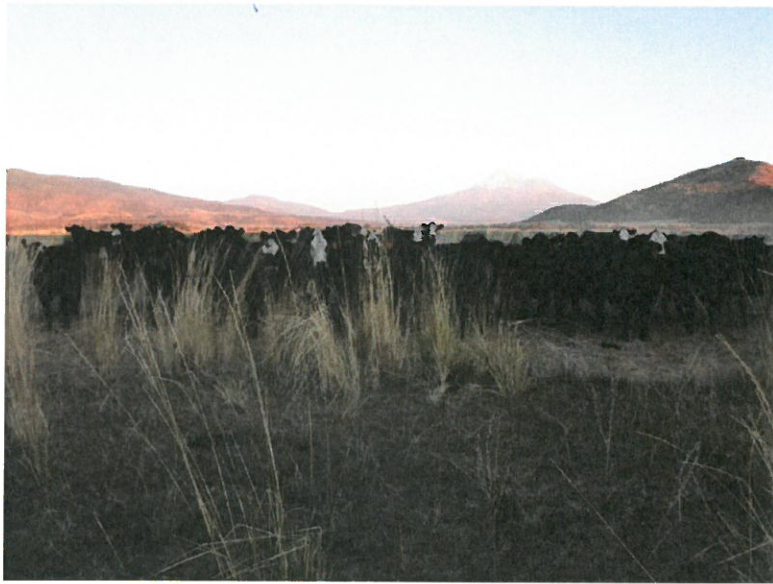
Photo 8 Plot 21c facing south

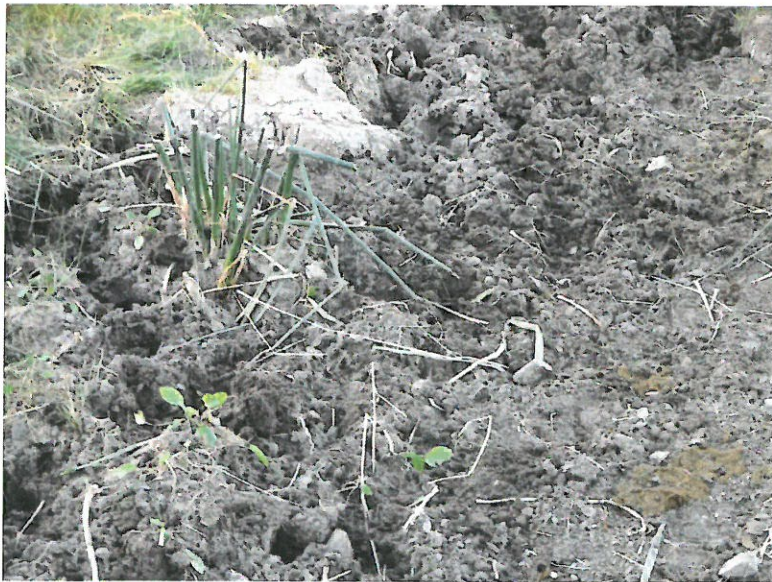
Photo 10 Plot 47b in October 2016

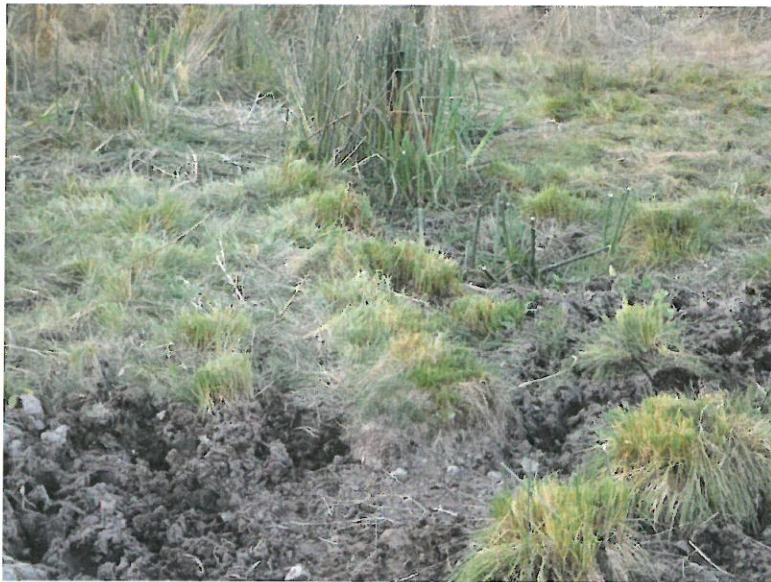
Photo 12 west of Plot 21a, facing north

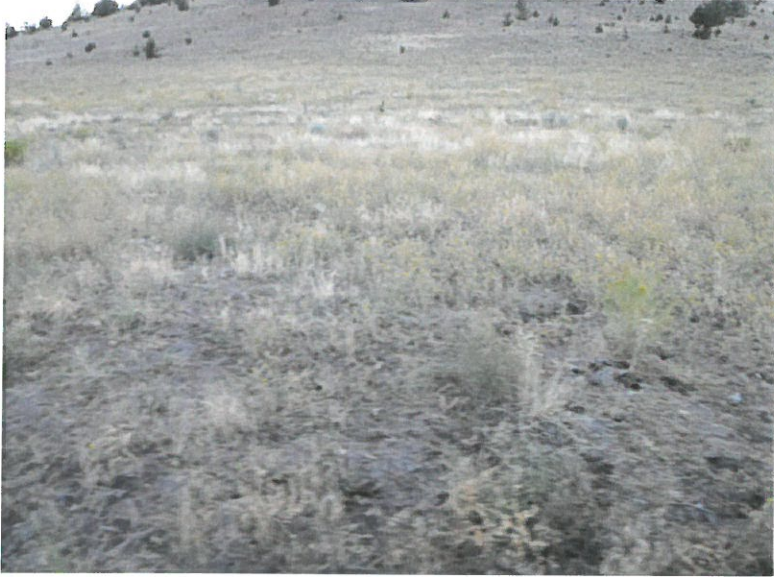
Photo 19 Plot 25 facing north

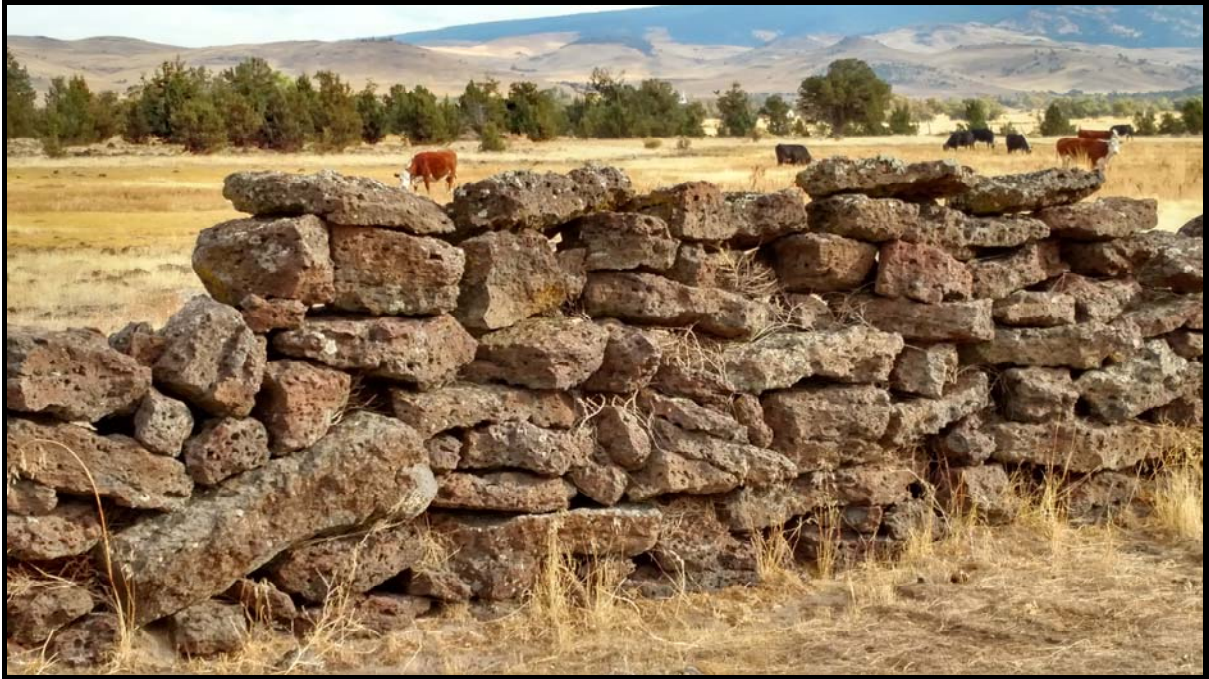
**View of rock wall fence delineating a pasture.**

The site consists of an extensive rock wall fence that is still used to define the edges of pastures located just north of Dorris Hill. No major breaches except for the gate was observed. Another segment of the wall continues outside of the current project area to the northwest. This wall, unlike many others in

the region, is not mentioned on the USGS topographic map. Constructed of large boulders/stones (three to eight courses), it currently ranges from about two to five feet in height and is one and one-half to two feet wide. No posts or wire were noted except at the gate. The wall is likely historic but has continued to be used and maintained through the modern era. Other rock walls with post and wire fencing on top were observed on the ranch, also still in use.

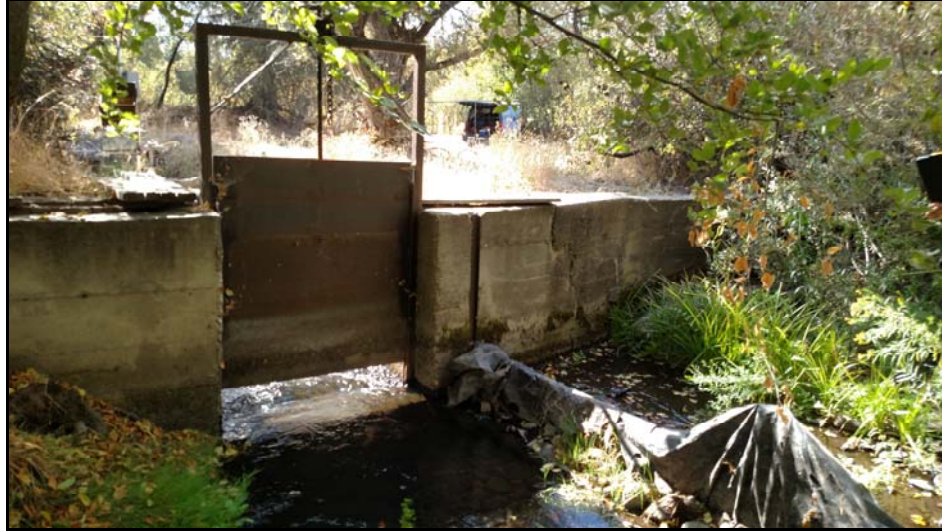
**View of headgate, retaining wall, and plastic-covered plank check dam.**

Current description also includes: There is a plank check dam with slots in concrete retaining walls on either side of the small river channel is present and allows for the raising and lowering of the water level and to divert it through a metal headgate, through the fish screen, and into the ditch. The concrete feature and retaining walls are substantial. The older concrete work utilized milled lumber forms and can be seen most easily in the concrete holding the headgate and its adjacent retaining walls. Two smaller wall segments have shifted either due to water flow or when the feature was being modified. The newer concrete work utilized plywood forms. This is especially evident along the curved concrete wall used to help divert the water into the overflow/fish return pipe. A curved segment of circular rebar set vertically in the wall may be an anchor point and/or may indicate that the particular segment was actually pre-cast in a different location and mechanically lowered into its current position. Also present is a parallel steel bar fish screen, an undershot water wheel used to mechanically clean the fish screen and allow the flow of water through the system into the ditch, and additional concrete to anchor them and to direct water flow. No historic artifacts were found in conjunction with the diversion feature.

The site consists of a mostly concrete diversion structure located on the Little Shasta River about 1.3 air-miles northeast of the small community of Little Shasta, in Siskiyou County. The structure diverts water into a ditch (the Montague Water Company Ditch aka the Haight/Hart Ditch) which flows southeast past the Little Shasta Cemetery and south into Little Shasta Valley. The structure appears to be mostly historic in nature but has been maintained and modified in the modern era. The only historic documentation found relating to the structure and ditch is a letter dated October 5, 1938 from the State of California Department of Natural Resources, Division of Fish and Game to Mr. George M. Haight and Ray Hart. The letter states that a survey had been completed and a fish screen located on the ditch was found to be nonfunctional and needed to be replaced. The description of a proposed replacement matches that which currently exists at the site. The ditch, diversion, and fish screen were obviously all present prior to the 1938 letter. Exactly when the current configuration was constructed is unknown. Concrete construction methods suggest the use of both plank forms (older) and plywood forms (newer). Circular and square rebar and hexagonal nuts versus square nuts also suggest different time periods. There is also a modern solar panel, junction box, and flow meter (gauging station). The feature appears to have been in relatively continuous use with maintenance and modifications occurring as needed since its original construction. Site integrity has been seriously compromised.

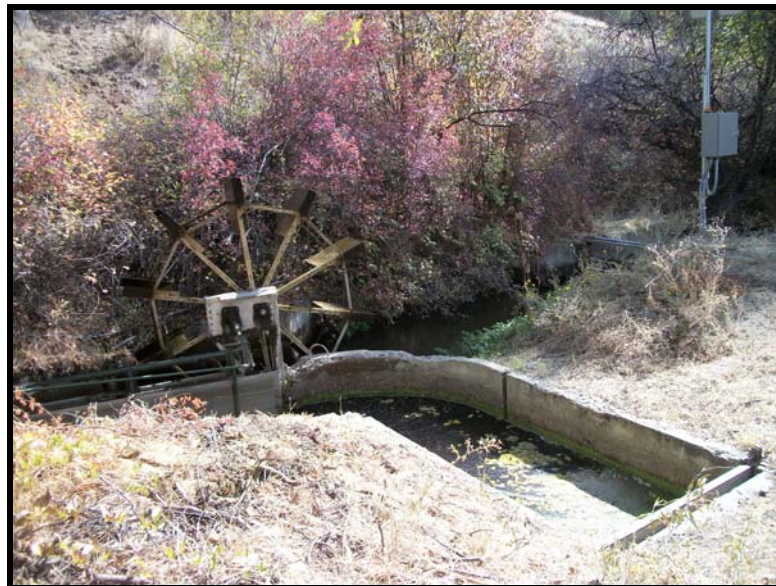
**View of undershot water wheel with attached fish screen cleaning mechanism, overflow area leading to fish return pipe, and the modern gauging station.**

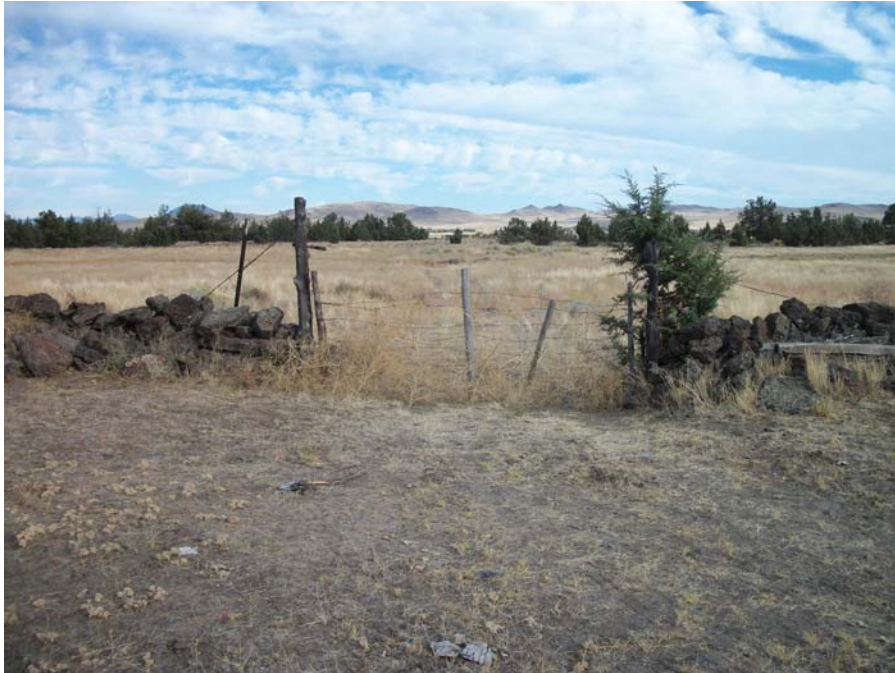
Site HR01. Roll Hart-01, Frame 01. View of post and wire gate in the rock wall fence. View is to the north.  
549792 mE x 4616364. 9/30/2016

Site HR01: The project calls for the installation of a pipe through this rock wall fence. Since the proposed route is through the existing wire gate and will not disturb the linear rock feature, there will be no affect to the site. This practice is recommended.

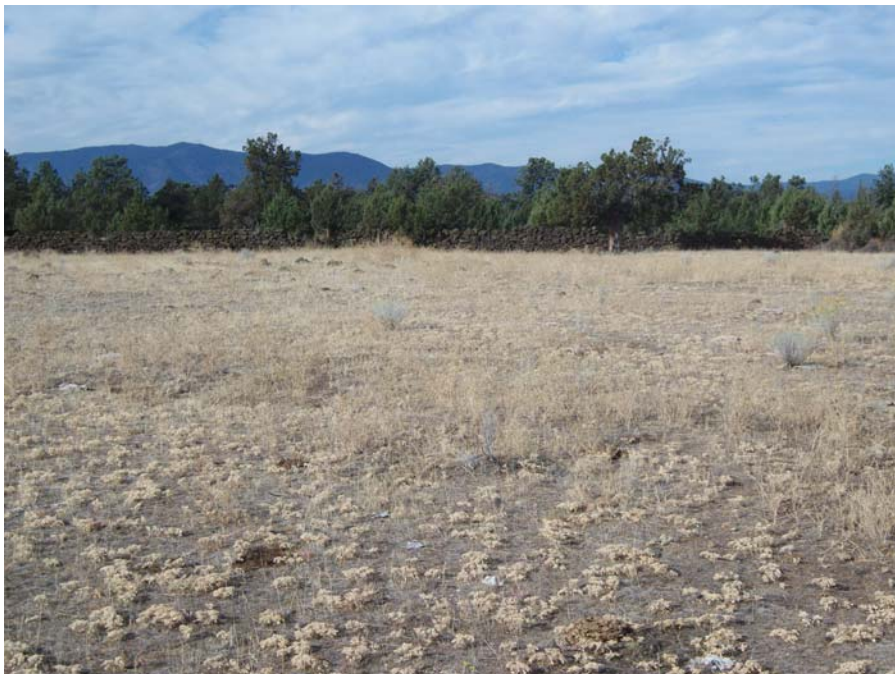
Site HR01. Roll Hart-01, Frame 02. Rock wall in distance west of gate after it turns south.  
View is at 256 degrees. 549792 mE x 4616364 mN. 9/30/2016

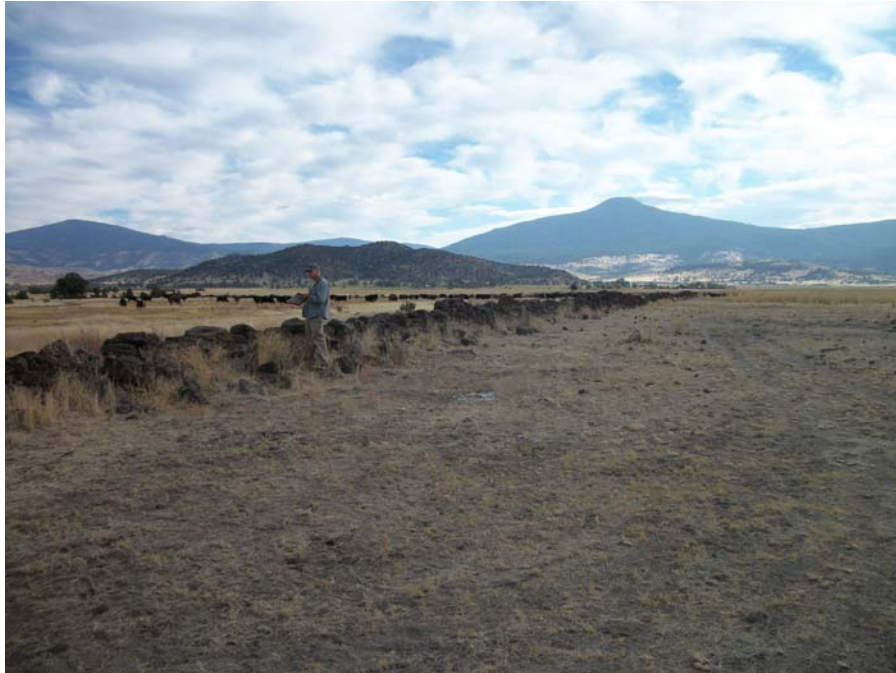
Site HR01. Roll Hart-01, Frame 03. Rock wall as it goes east from the gate. Note how has it has deteriorated (fallen rocks) and the cows in the pasture beyond. View is at 98 degrees. 549792 mE x 4616364 mN. 9/30/2016

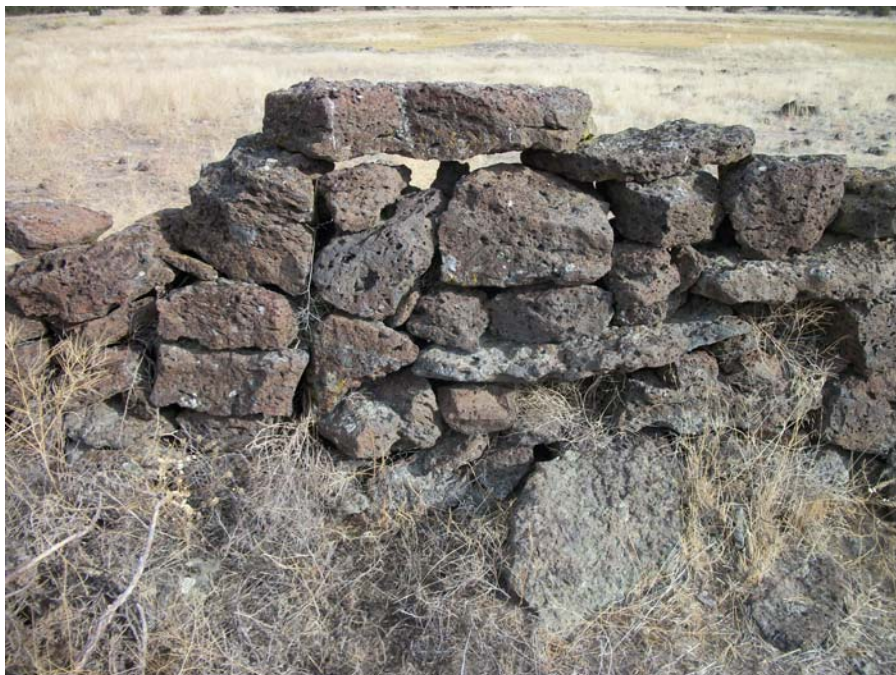
Site HR01. Roll Hart-01, Frame 04. Closeup of rock wall. Shows construction. View 350 degrees. 549818 mE x 4616377 mN. 9/30/2016

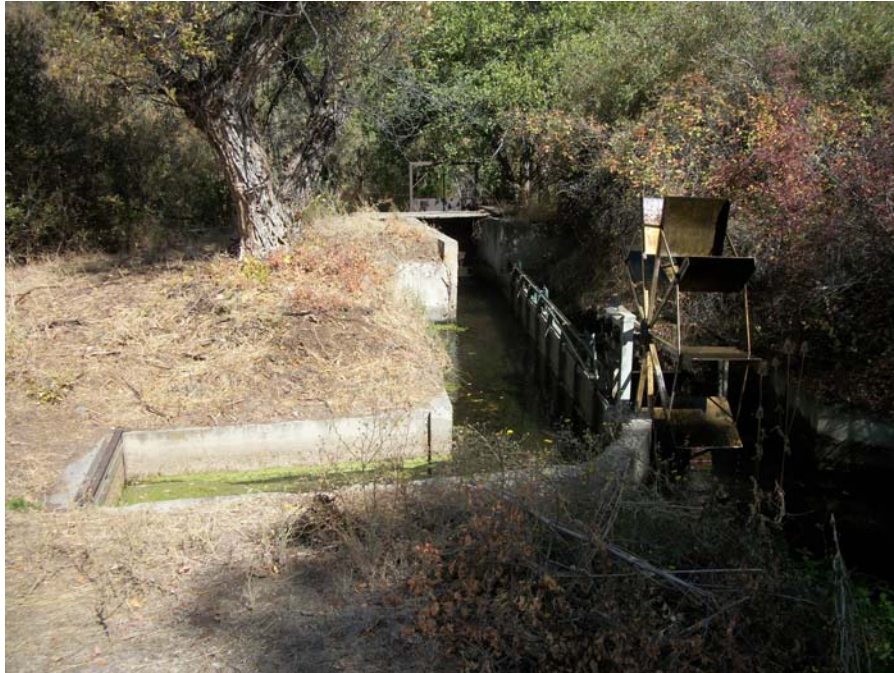
Site HR02. Roll Hart-01, Frame 06. Overview. Shows diversion structure with concrete retaining walls, undershot water wheel (allows for mechanical cleaning of fish screen), fish screen, and headgate. View 64 degrees.

552448 mE x 4619169 mN. 9/30/2016

The site is recommended as not eligible to the NRHP due to poor integrity. While the structure fulfills a historic function and has historic concrete elements, it has been heavily modified in the modern era with both modern concrete and modern mechanical components. The modern gauging station is also an intrusive element; even though it is an equivalent of a historic function. Too much of the structure has changed (with modern equivalents, but has changed none-the-less). As such, the structure has greatly diminished values of workmanship, design, feeling, and materials. Additionally, the structure would be a non-contributing component of any larger, associated irrigation system that may be eligible.

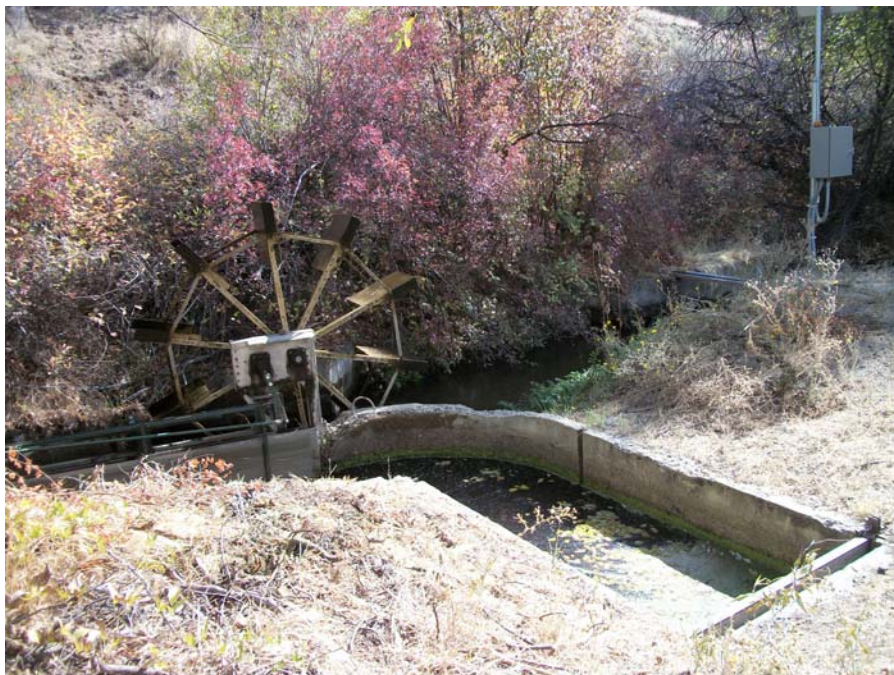
Site HR02. Roll Hart-01, Frame 07. Overview of south end of diversion structure. Diversion ditch is to right of water wheel. Flow meter and solar panel is at far right. View 160 degrees.

552448 mE x 4619175 mN. 9/30/2016

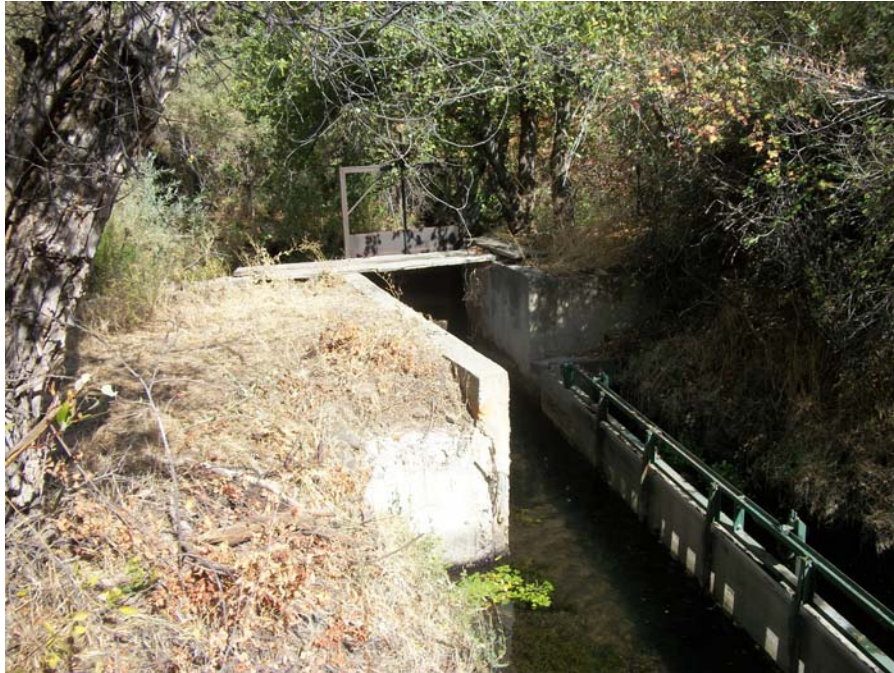
Site HR02. Roll Hart-01, Frame 08. View of diversion structure with fish screen on right and headgate in background, middle. View 170 degrees. 9/30/2016.

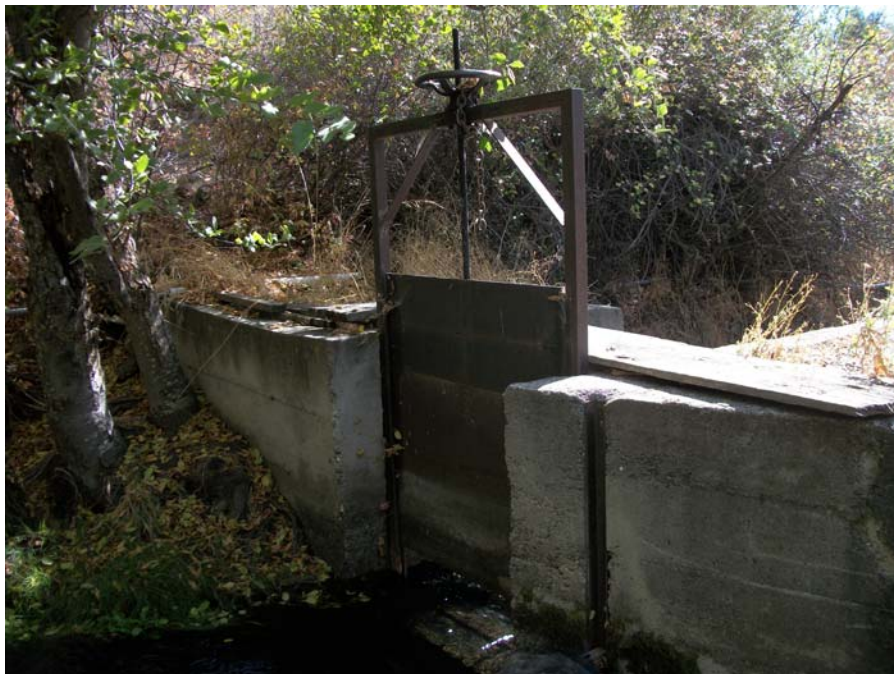
Site HR02. Roll Hart-01, Frame 09. North end of diversion structure showing concrete work, headgate, and wheel. Milled lumber forms were used when this part of the structure was built. View 164 degrees. 9/30/2016.

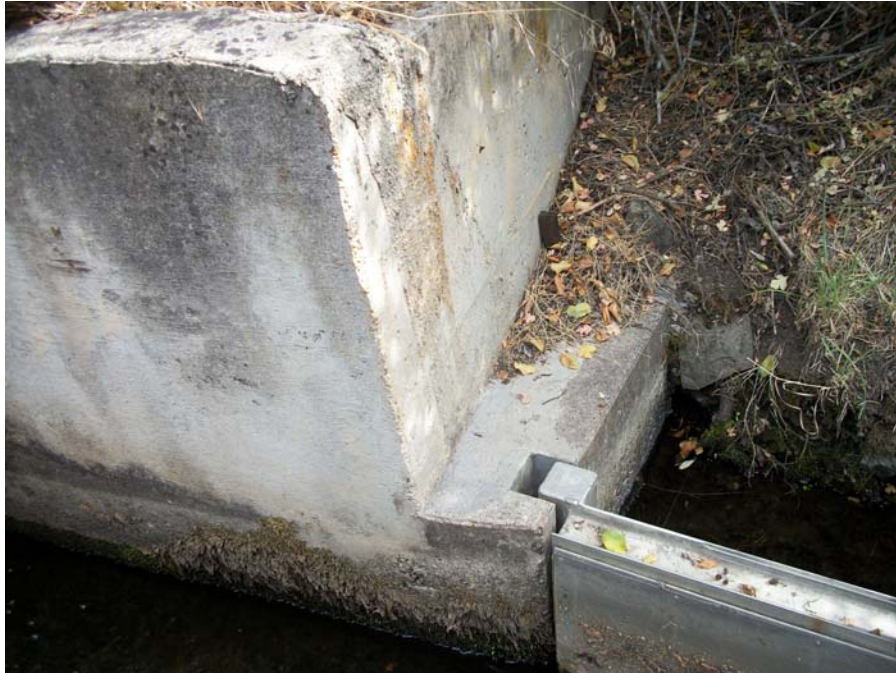
Site HR02. Roll Hart-01, Frame 13. Closeup showing concrete work and where the fish screen is anchored to it.  
View 104 degrees. 9/30/2016.

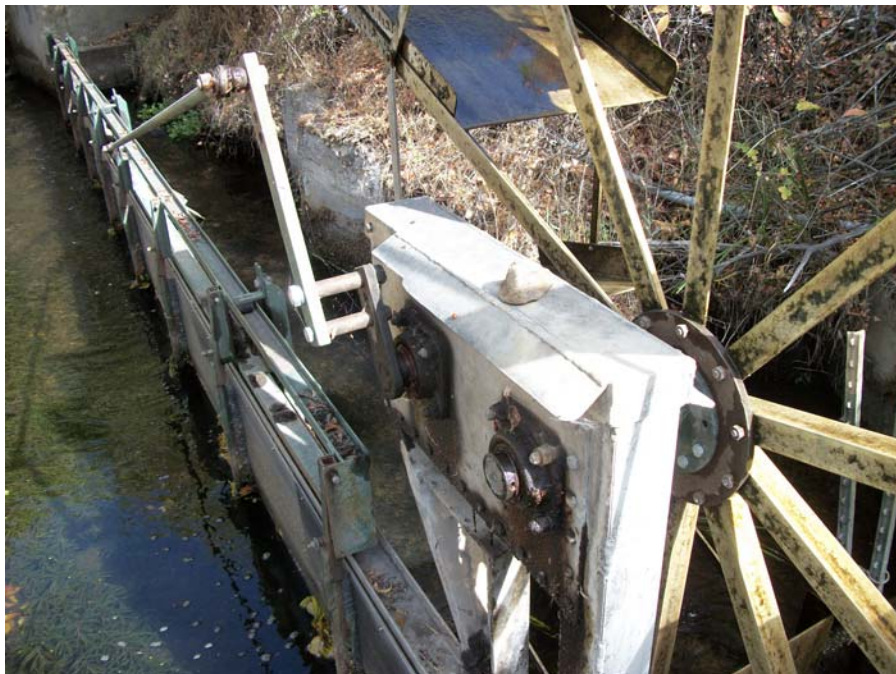
Site HR02. Roll Hart-01, Frame 14. Water wheel mechanism where it connects to fish screen.  
View 80 degrees. 9/30/2016.

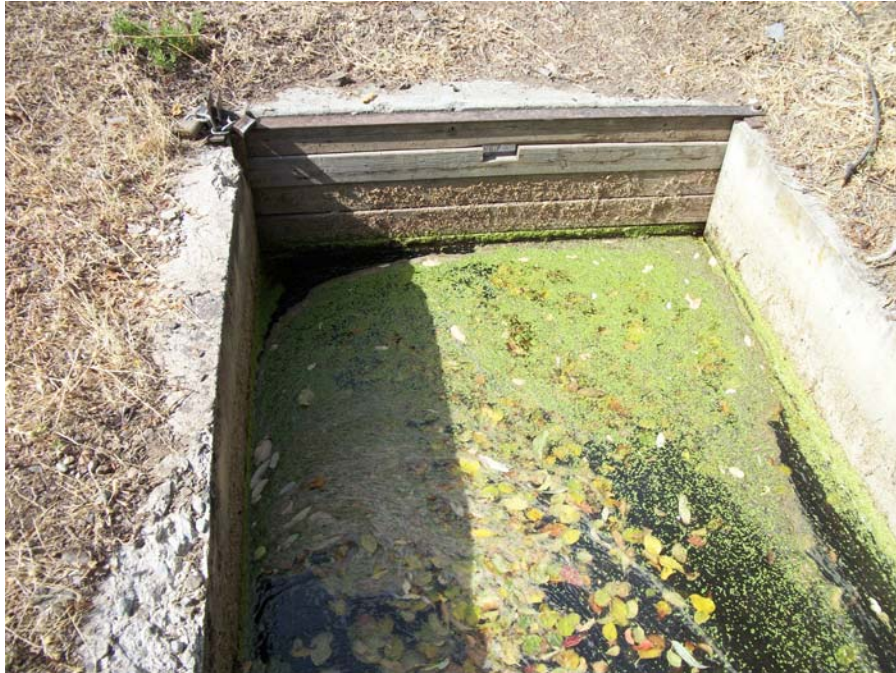
Site HR02. Roll Hart-01, Frame 15. View of overflow channel. Flows into a pipe just below the water surface. This pipe was likely the fish return pipe.  
View 318 degrees. 9/30/2016.

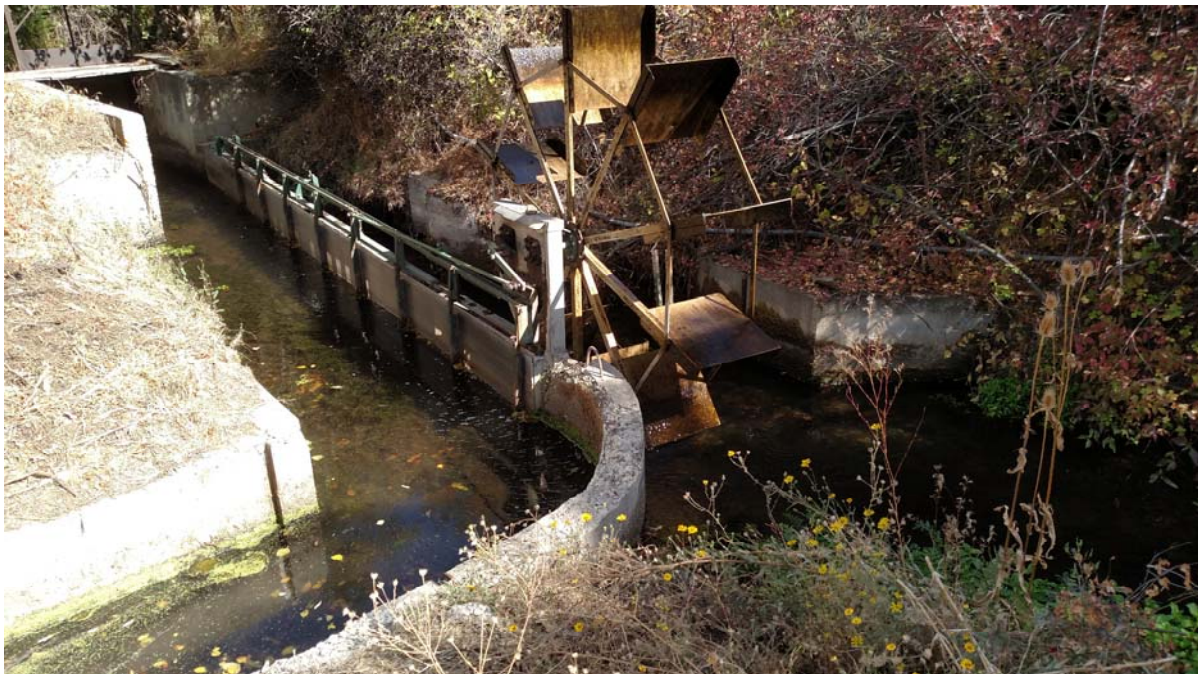
Site HR02. Roll Hart-01, Frame 16. Overview. 9/30/2016.

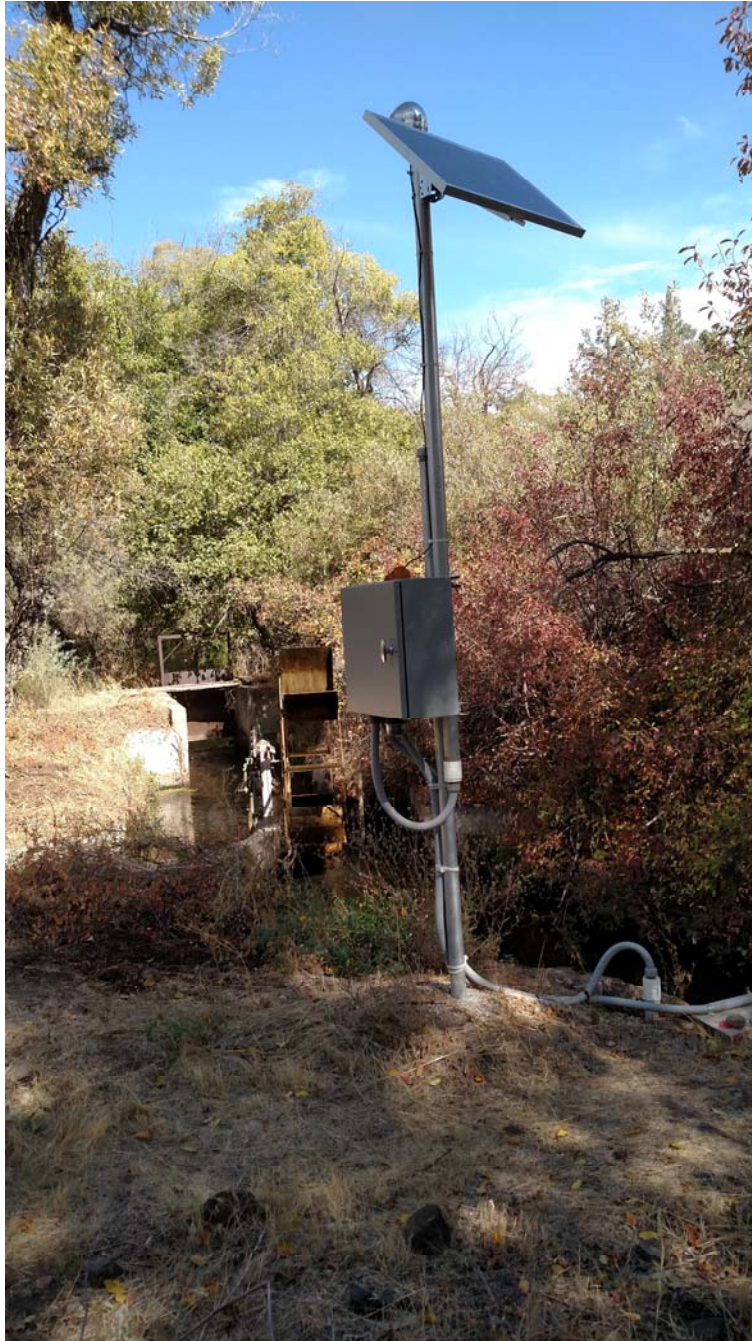
Site HR02. Roll Hart-01, Frame 17. View of flow solar panel with junction box.  
Connects to flow meter at surface on right.  
Site datum.  
9/30/2016

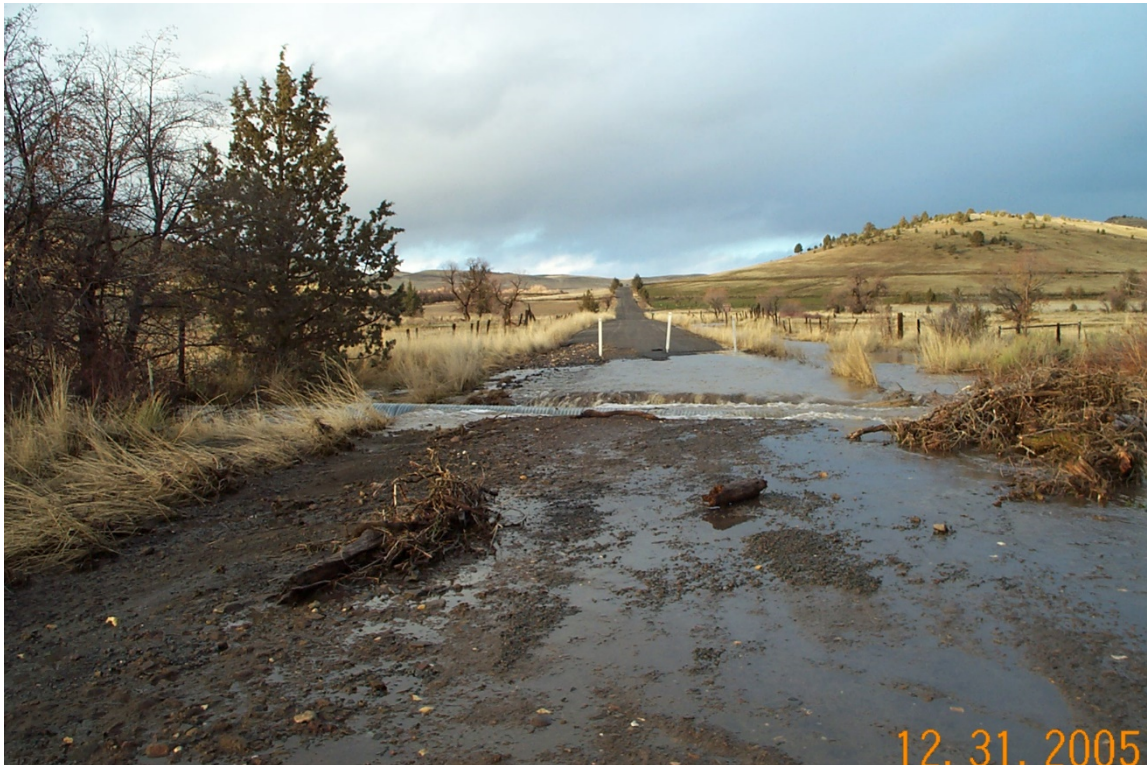
**Photograph 1. 2005 Post Flood Photograph Harry Cash Road (700 ft North of Bridge)**

The December 2005 flood, although not as large as the 1955 and 1964 floods, overtopped Harry Cash Road and scoured around the Musgrave Ditch culvert crossing at Harry Cash Road. Photograph 1 shows the culvert crossing as viewed from the south. Photograph 2 shows Harry Cash Road from a vantage point about 700 north of the bridge. Photograph 3 shows debris and sediment deposited along Harry Cash Road. This photograph was taken about 200 feet south of the bridge and was taken looking north. County Public Works Department provided these photographs for inclusion in this report.

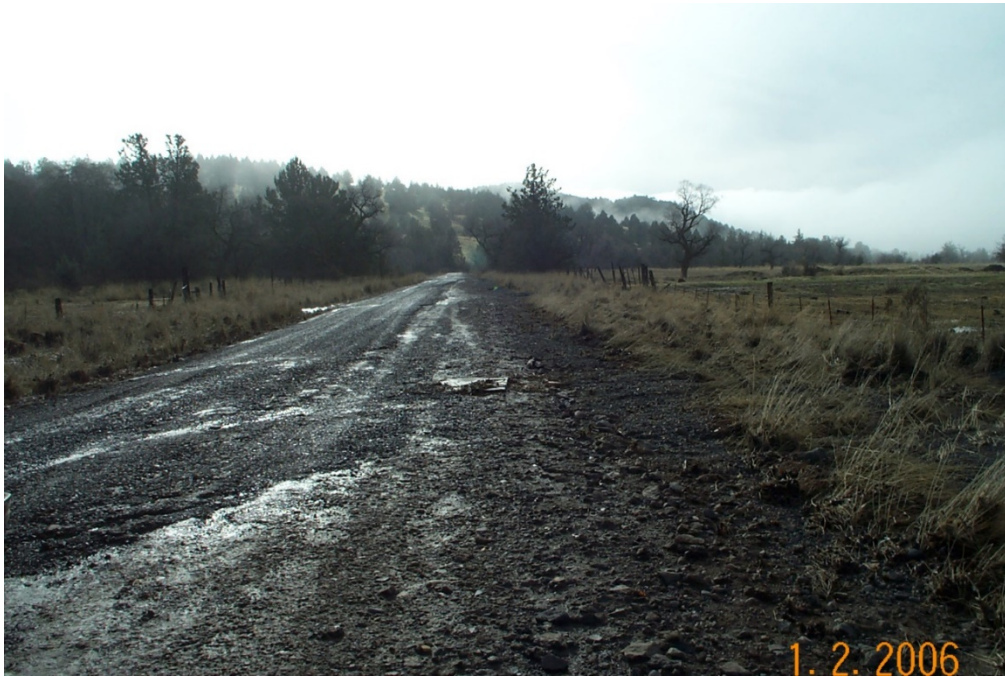
**Photograph 2. 2005 Post Flood Harry Cash Road (700 ft North of Bridge)**

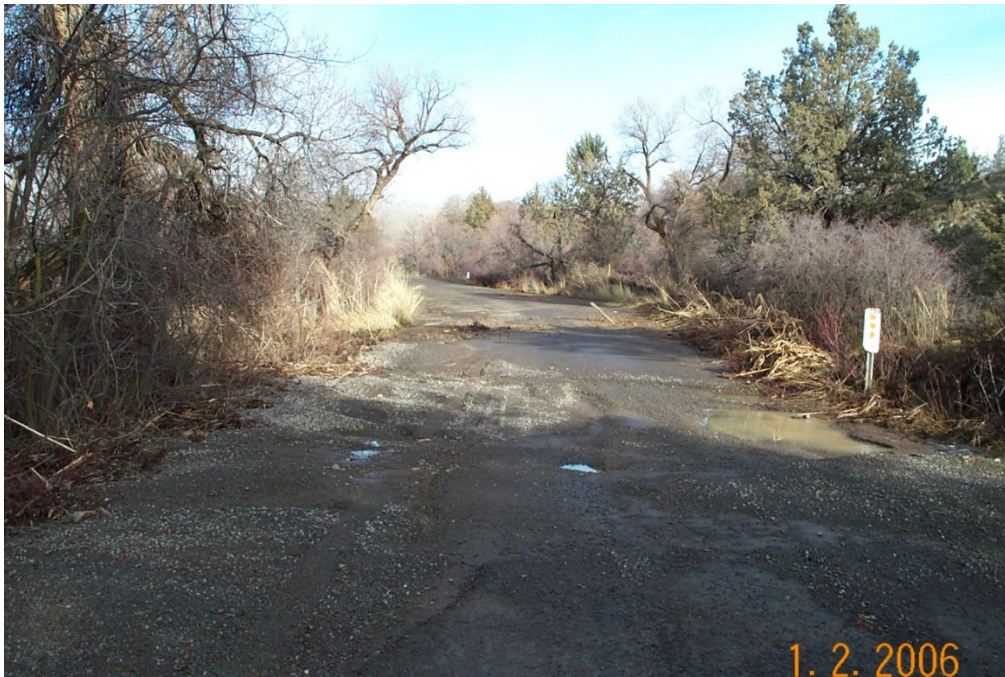
**Photograph 3. Post Flood 2005 Flood Harry Cash Road (200 feet south of the Bridge)**
