Point Pinole Fishing Pier Improvements: Final Programmatic Report (AMENDED)

Recipient Organization/Agency: East Bay Regional Park District

Date Submitted: April 29, 2016 (revised May 31, 2016)

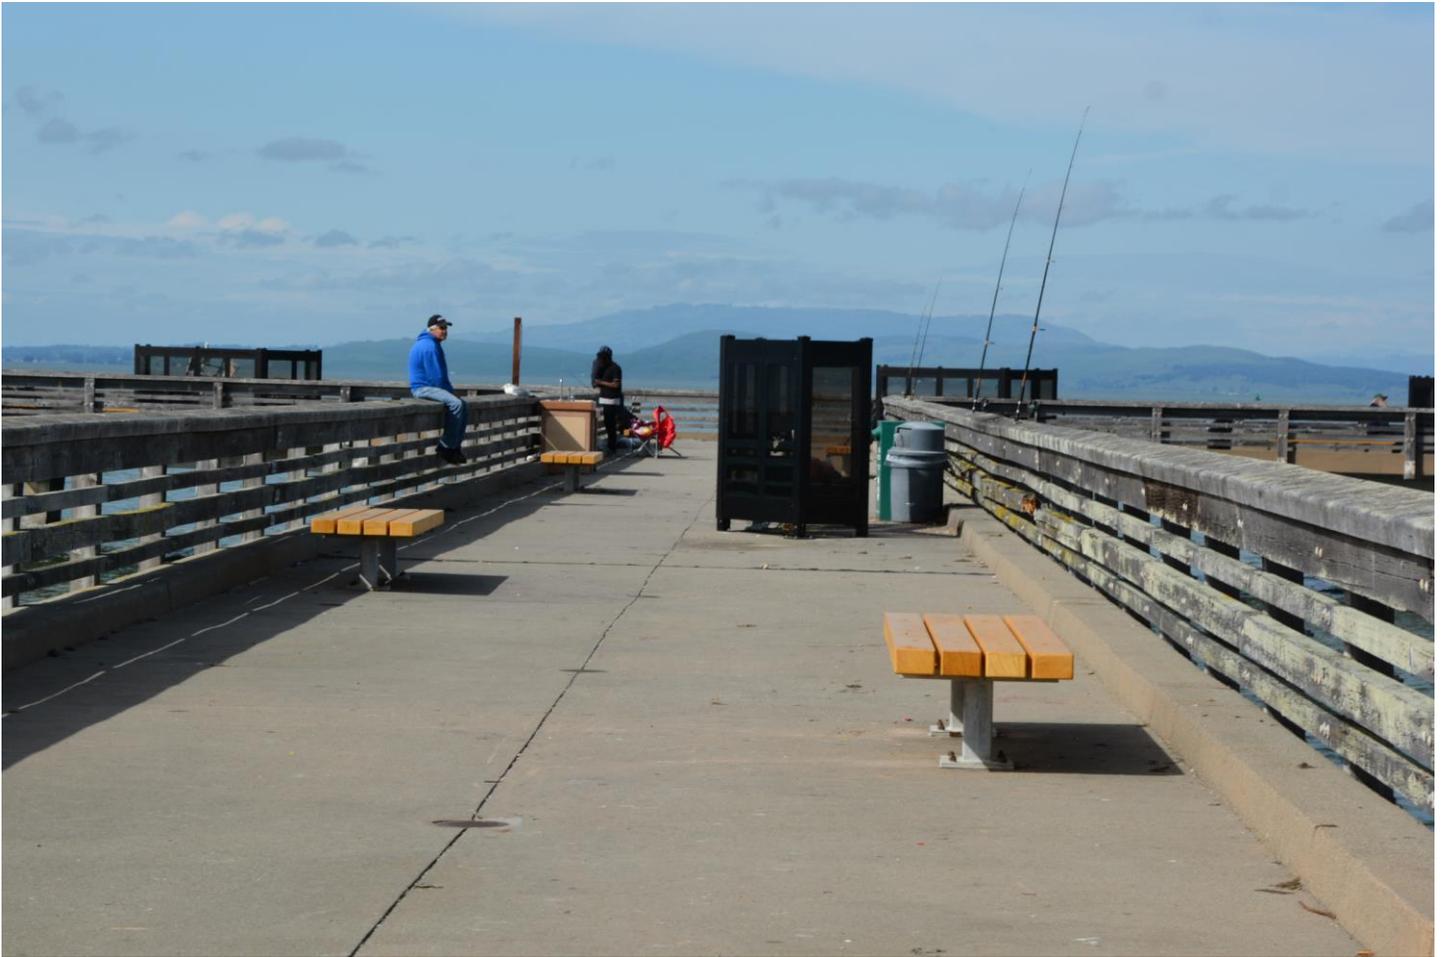
Photograph 1: New windcreens, benches and beautiful views (Photo by Mona Koh)

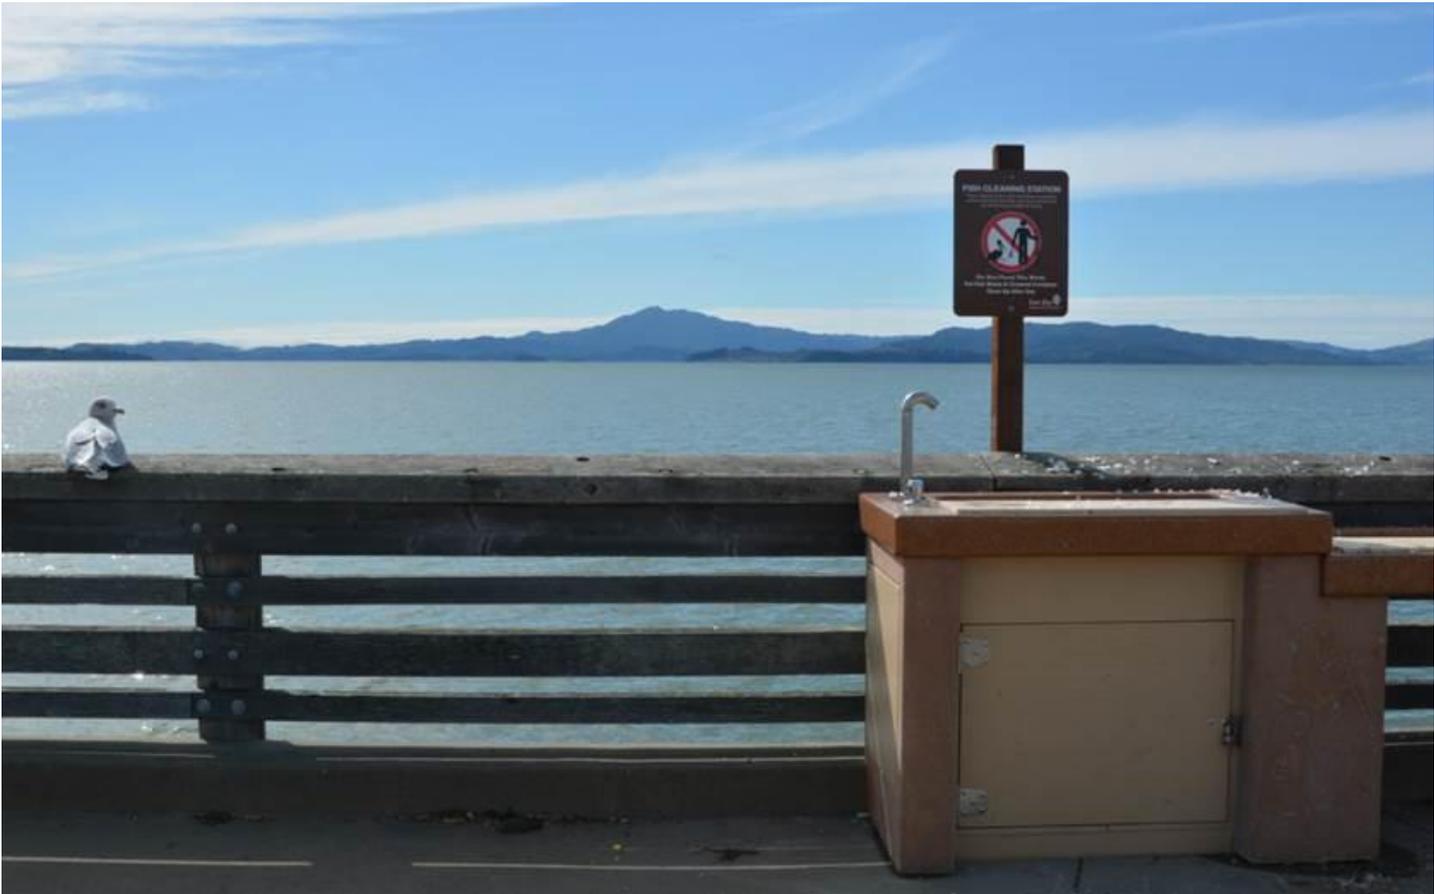
Photograph 2: Fish Cleaning Station with Pelican Sign (Photo by Zeneida Trinidad)

The majority of work was completed by a construction contractor, Pleasanton Engineering Contractors. EBRPD's Maintenance and Skilled Trades Staff (MAST) fabricated, delivered and installed the Fish Cleaning Station and hooked up the water and drain pipe to the stub ups installed by Contractor. In-house design services were used. All planned activities were completed and are summarized below:

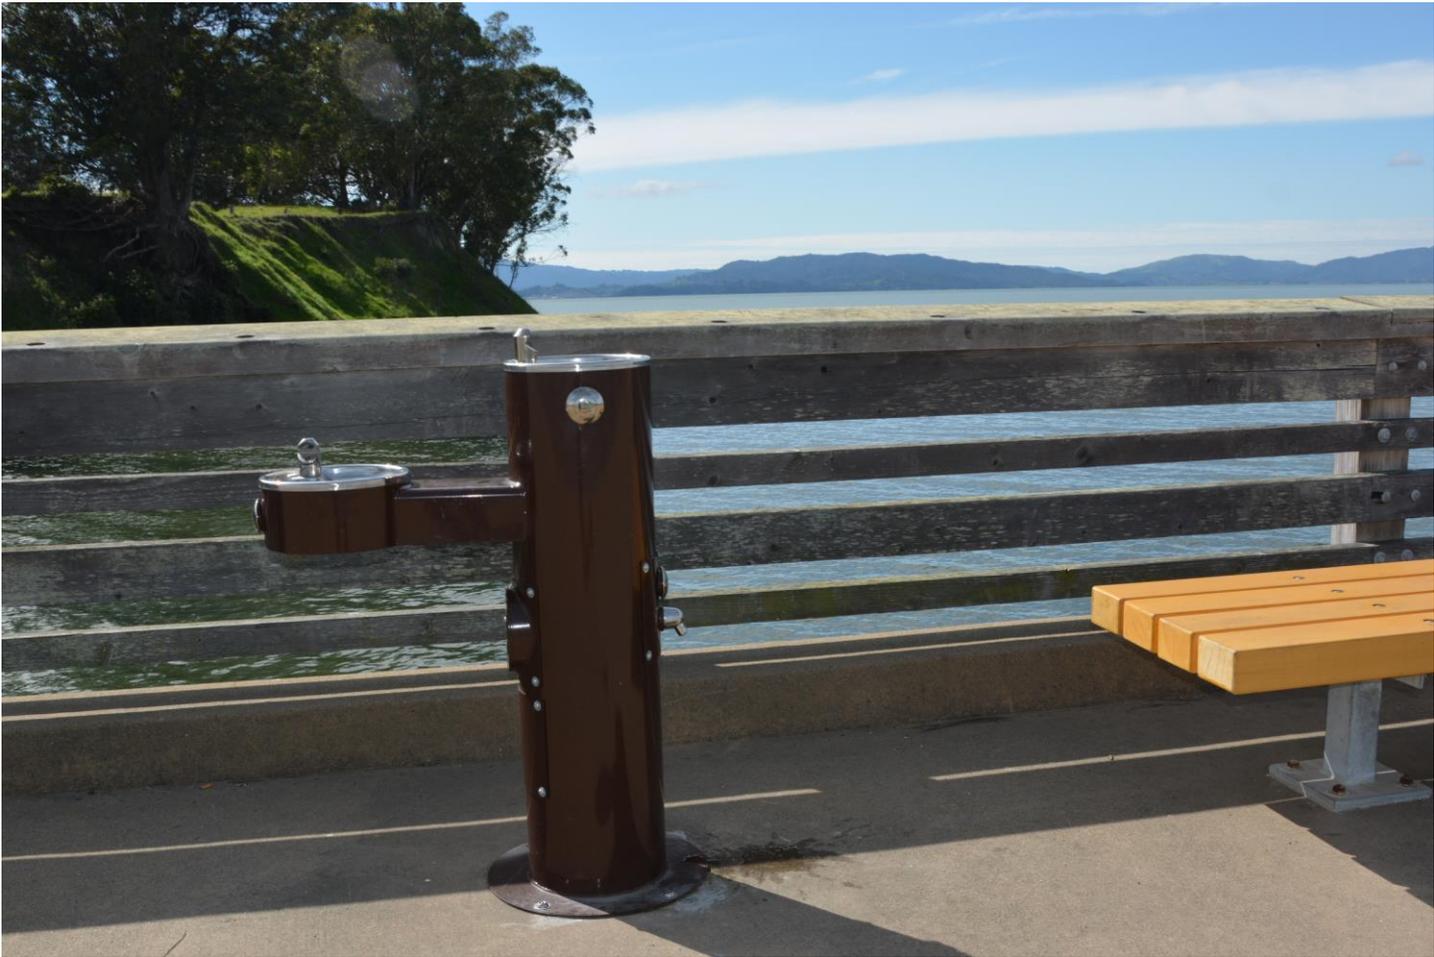
Photograph 3: New ADA drinking fountain and bench with weather resistant wood.

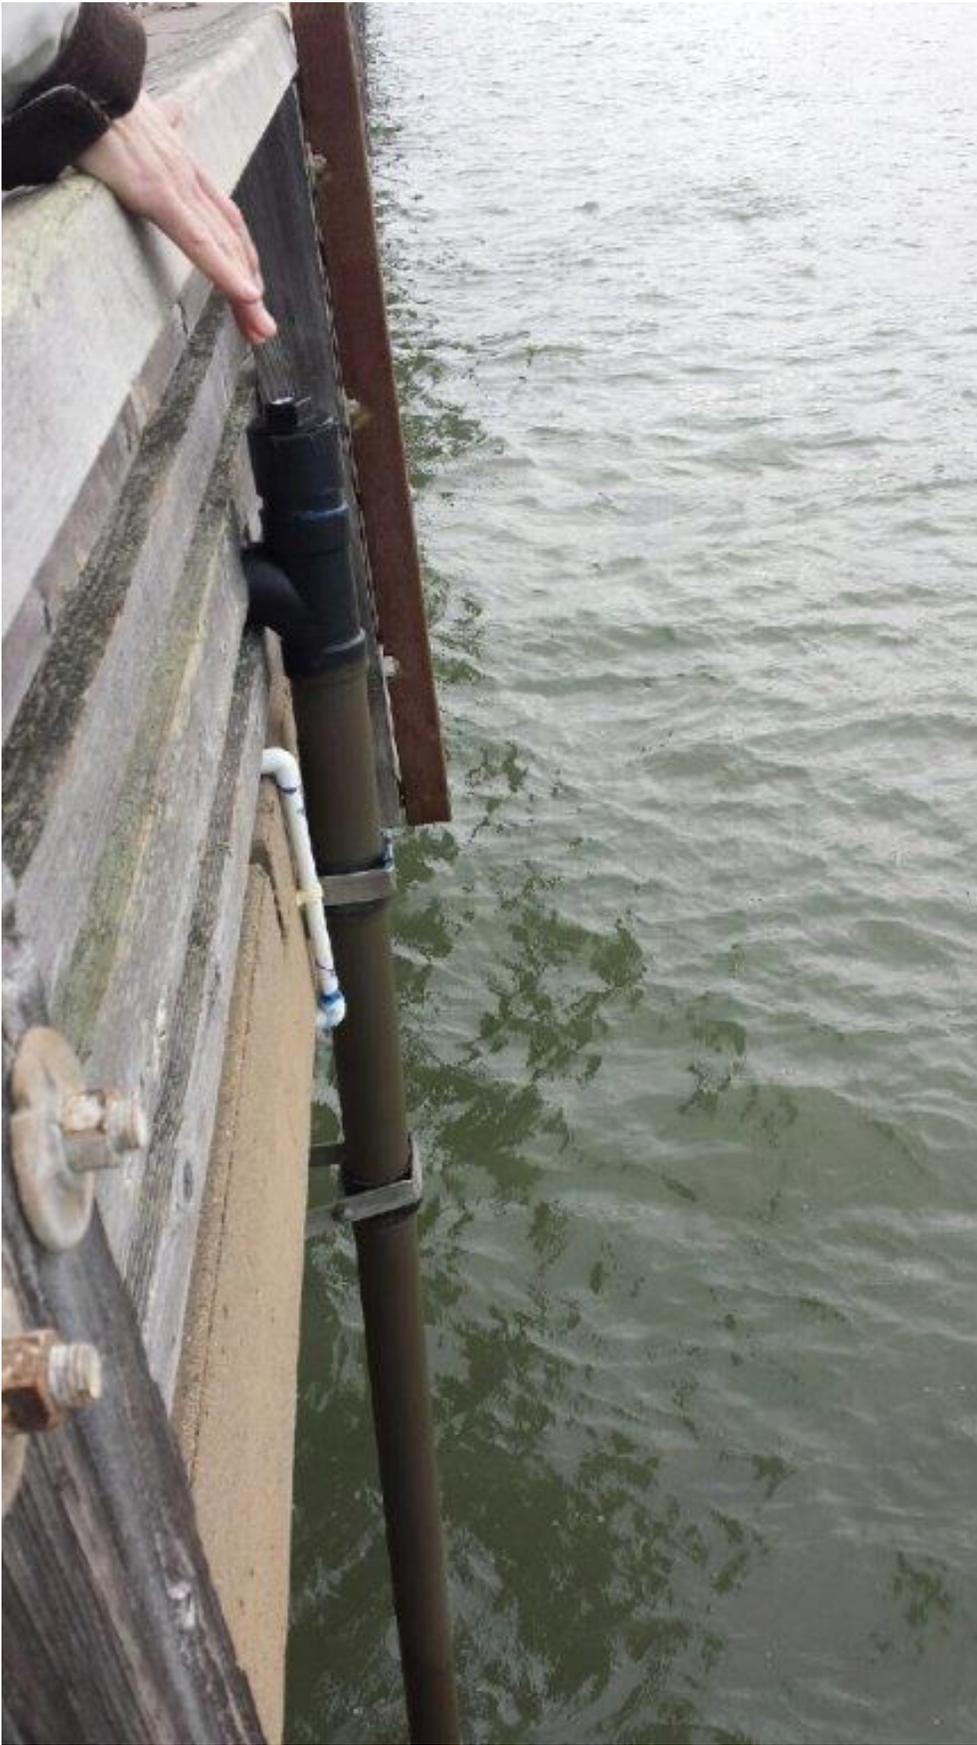
Photograph 4: Plumbing to fish cleaning station underneath pier (Photo by Mona Koh).

It was a challenge to install the drainage pipe and water supply lines under the pier and into the water. The contractor had to have a boat and workers were tied to the boat while working. All this work depended upon the weather and tide condition. A grant extension was requested and approved to accommodate for this challenge. A lesson learned would be to have asked for a time extension earlier.

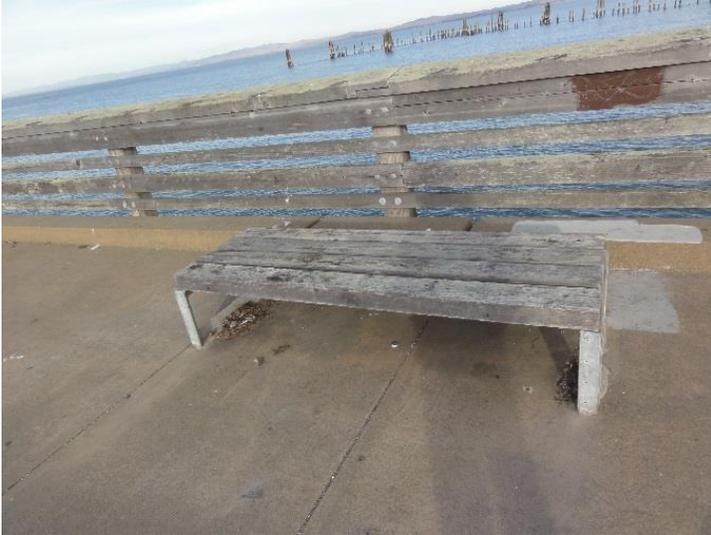
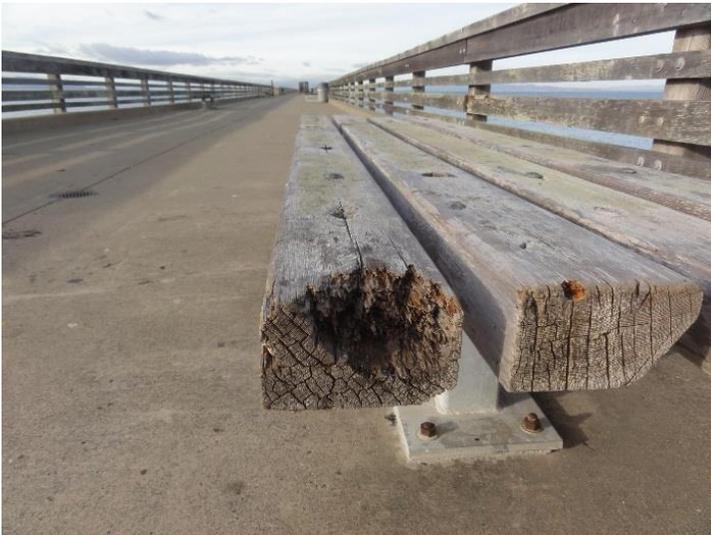
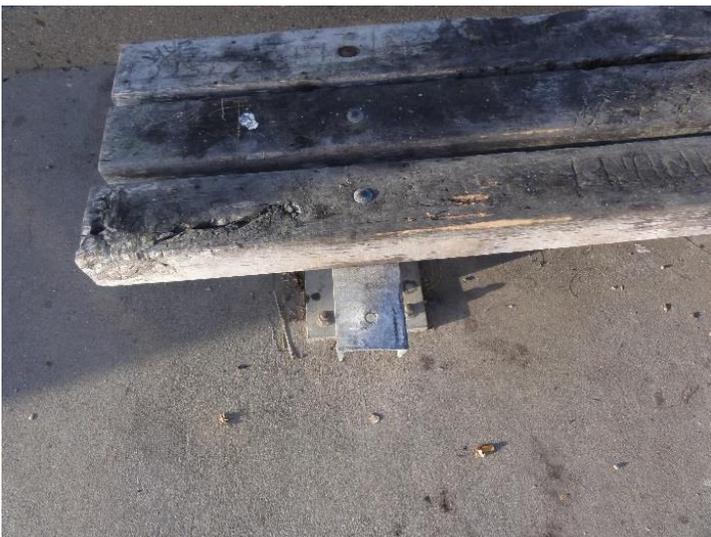
Photographs 5 to 7: Wood benches before the project, showing non-conforming steel supports (Photo 5, top), wood deterioration (Photo 6, middle), and damage from vandalism (Photo 7, bottom)

The project as a whole was under-budget. We got a very low bid of \$99,000 for the Pier furniture replacement. The Engineers estimate of \$143,000, was in the middle of the lowest bid and the highest bid. A small amount was paid for additional contingency work. Another thing that lessened the cost is that the steel bench supports were still in excellent shape so they were reused instead of replaced. Only two non-conforming bench supports were replaced.

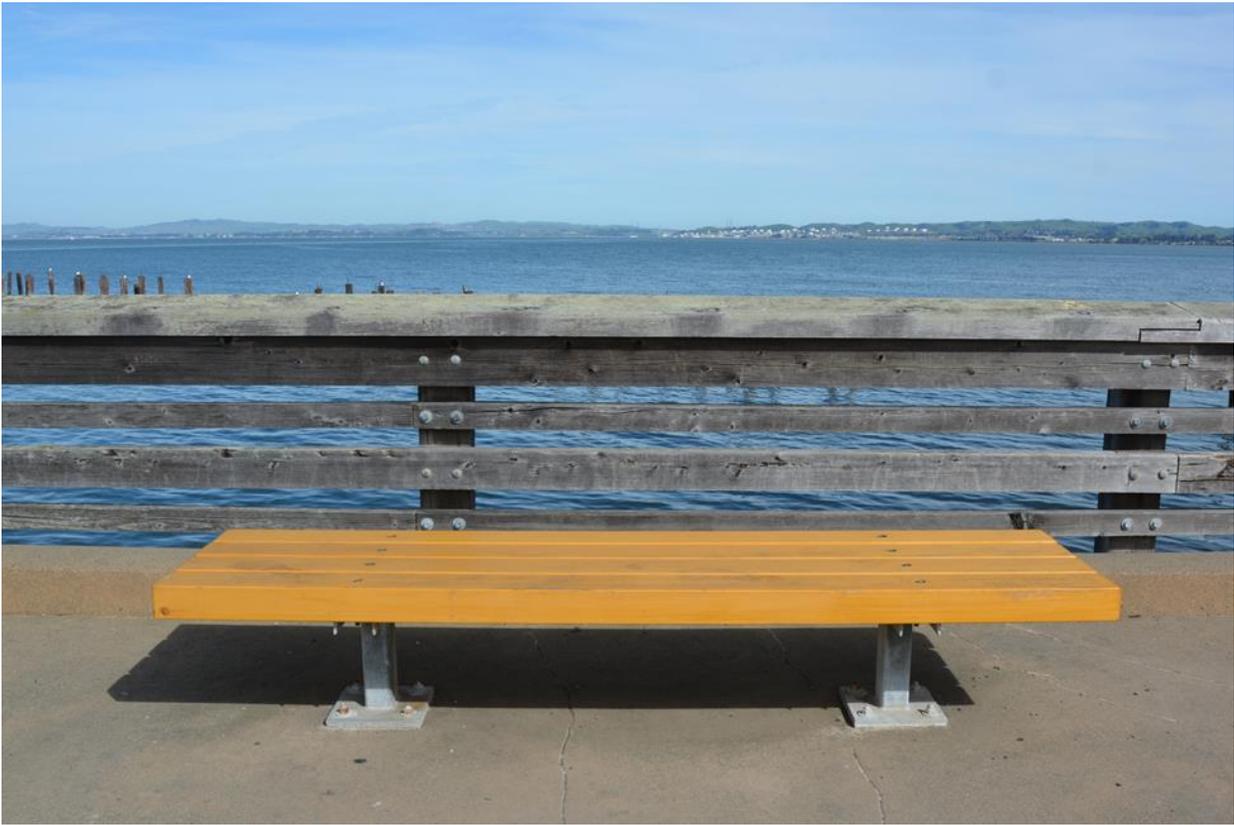
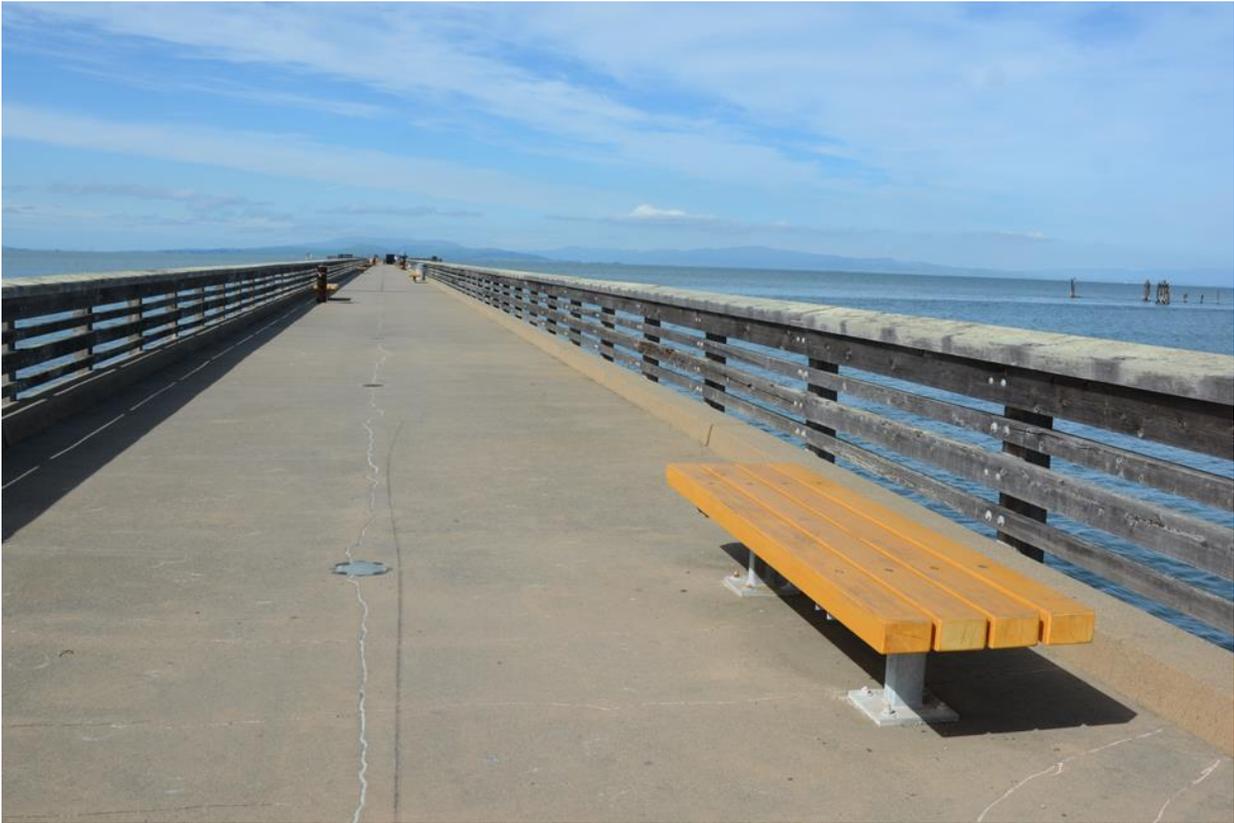
Photographs 8 and 9: Front view (Photo 8, top) and side view (Photo 9, bottom) of new Alaskan Yellow Cedar wood replacement benches after the project.

Procurement of the specified 19% low moisture content for the Seasoned Alaskan Yellow Cedar for the wood bench slats proved to be a challenge. Availability was sparse for the type of wood specified. There was no choice alternate for the appropriate wood that would withstand the harsh sea conditions, so the specification had to be revised to allow for a higher moisture content.

The improved fishing facilities are now open to the public and being used daily by park visitors. The Alaskan Yellow Cedar bench planks that replaced the weathered bench planks are very resistant to the harsh marine environment. It also added to the renewed aesthetic appearance of the pier because of its color and fine finish.

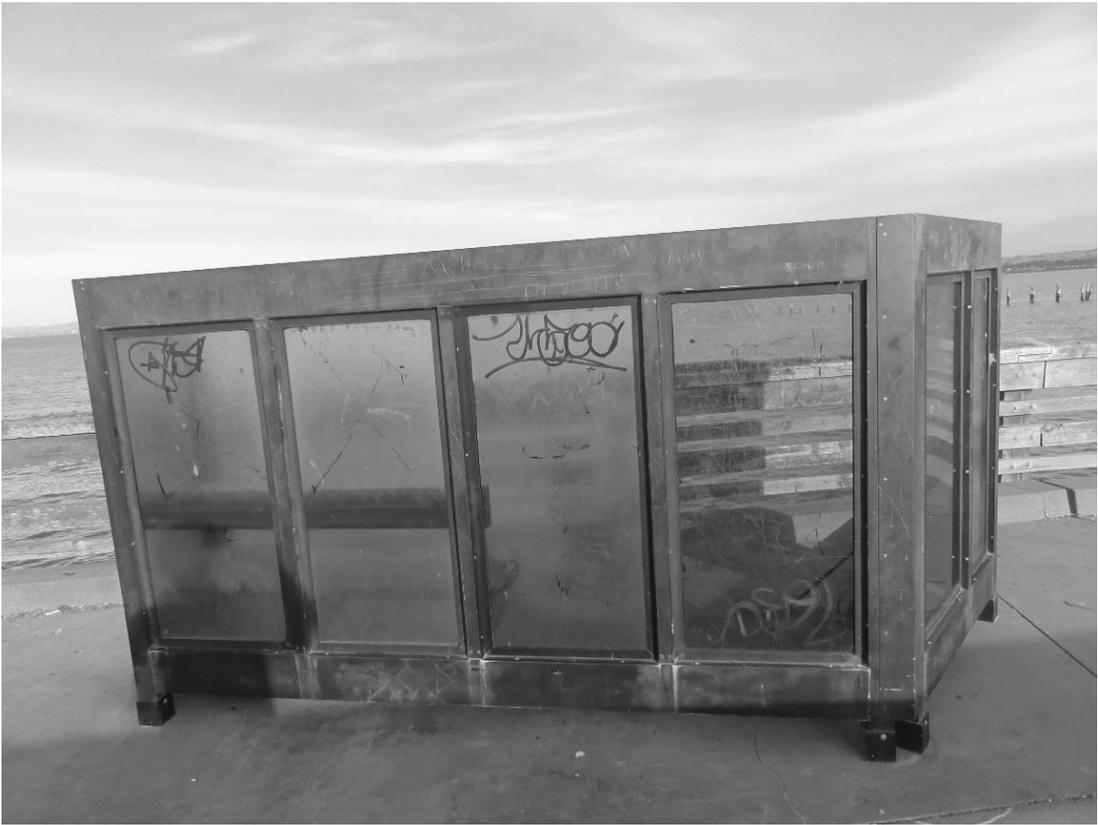
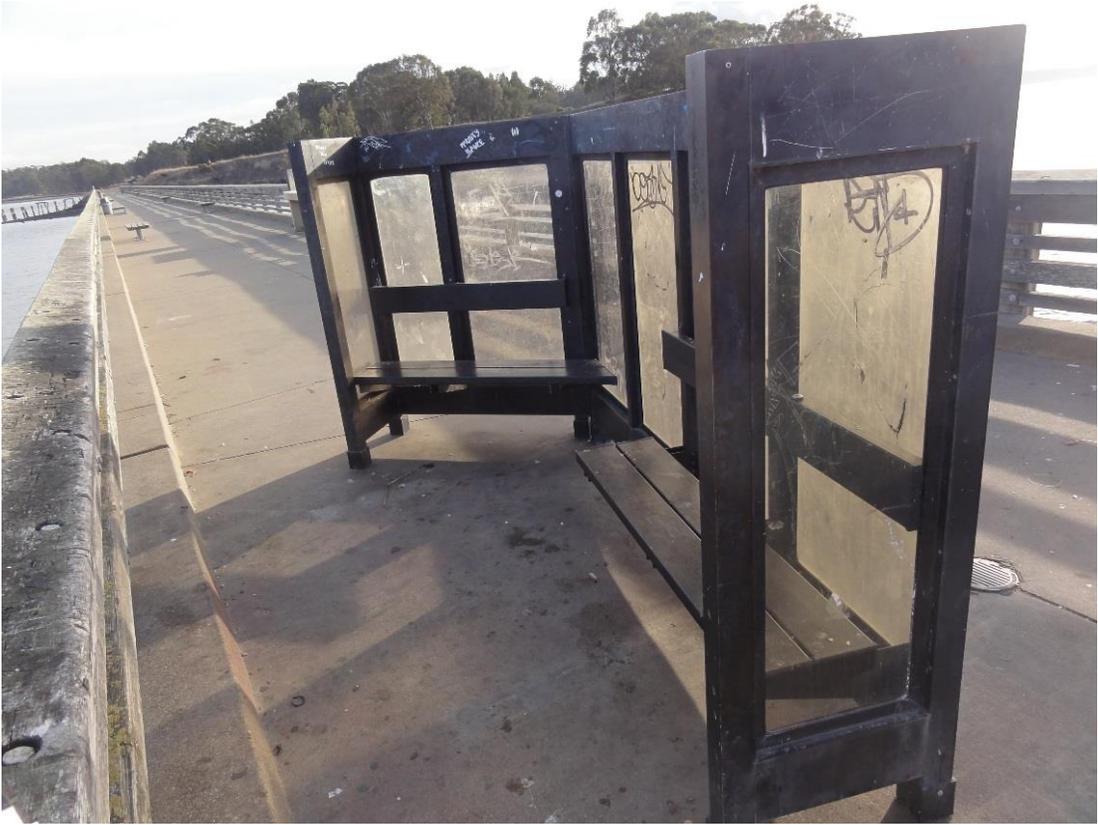
Photographs 10 and 11: Windscreens before the project had been vandalized and were not ADA compliant. Views of windscreens from behind (Photo 10, top) and the front (Photo 11, bottom).

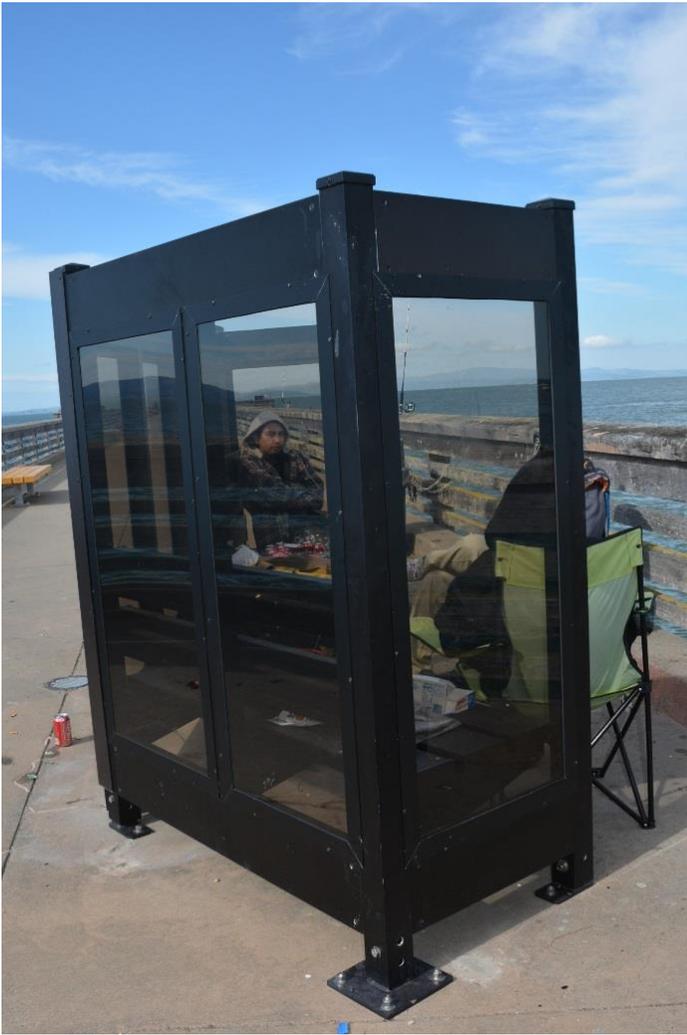
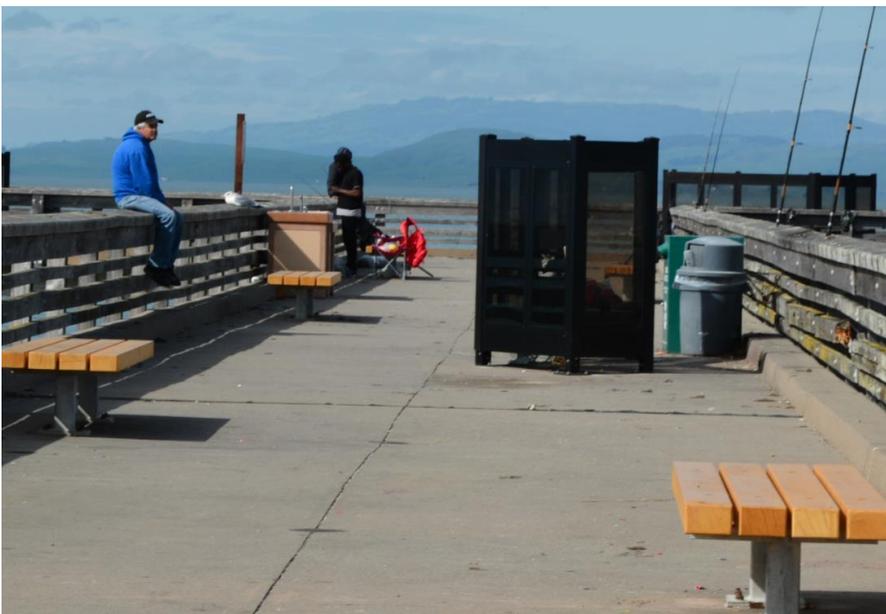
Photographs 12 and 13: New windscreens after the project with improved accessibility.

The District furnished windscreens were purchased from the original manufacturers of the old windscreens. The design was slightly revised but had primarily the same look. The manufacturers "Brasco" are on the East Coast, so shipping and design coordination was a challenge. Defective production of some pieces had to be reordered, which delayed installation and assembly until correct parts were fabricated and shipped by "Brasco". Lessons learned: Project Manager should allot time for new windscreens design and make it part of the construction contract so that all coordination and defects are on the Contractor's responsibility.

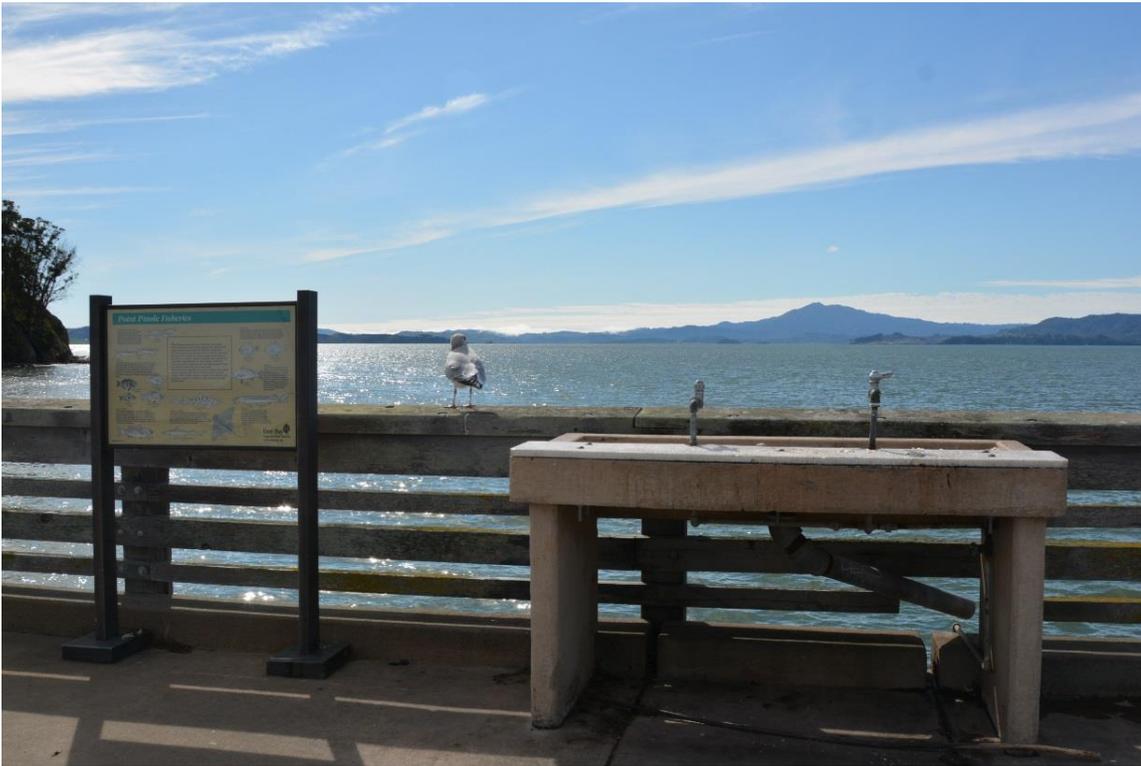
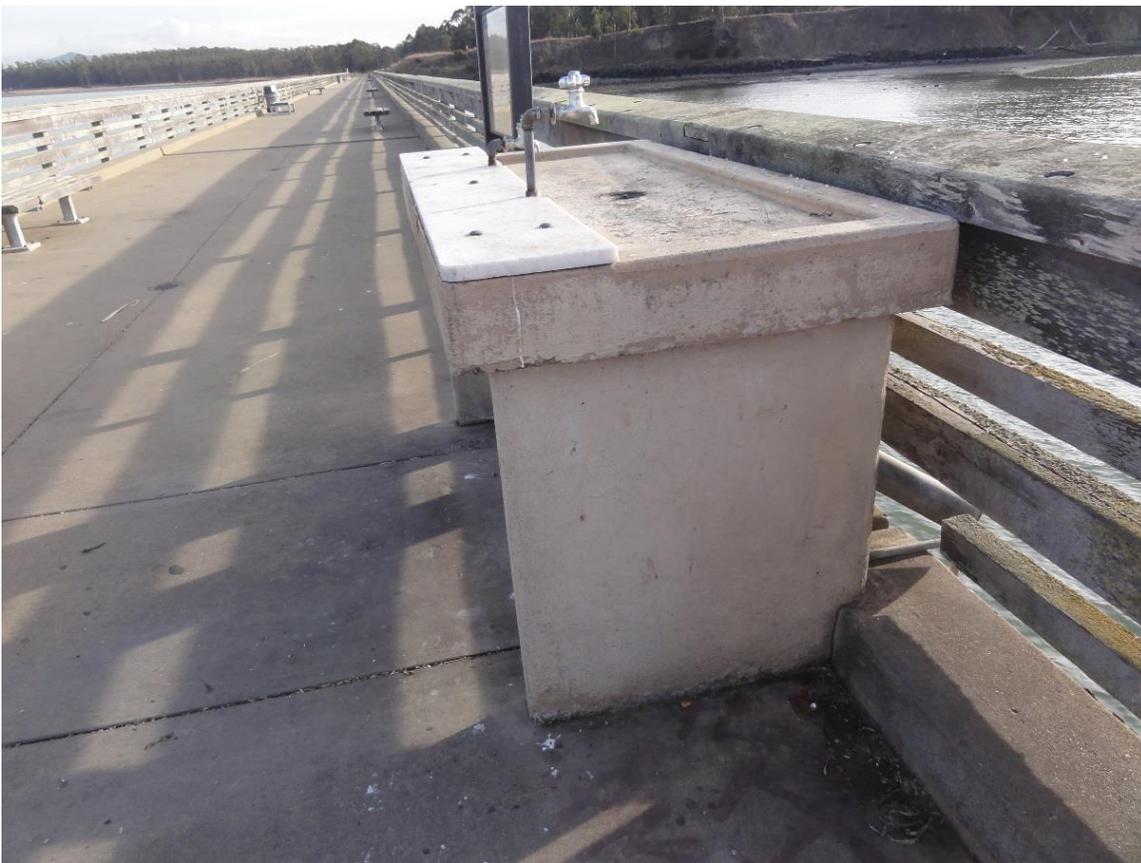
Photographs 14 and 15: Front view (Photo 14, top) and side view (Photo 15, bottom) of fish cleaning table before the project.

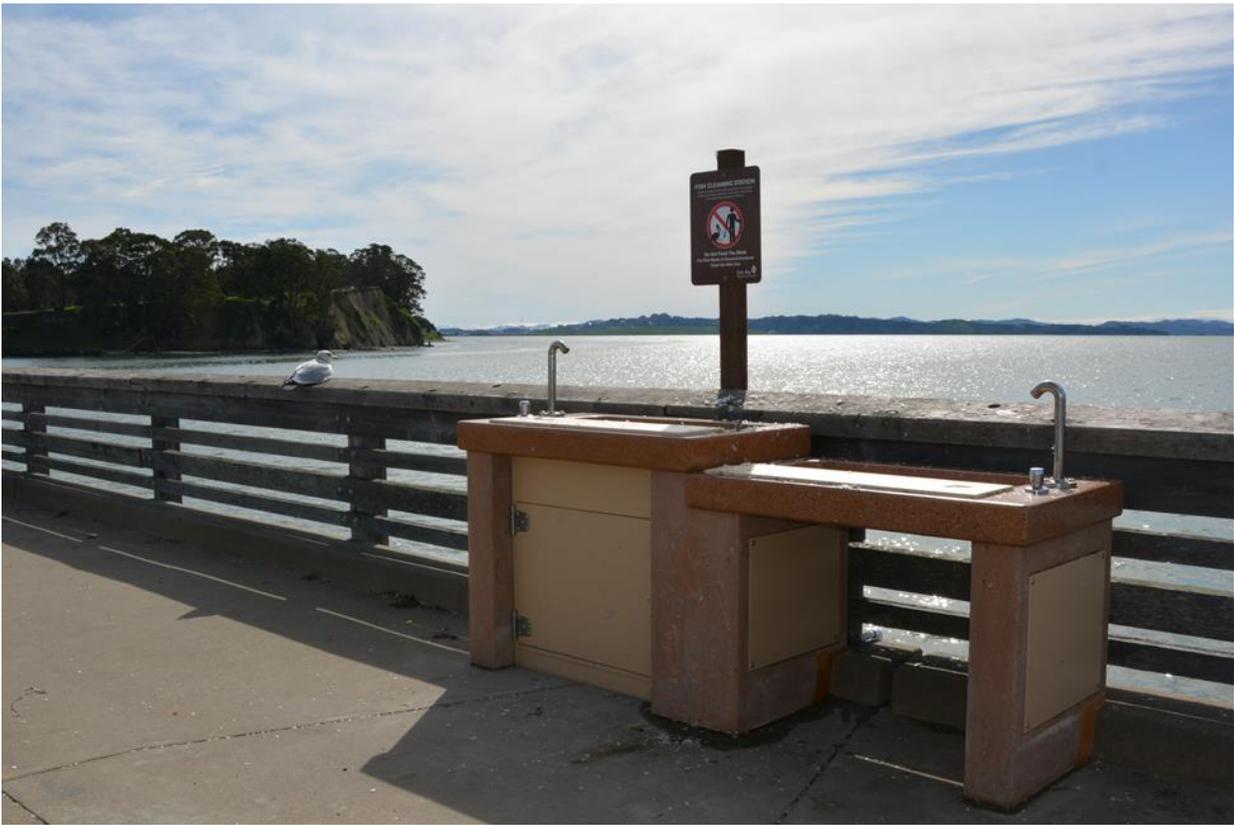
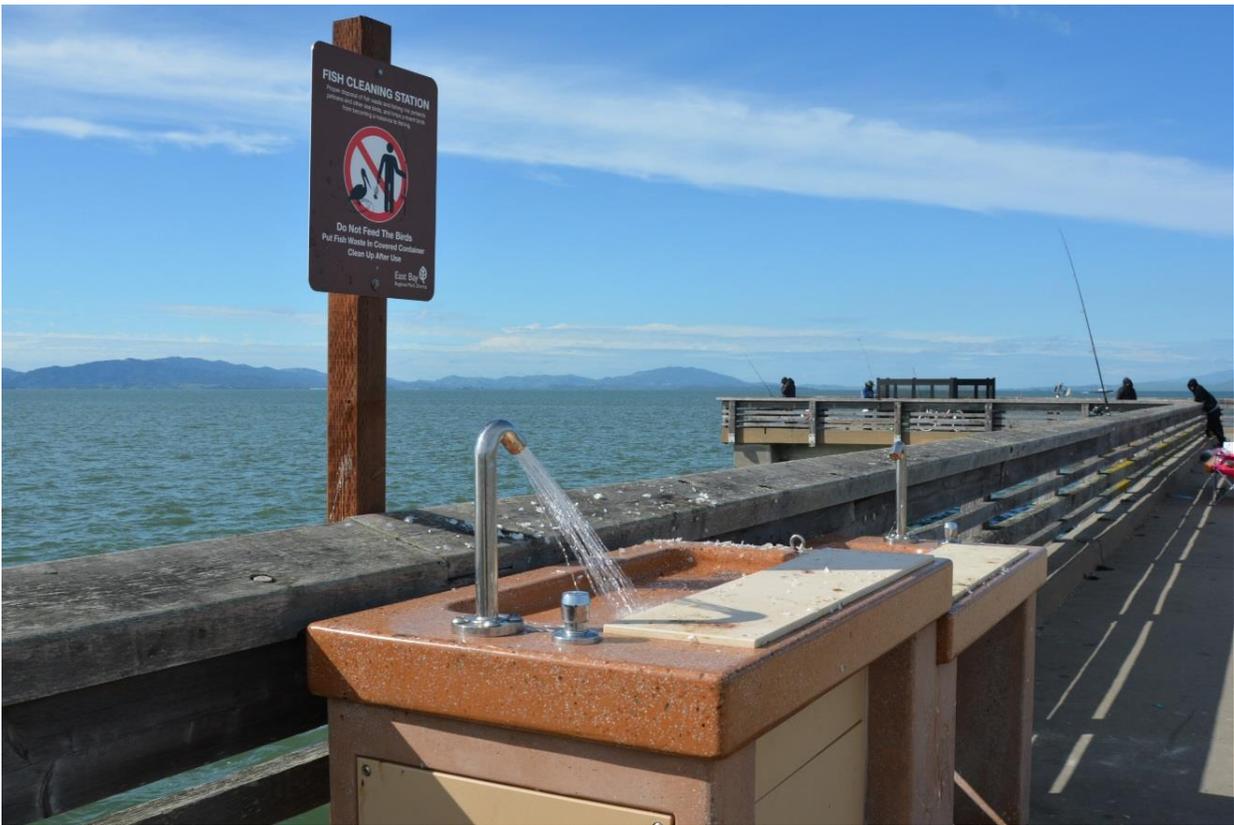
Photographs 16 and 17: Front view (Photo 16, top) and side view (photo 17, bottom) of fish cleaning table after the project, showing improvements in accessibility.

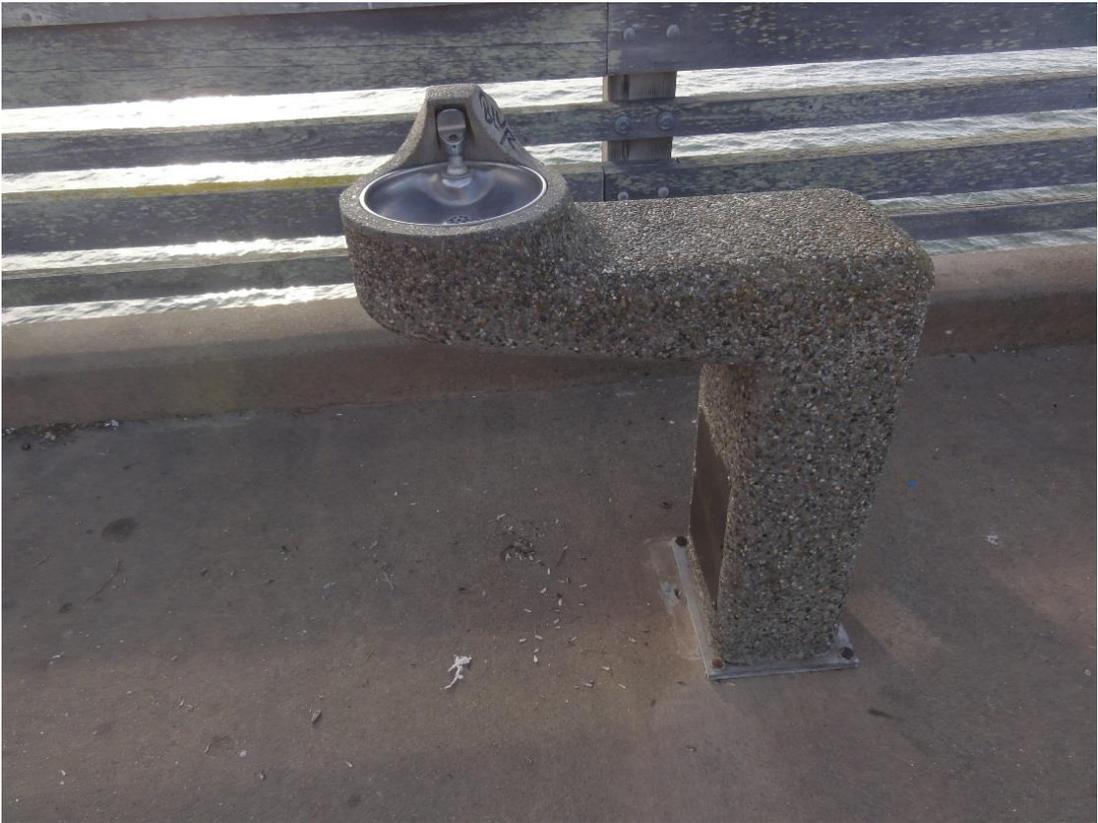
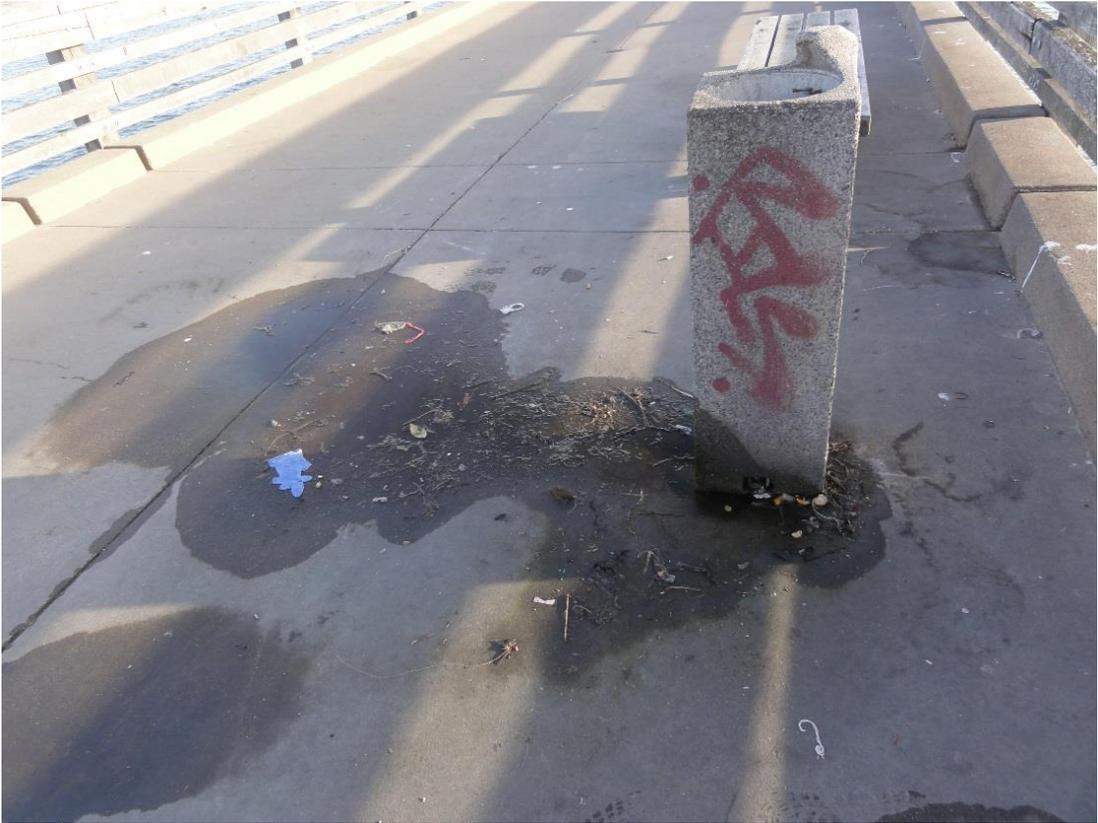
Photographs 18 and 19: Front view (Photo 18, top) and side view (photo 19, bottom) of drinking fountain before the project

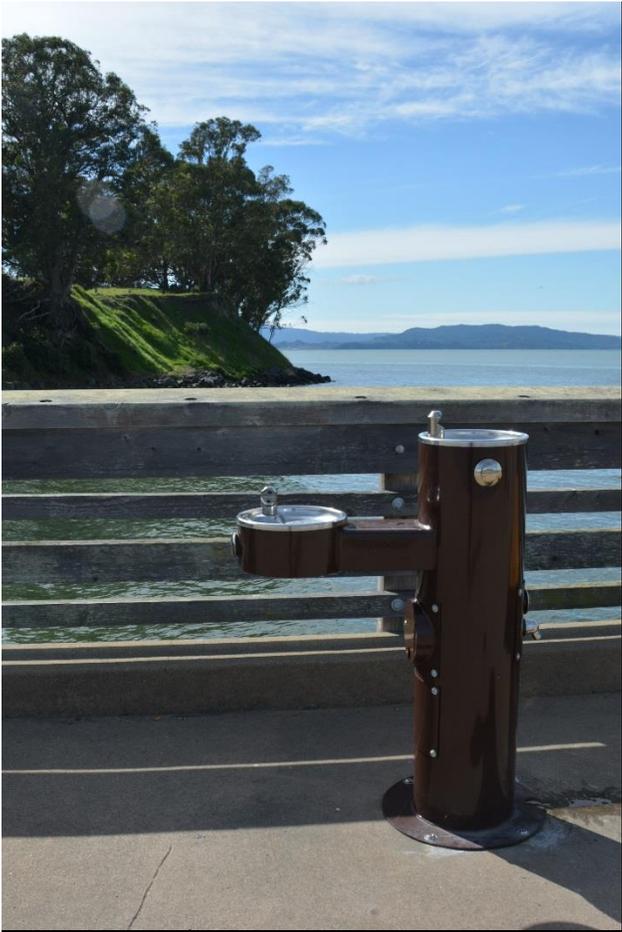
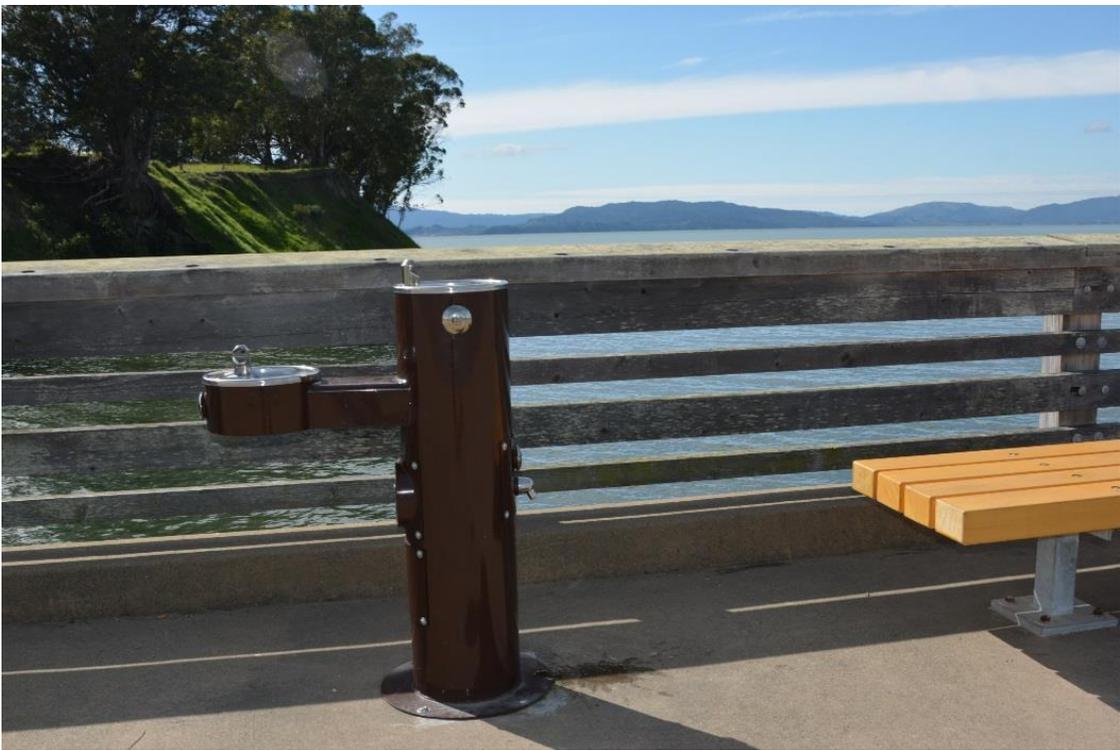
Photographs 20 and 21: Drinking fountain after the project showing improvements in accessibility (Photo 20, top) and proximity to replacement bench (Photo 21, bottom).
